THE TOWNSHIP OF NORTH DUNDAS

DRAFT BRIDGE MANAGEMENT STUDY REPORT 18 BRIDGES / 31 CULVERTS

March 2023

HP Engineering Inc.

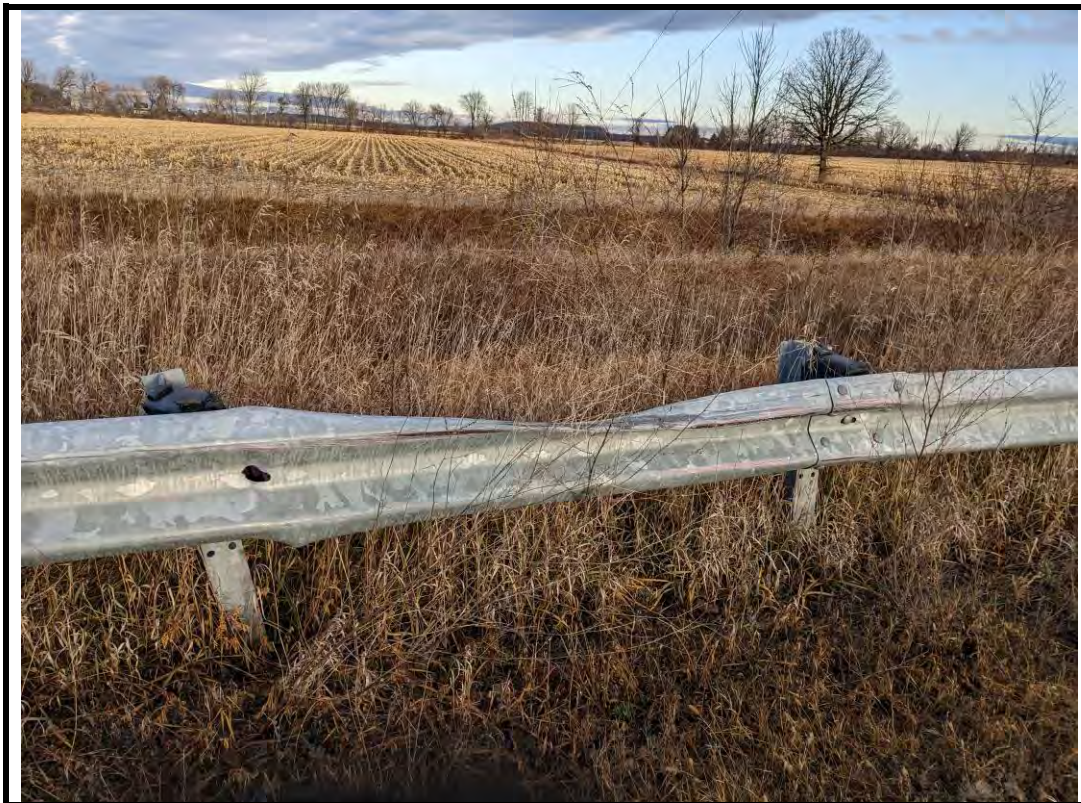
Photo 10 Impact damage at northeast approach barrier

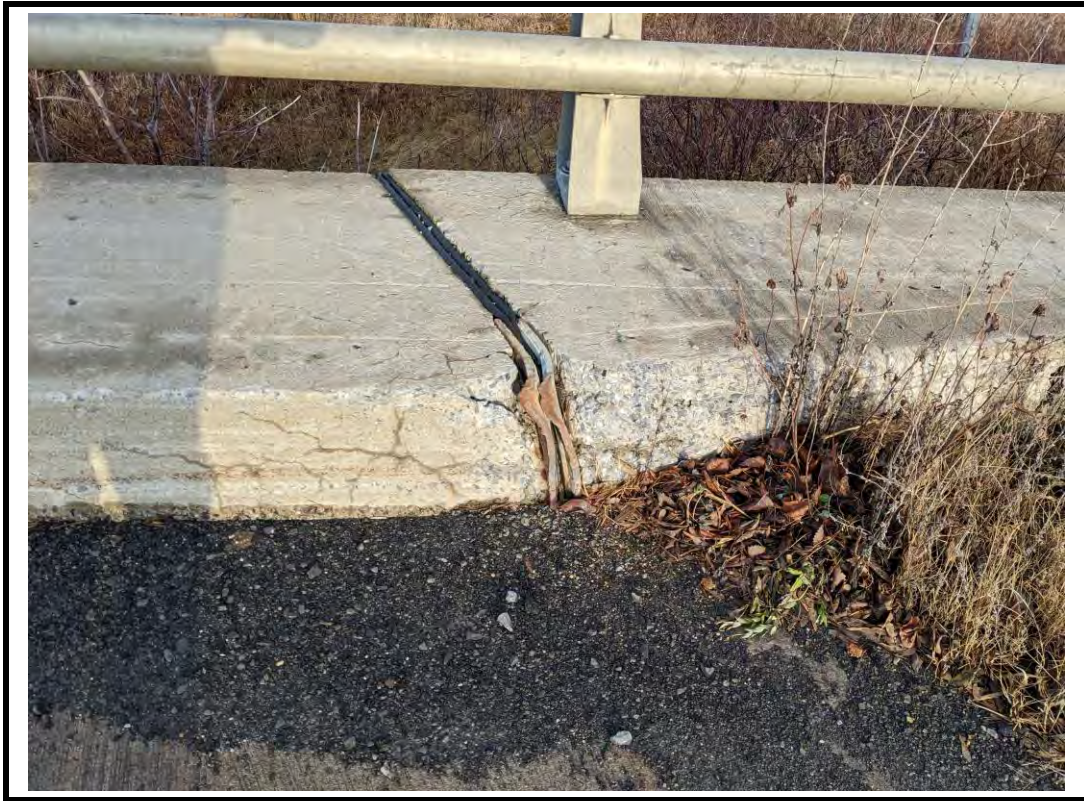
Photo 17 Scaling on curb and damage at northeast joint

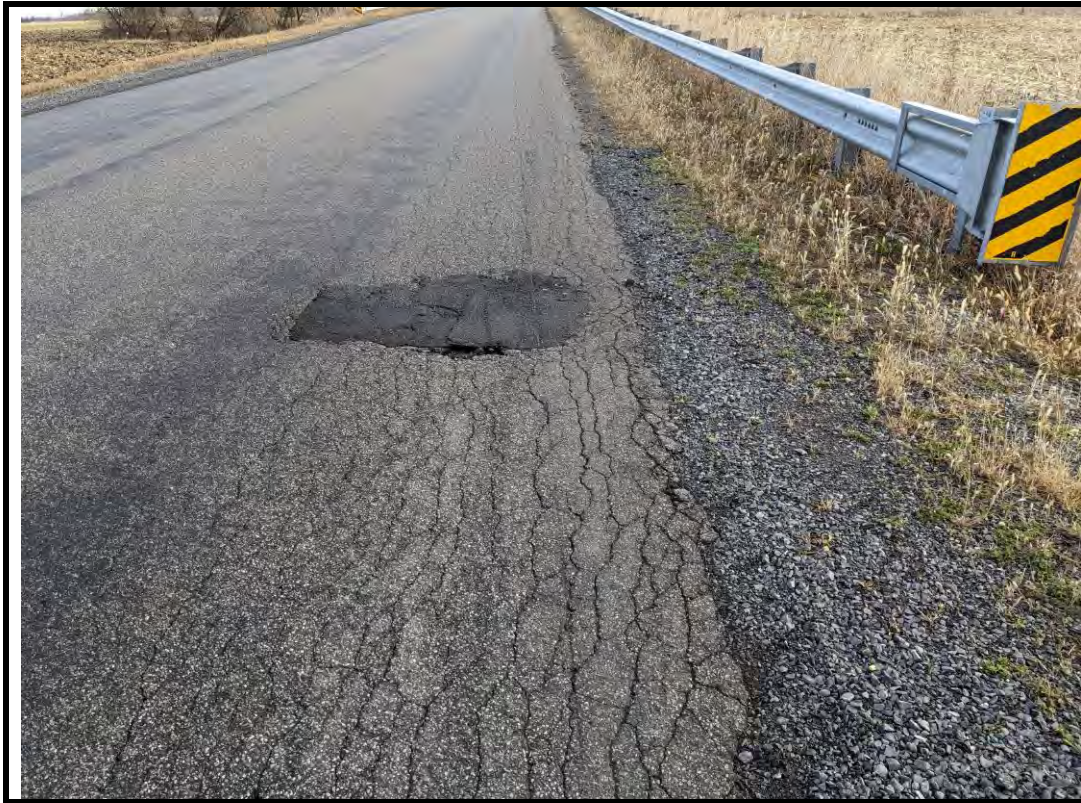
Photo 7 Pothole, patch, and crack at southwest approach wearing surface

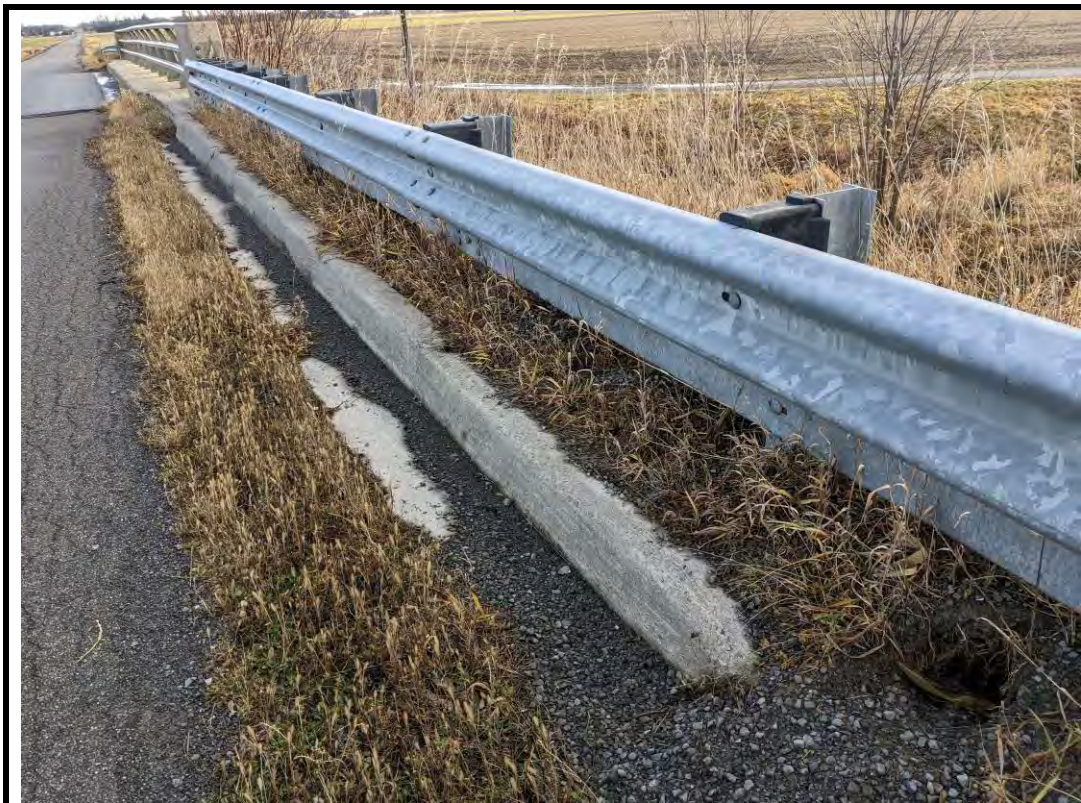
Photo 8 Vegetation and aggradation at southwest approach (typical)

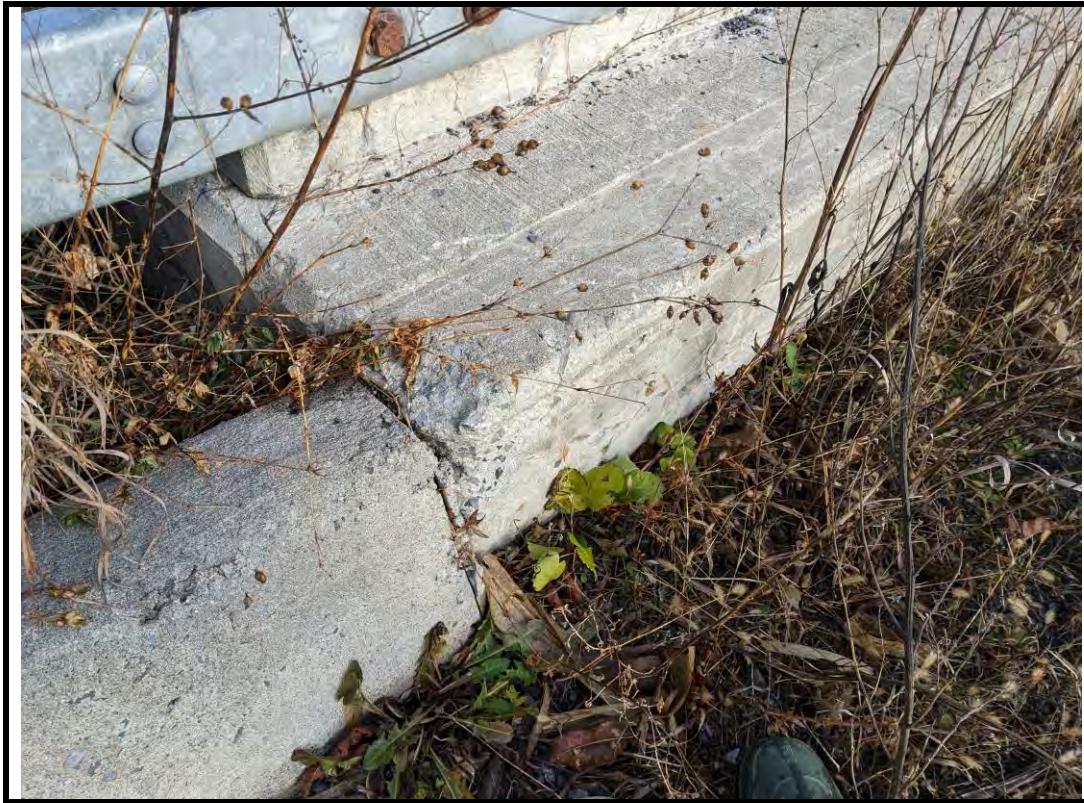
Photo 9 Spall on northwest barrier curb at transition

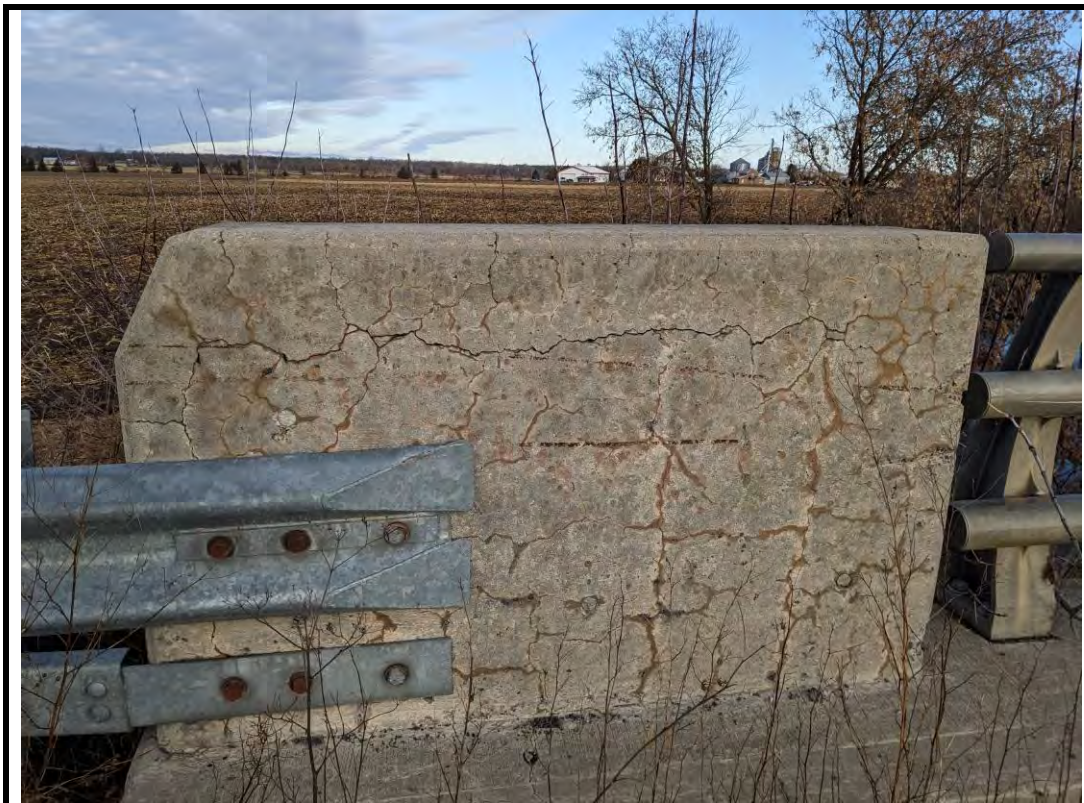
Photo 10 Wide AAR cracking at northwest barrier end wall

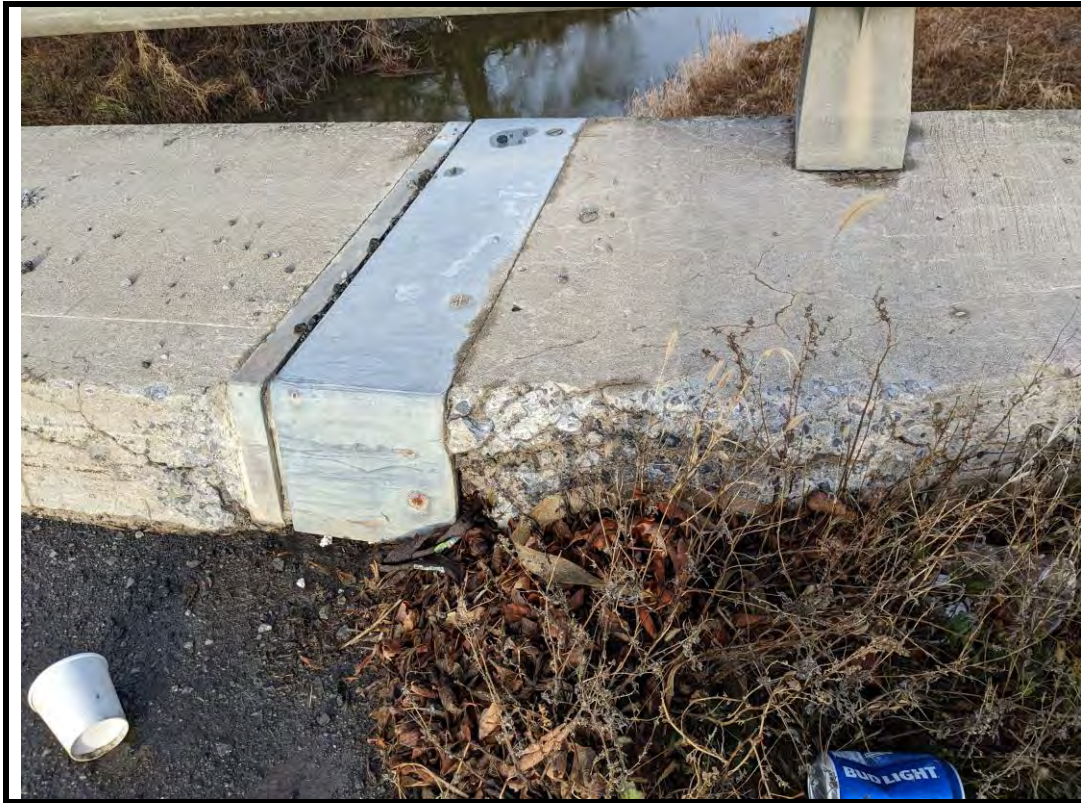
Photo 11 Spall at northeast barrier curb near joint

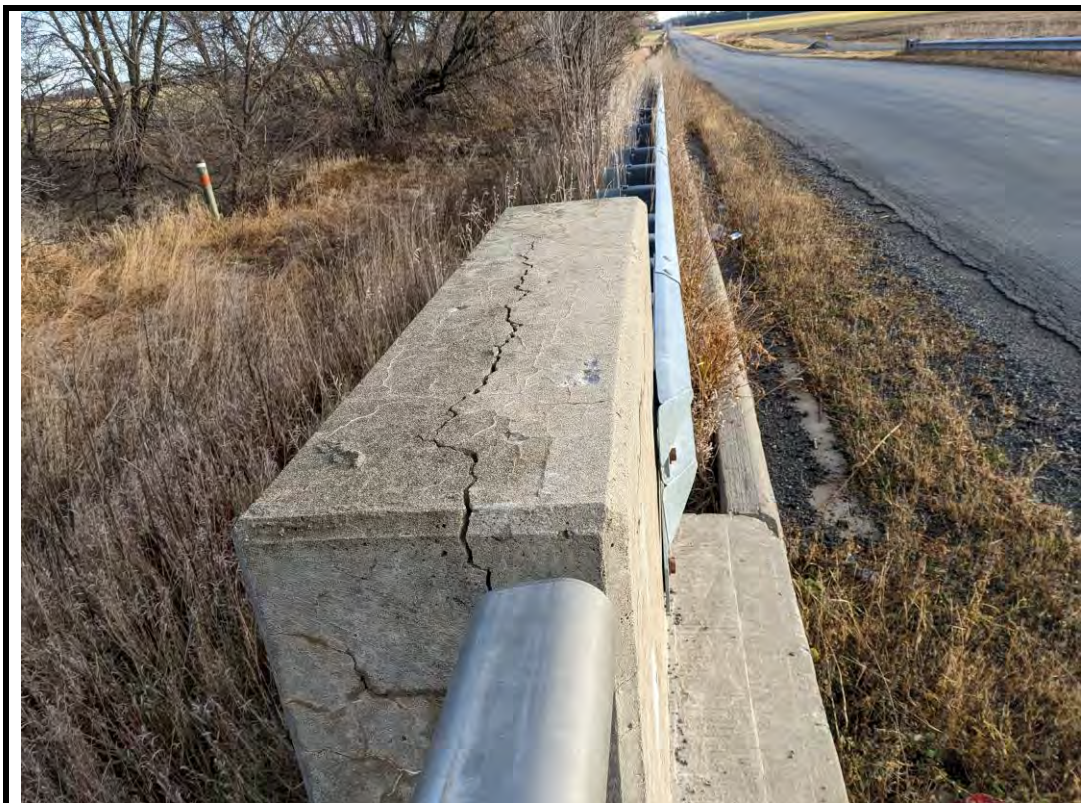
Photo 12 Wide crack at northeast barrier end wall

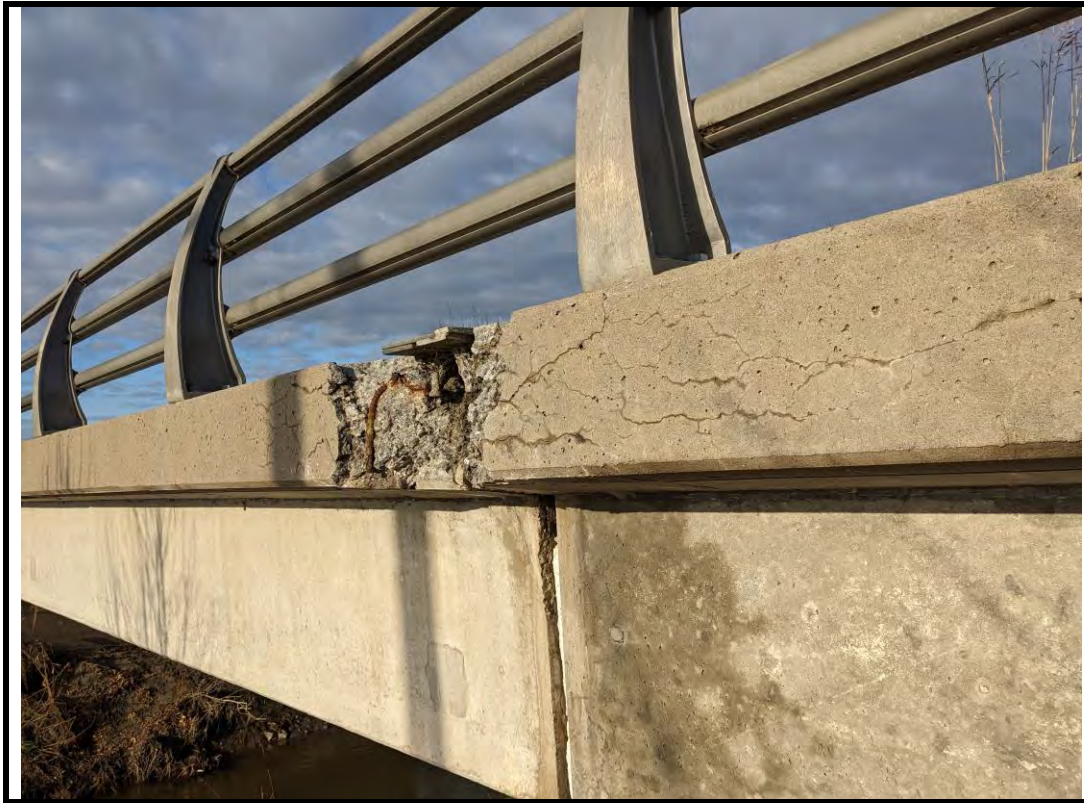
Photo 13 Spall at southeast joint and deck fascia

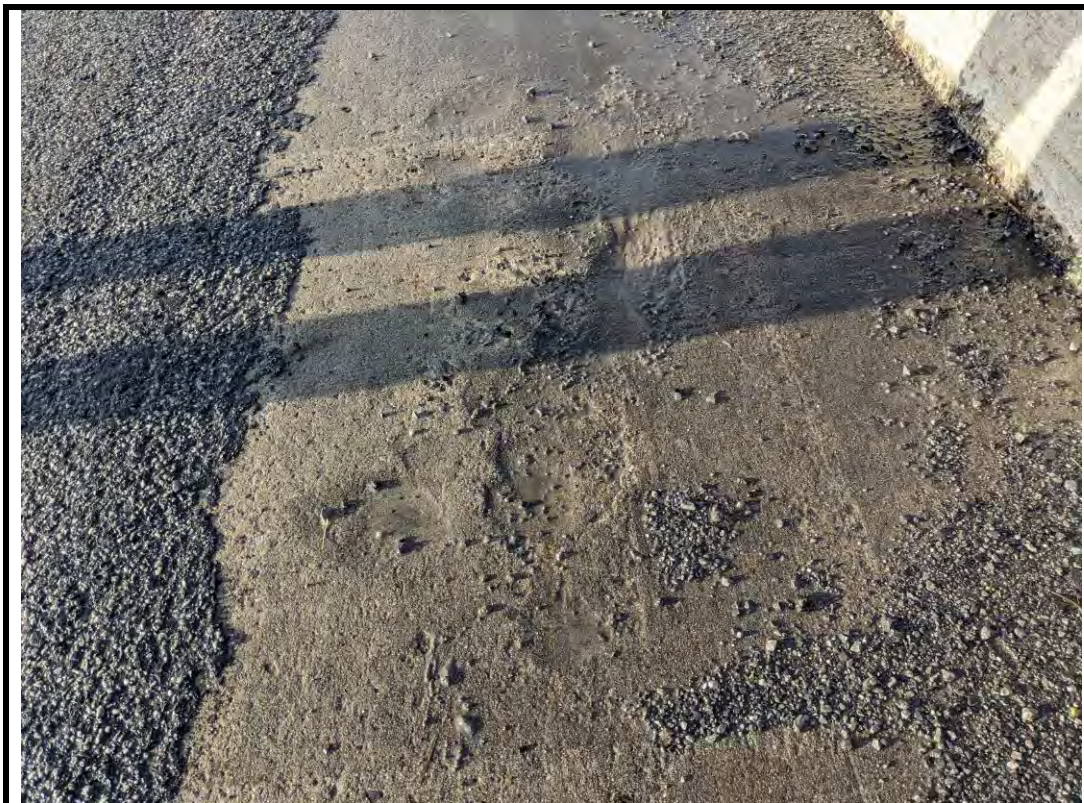
Photo 14 Exposed concrete deck top beside surface treatment

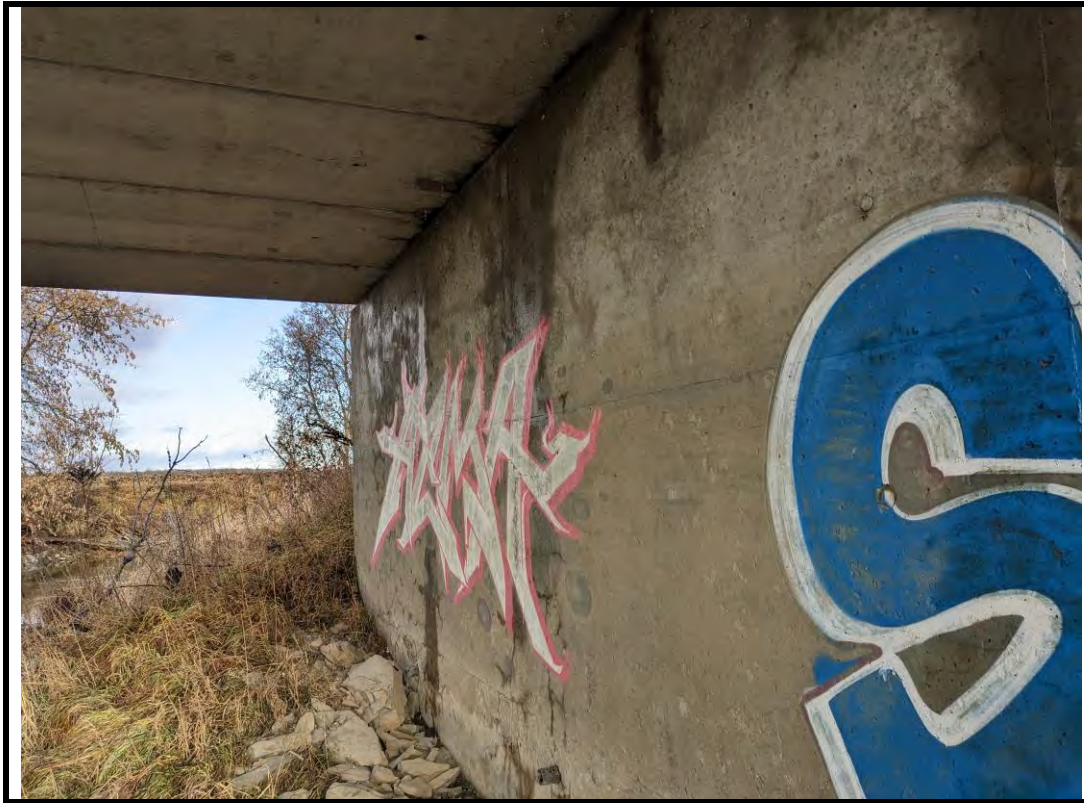
Photo 15 Evidence of leaking and joint failure at east abutment wall

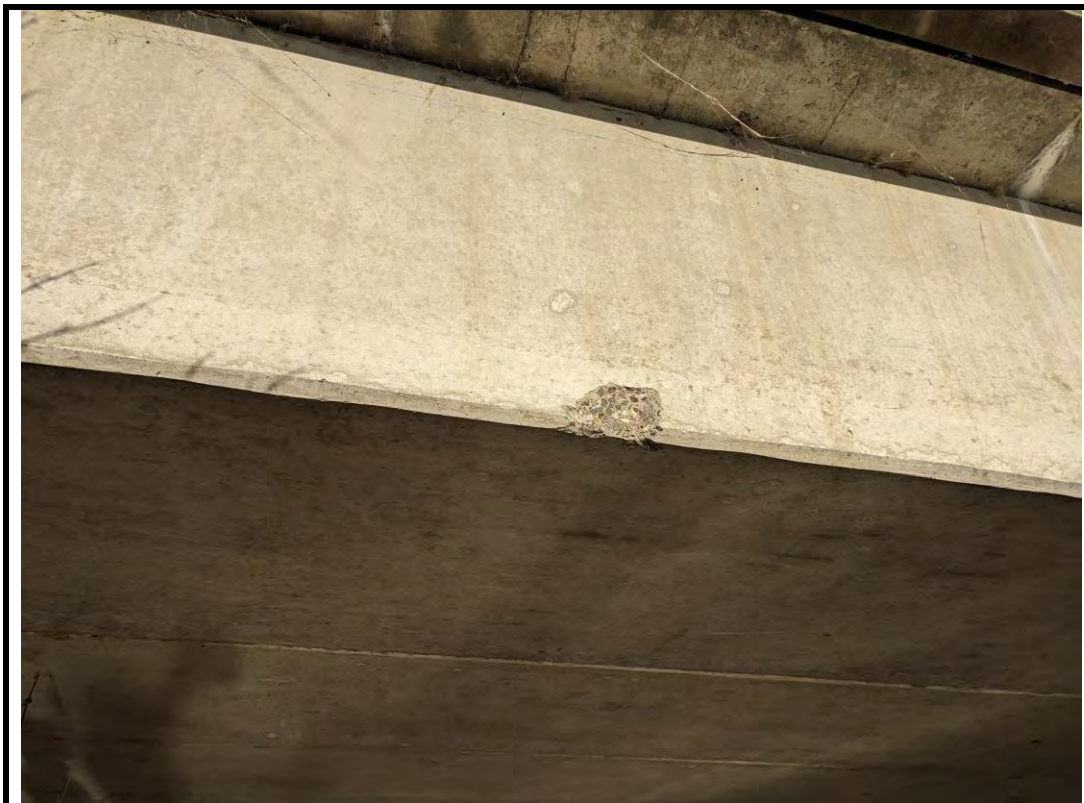
Photo 16 Small spall on south box girder side (named as soffit in report)

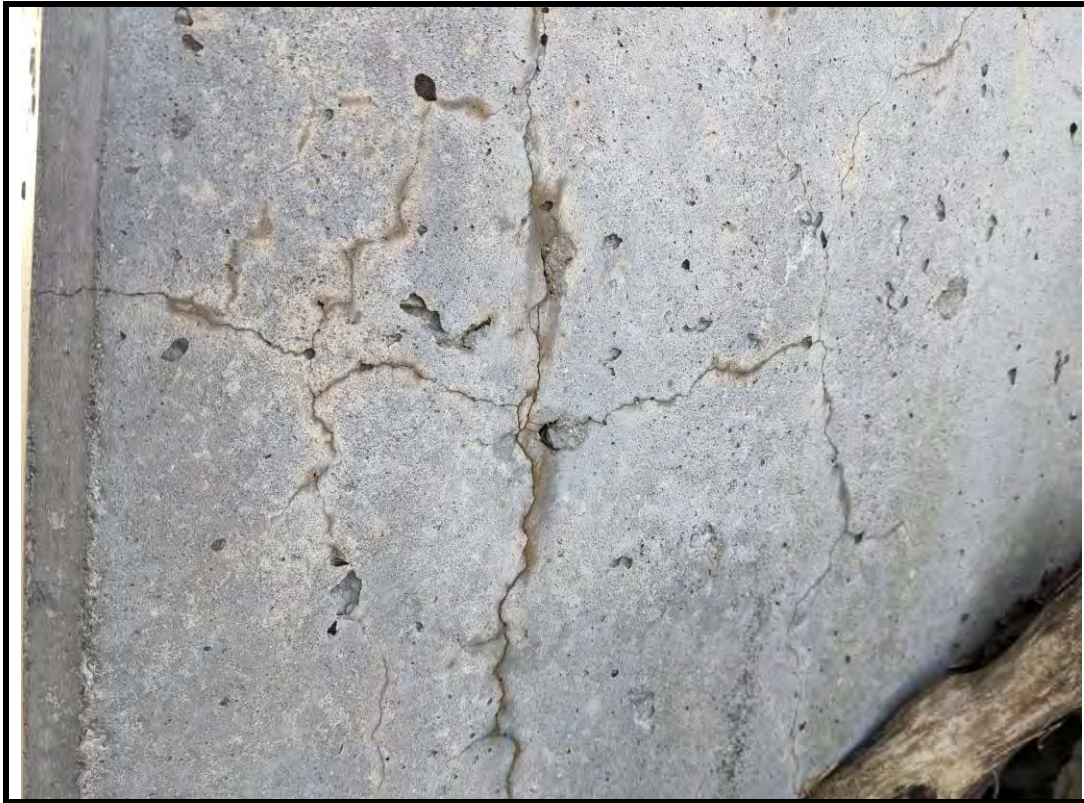
Photo 17 Cracks in northwest abutment wall

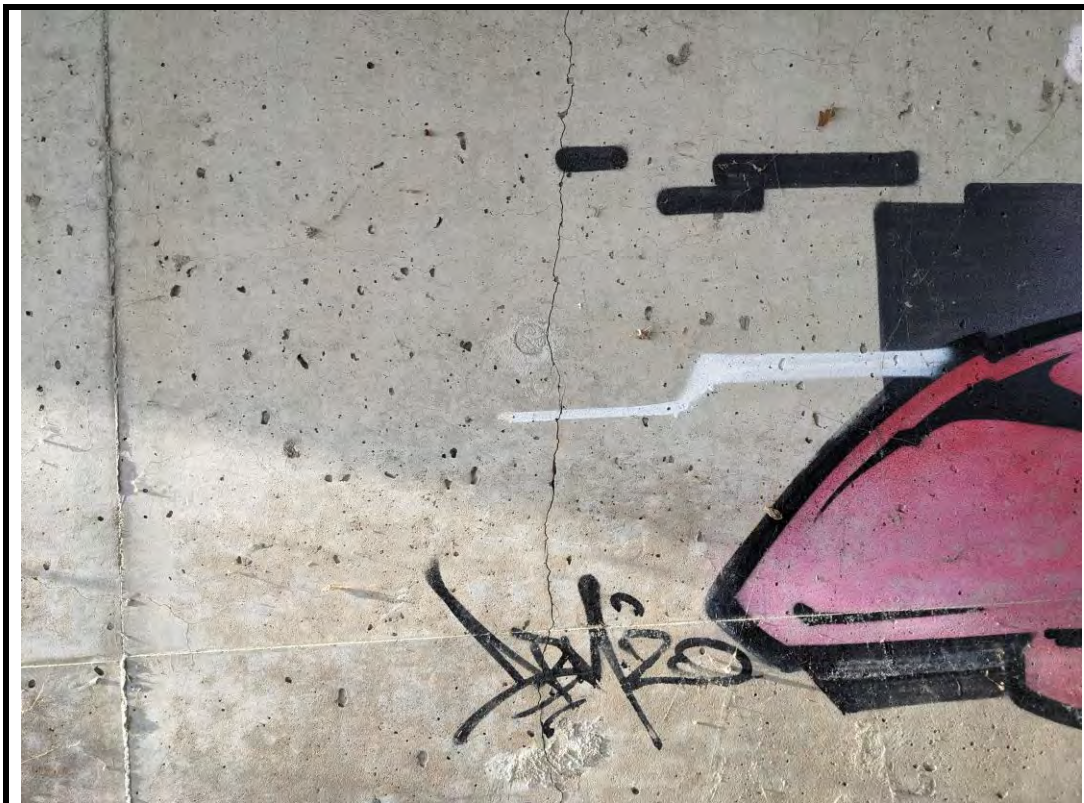
Photo 18 Crack in west abutment wall

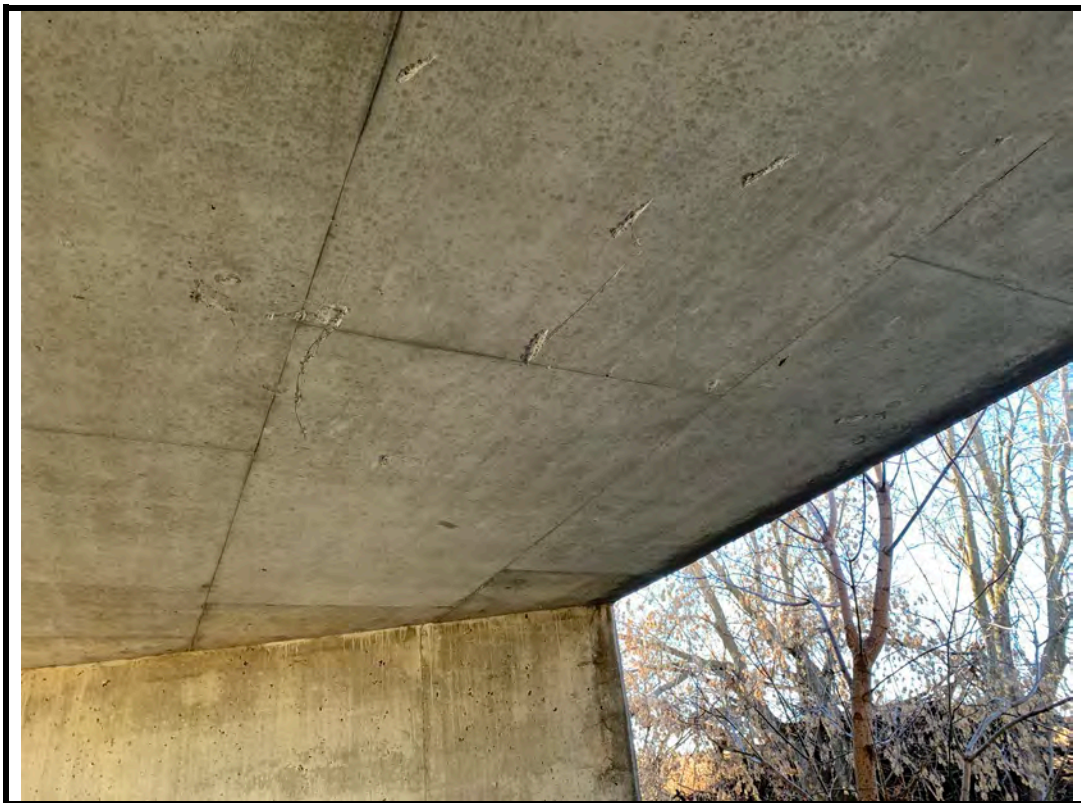
Photo 12 Localized spalls on interior soffit

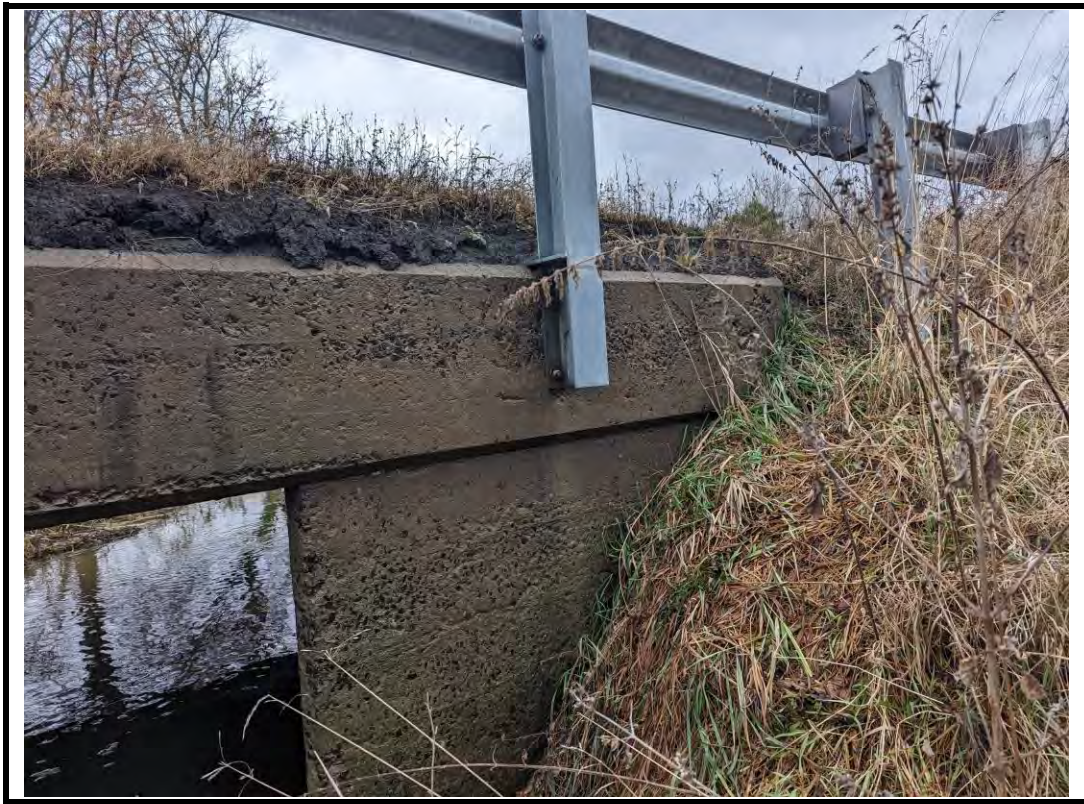
Photo 17 Scaling on wingwalls

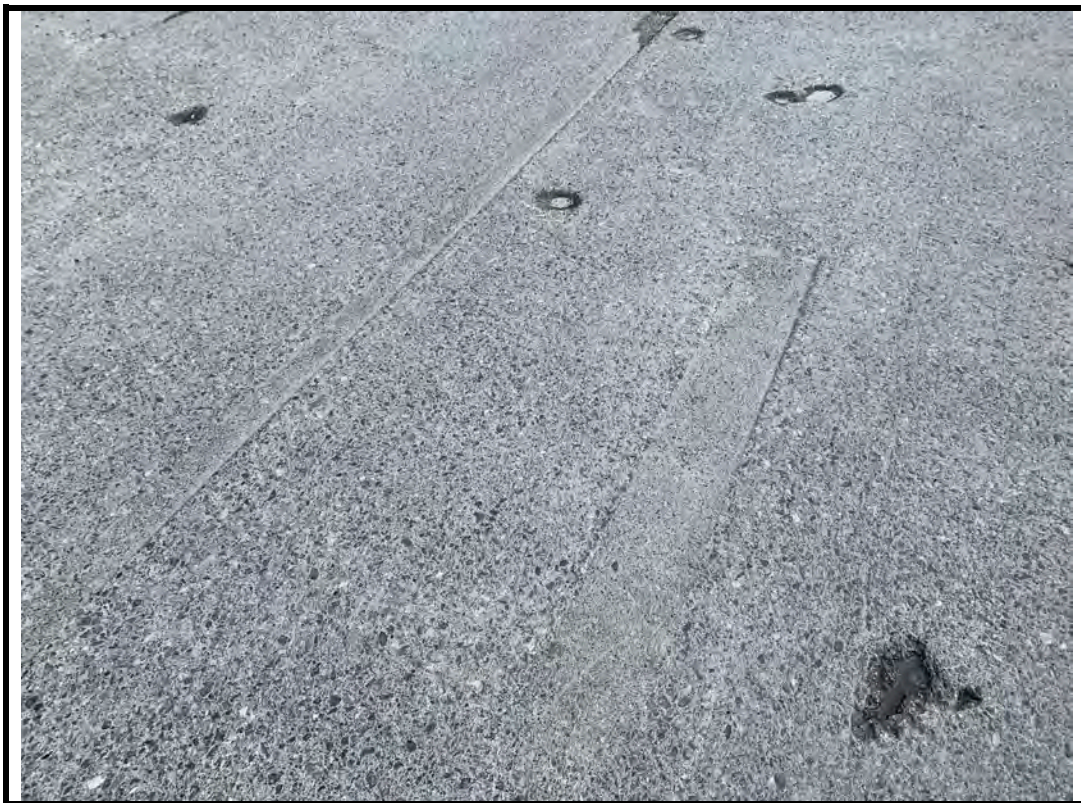
Photo 12 Abrasions and small spall on exposed deck surface

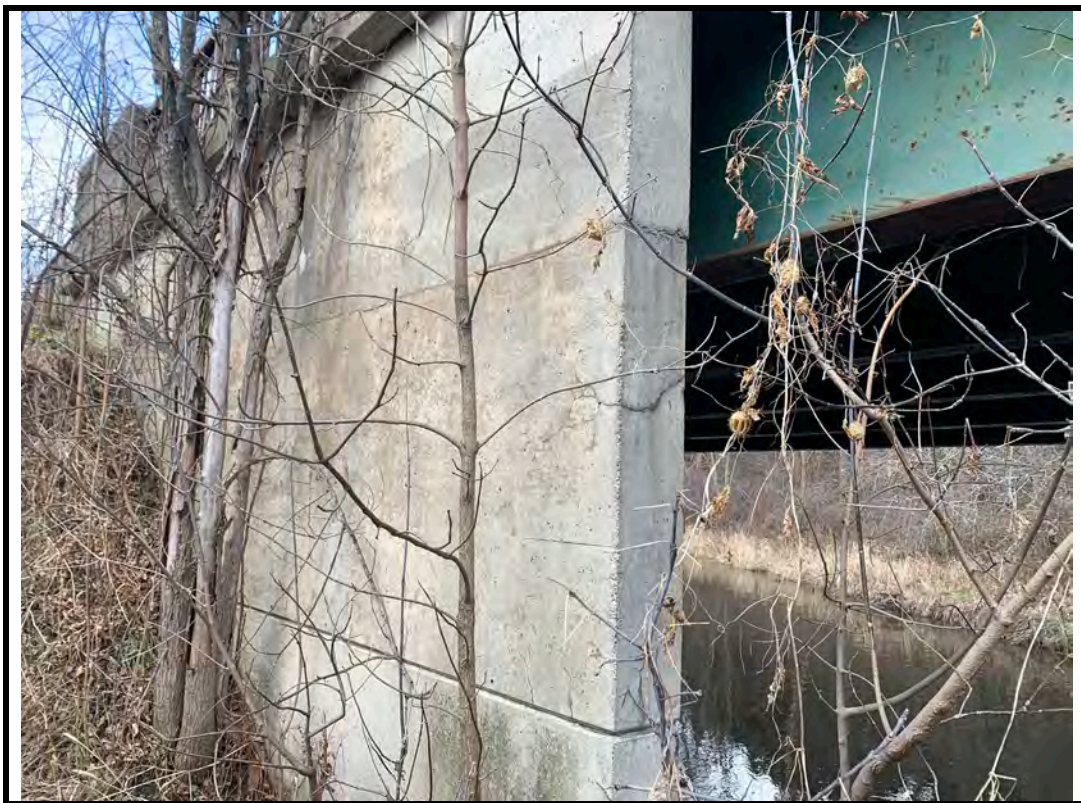
Photo 17 Crack on northwest wingwall

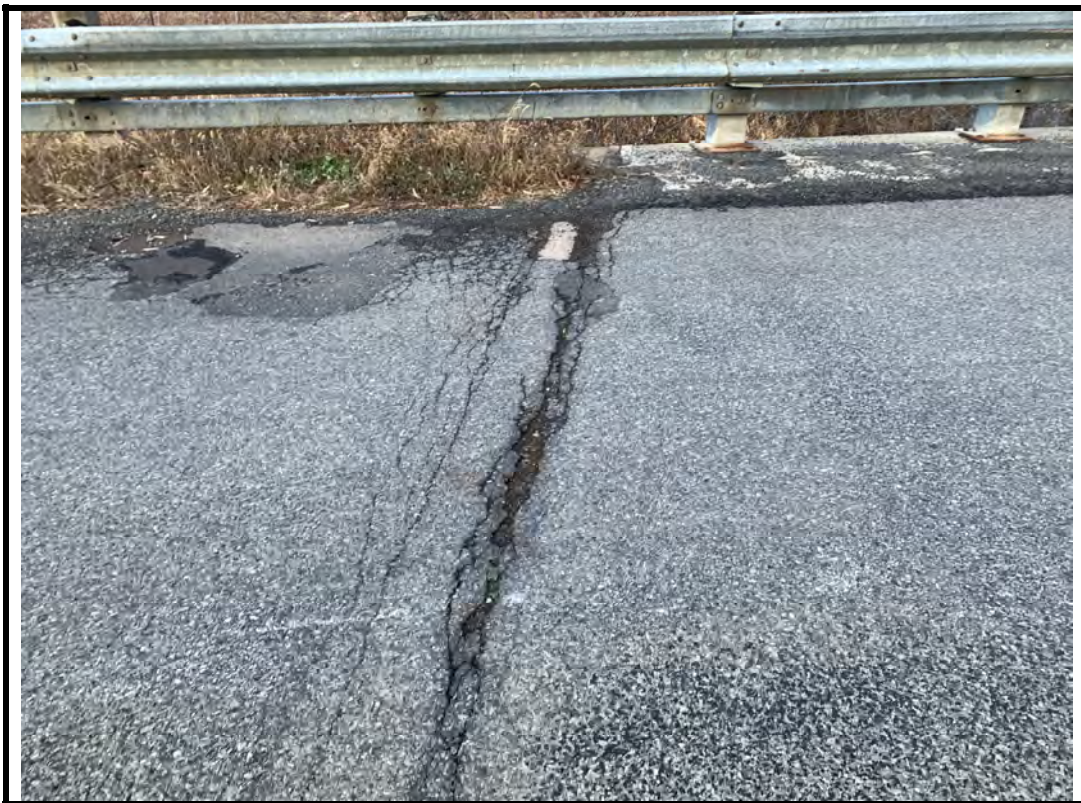
Photo 12 Wide crack and small potholes at west end of deck, at joint location

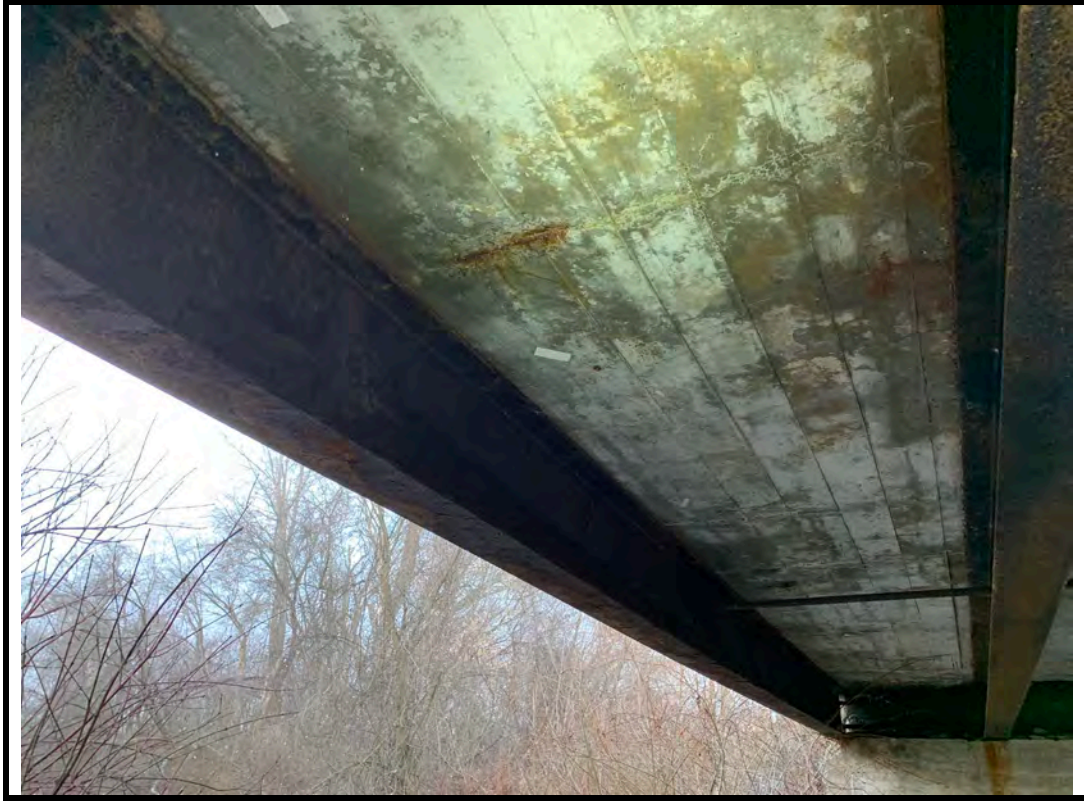
Photo 13 Rust stains efflorescence on interior soffit

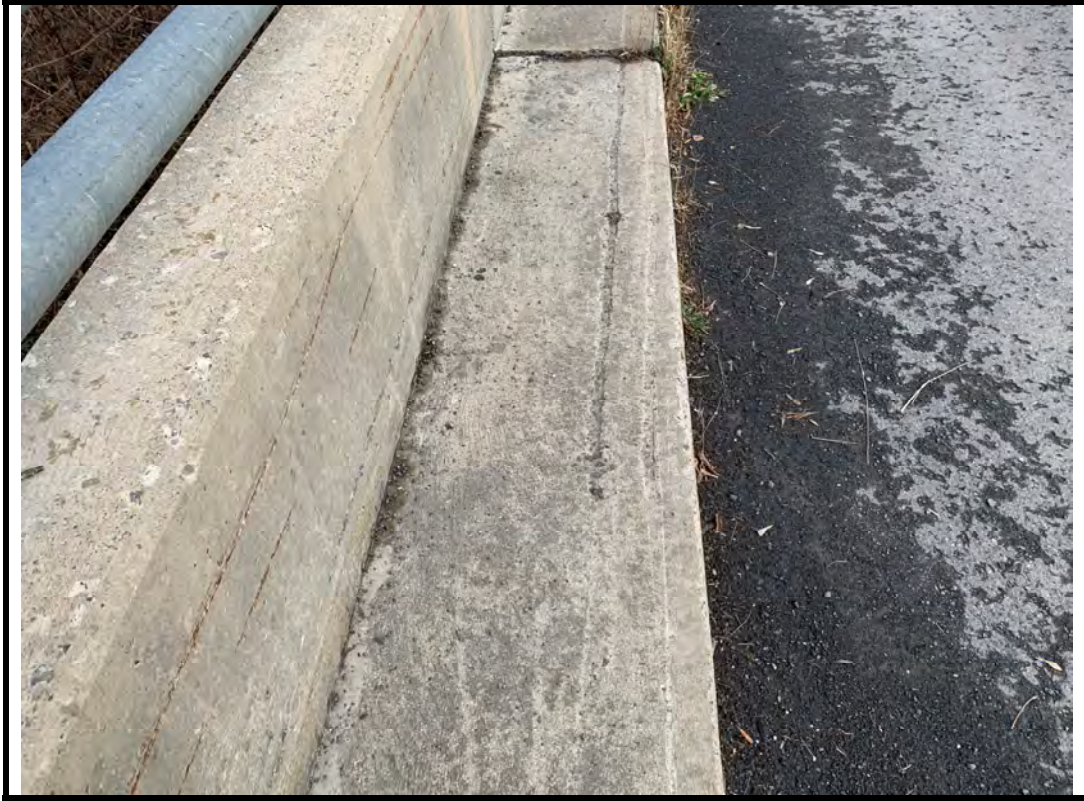
Photo 9 Abrasions on south curb

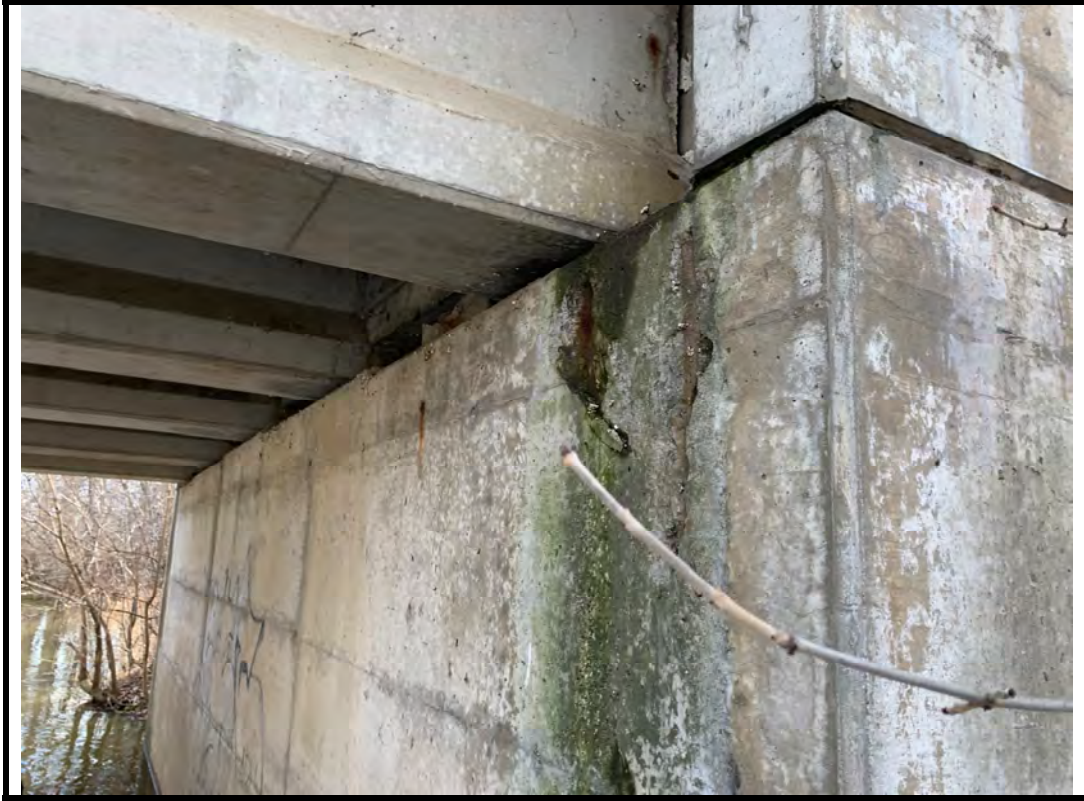
Photo 19 Staining and delamination on north end of east abutment wall

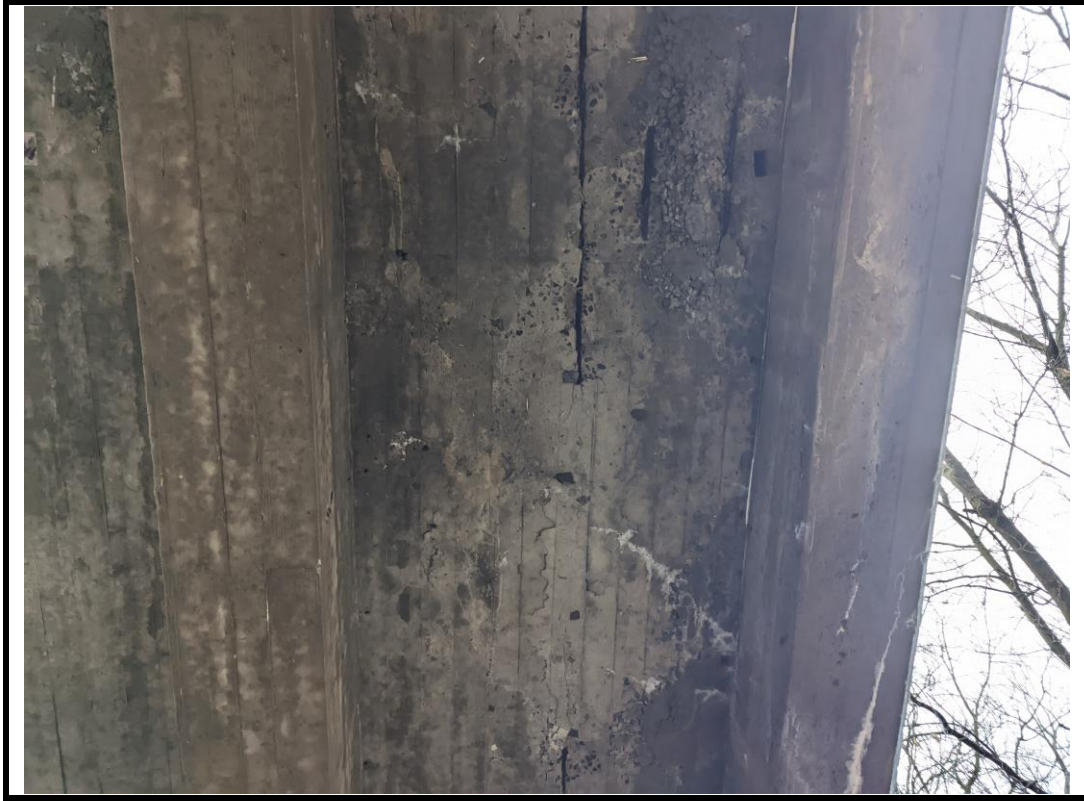
Photo 13 ECR, spalls, efflorescence and cracks on soffit (typ.)

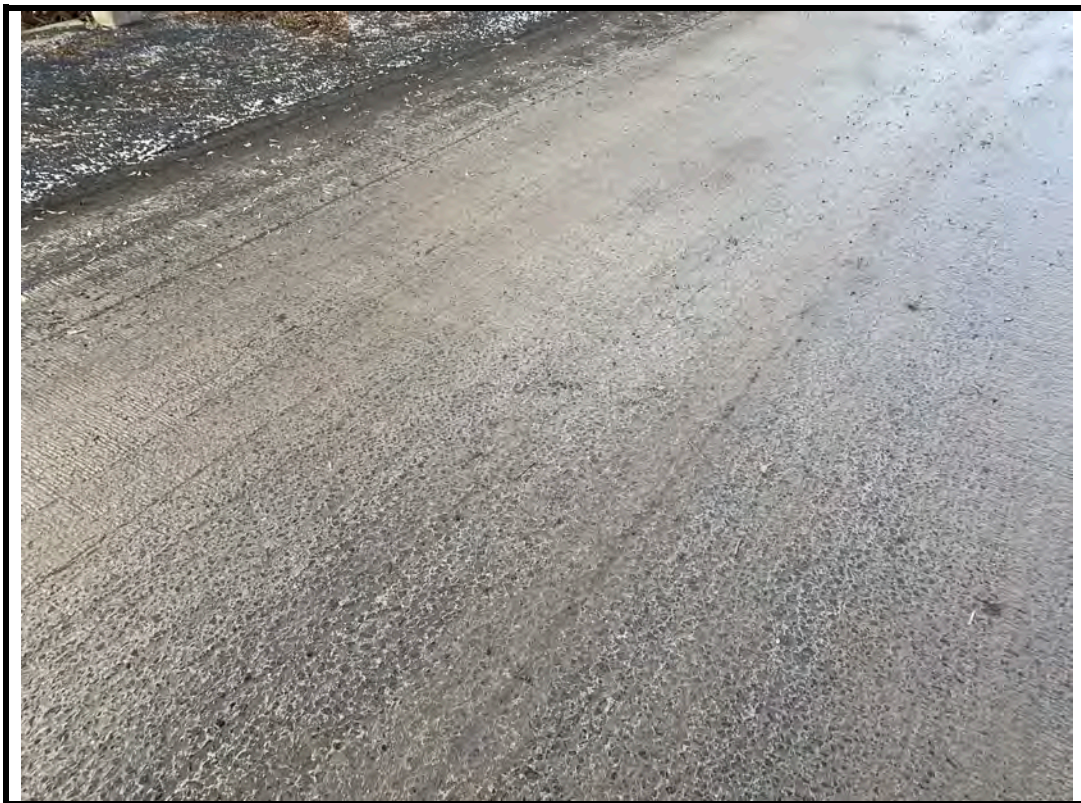
Photo 12 Wide cracks and abrasions on deck top

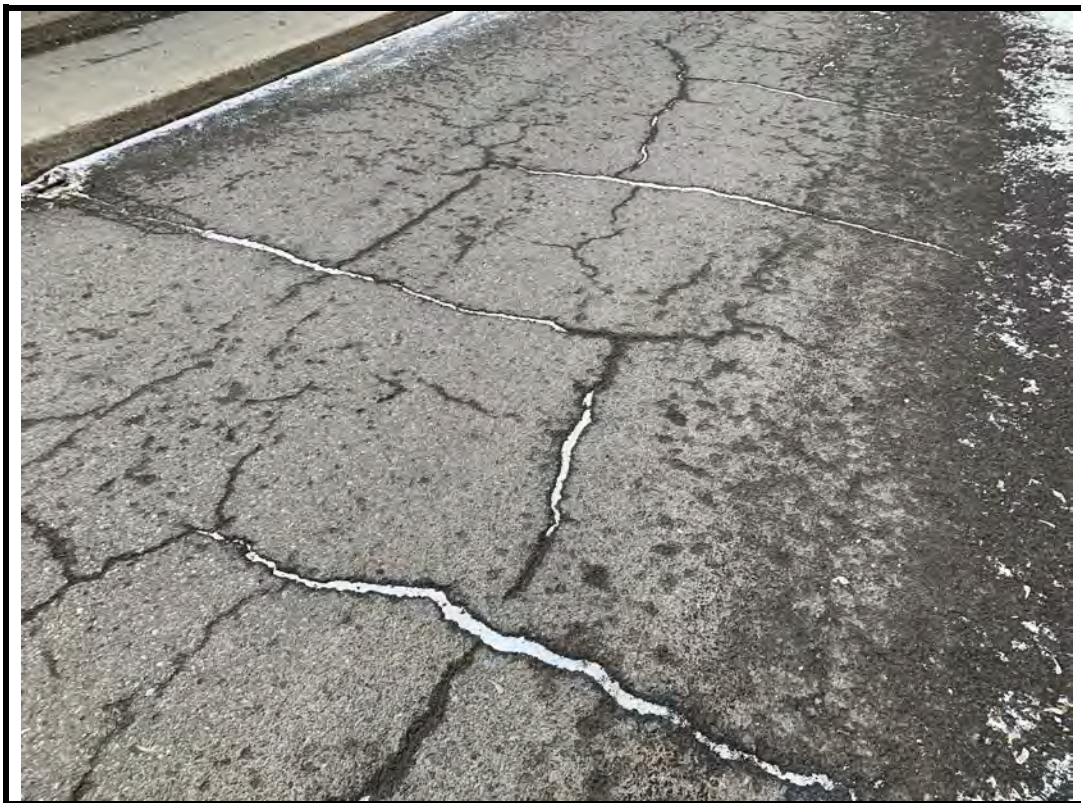
Photo 12 Wide longitudinal and transverse cracks on deck wearing surface

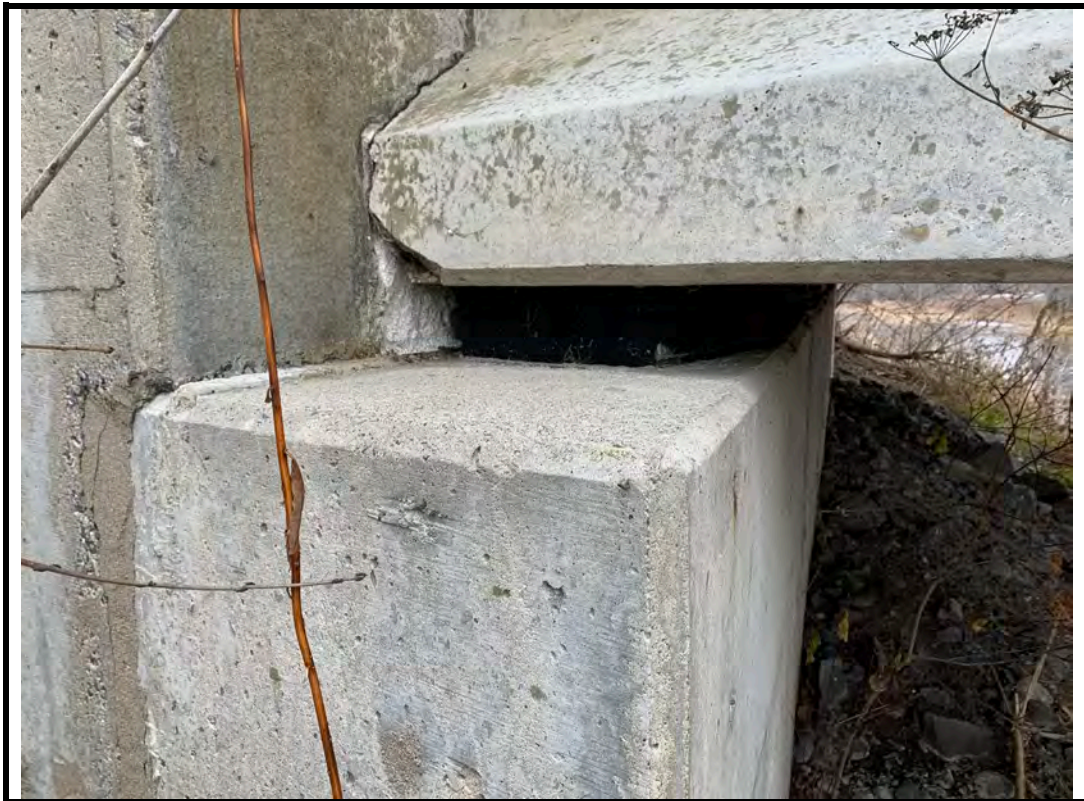
Photo 14 Small spall at west end of south girder
