THE TOWNSHIP OF NORTH DUNDAS

DRAFT BRIDGE MANAGEMENT STUDY REPORT 18 BRIDGES / 31 CULVERTS

March 2023

HP Engineering Inc.

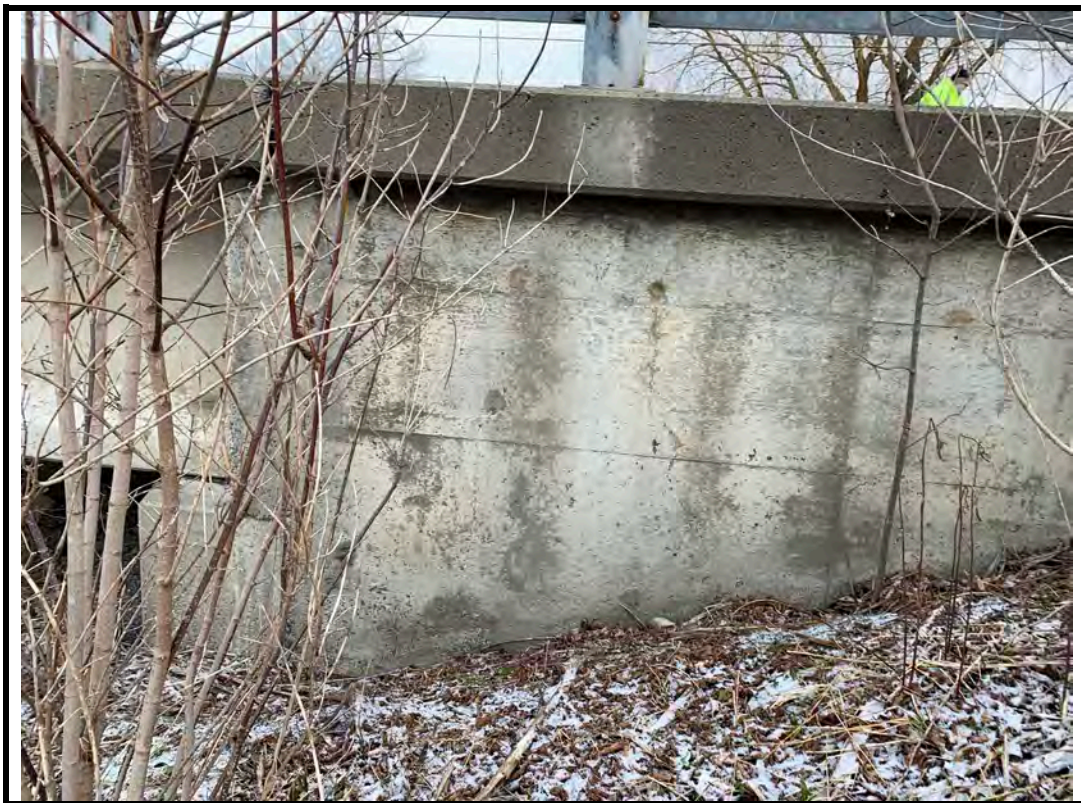
Photo 18 Narrow cracks on northwest wingwall

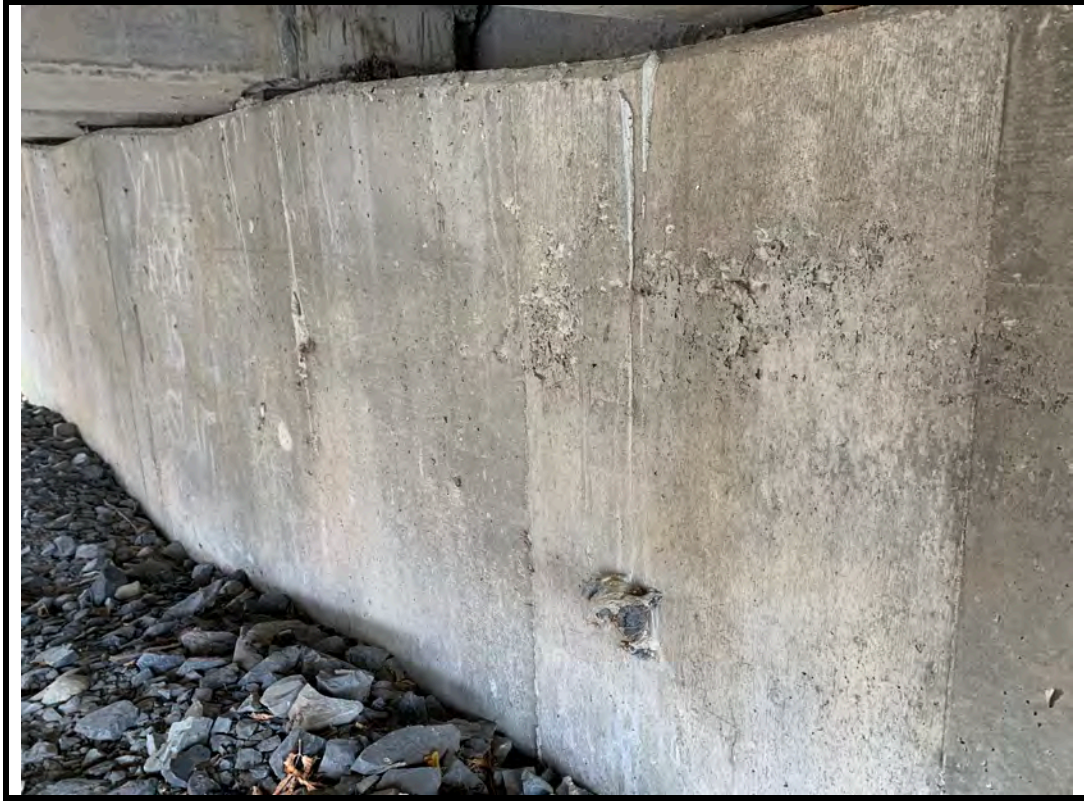
Photo 19 Localized moderate honeycombing on east abutment wall

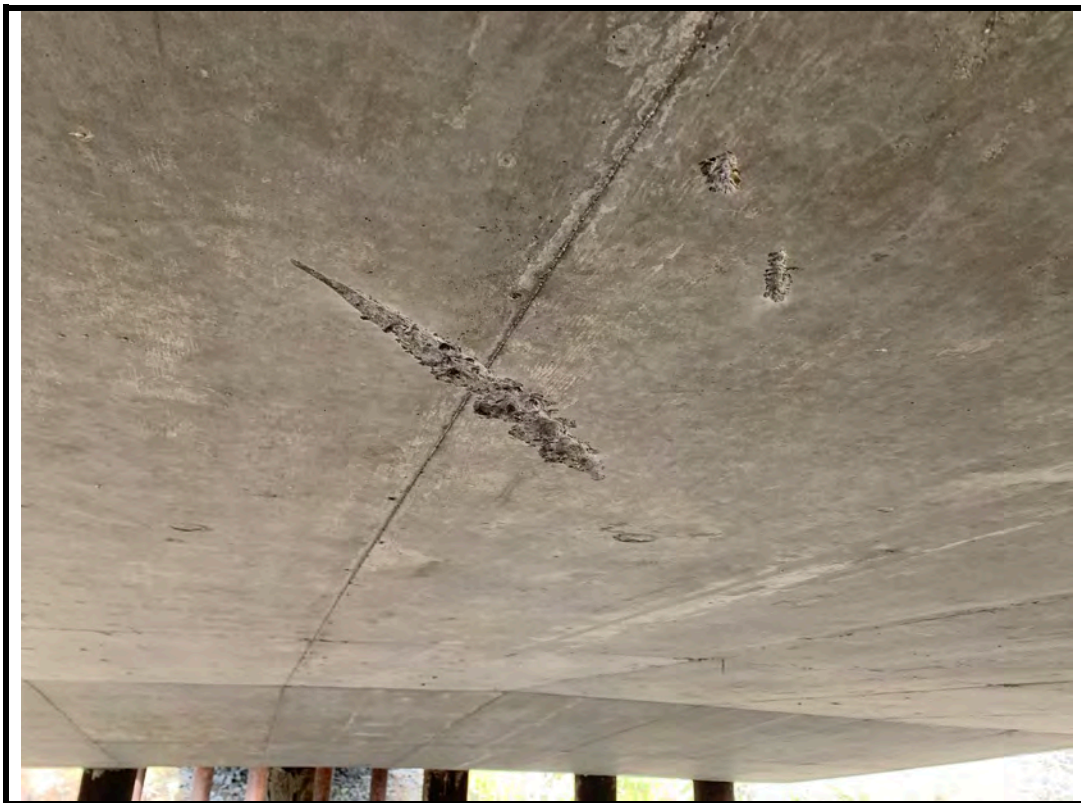
Photo 16 Small spall on south side of interior soffit

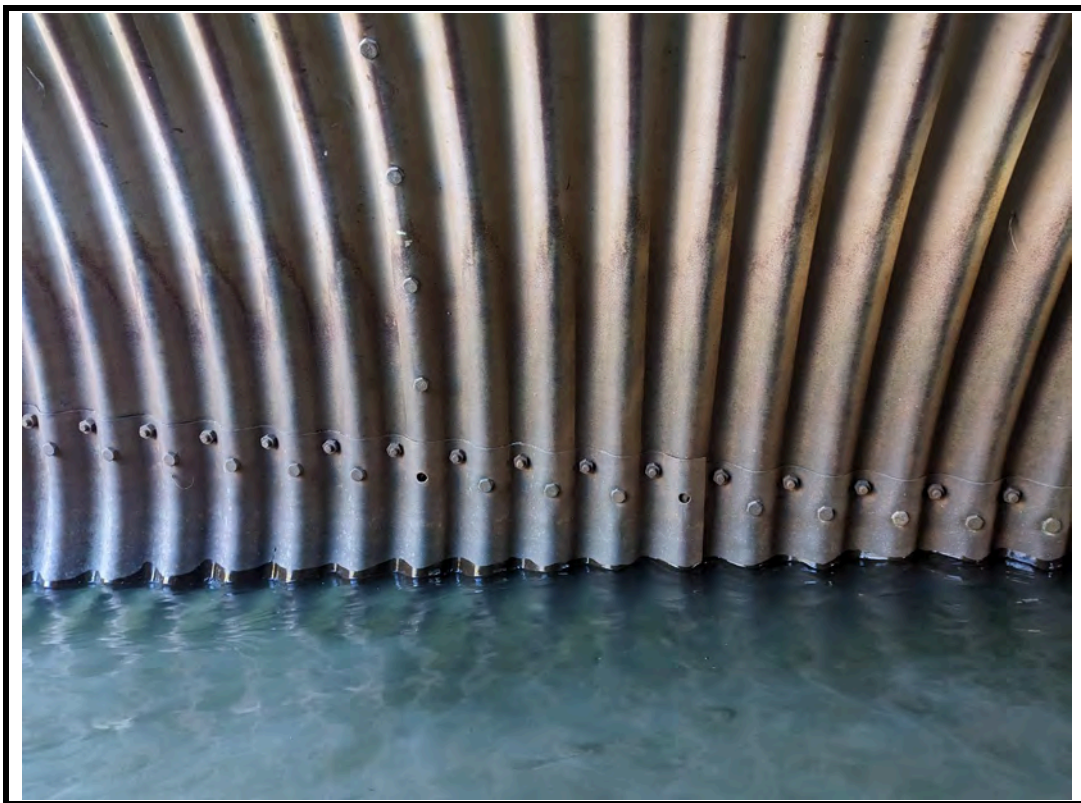
Photo 9 Light corrosion and missing bolt on east barrel wall

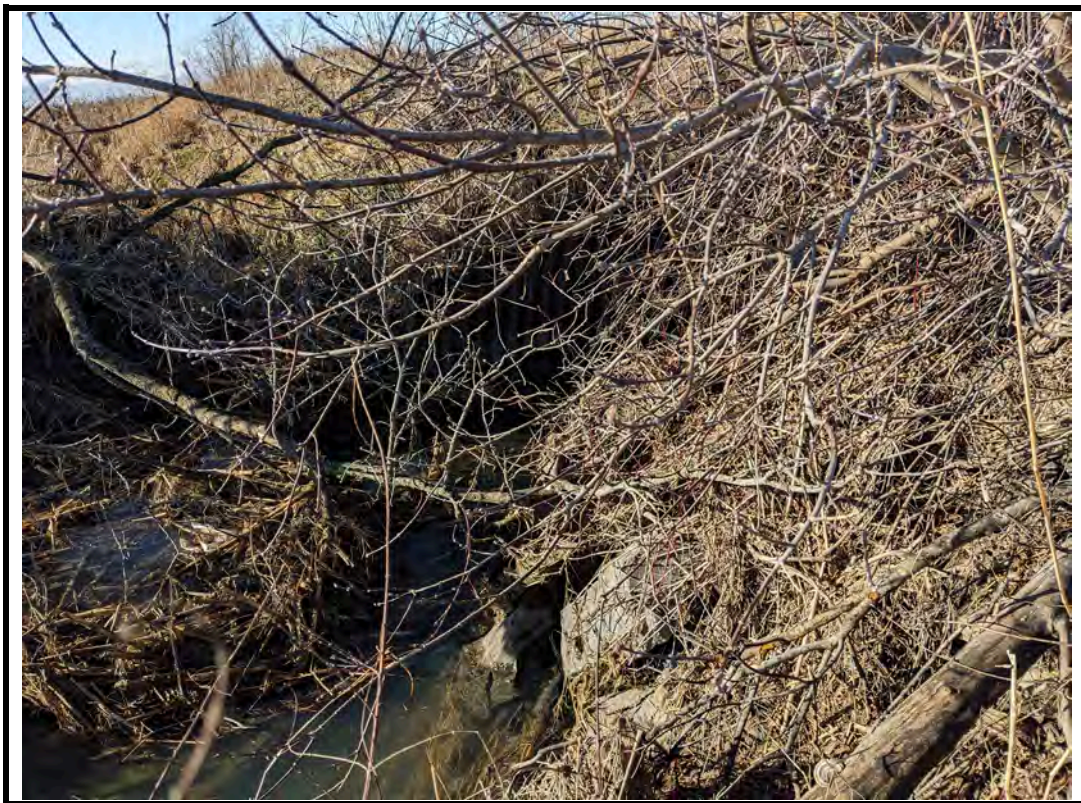
Photo 12 Debris blocking south side of barrel

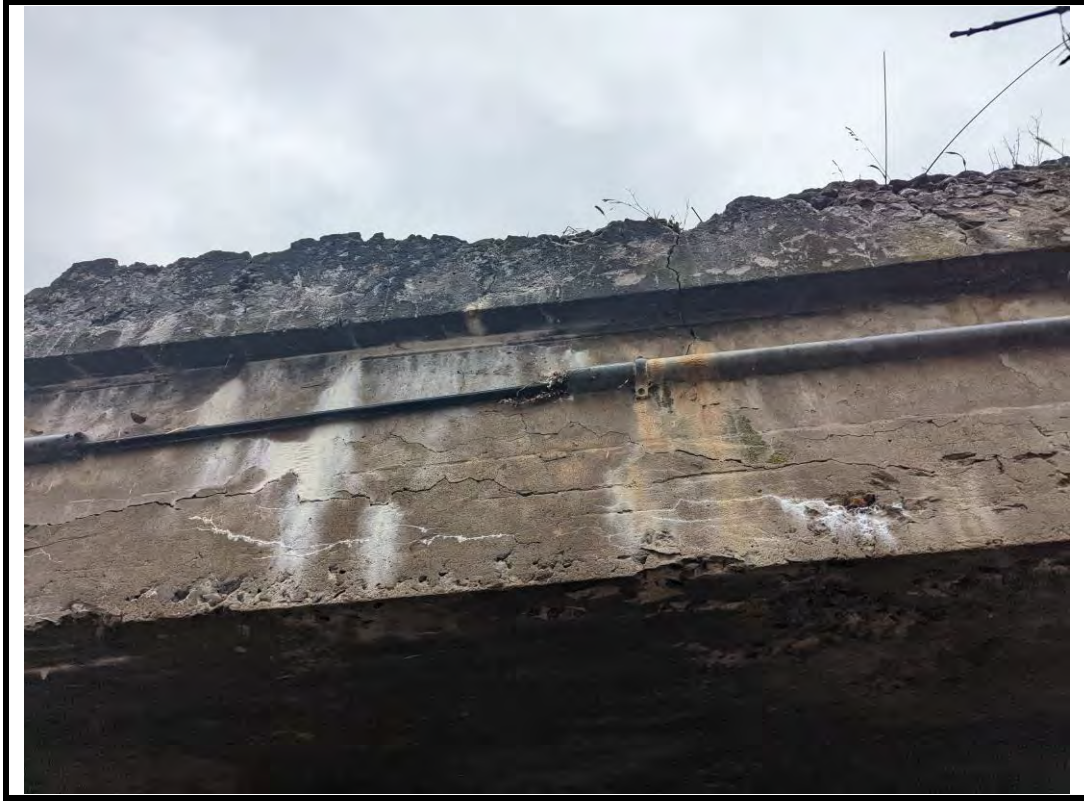
Photo 9 Cracks and efflorescence at north barrel, with spalls along deck

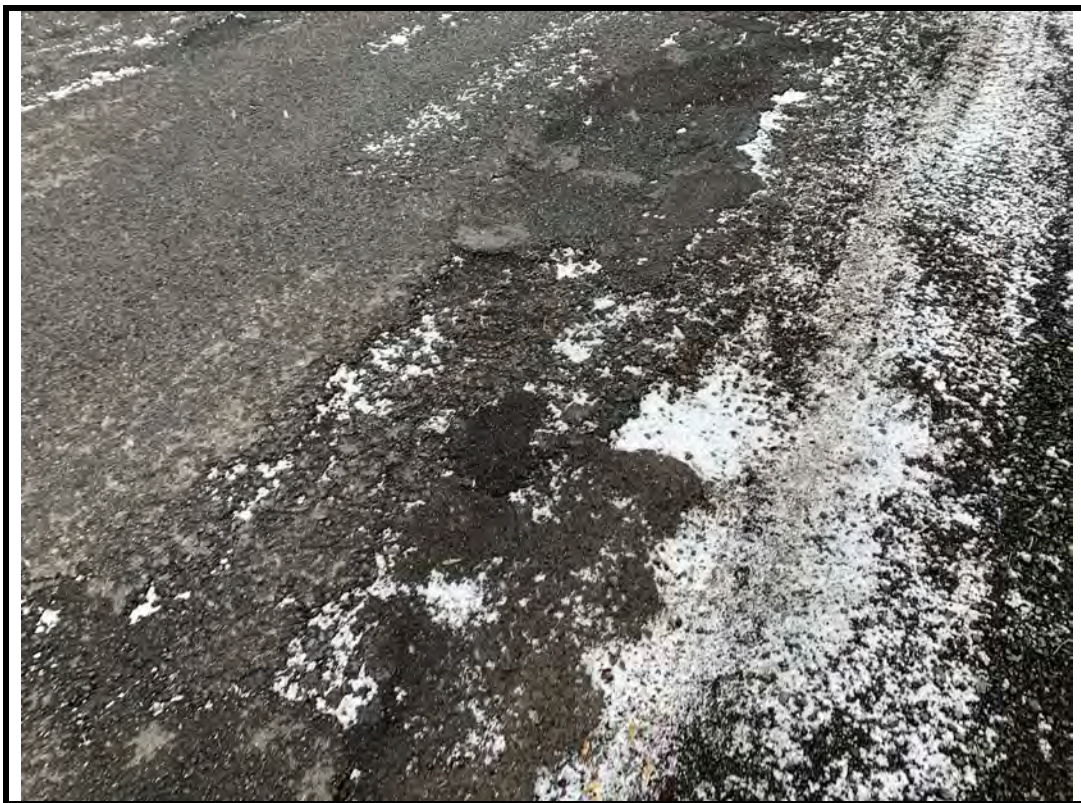
Photo 7 Potholes and patched potholes noted on south wearing surface

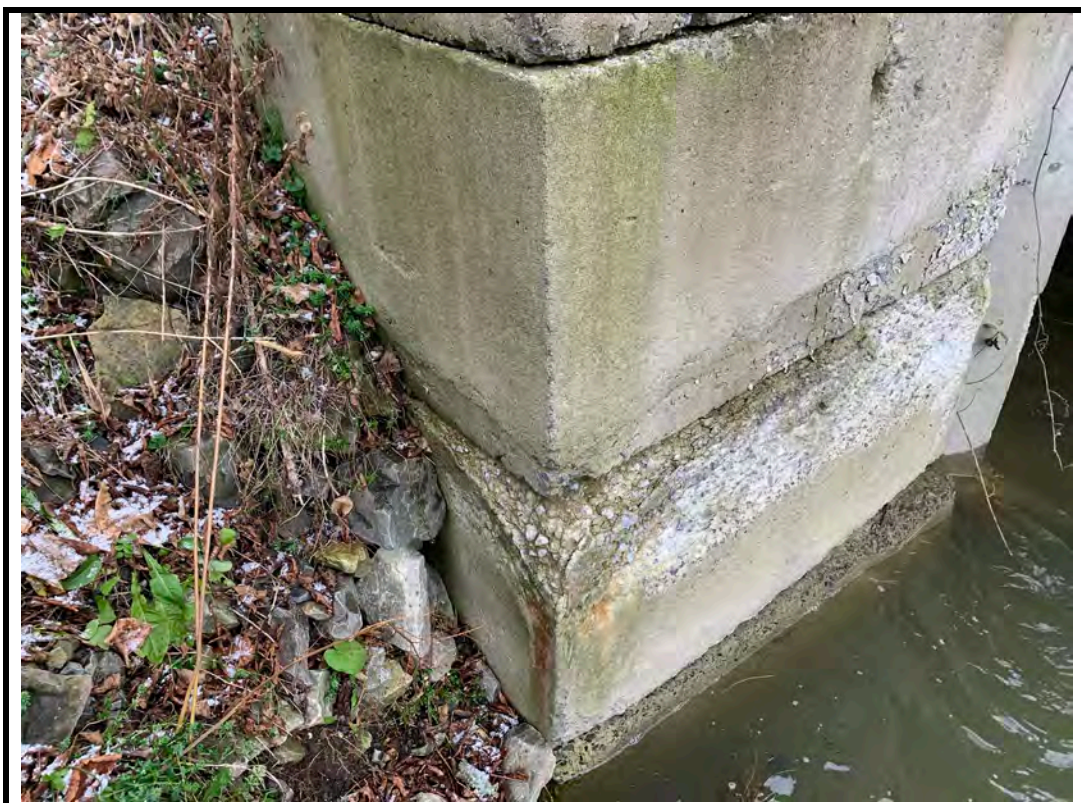
Photo 8 Disintegration on southeast block wall

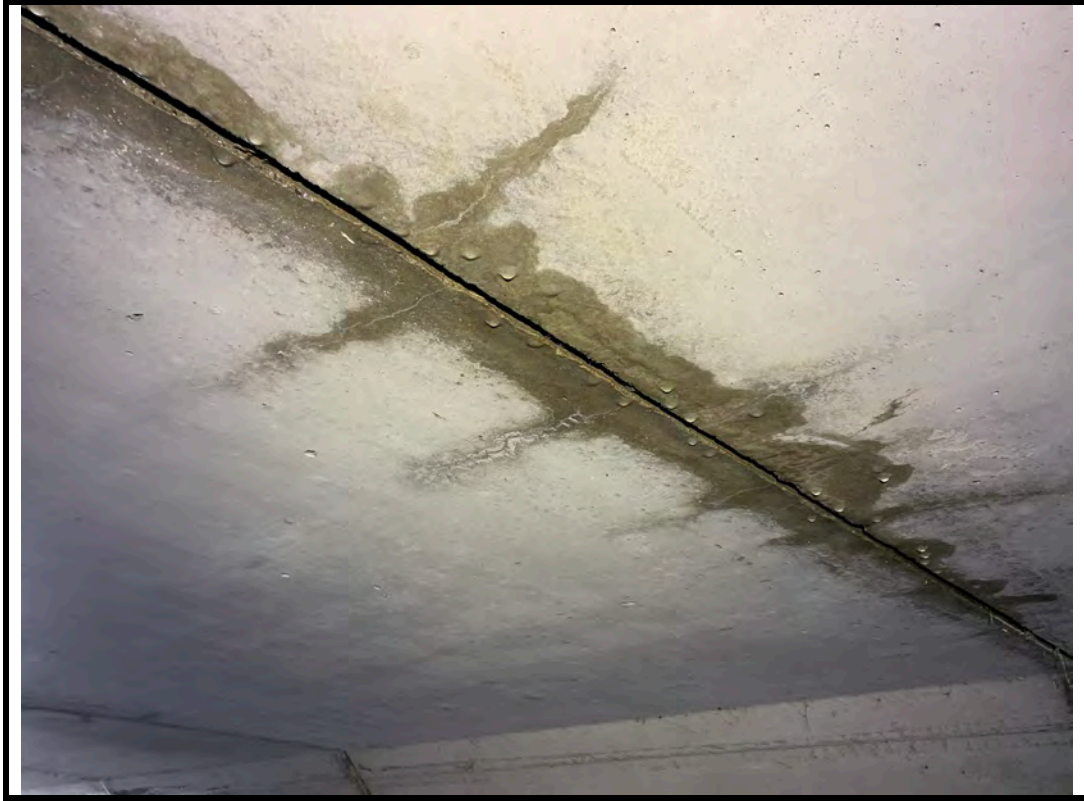
Photo 11 Active leaking at precast barrel joints

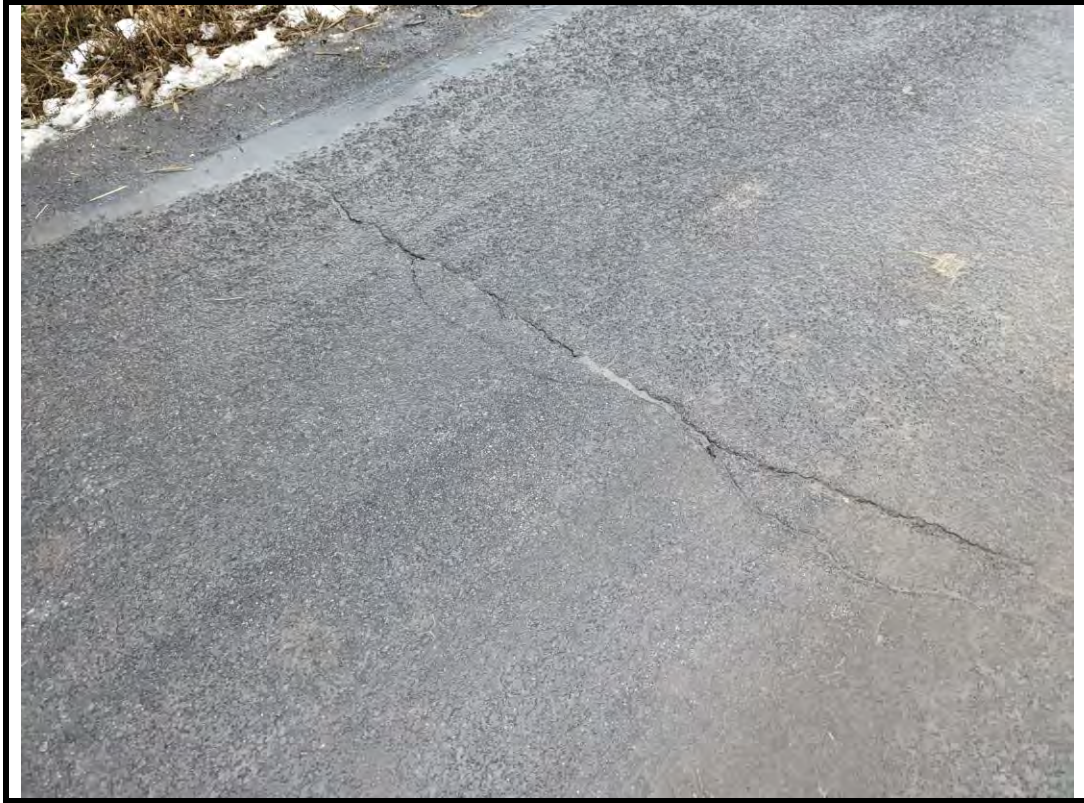
Photo 7 Transverse Crack in Approach Wearing Surface

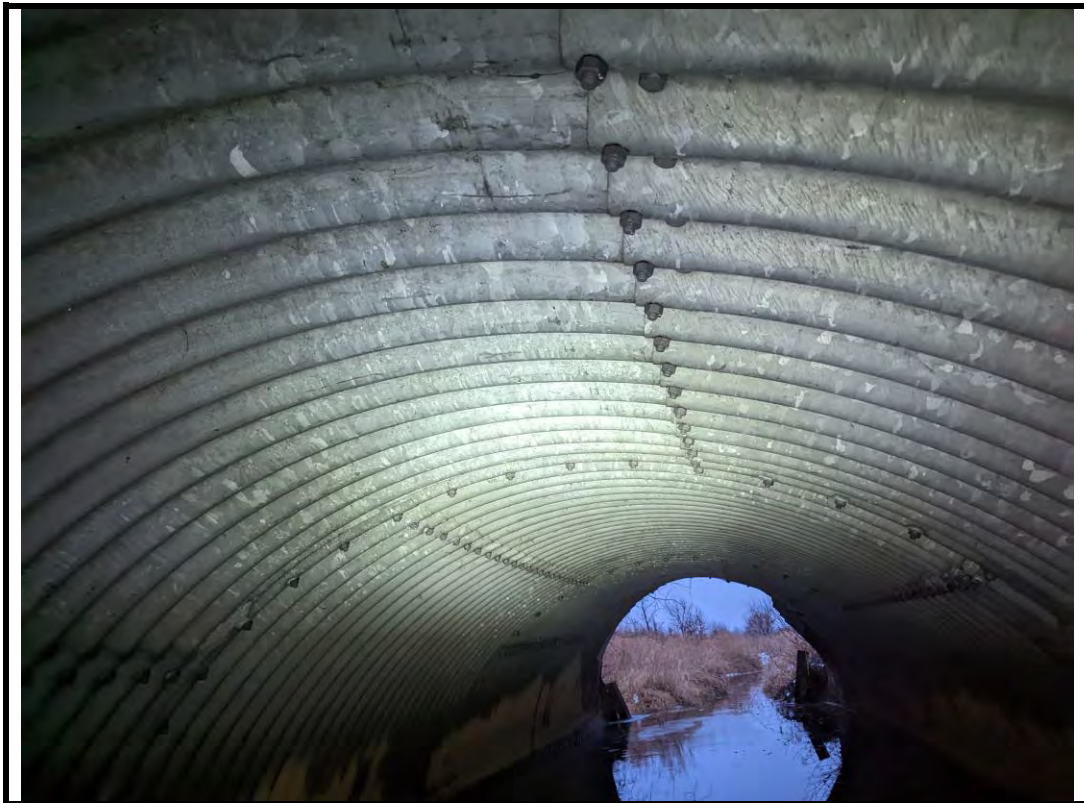
Photo 8 Sagging in pipe arch below roadway

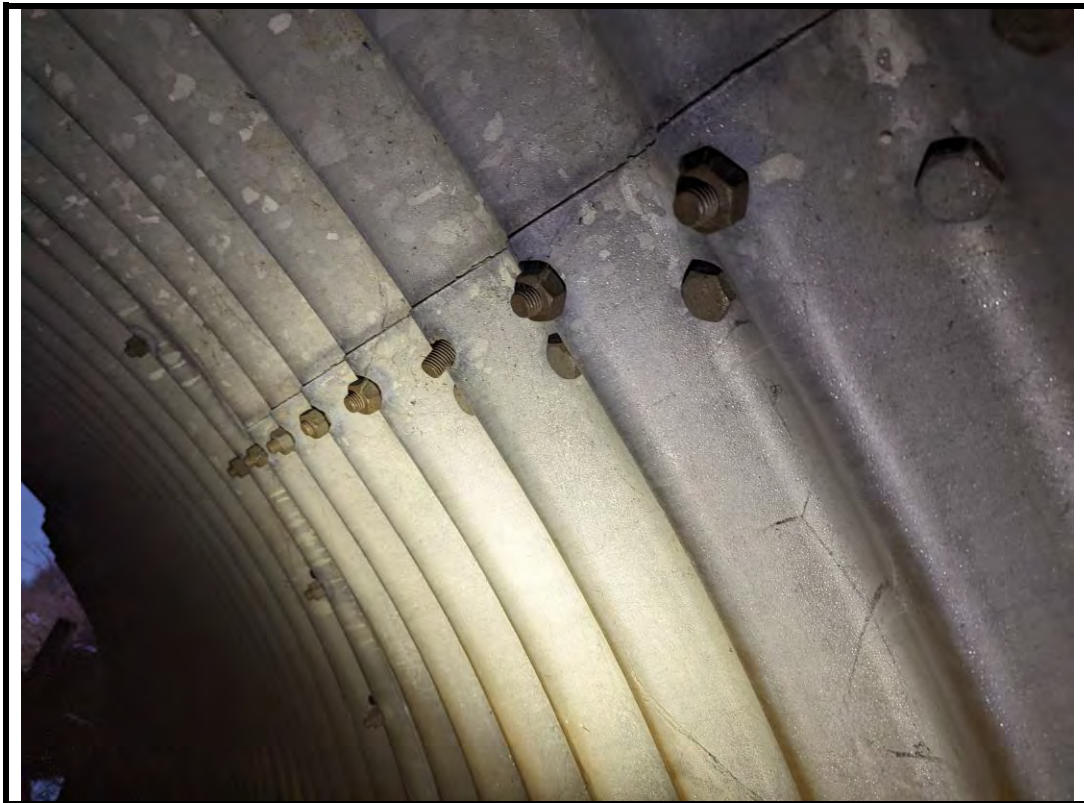
Photo 10 Missing nut in barrel (Typical)

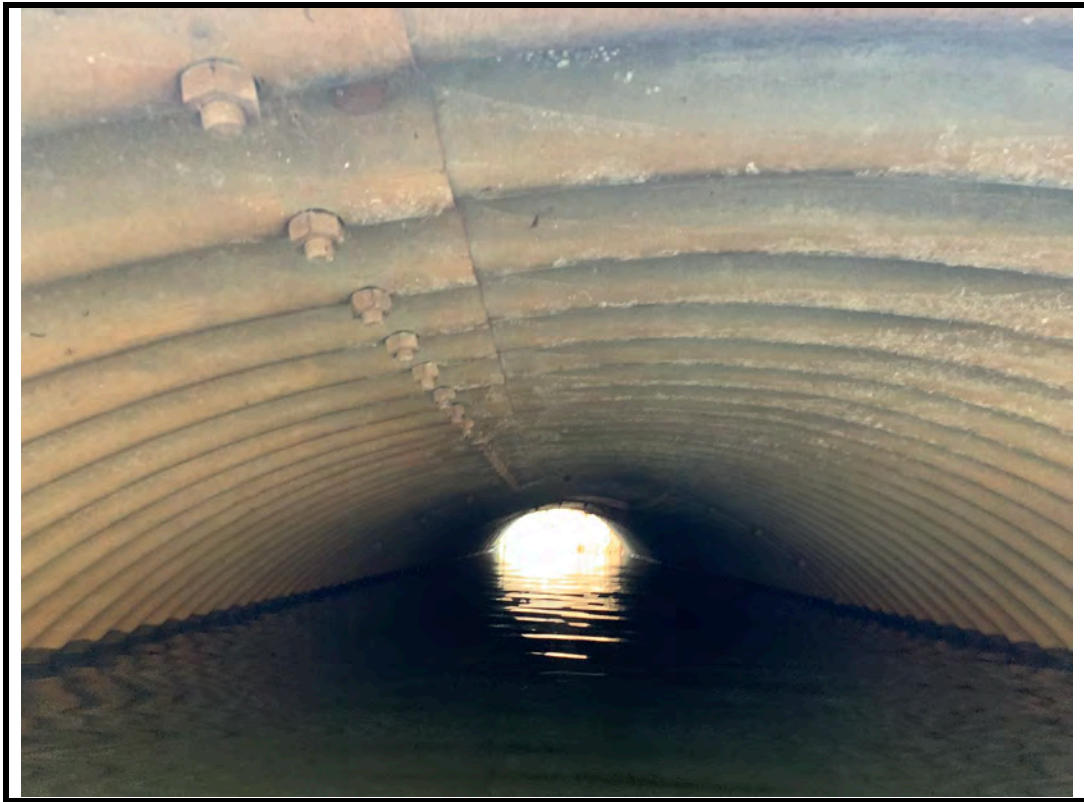
Photo 9 Slight sag in barrel under road

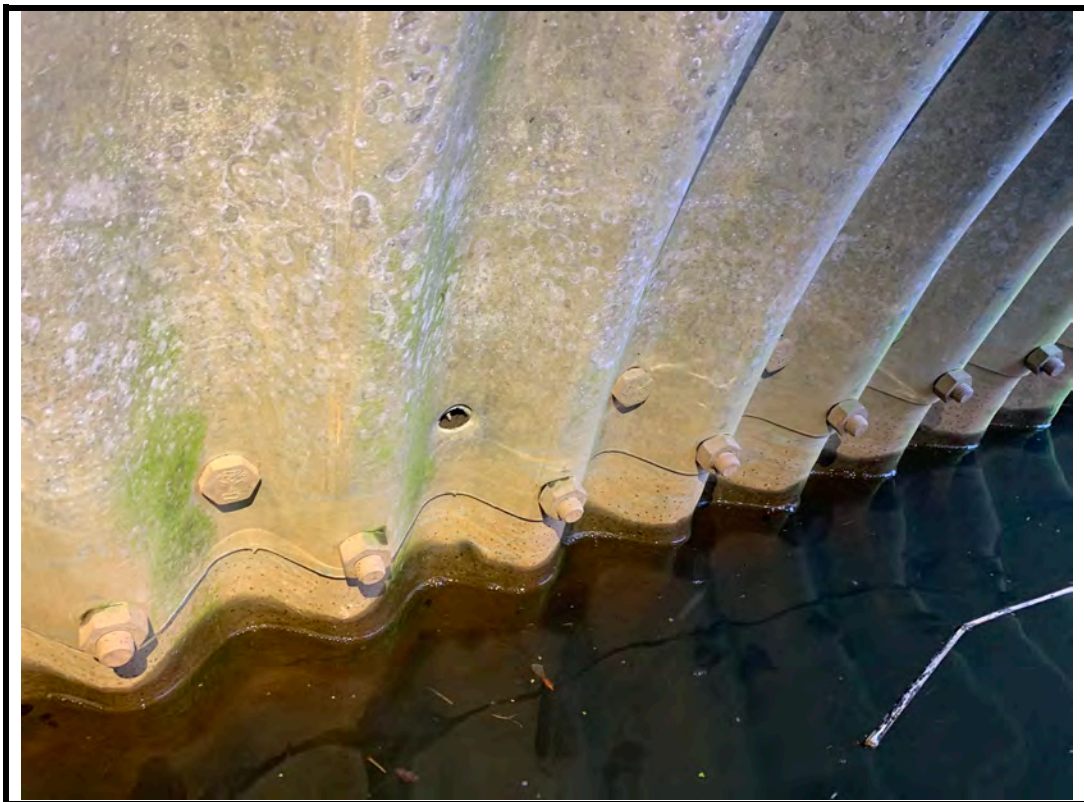
Photo 10 Missing bolt at west end of barrel

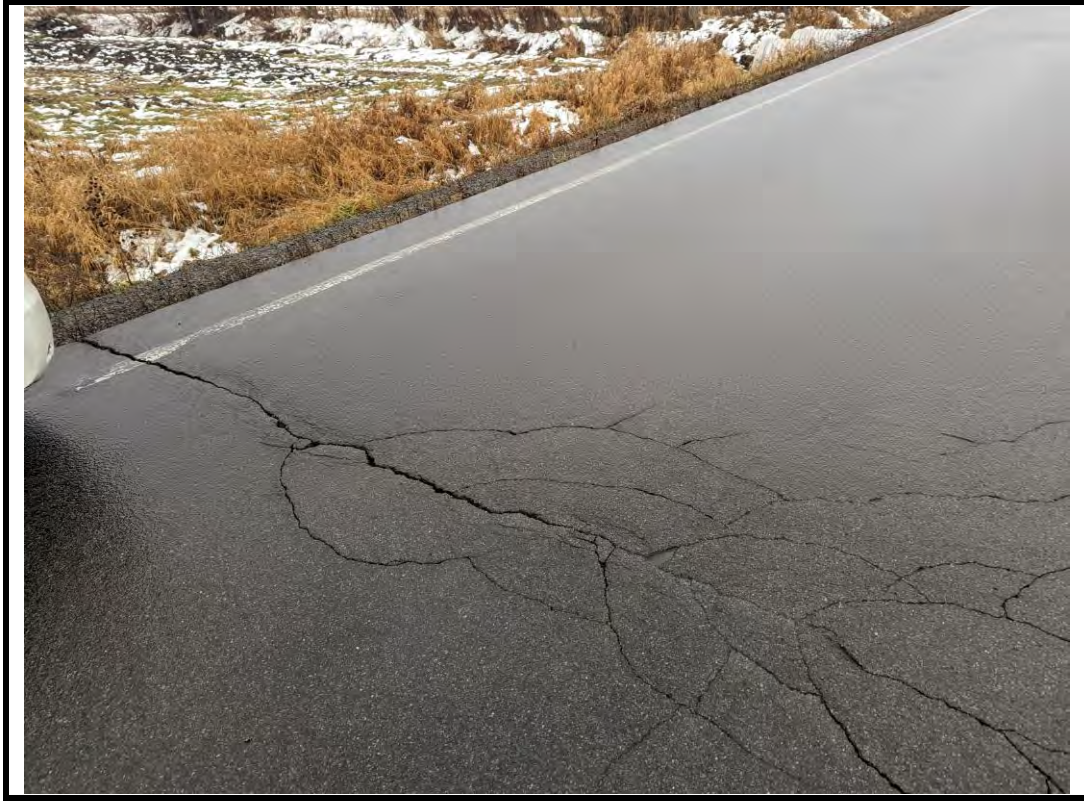
Photo 7 Transverse crack in asphalt approach wearing surface above structure

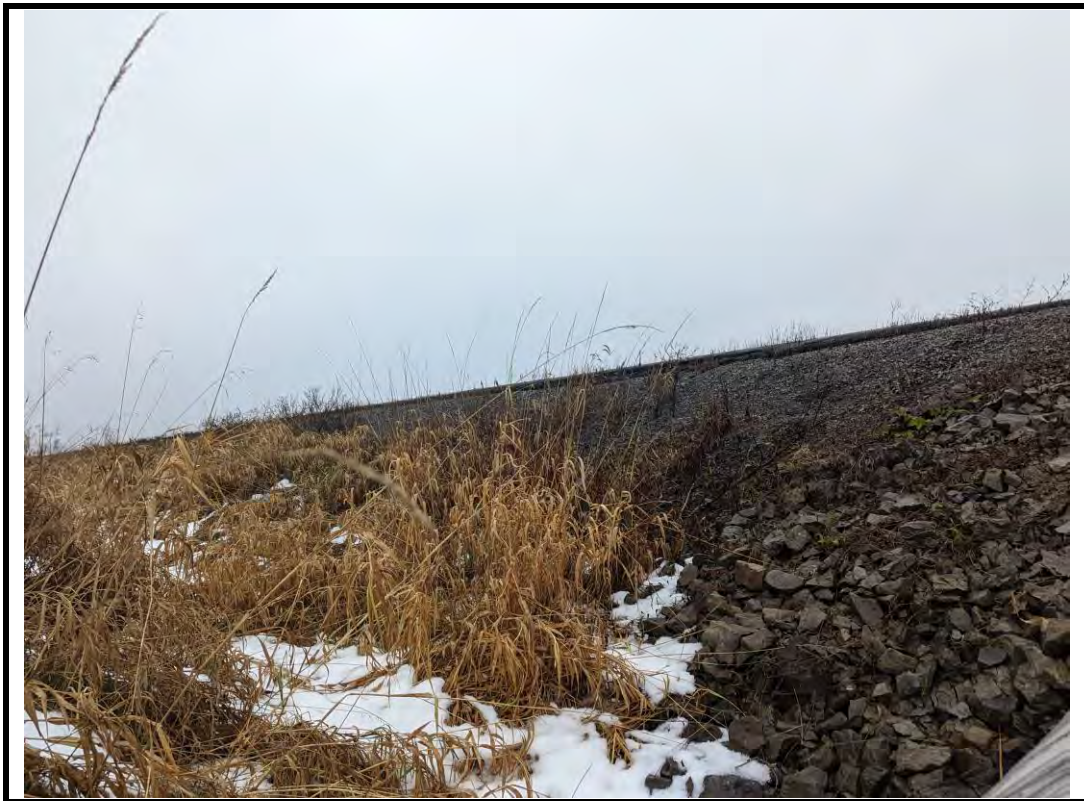
Photo 12 Light loss of Rip Rap at southwest embankment

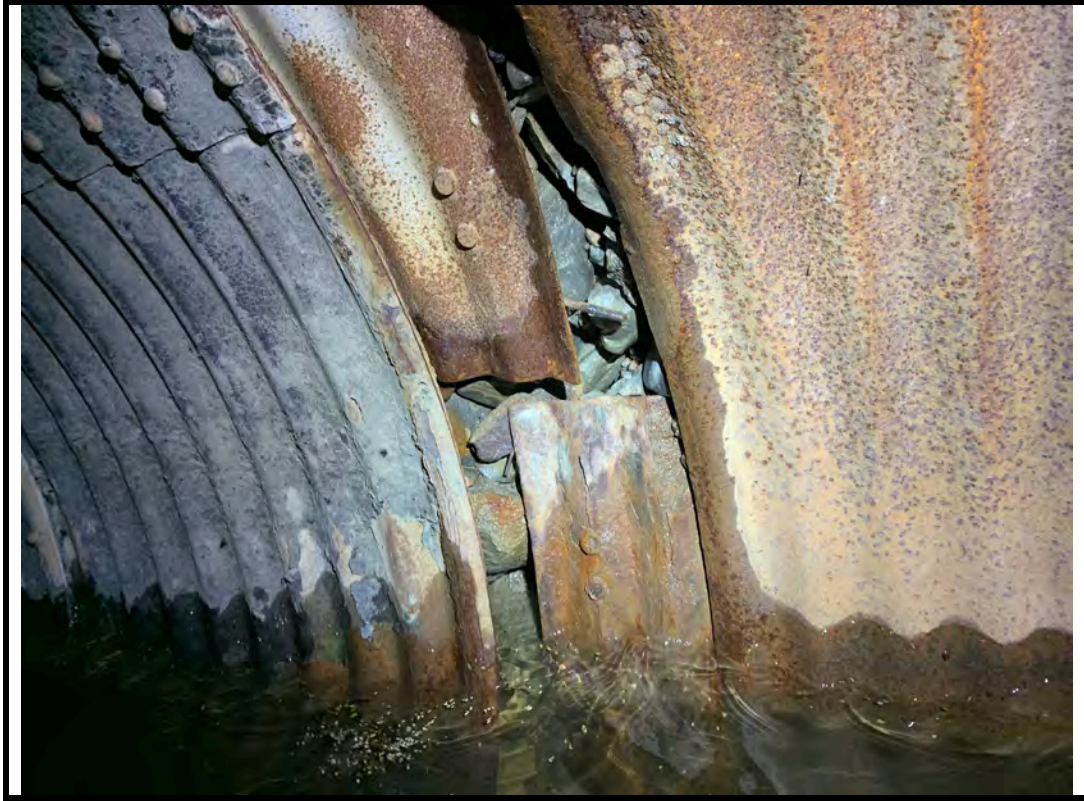
Photo 13 Separation of seam in north barrel

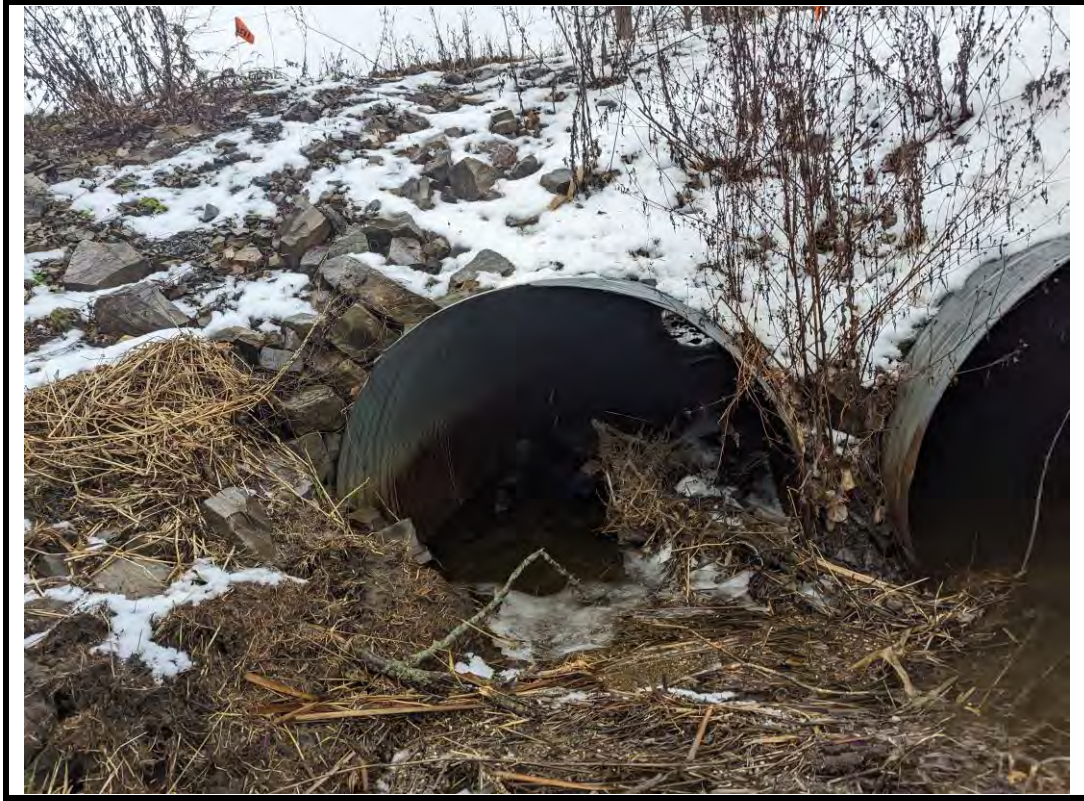
Photo 9 Debris buildup at east barrel inlet

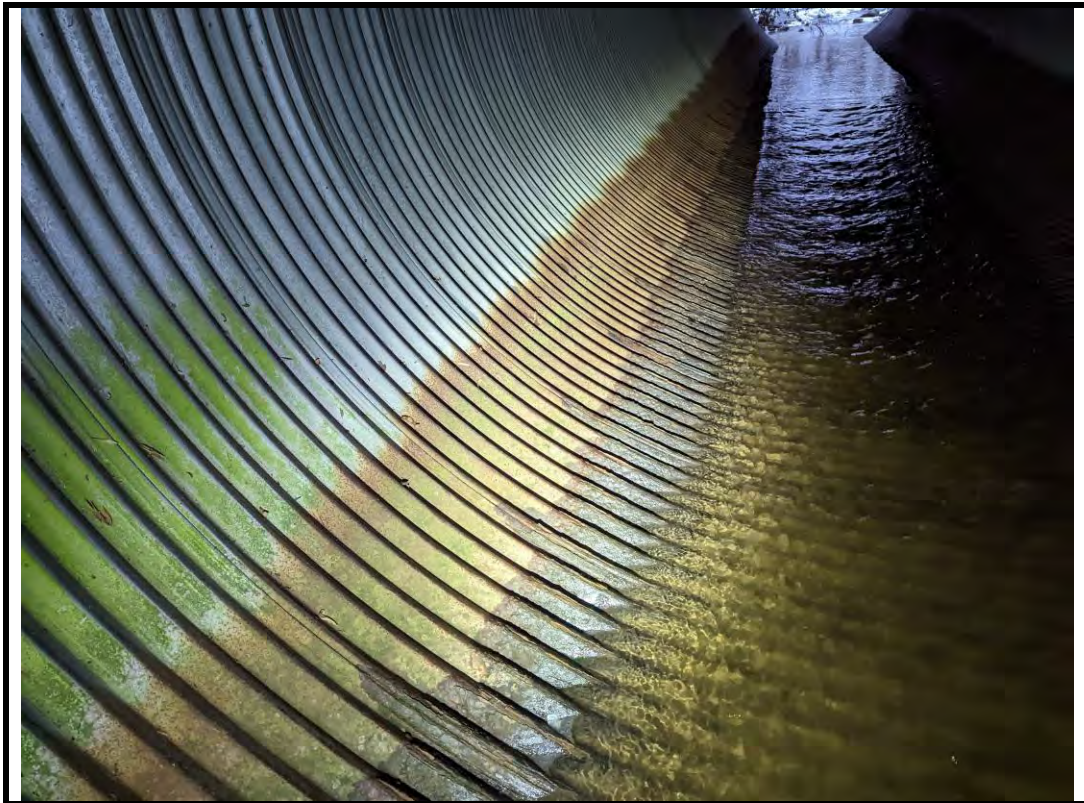
Photo 8 Corrosion along bottom of pipe

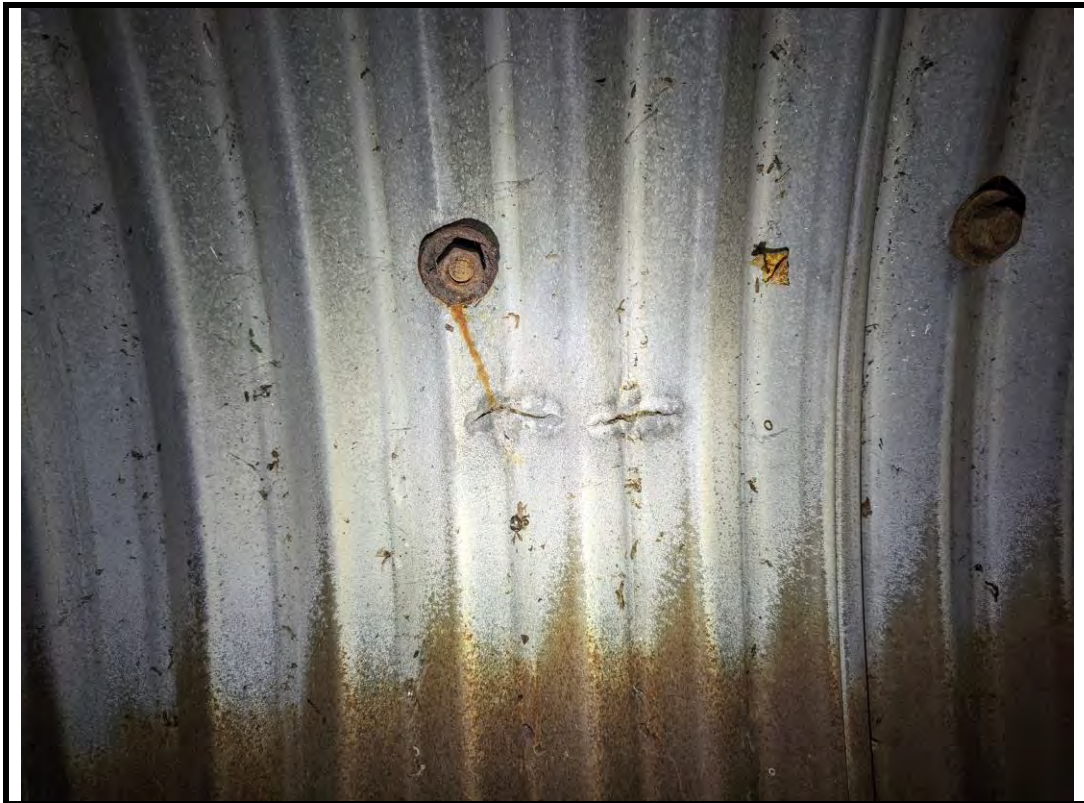
Photo 10 Perforations on barrel wall

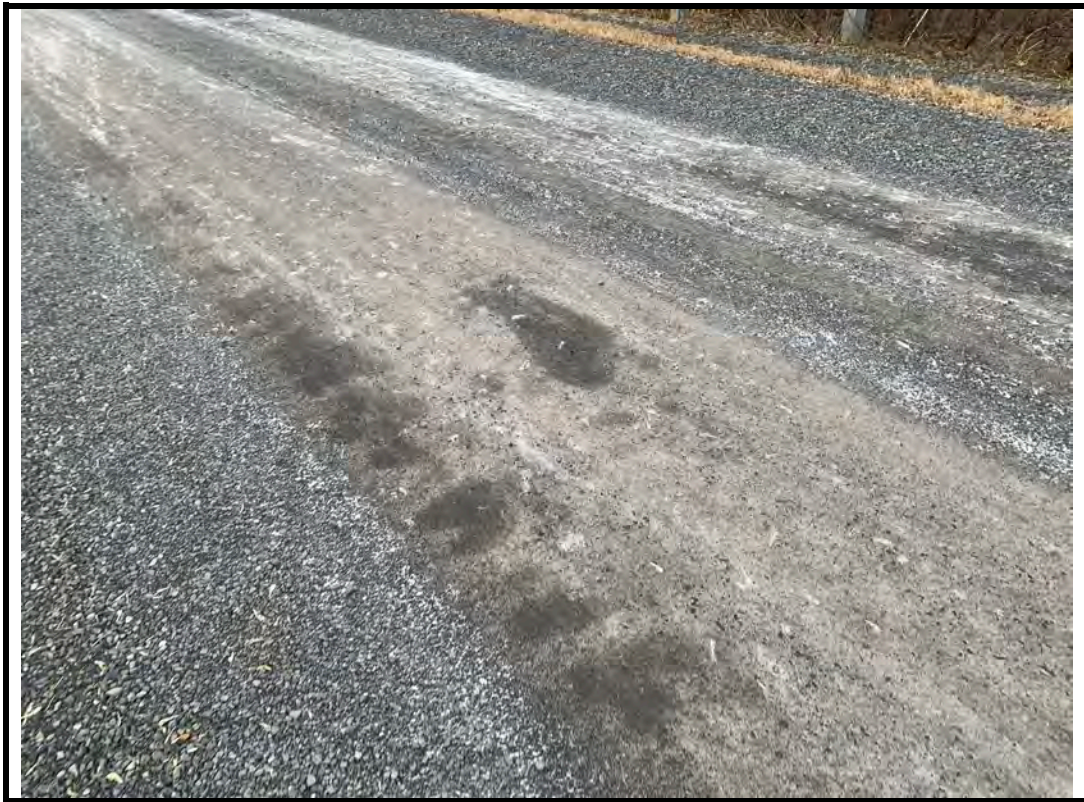
Photo 7 Moderate tire rutting on east wearing surface

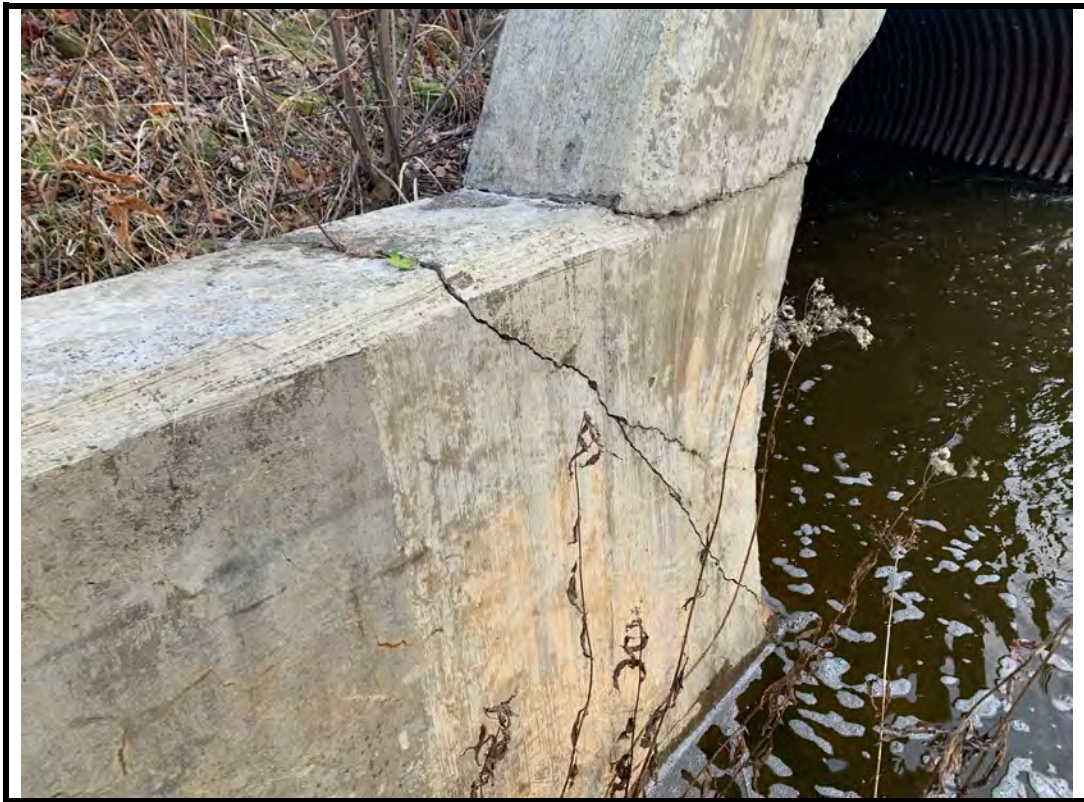
Photo 9 Wide crack at southwest corner of south concrete wall

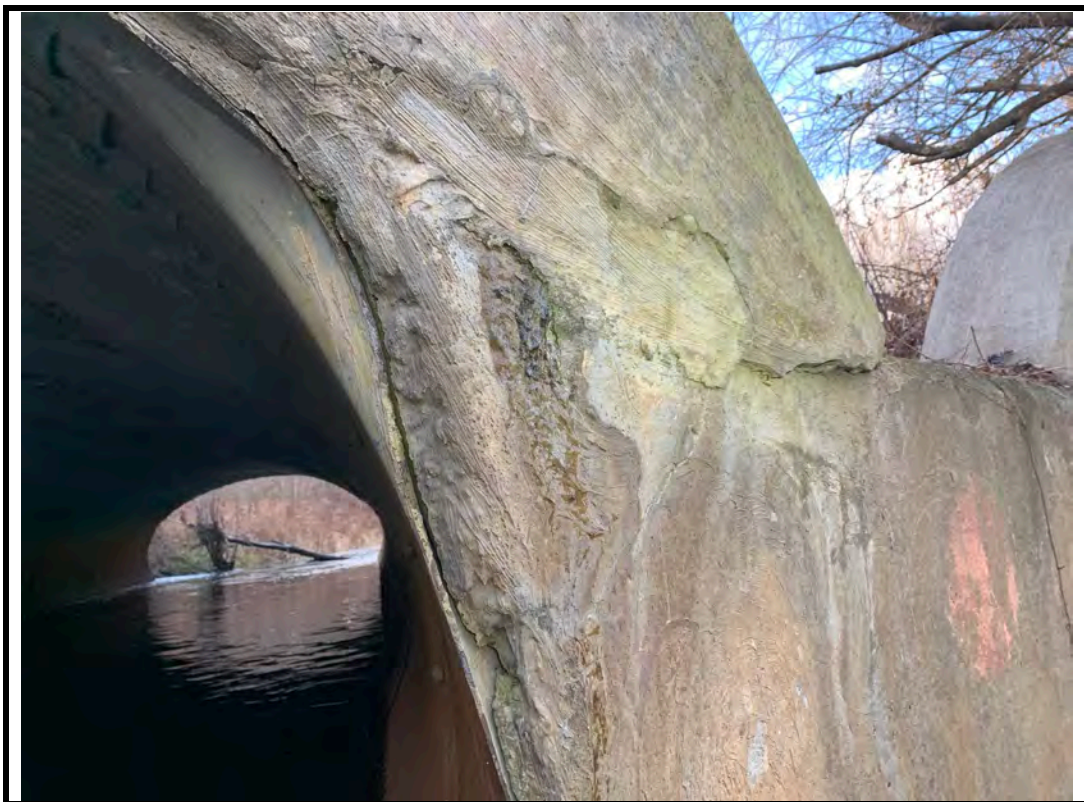
Photo 10 Spall on north concrete wall

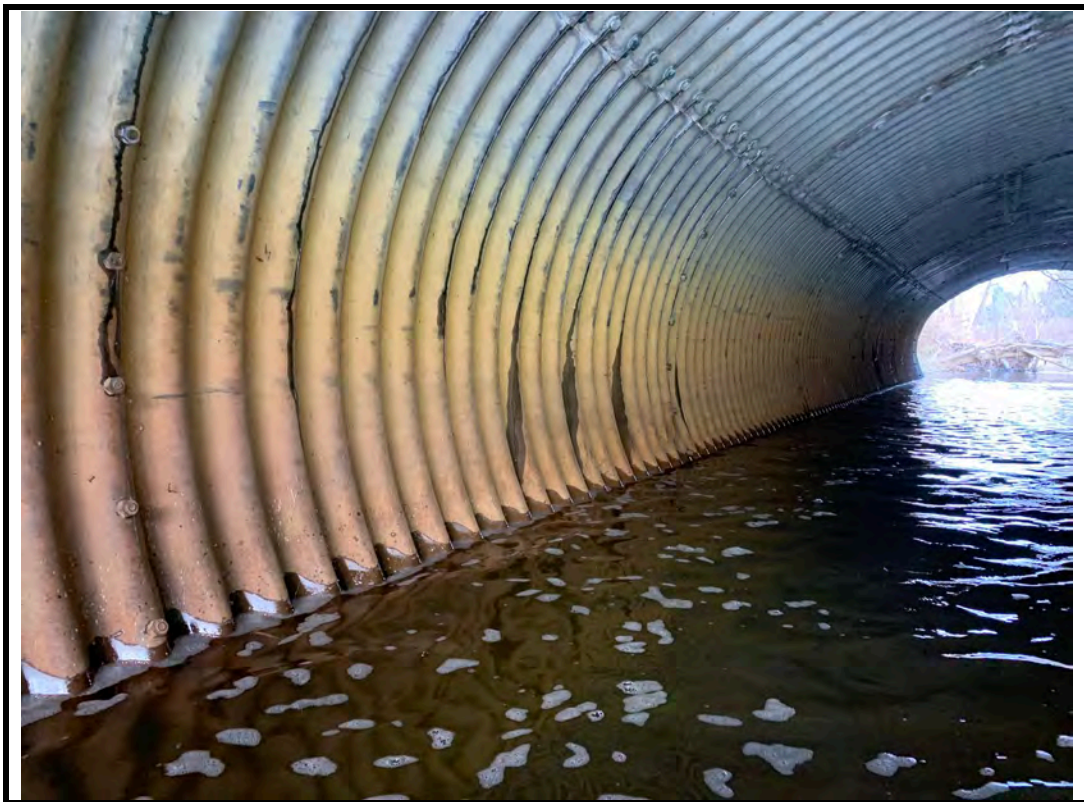
Photo 12 Wet areas and evidence of leaking in west barrel

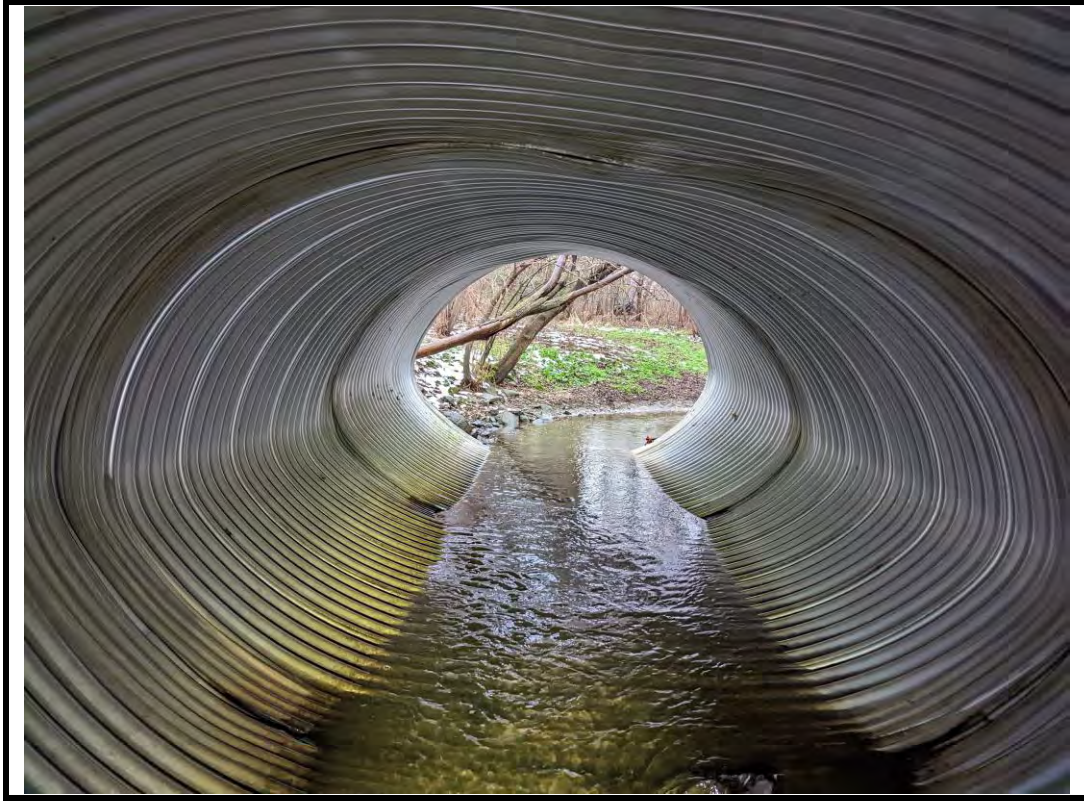
Photo 9 Deformation along top of pipe and light localized corrosion at joints

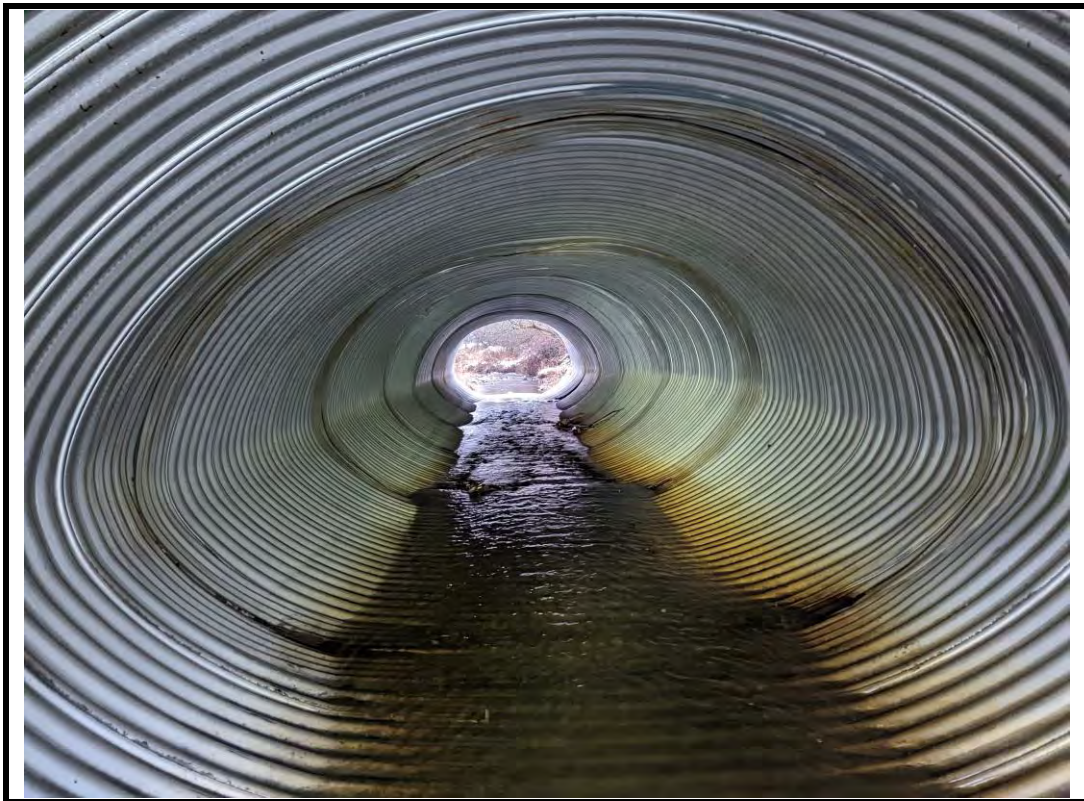
Photo 12 Corrosion along bottom of pipe and at joints
