THE TOWNSHIP OF NORTH DUNDAS

DRAFT BRIDGE MANAGEMENT STUDY REPORT 18 BRIDGES / 31 CULVERTS

March 2023

HP Engineering Inc.

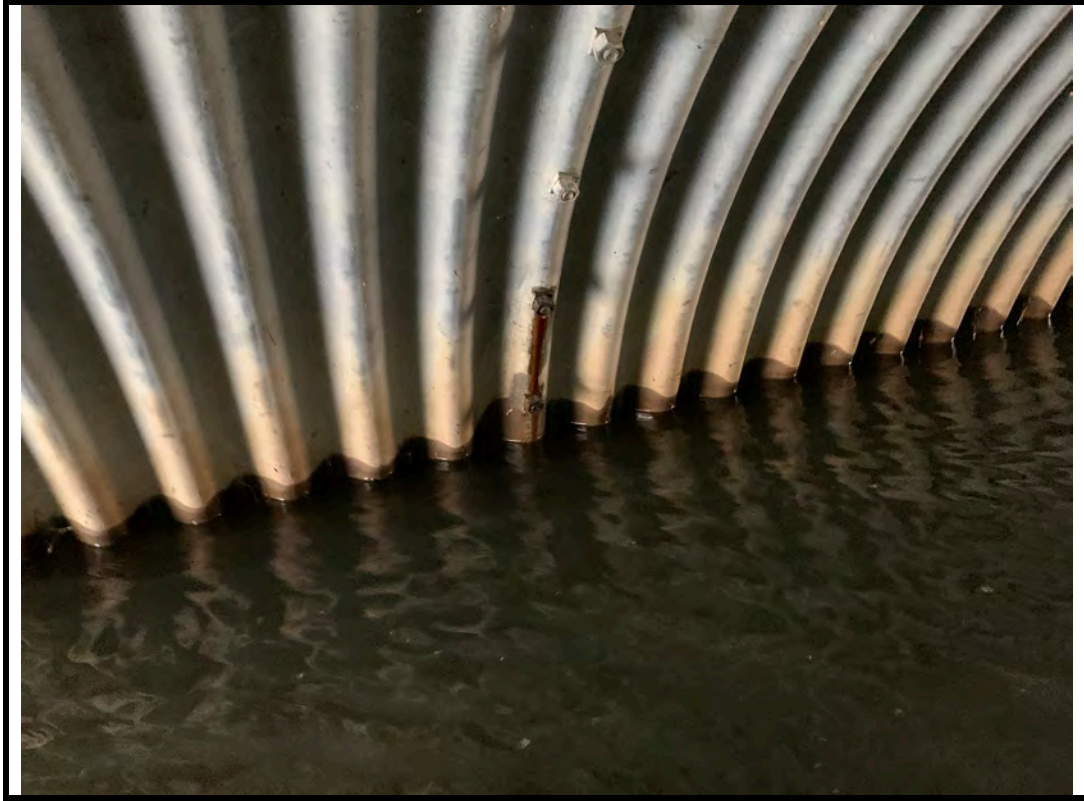
Photo 9 Evidence of leakage at east end of barrel

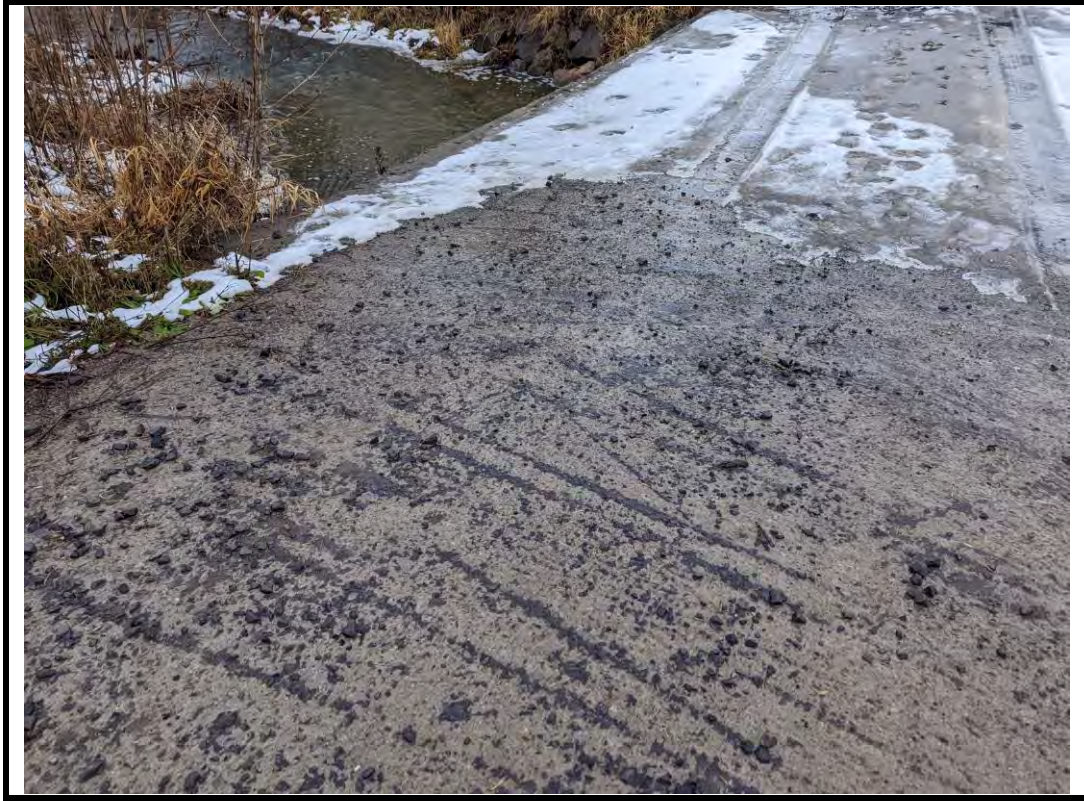
Photo 13 Scaling along top of exposed concrete deck

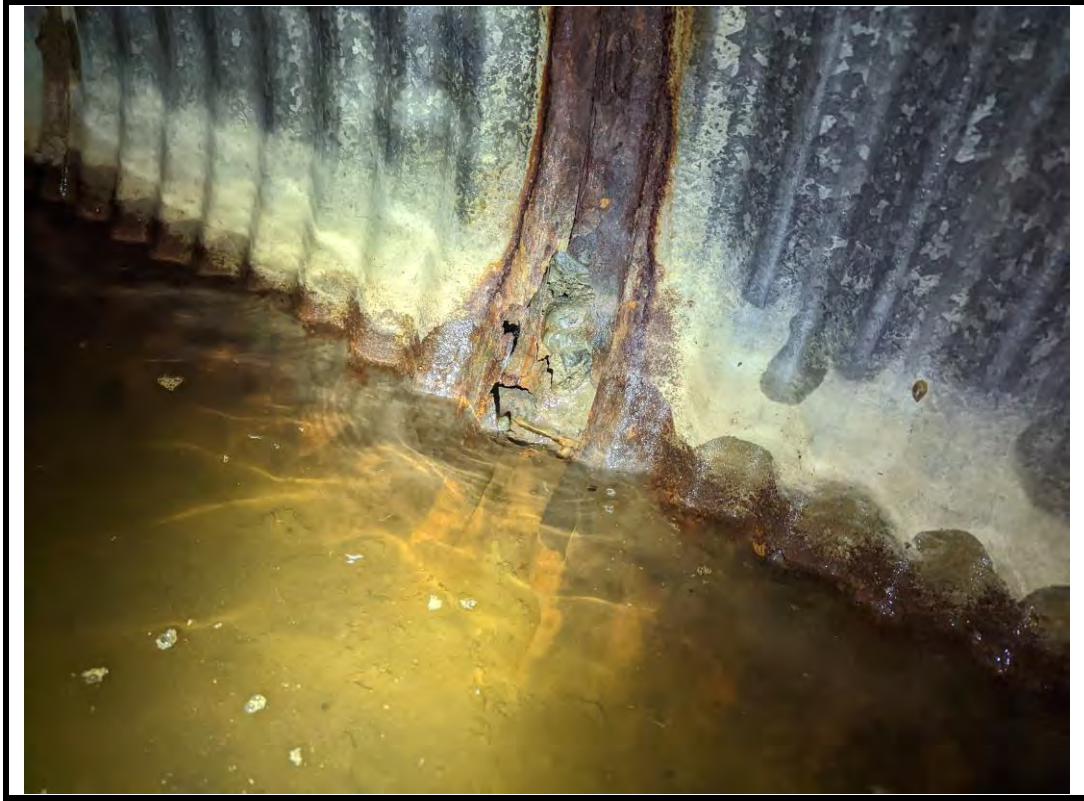
Photo 9 Perforation, corrosion, and sedimentation at midspan of South barrel

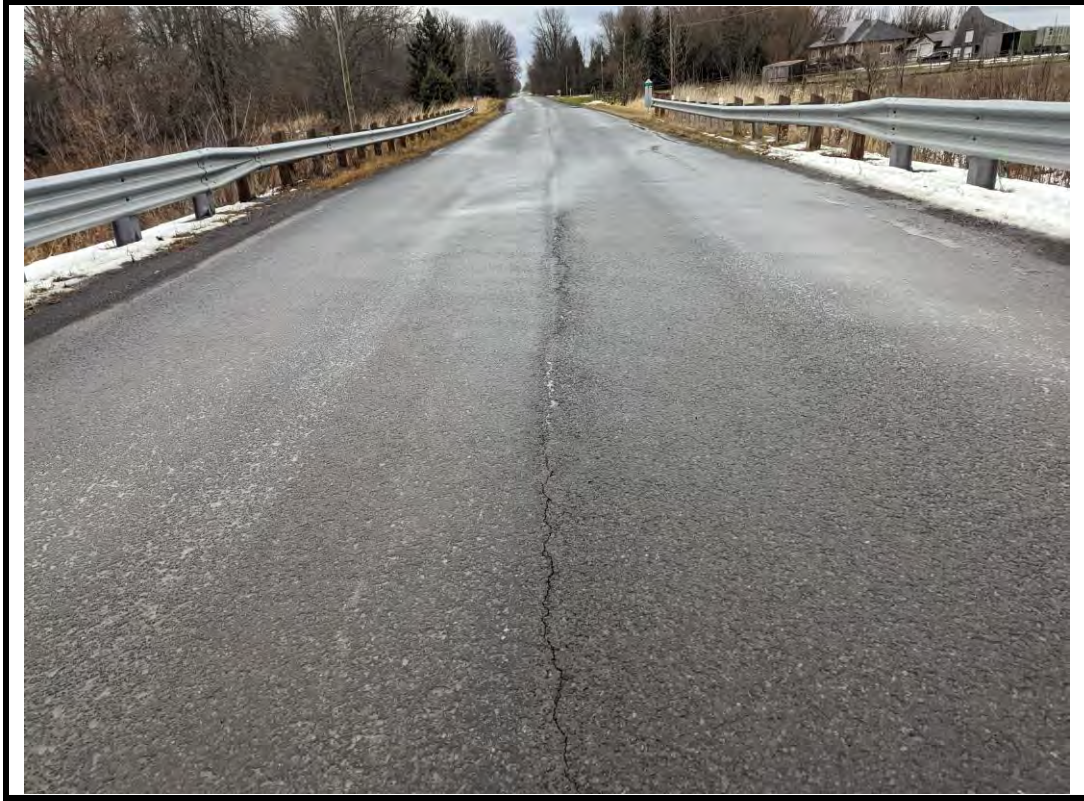
Photo 9 Medium longitudinal crack and raveling in asphalt wearing surface

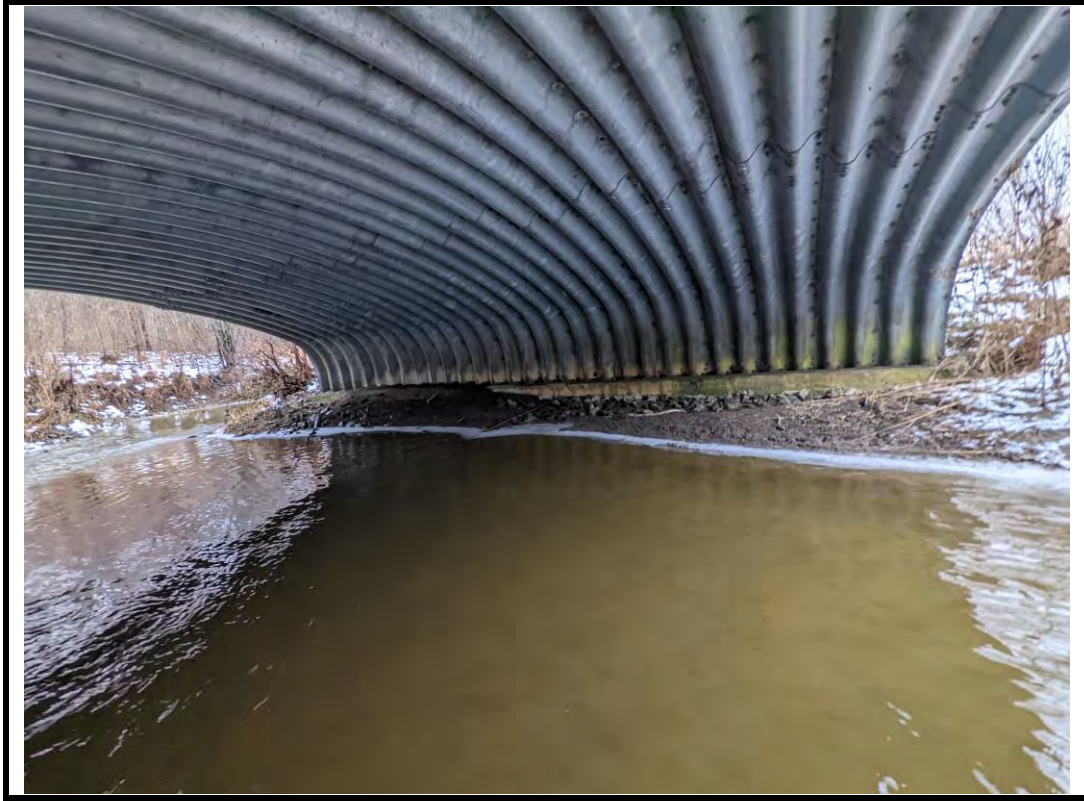
Photo 11 Sediment buildup within culvert along stream bed

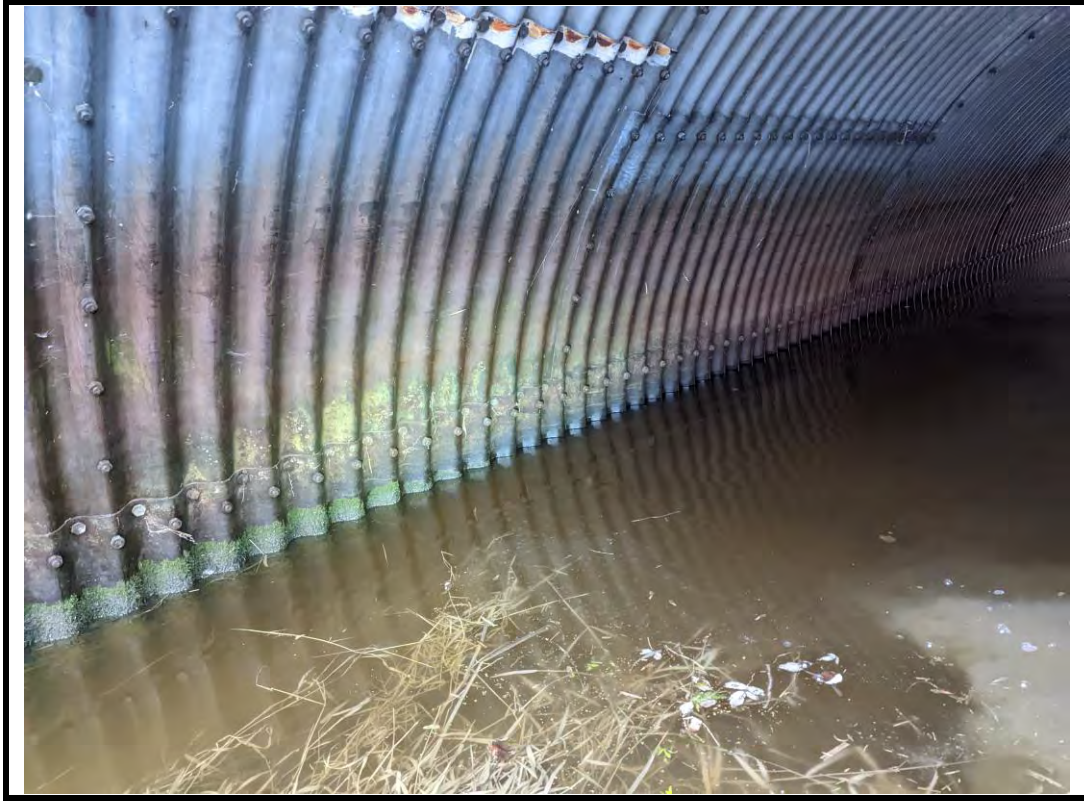
Photo 9 Corrosion and coating loss (typ.)
