THE TOWNSHIP OF NORTH DUNDAS

DRAFT BRIDGE MANAGEMENT STUDY REPORT 18 BRIDGES / 31 CULVERTS

March 2023

HP Engineering Inc.

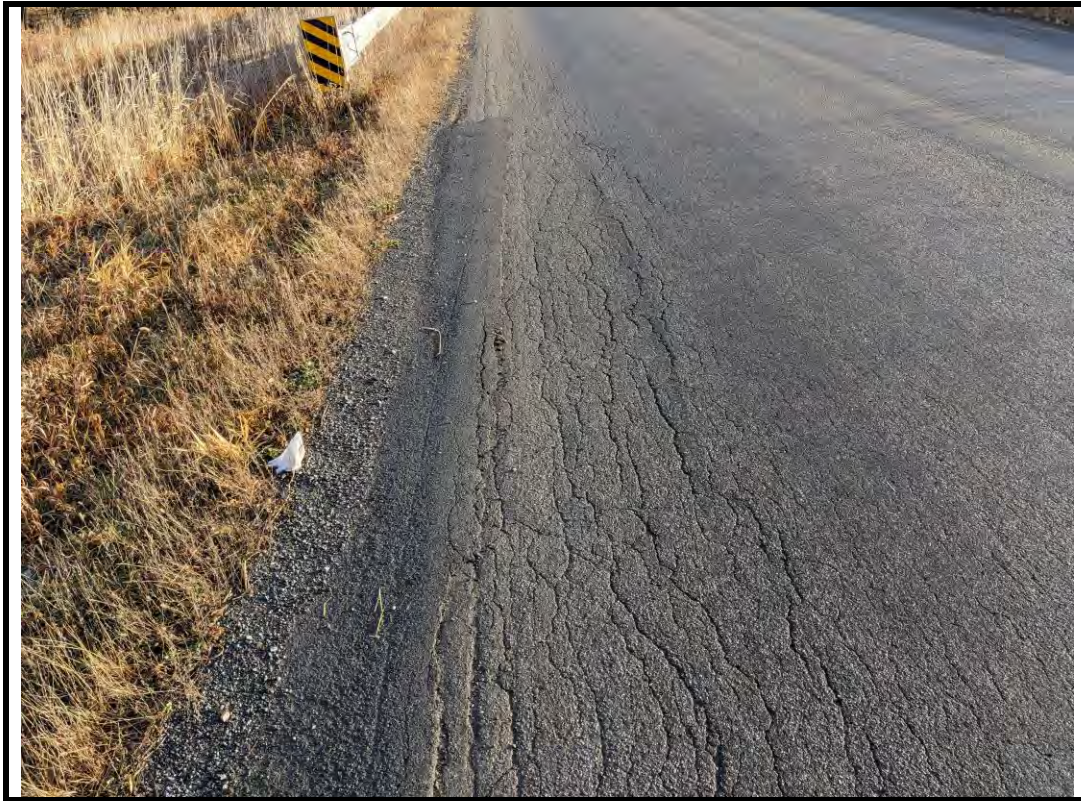
Photo 7 Alligator cracking in west approach wearing surface

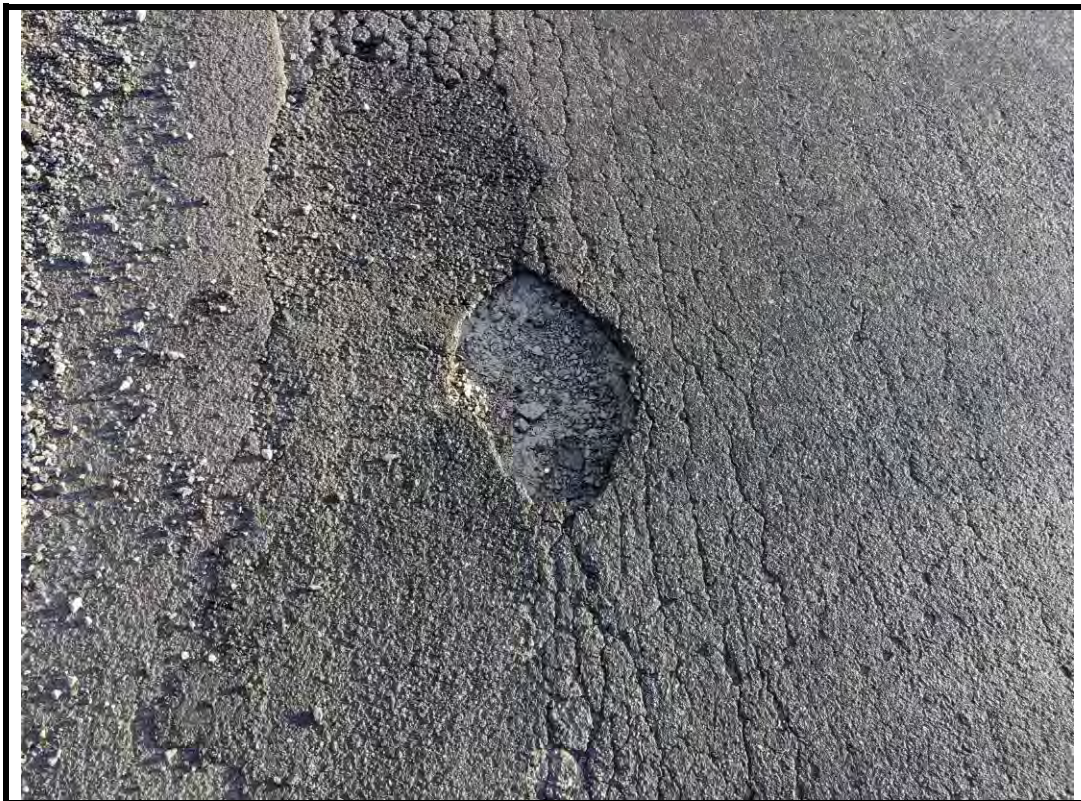
Photo 8 Pothole in west approach

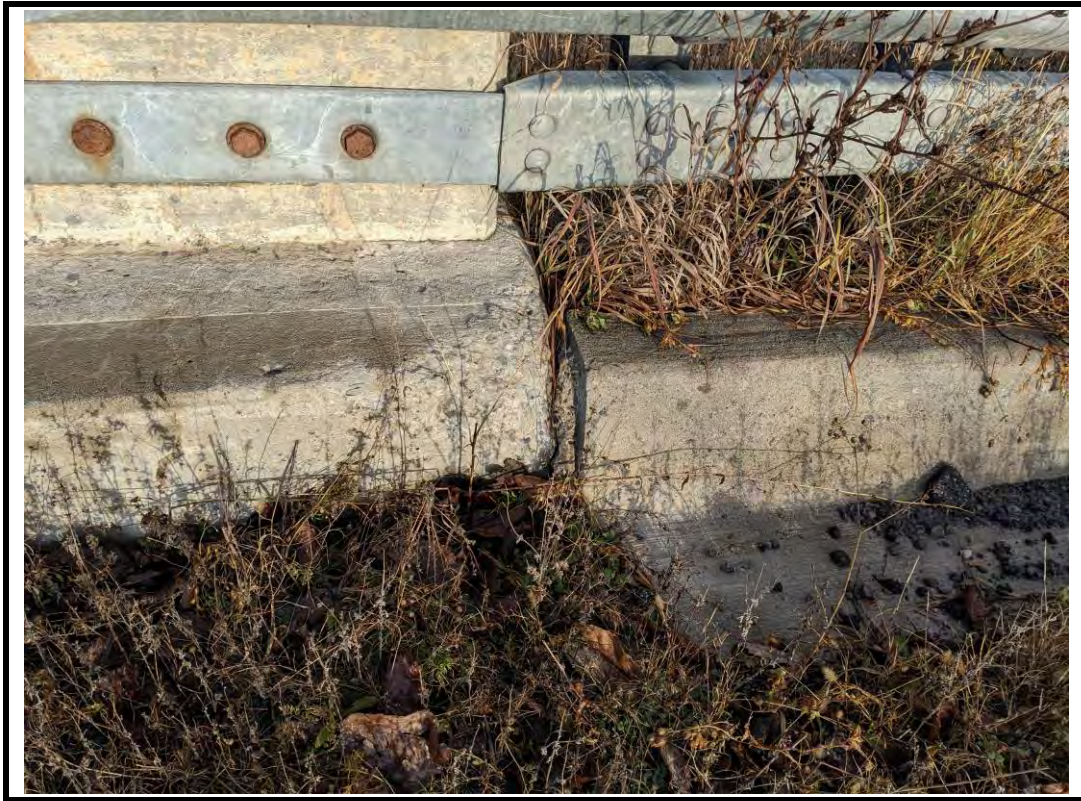
Photo 9 Spall on northeast barrier curb

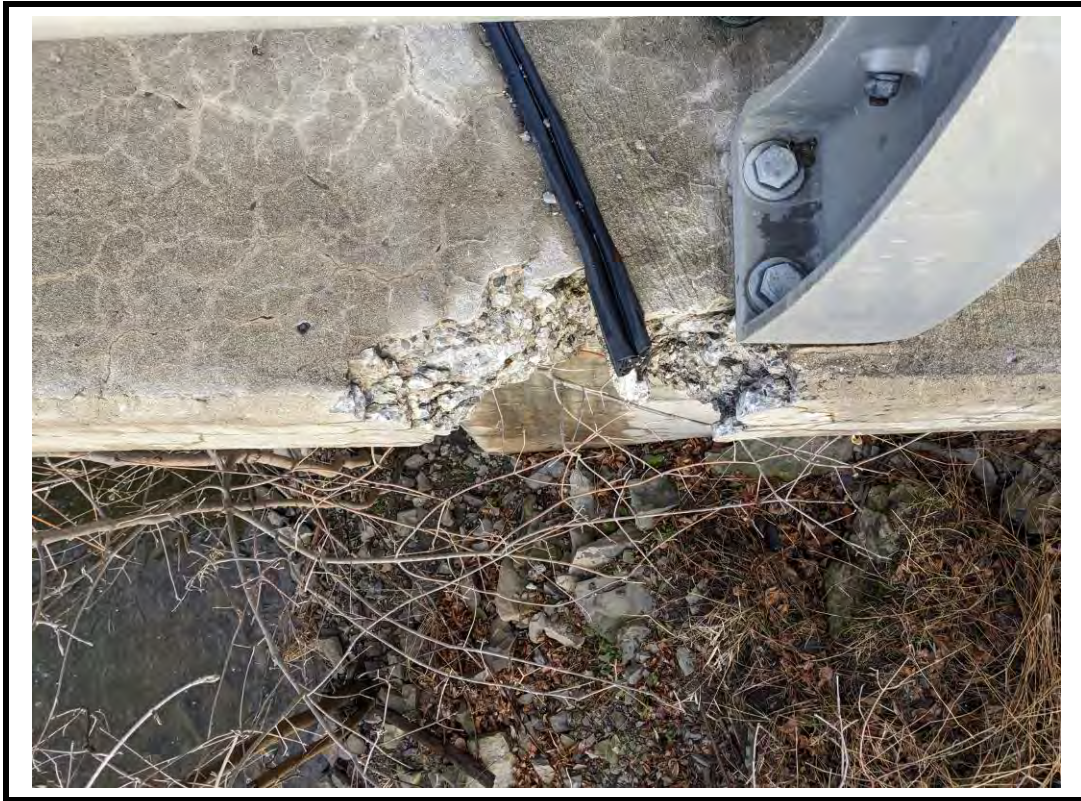
Photo 11 Spall at east joint and deck

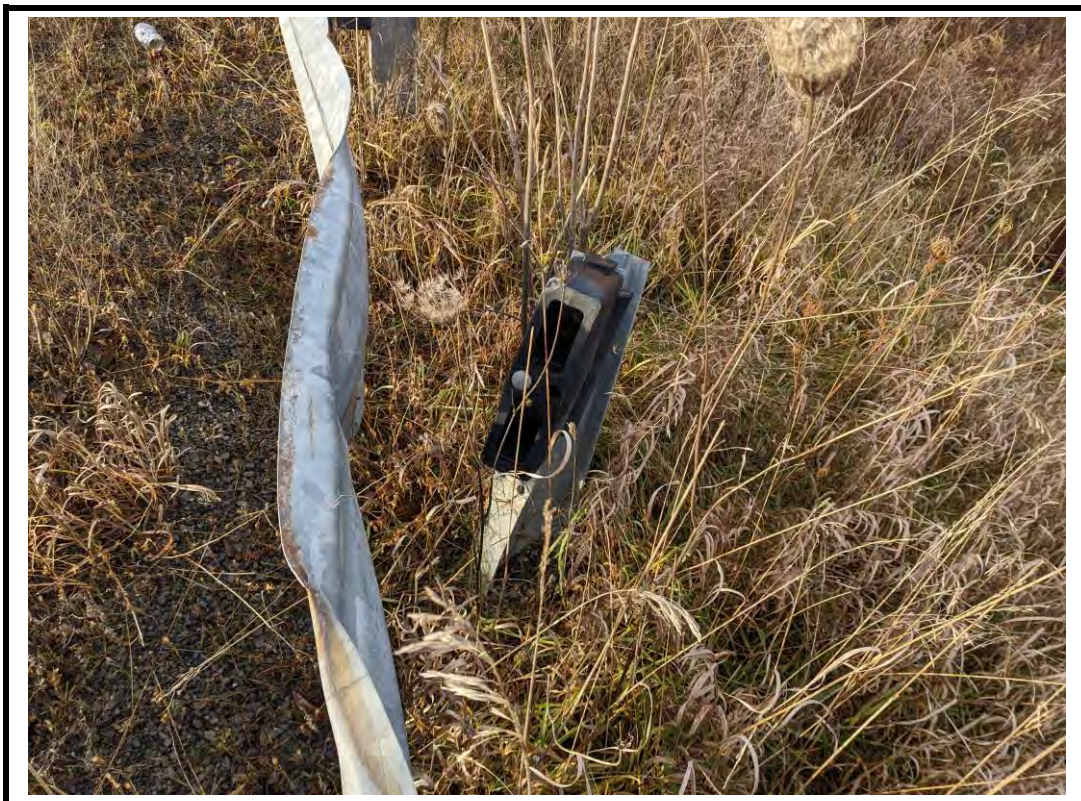
Photo 12 Disconnected and damaged barrier post

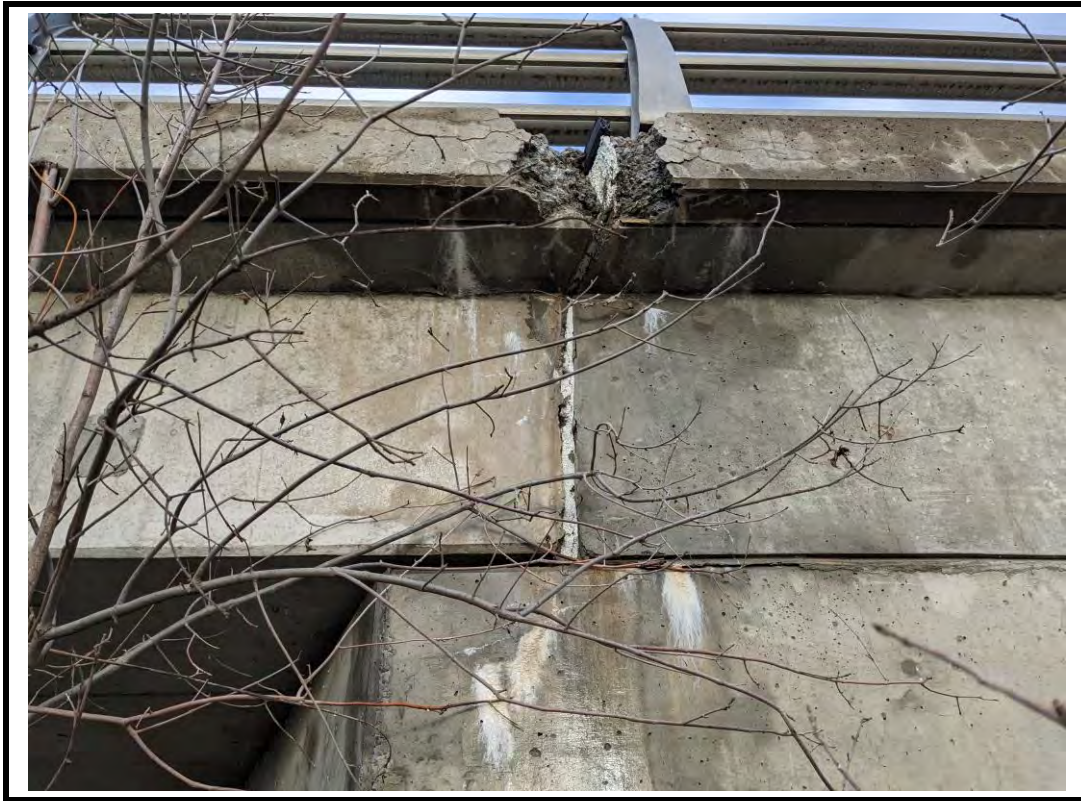
Photo 13 Spall and efflorescence at southeast joint and deck fascia

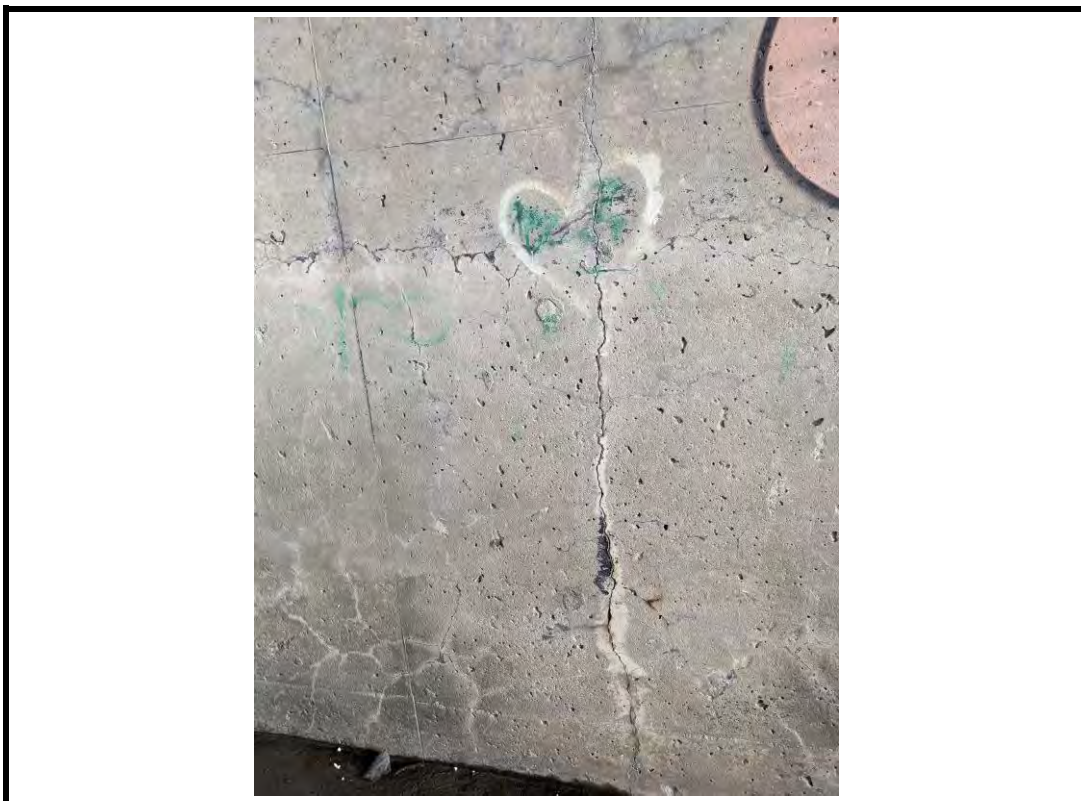
Photo 14 Wide vertical crack in east abutment wall with possible AAR

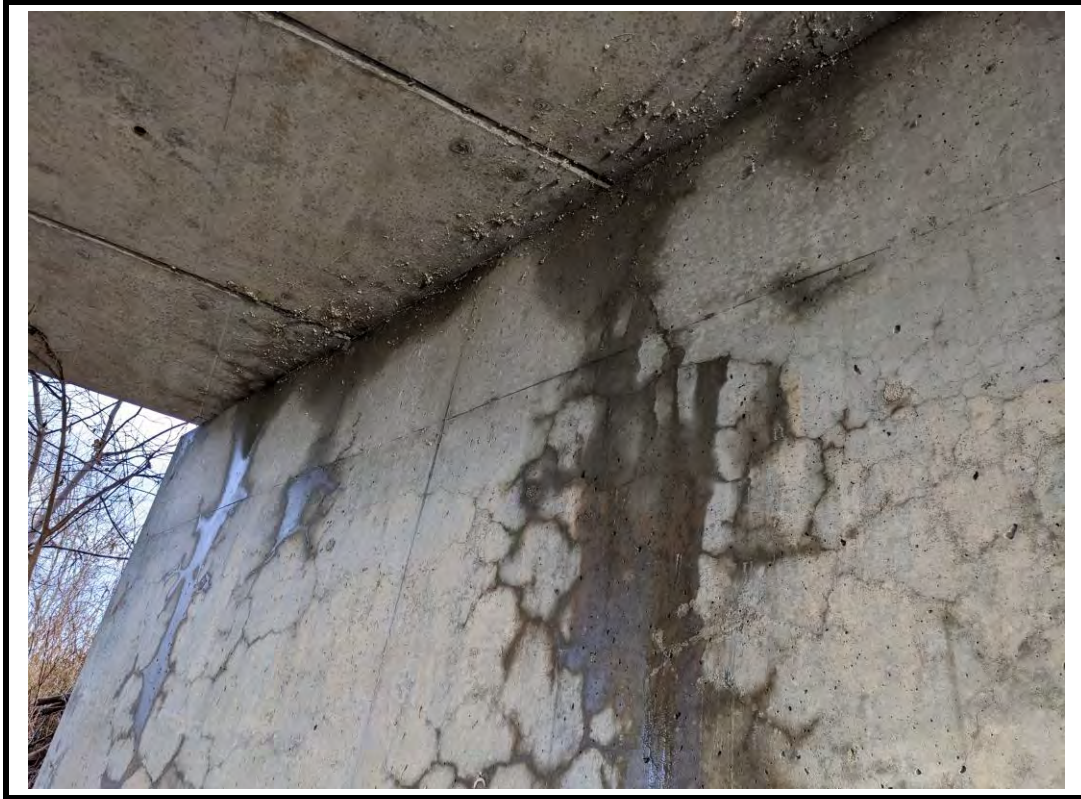
Photo 15 Evidence of joint failure at east abutment wall

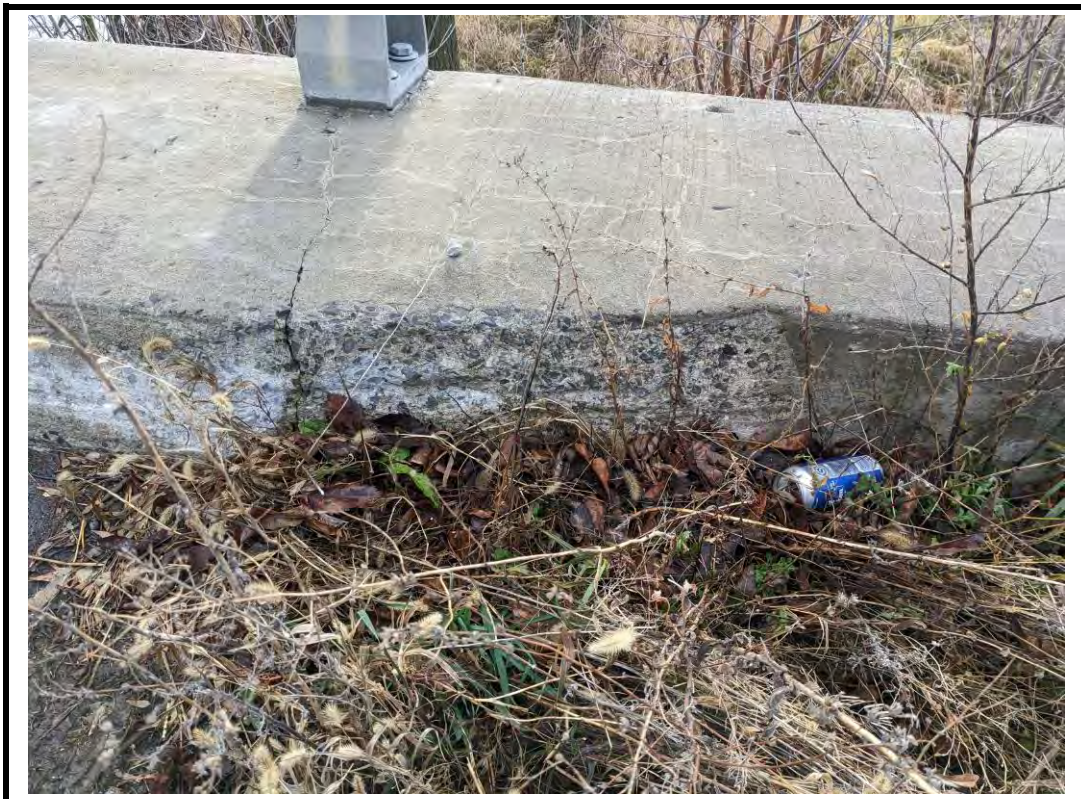
Photo 16 Scaling on deck barrier curb

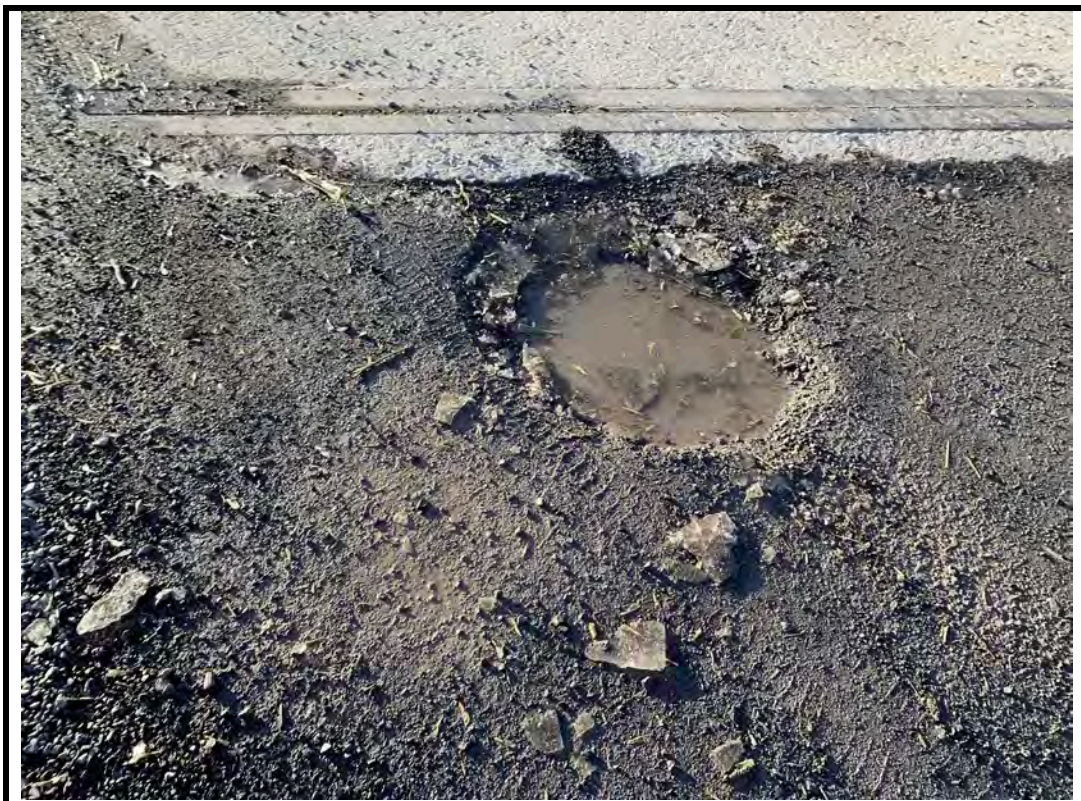
Photo 8 Large potholes and settlement noted on east approach

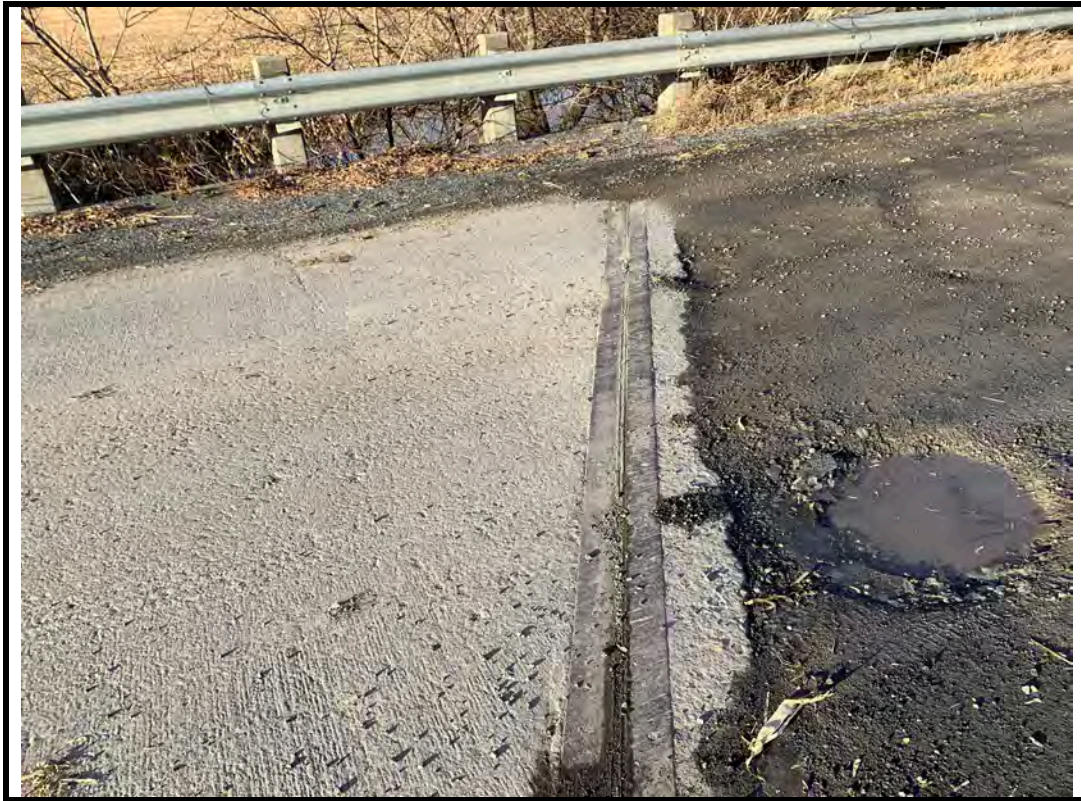
Photo 9 Abrasions noted on strip seal on east expansion joint

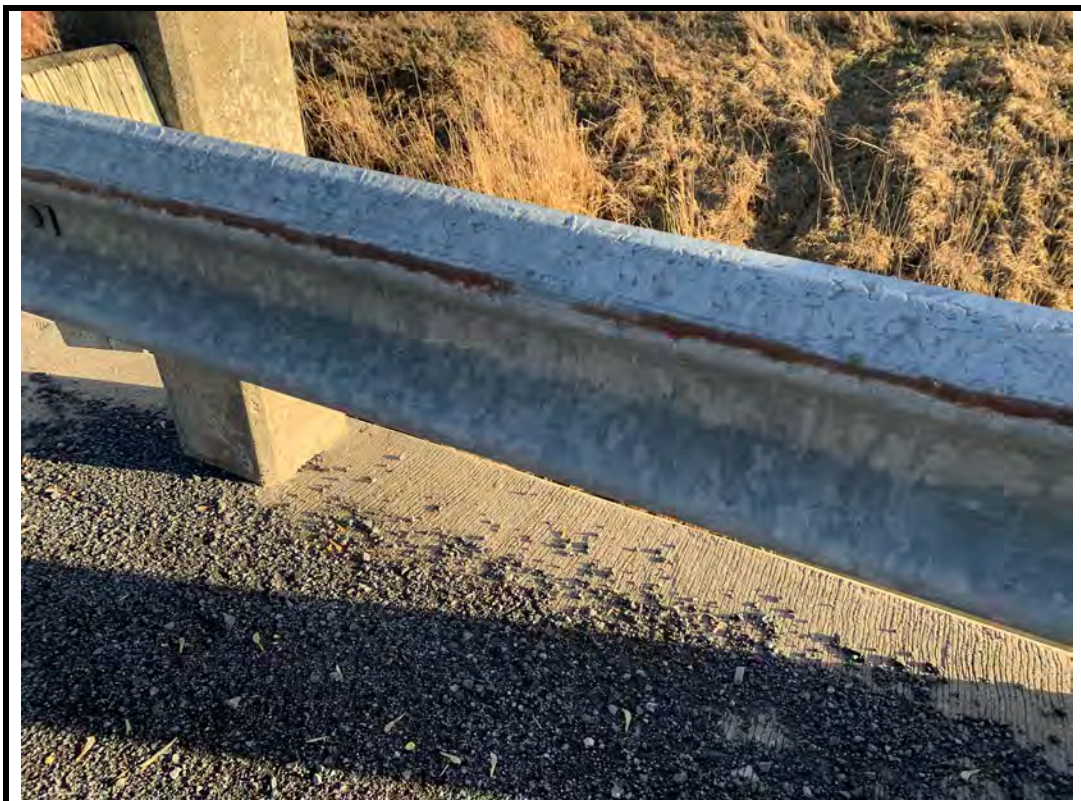
Photo 10 Collision damage on southwest corner of deck barrier

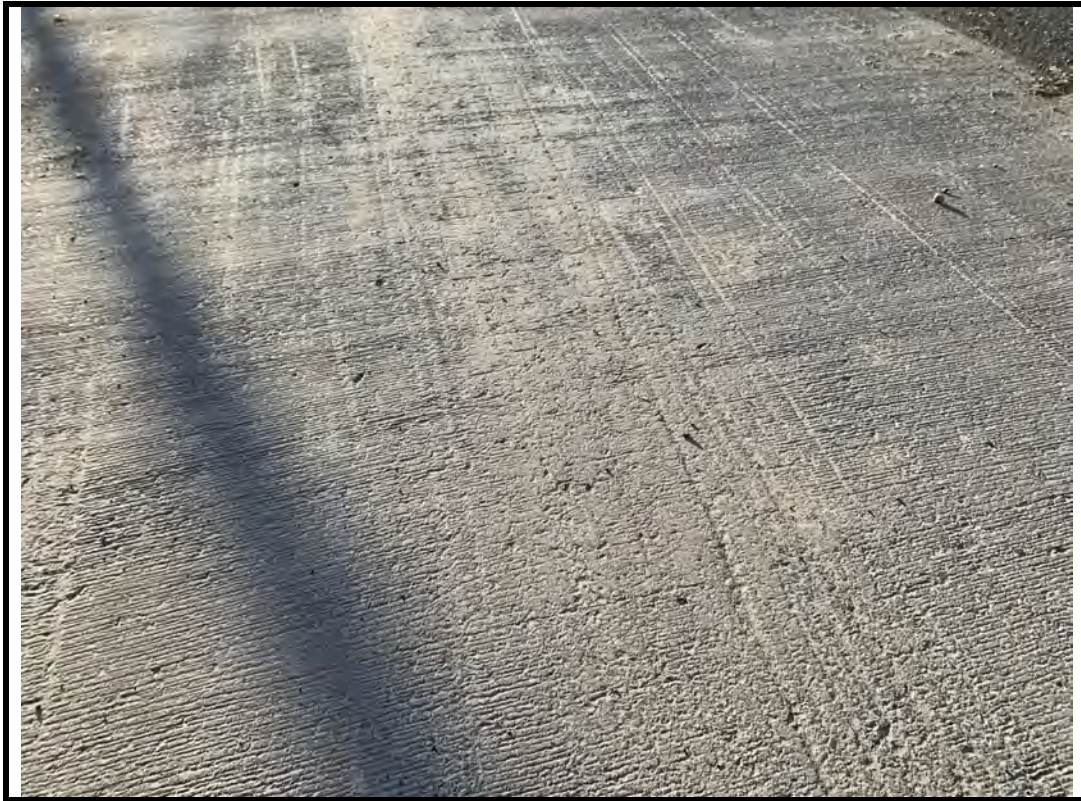
Photo 11 Abrasions and scaling on exposed concrete deck top.

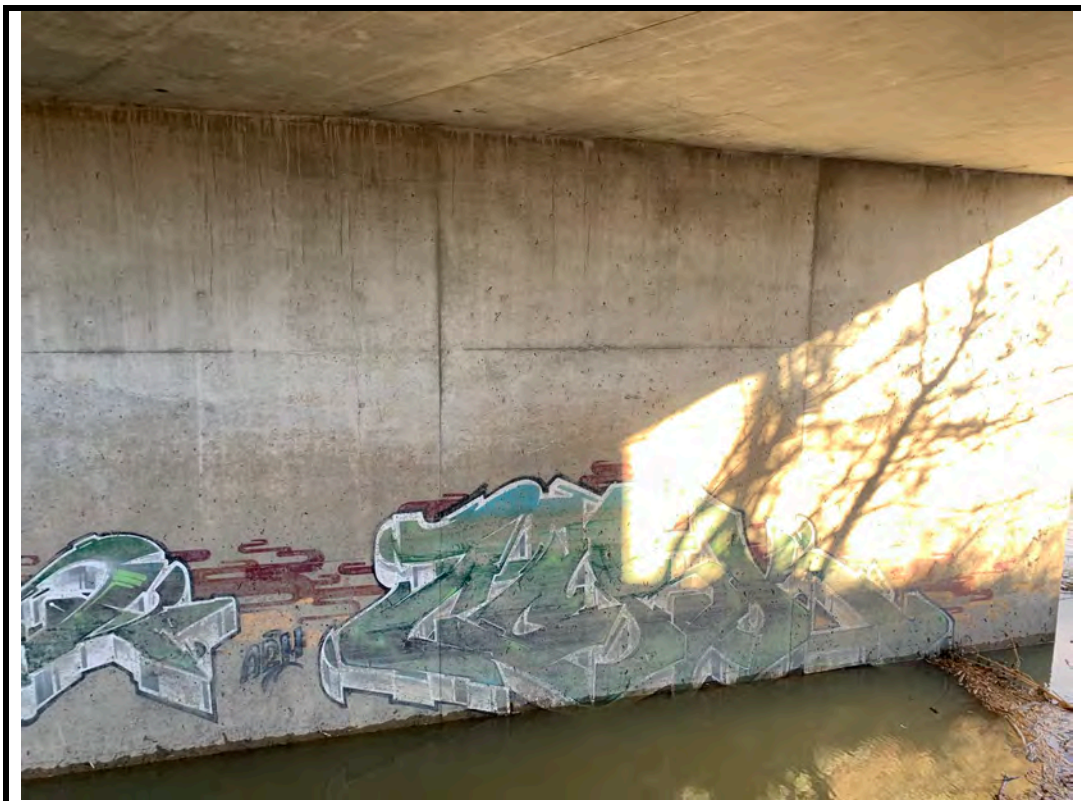
Photo 16 Graffiti on west face of pier

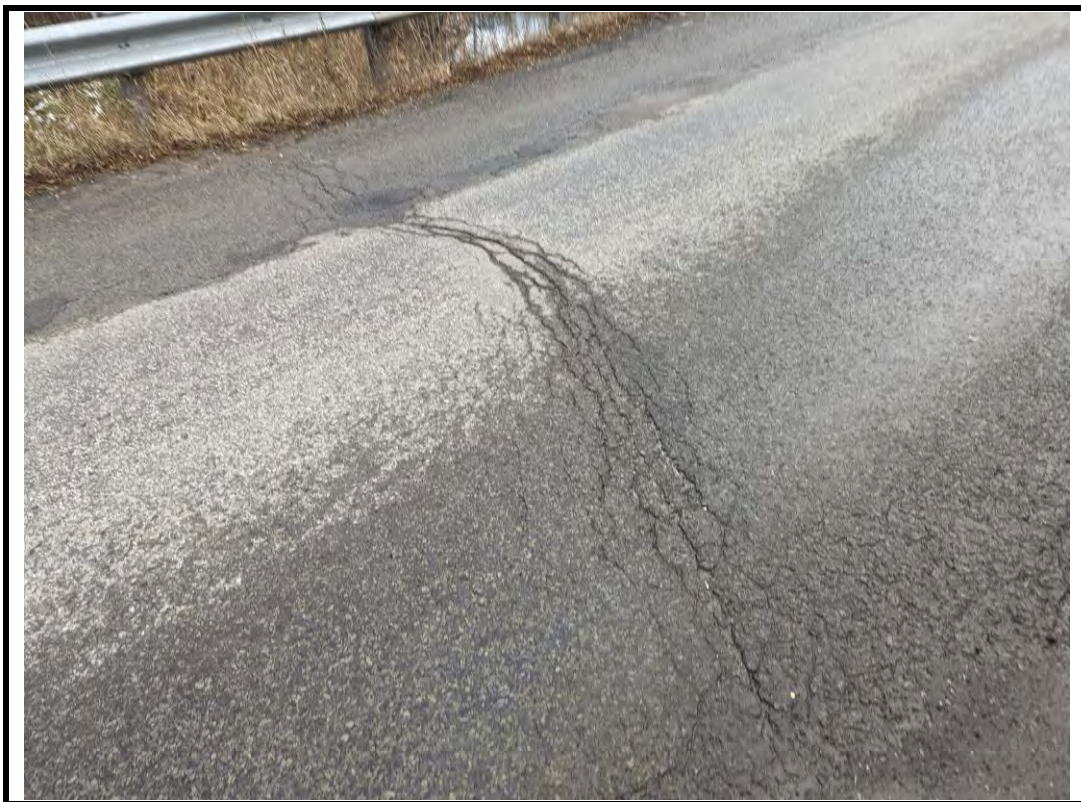
Photo 8 **Transverse cracks, patched potholes, and raveling on wearing surface**

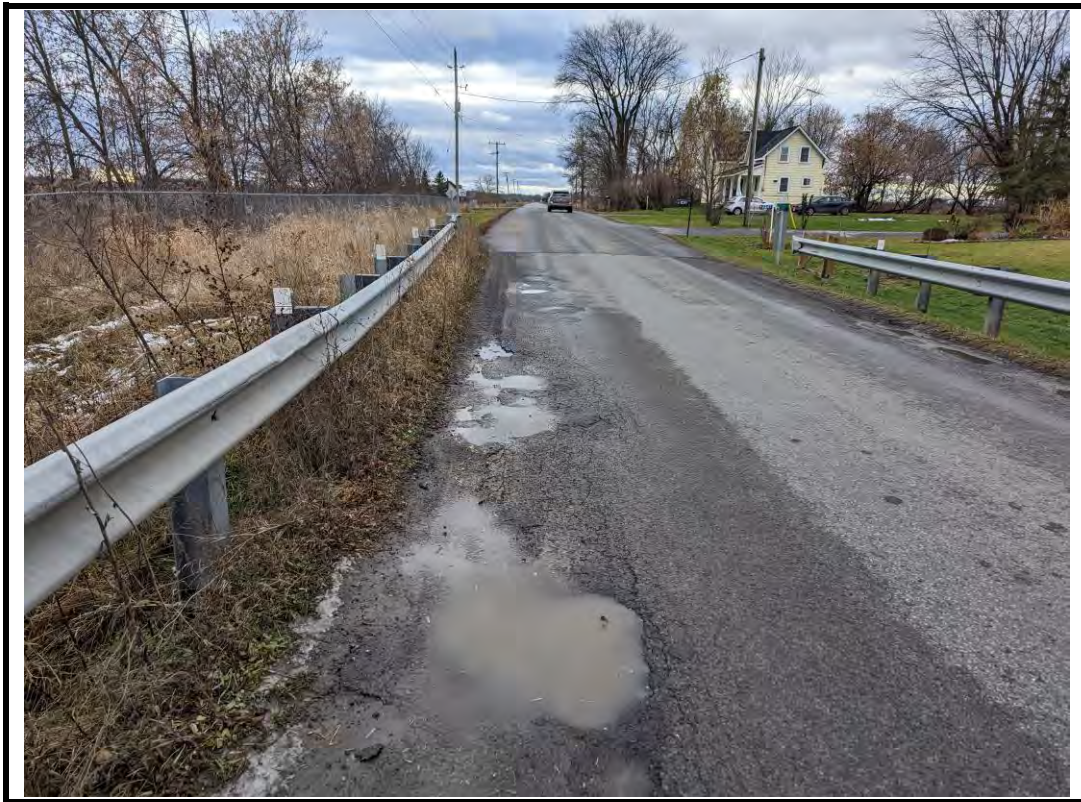
Photo 9 Potholes, ponding, and cracks in asphalt wearing surface

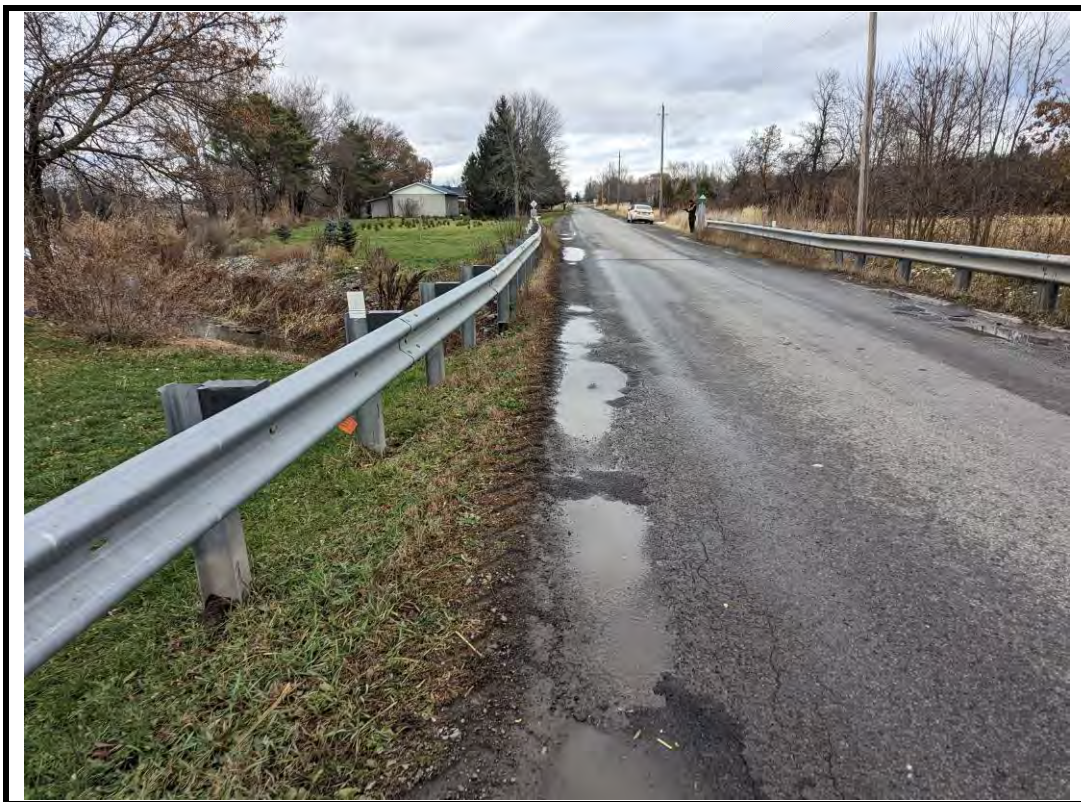
Photo 10 Light abrasions on guide rail posts

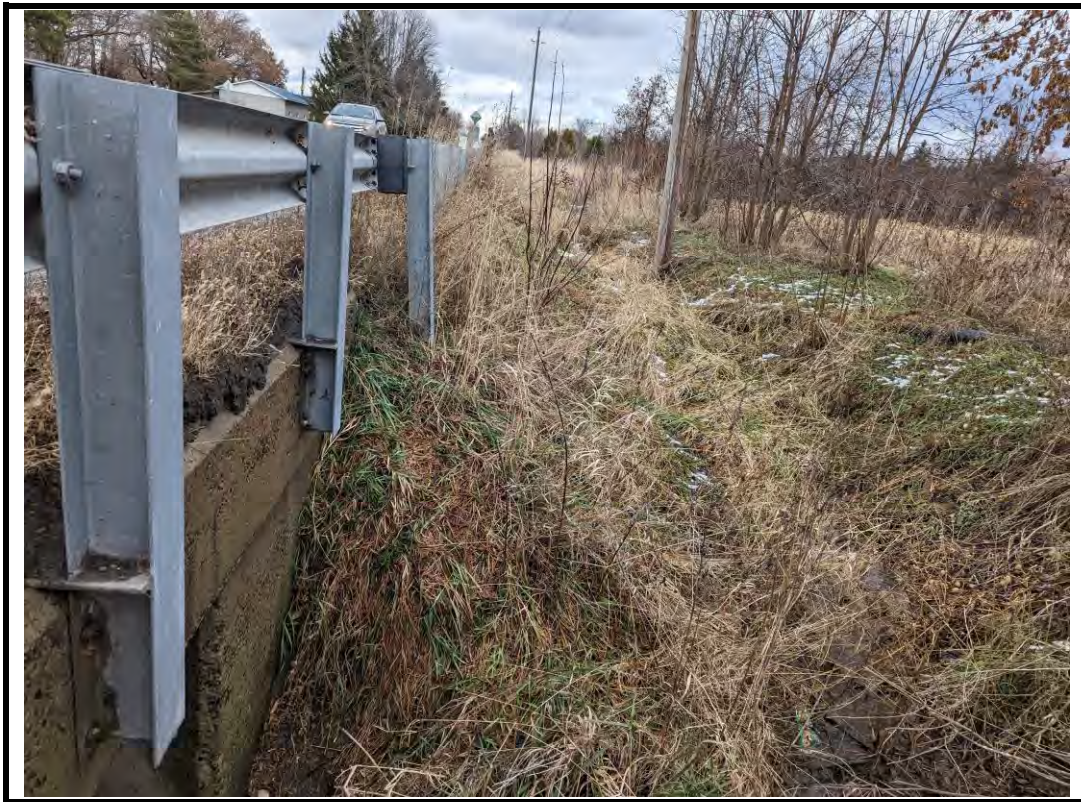
Photo 11 Disconnected/rotated barrier post and loss of fill at the southeast

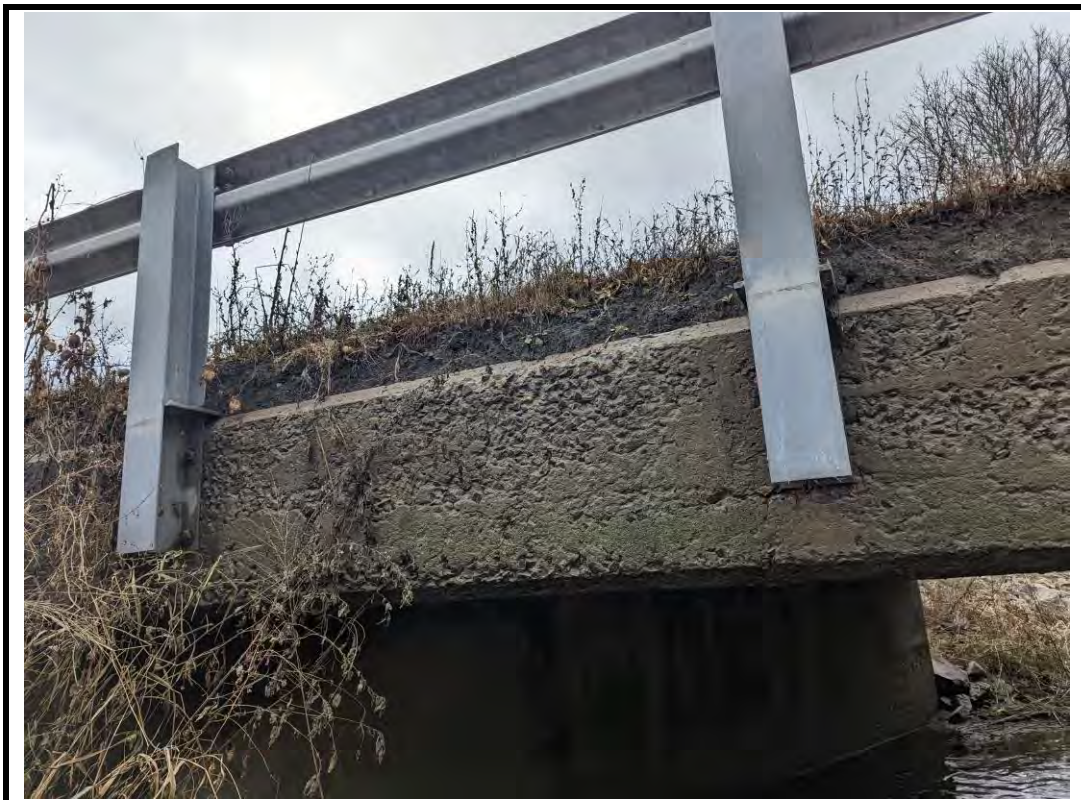
Photo 12 Scaling on deck soffit exterior/fascia (typ.)

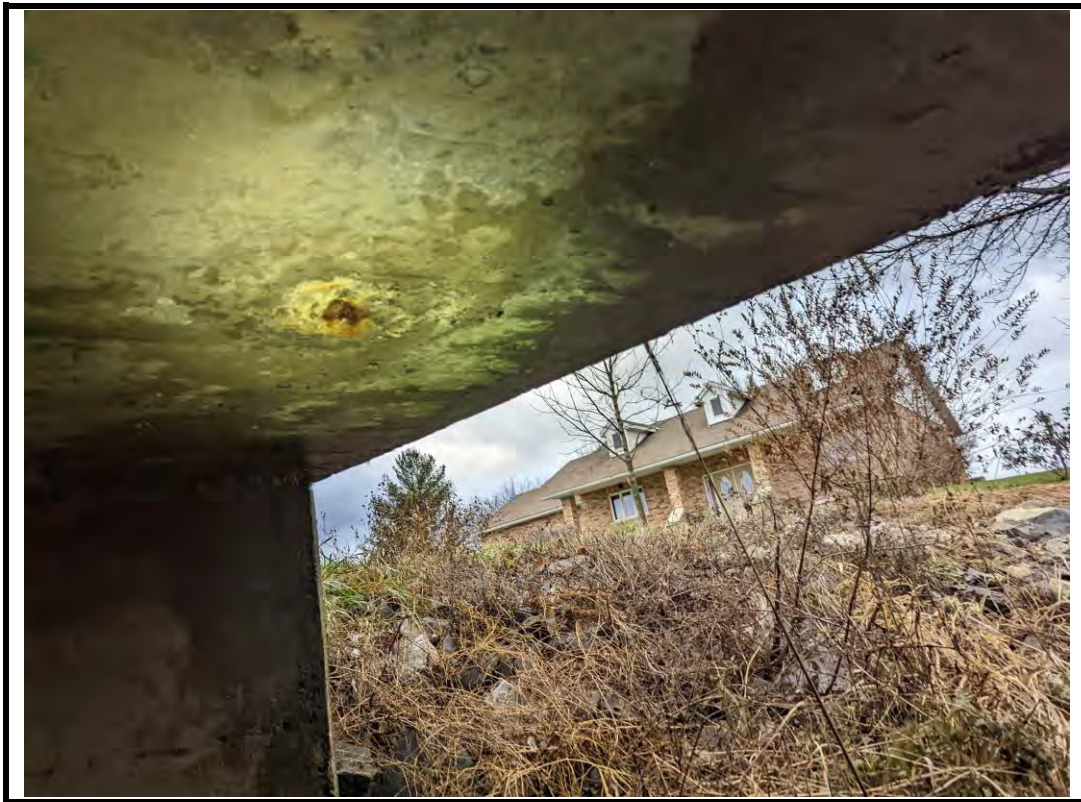
Photo 13 Small spall with ECR on the deck soffit

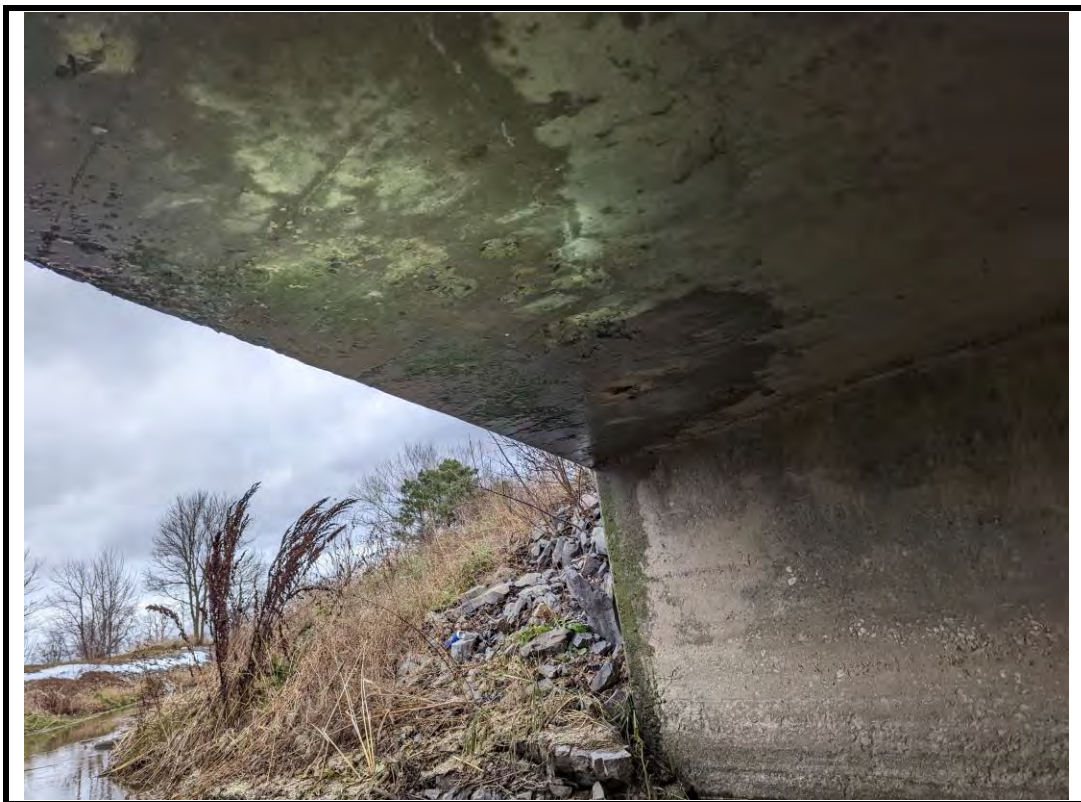
Photo 14 Scaling and wet stains on deck soffit

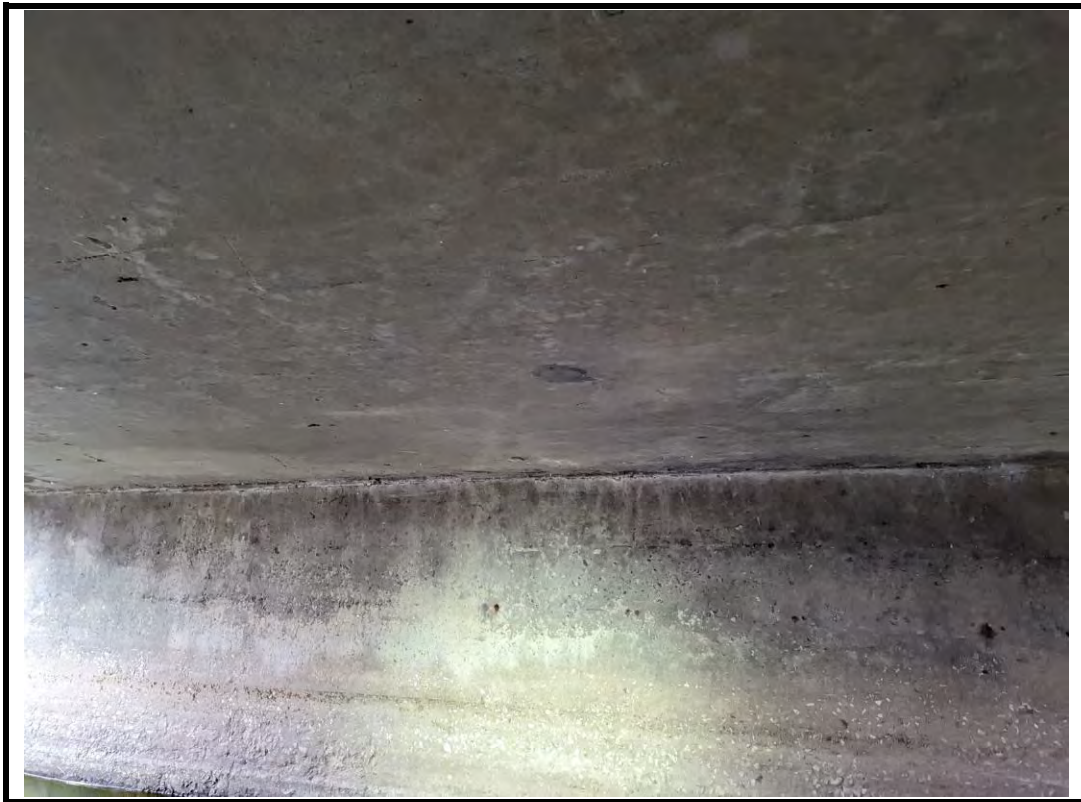
Photo 15 Scaling, wet stains, and light scour on abutment walls

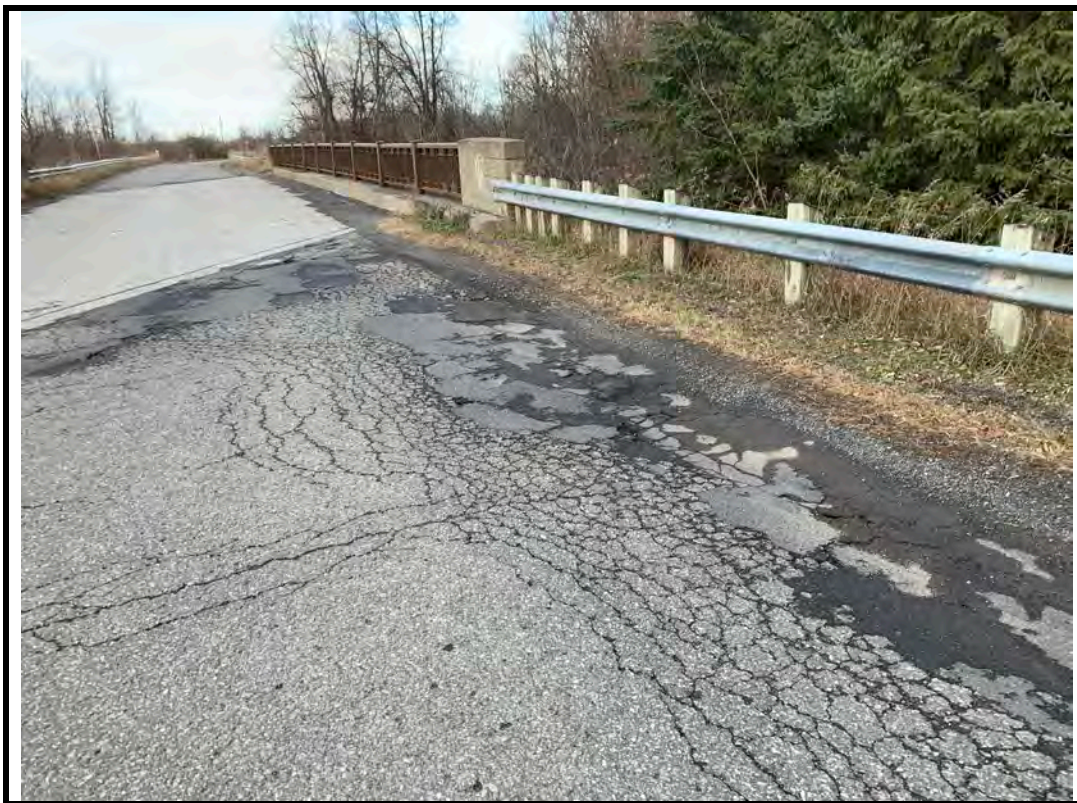
Photo 7 Wide pattern cracks, potholes and asphalt patches on north approach

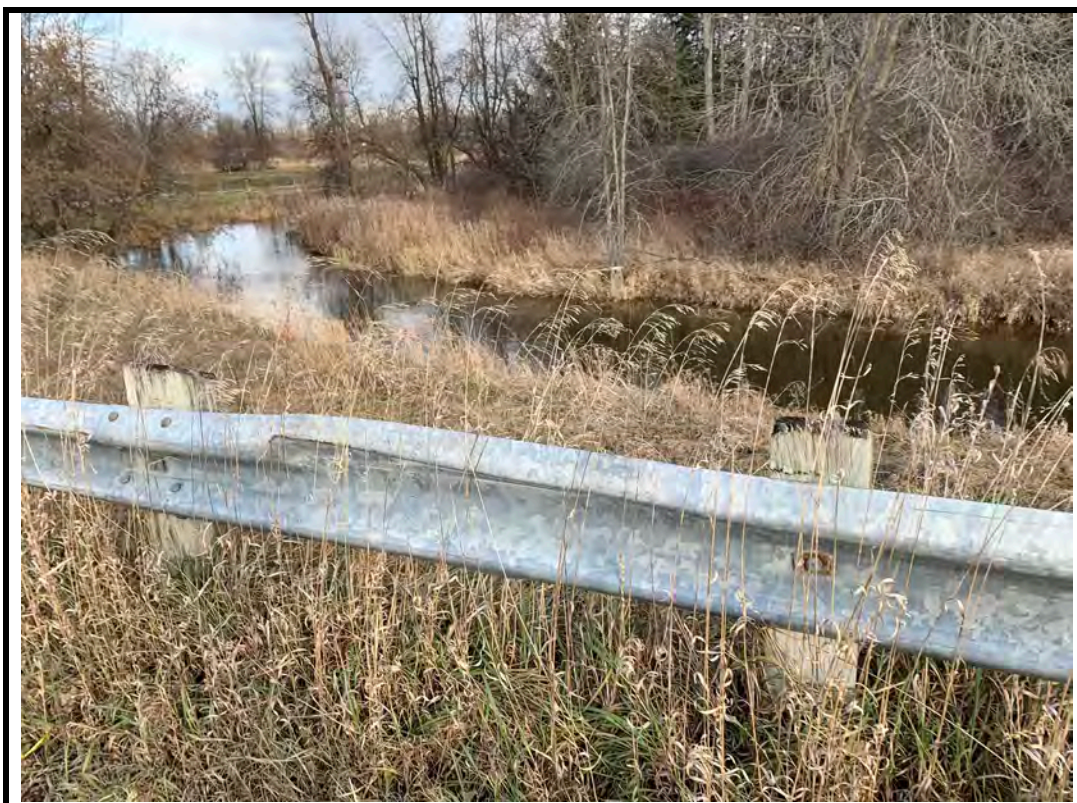
Photo 8 Collision damage on southwest guiderail

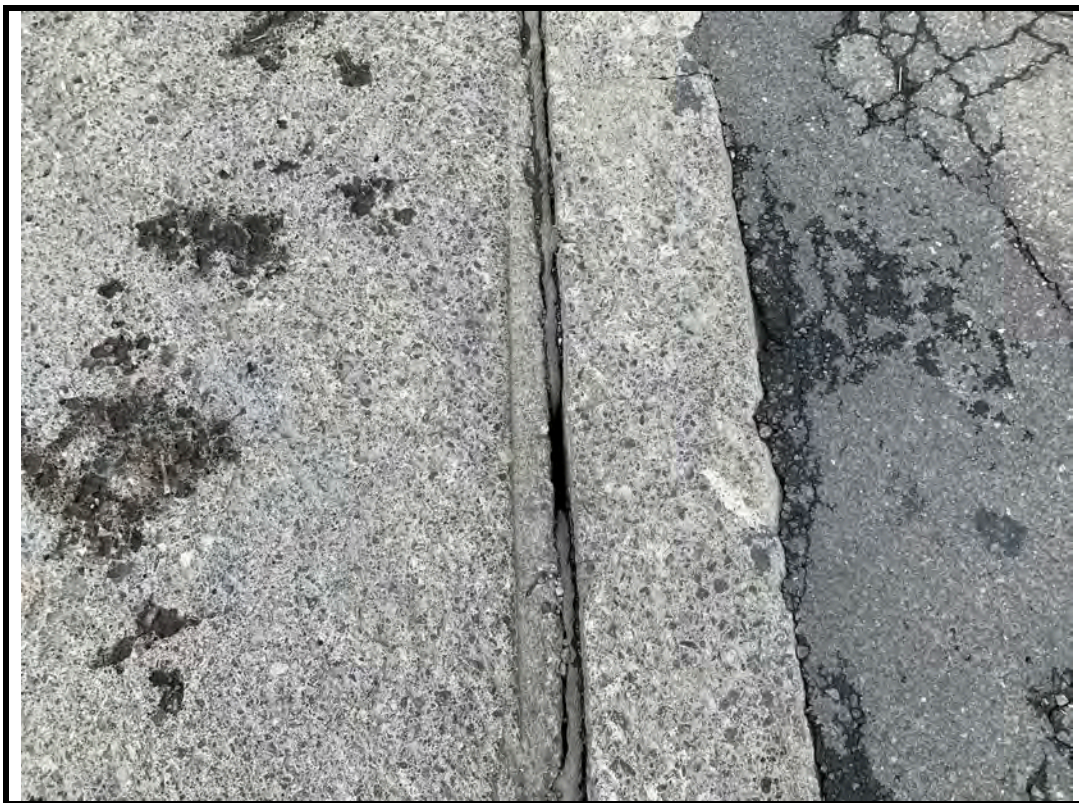
Photo 9 Missing portion of seal on north expansion joint

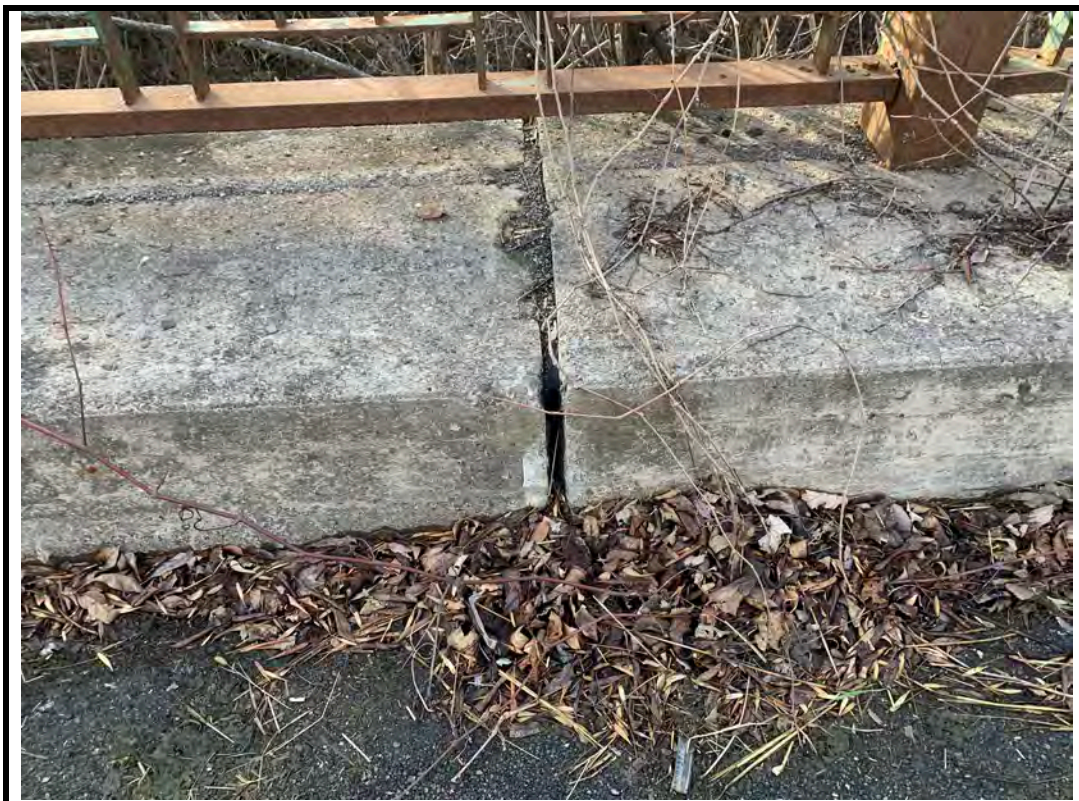
Photo 10 Scaling on top of west concrete curb
