THE TOWNSHIP OF NORTH DUNDAS

DRAFT BRIDGE MANAGEMENT STUDY REPORT 18 BRIDGES / 31 CULVERTS

March 2023

HP Engineering Inc.

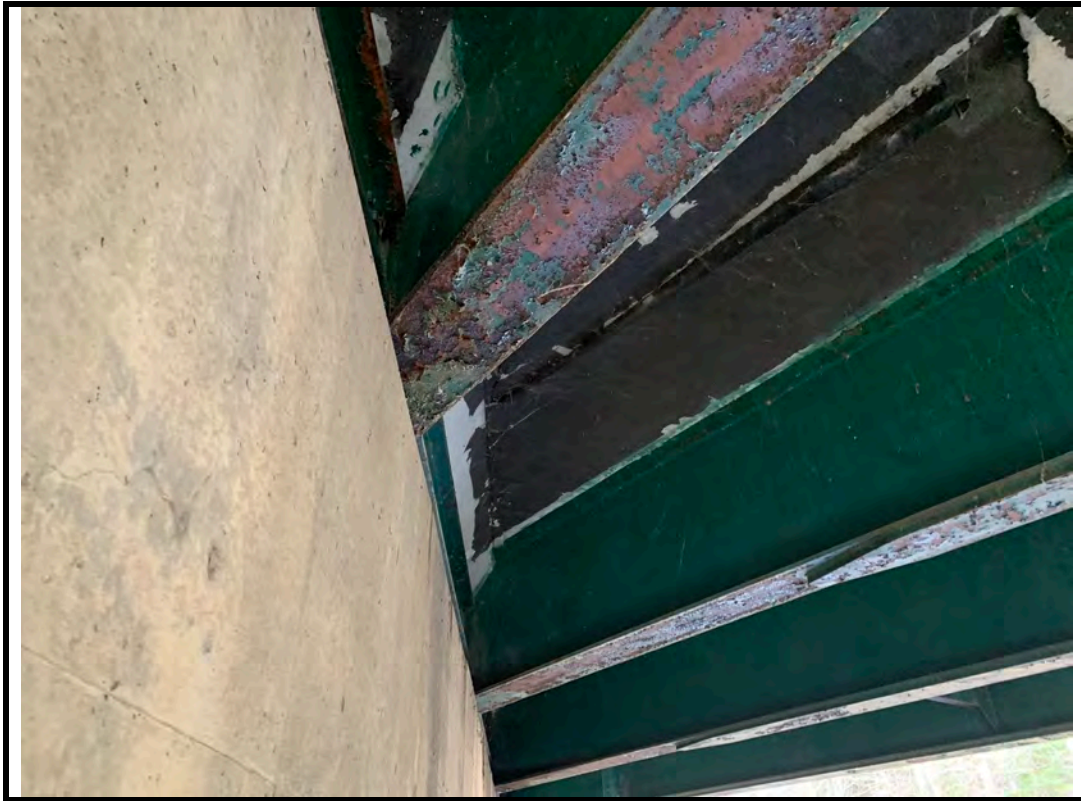
Photo 15 Corrosion and coating failure on north end of interior girder

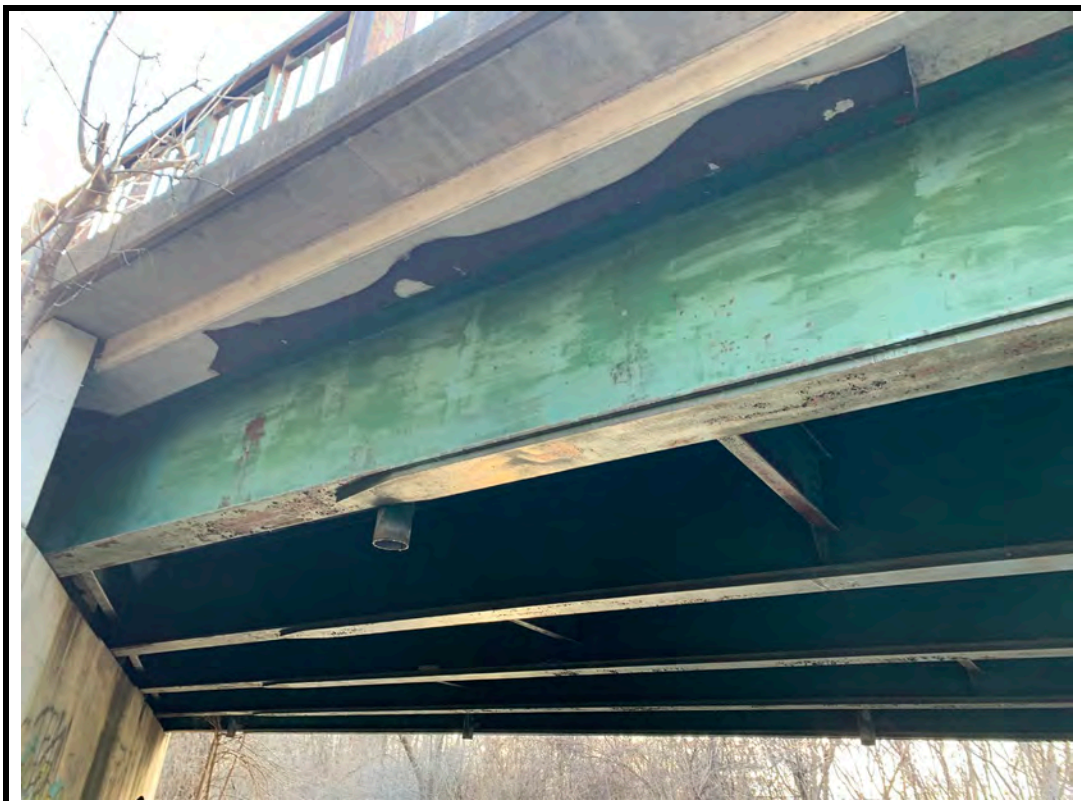
Photo 16 Light corrosion and coating failure on east exterior girder

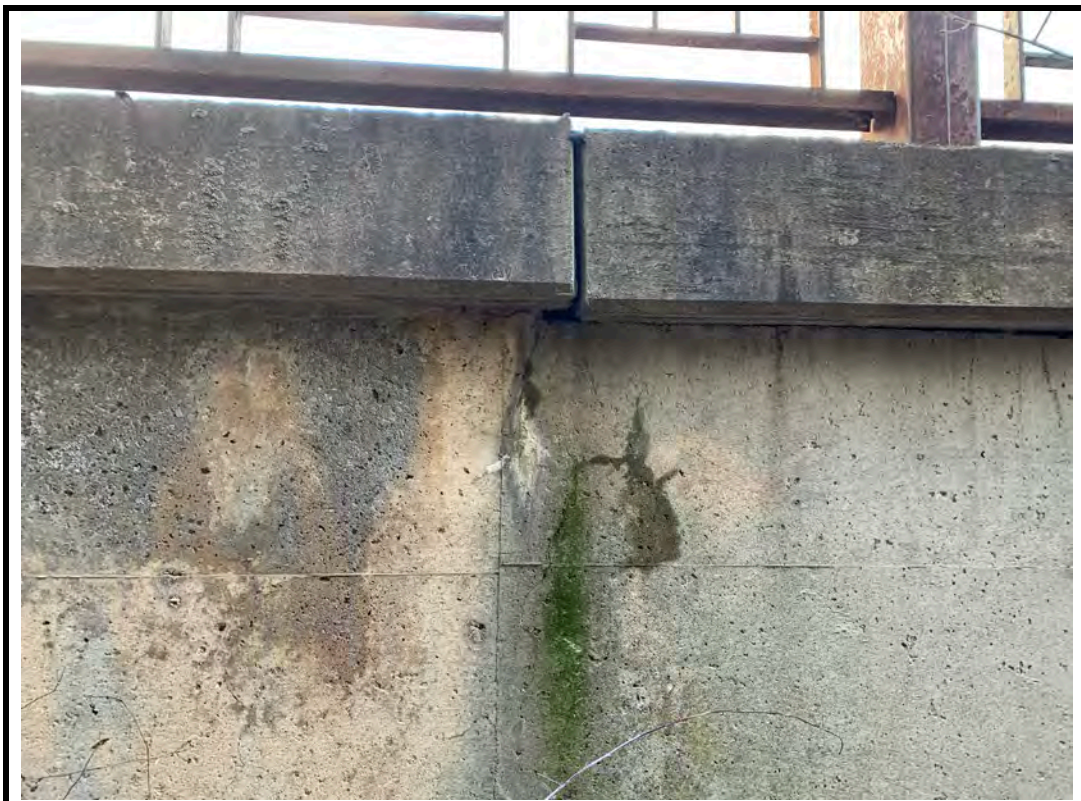
Photo 18 Medium cracks with efflorescence on southeast wingwall

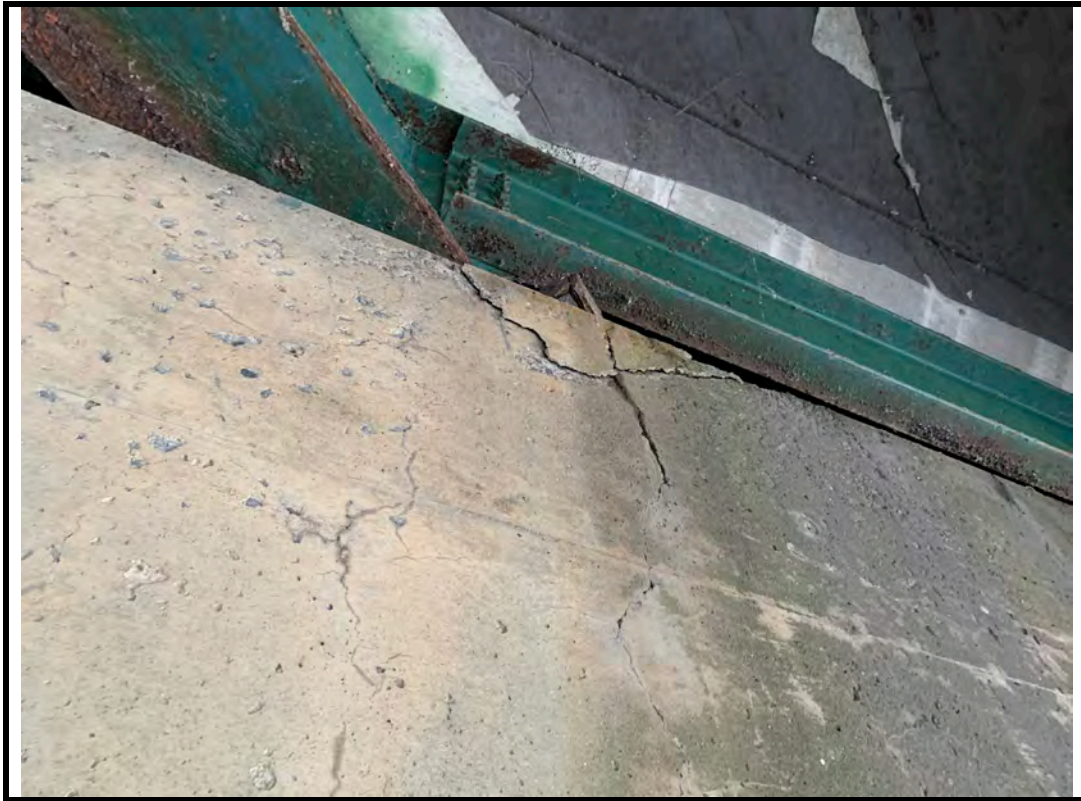
Photo 19 Delamination on south abutment wall below girder

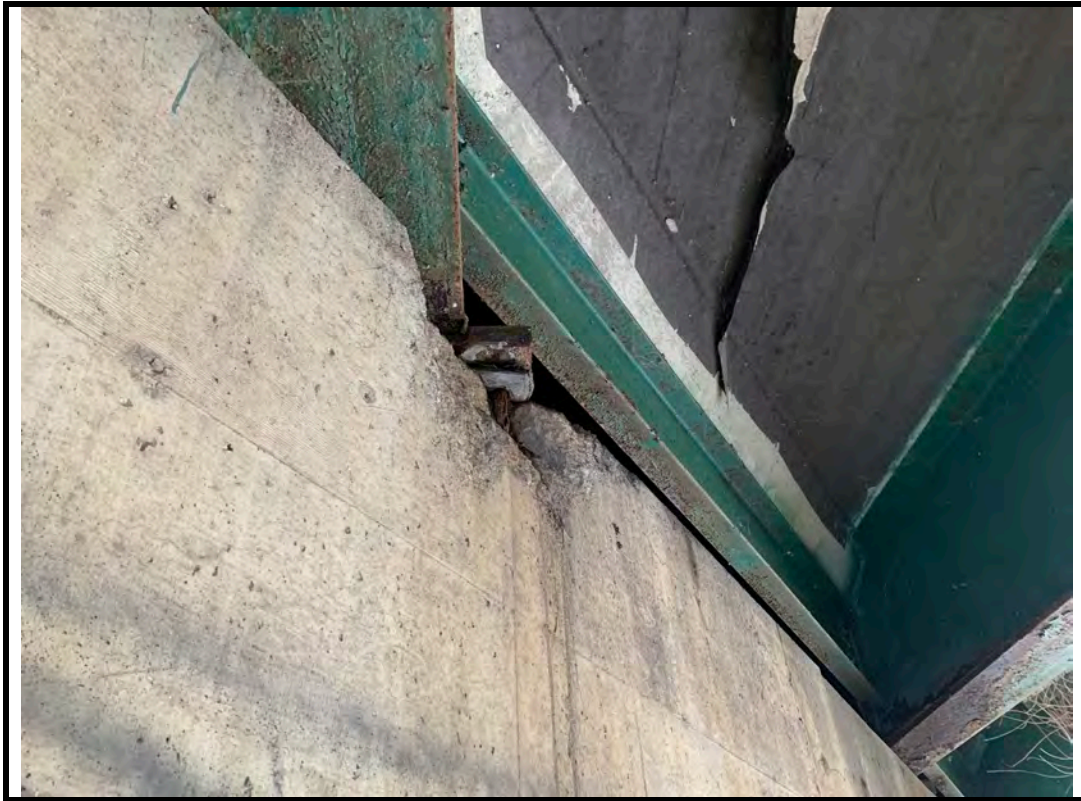
Photo 21 Spall below girder end on north abutment wall

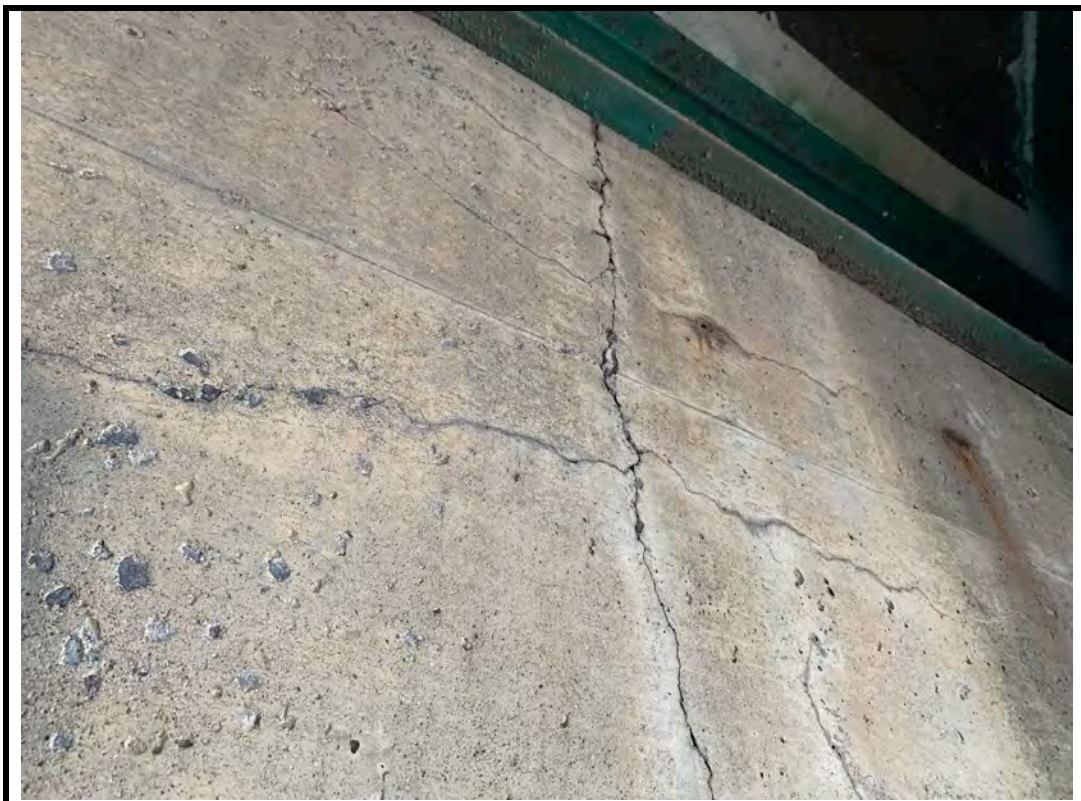
Photo 22 Wide vertical crack on south abutment wall

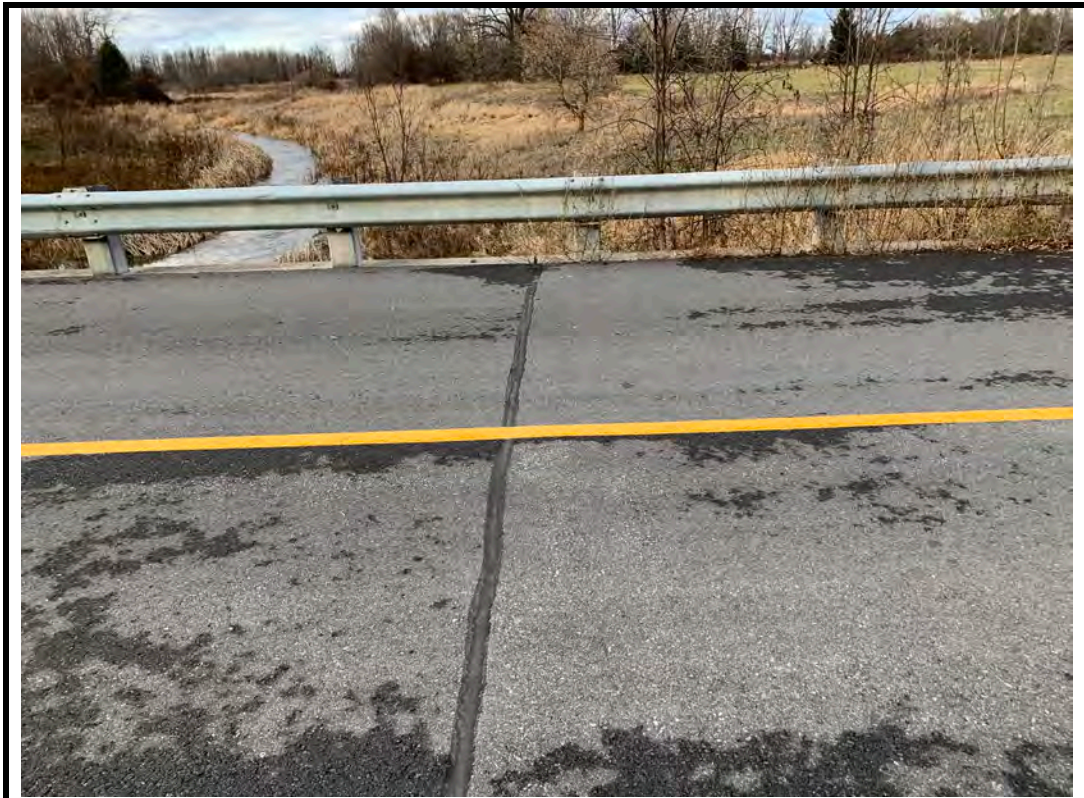
Photo 8 Seal at east end of structure

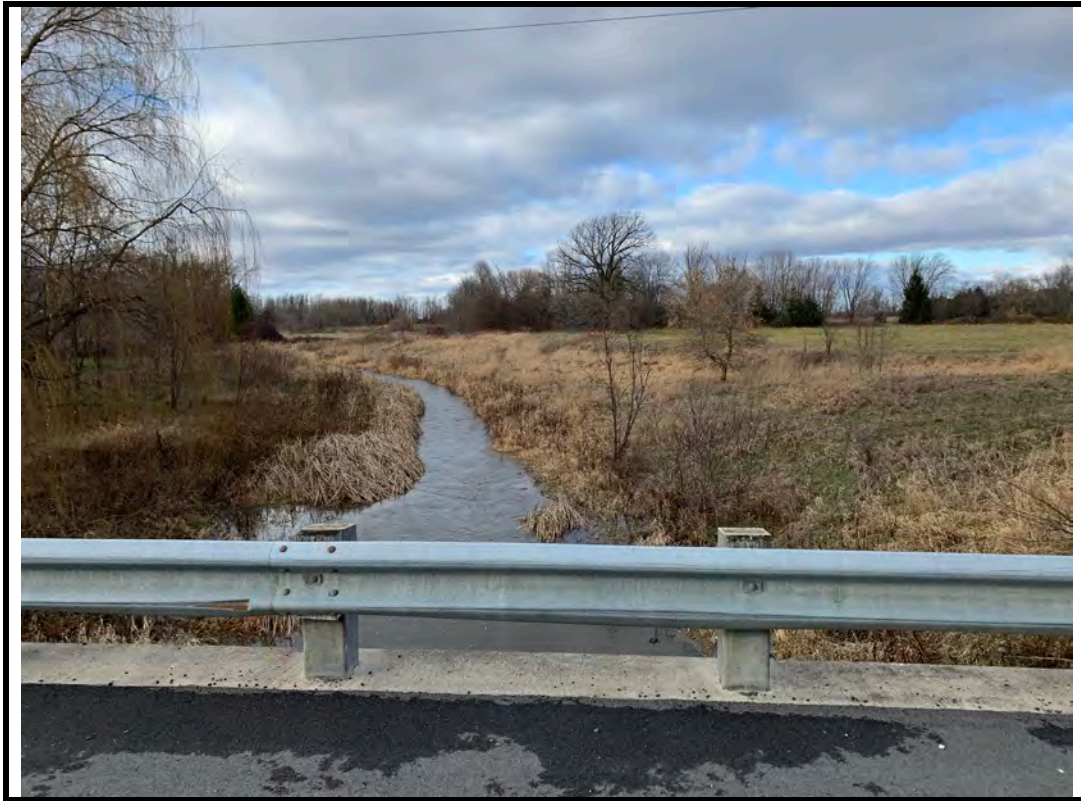
Photo 9 Abrasions on north deck barrier

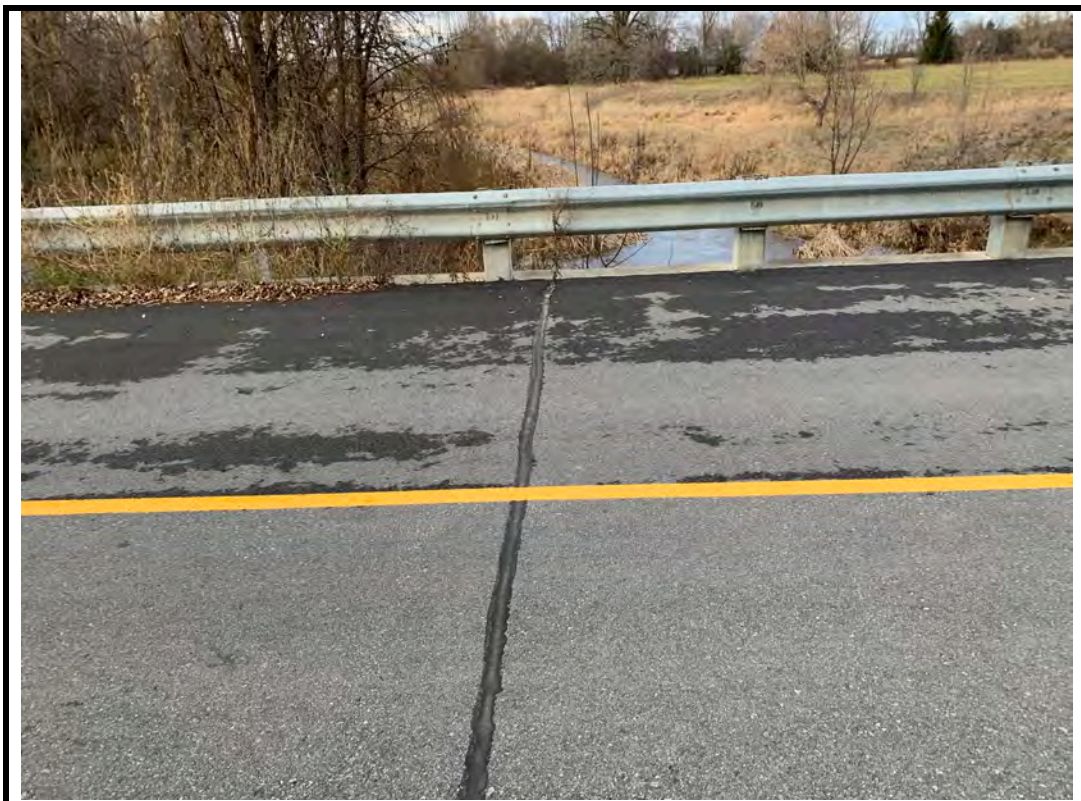
Photo 10 New asphalt at west end of deck wearing surface

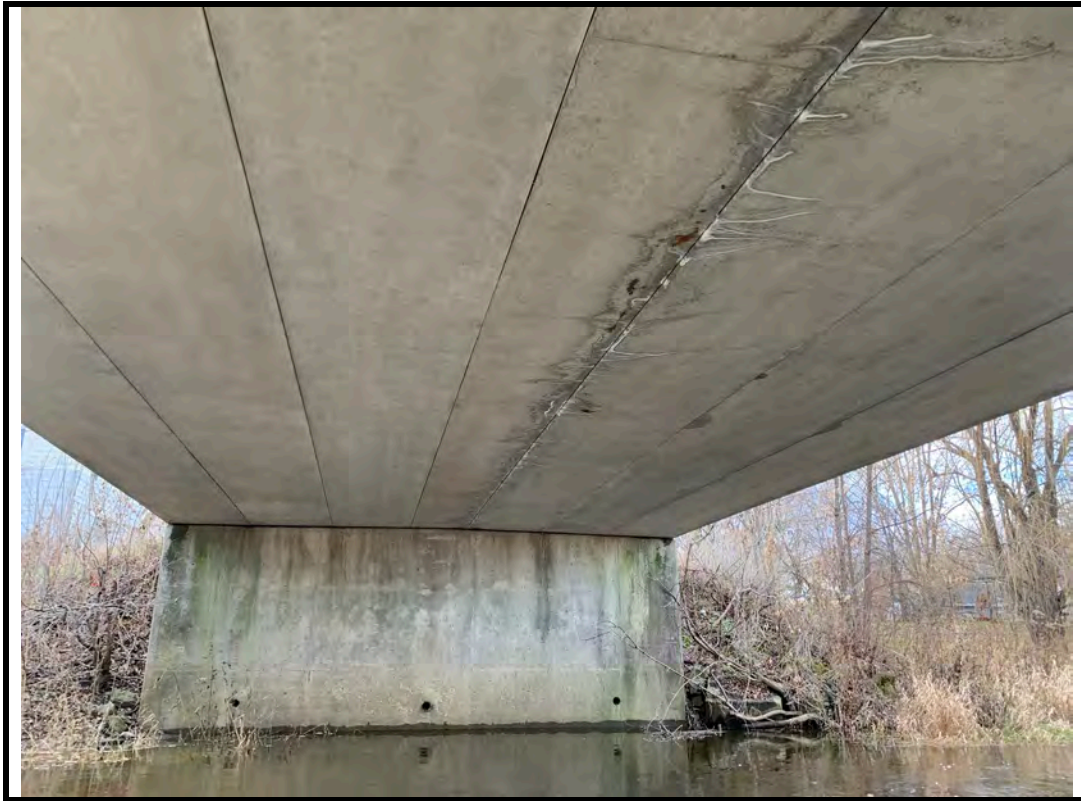
Photo 11 Efflorescence and evidence of leakage between box girders

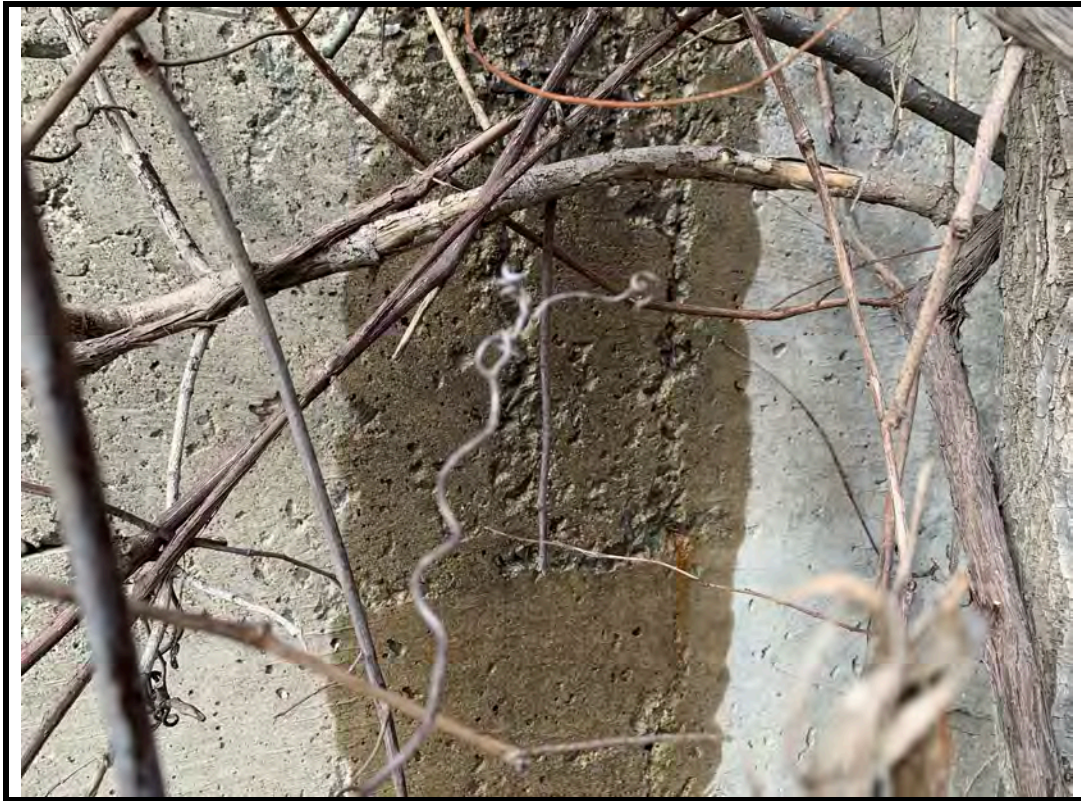
Photo 15 Scaling on north abutment wall

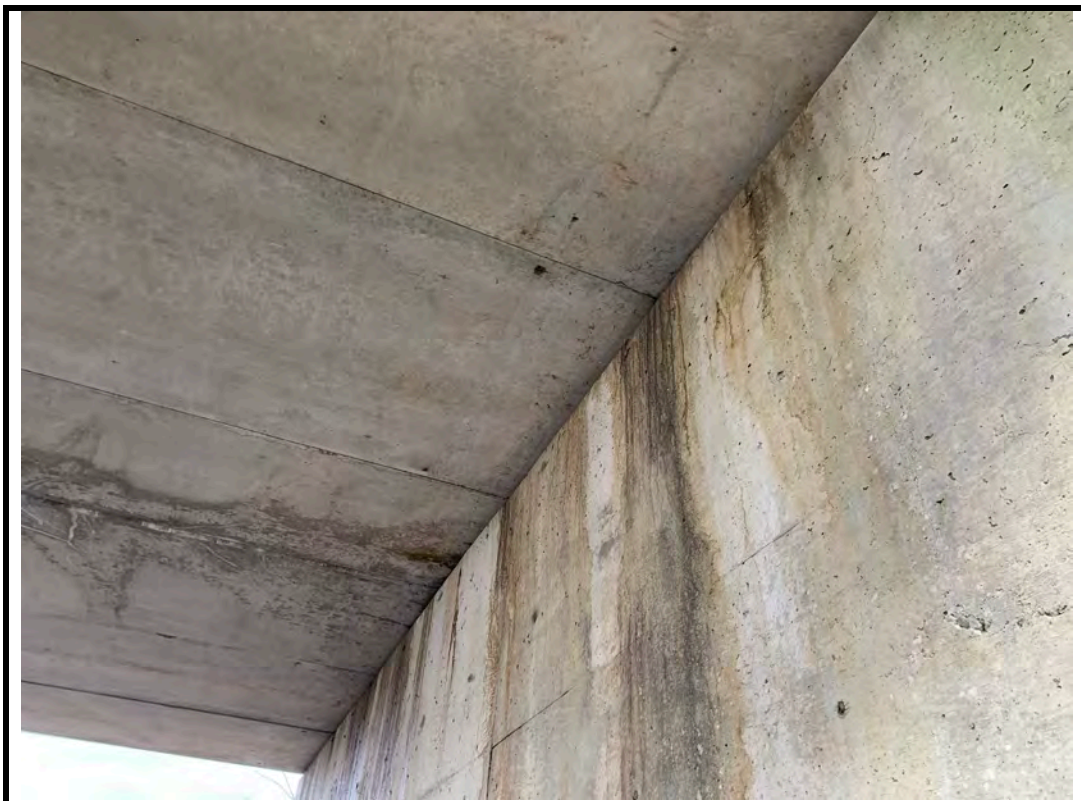
Photo 16 Staining at top of west abutment wall

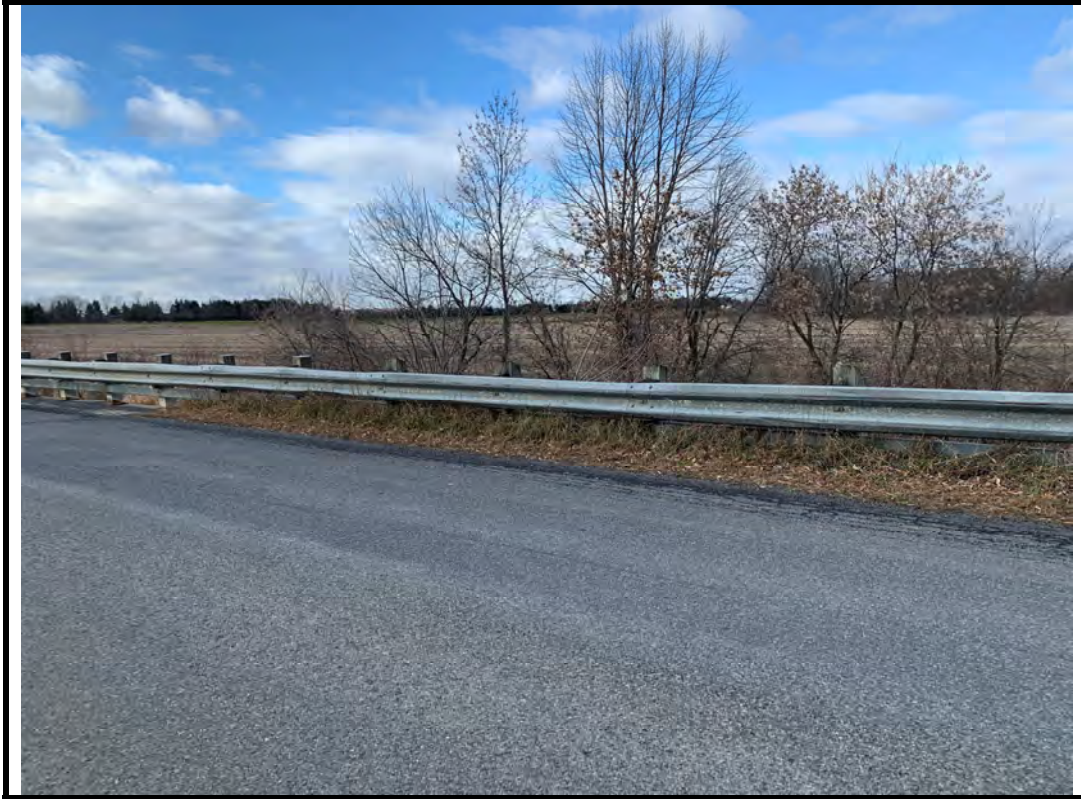
Photo 7 Collision damage on existing approach barrier at northeast corner of structure

Element Group:	Approaches	Length:	NE: 30.5, SE: 24.8, SW: 28.6, NW: 24.8				
Element Name:	Barrier	Width:					
Location:	NE, SE, NW & SW of Structure	Height:					
Material:	Steel	Count (items):	4				
Element Type:	Steel Flex Beam on Steel Posts (SBGR)	Total Quantity:	108.7 m				
Environment:	Severe	Limited Inspection					
Protection System:	None					Perform. Deficiencies	
Condition Data:	Units m	Exc.	Good 90	Fair 11.5	Poor* 7.2		
Comments:	New end treatments installed since previous inspection. Collision damage noted on existing guiderail.						
Recommended Work:		Rehab	Replace	Maintenance Needs: 3			
		1-5 years	6-10 years	Urgent	X	1 year	2 years
				Replace damaged barrier sections

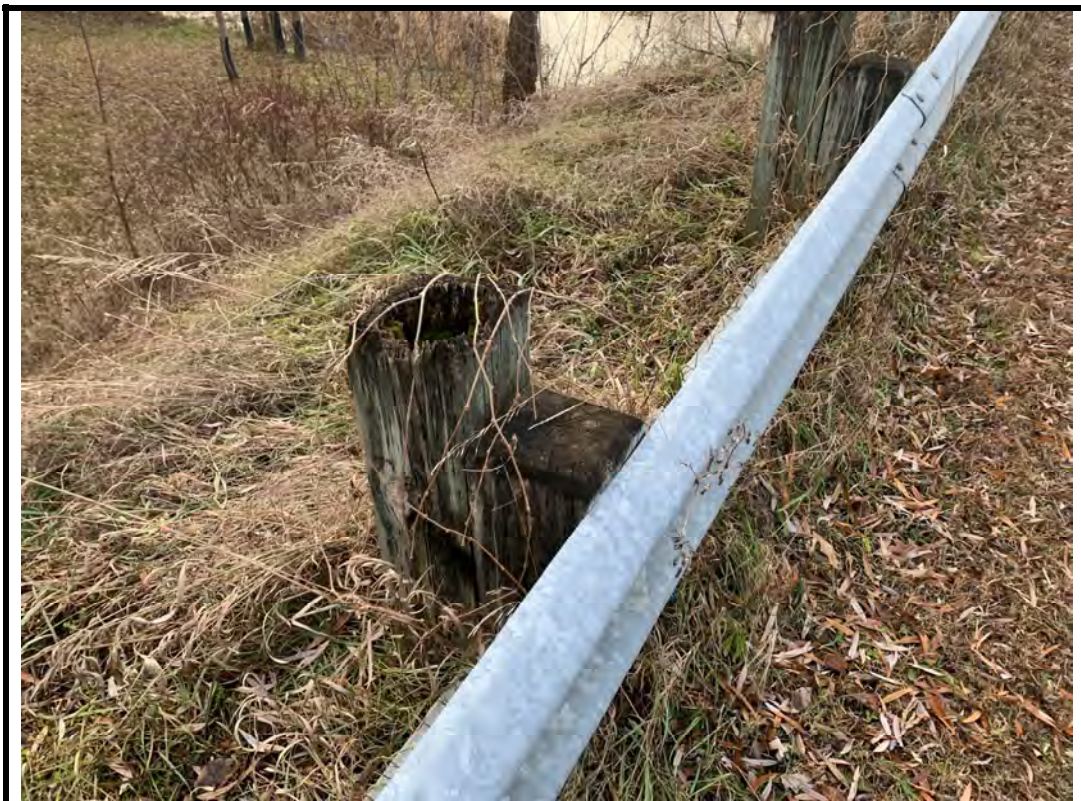
Photo 8 Severe rot on timber posts at southeast approach barrier

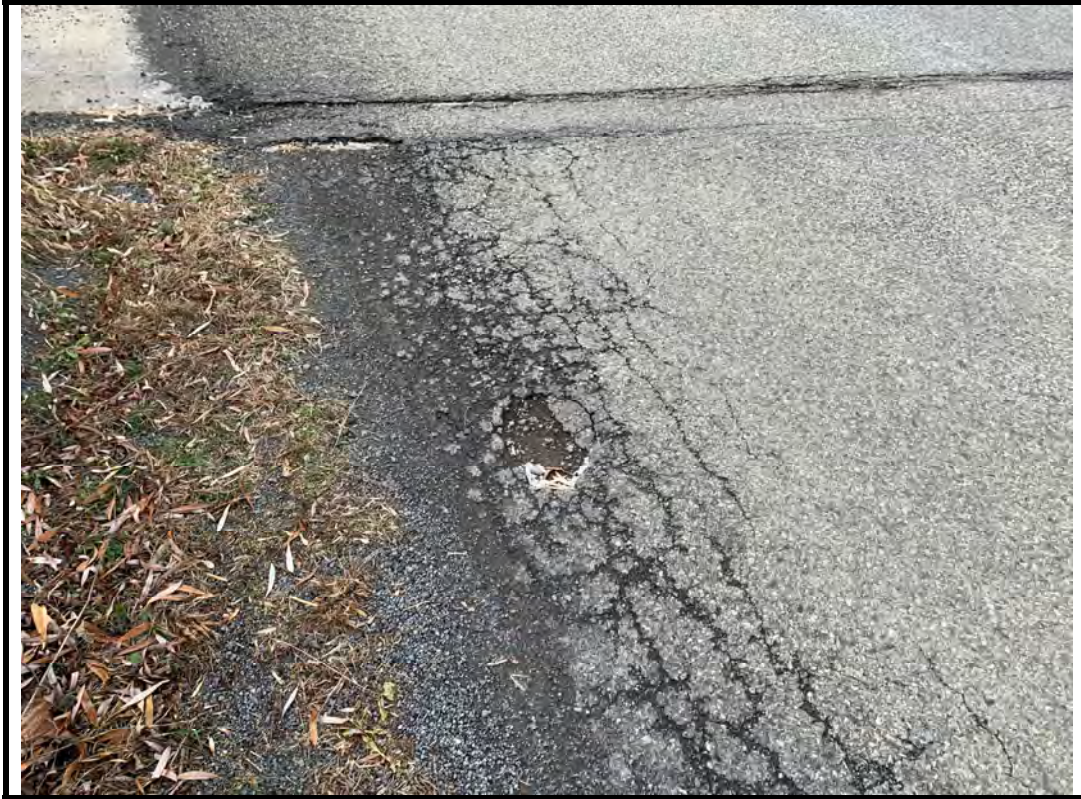
Photo 9 Small potholes at south edge of east approach wearing surface

Element Group:	Approaches	Length:	6				
Element Name:	Wearing Surface	Width:	6				
Location:	East and West Side of Structure	Height:					
Material:	Asphalt	Count (items):	2				
Element Type:	Asphalt Surface Treatment	Total Quantity:	72.0 m ²				
Environment:	Severe	Limited Inspection					
Protection System:	None					Perform. Deficiencies	
Condition Data:	Units m ²	Exc.	Good 71.5	Fair 0.5	Poor*		
Comments:	Cracks and potholes forming at west approach at interface with deck. Minor settlement noted at both ends of deck. Previous patch repairs noted.						
Recommended Work:		Rehab	Replace	Maintenance Needs:			
		1-5 years	6-10 years	Urgent		1 year	2 years
				Repair asphalt surface treatment and patch pothole

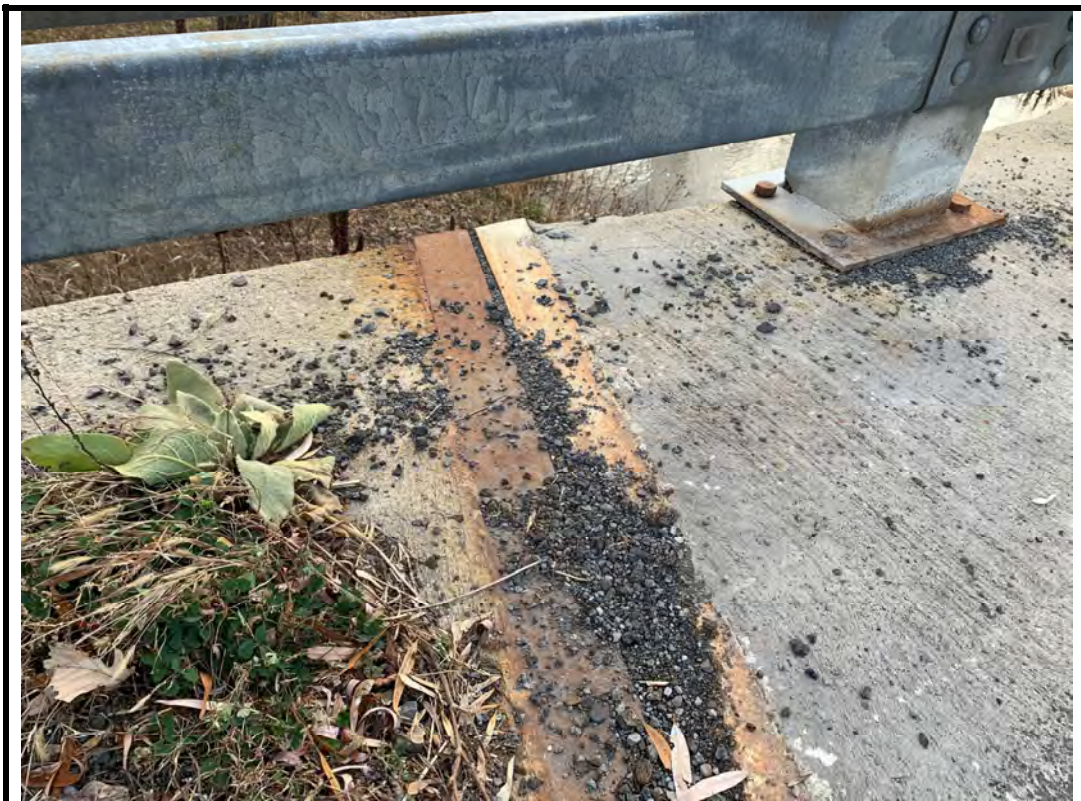
Photo 10 Light corrosion noted on visible portions of expansion joint

Element Group:	Joints	Length:	9.2				
Element Name:	Other	Width:					
Location:	East & West Side of Structure	Height:					
Material:	Other	Count (items):					
Element Type:	Expansion Joint	Total Quantity:	9.2 m				
Environment:	Severe	Limited Inspection	X				
Protection System:	None					Perform. Deficiencies	
Condition Data:	Units m	Exc.	Good 9.2	Fair	Poor*		
Comments:	StrExpansion joint have been paved over. Light corroion noted at visible portions of joints.						
Recommended Work:		Rehab	Replace	Maintenance Needs:			
		1-5 years	6-10 years	Urgent		1 year	2 years
				Install supports.

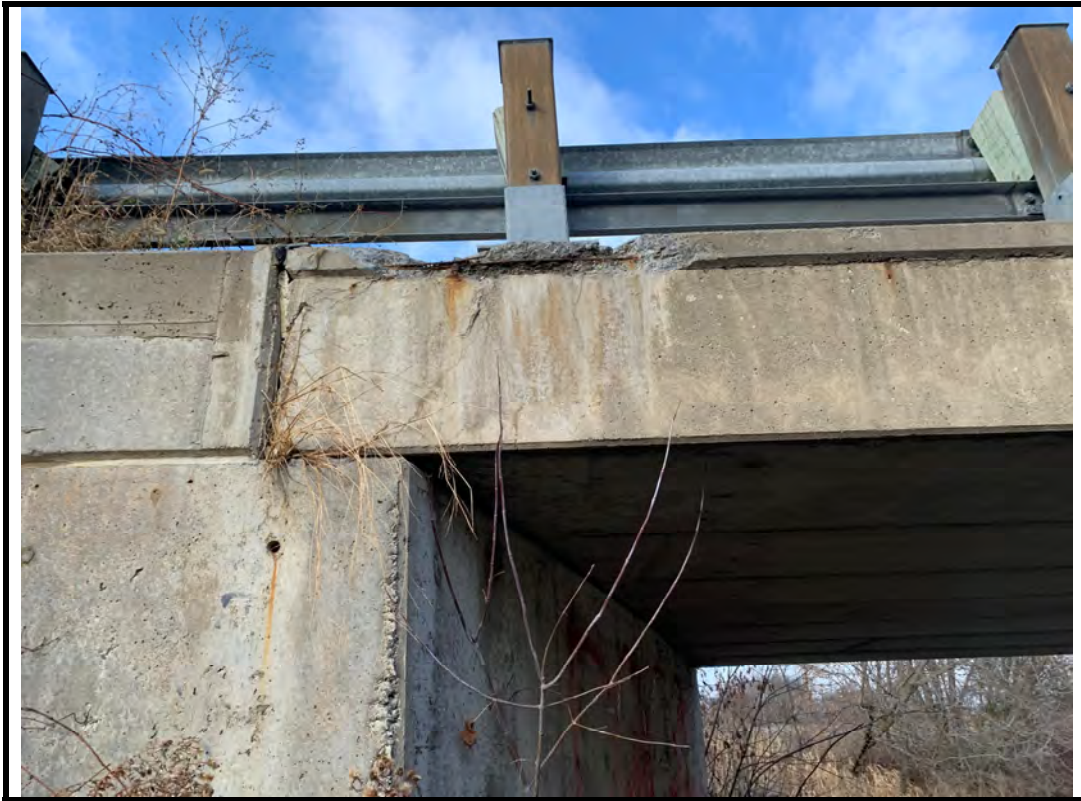
Photo 13 Spall with exposed corroded reinforcement at southeast corner

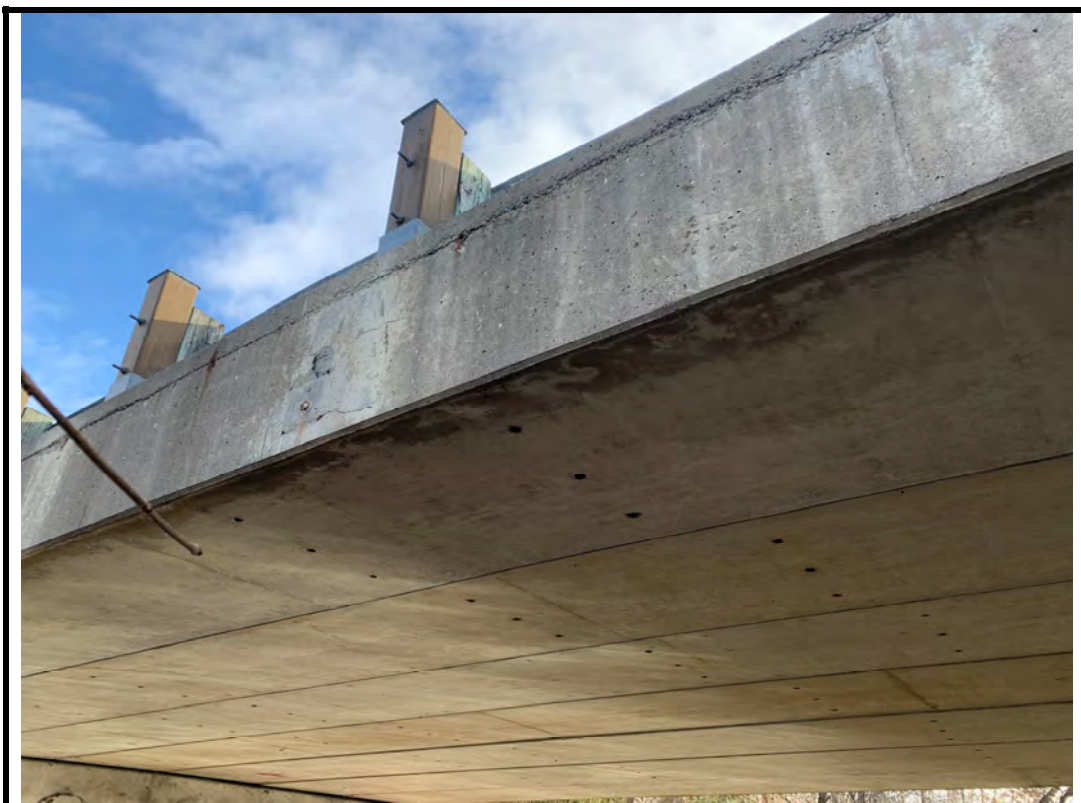
Photo 14 Staining at edges of underside of structure

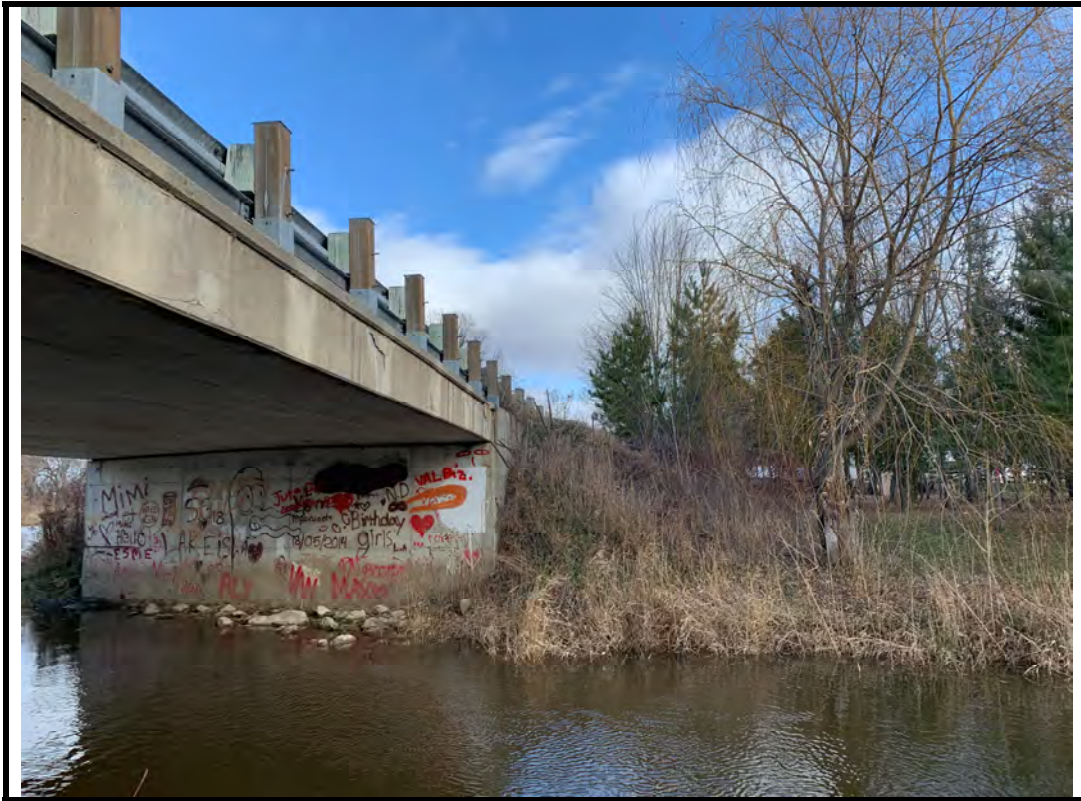
Photo 19 Moderate erosion at southeast embankment

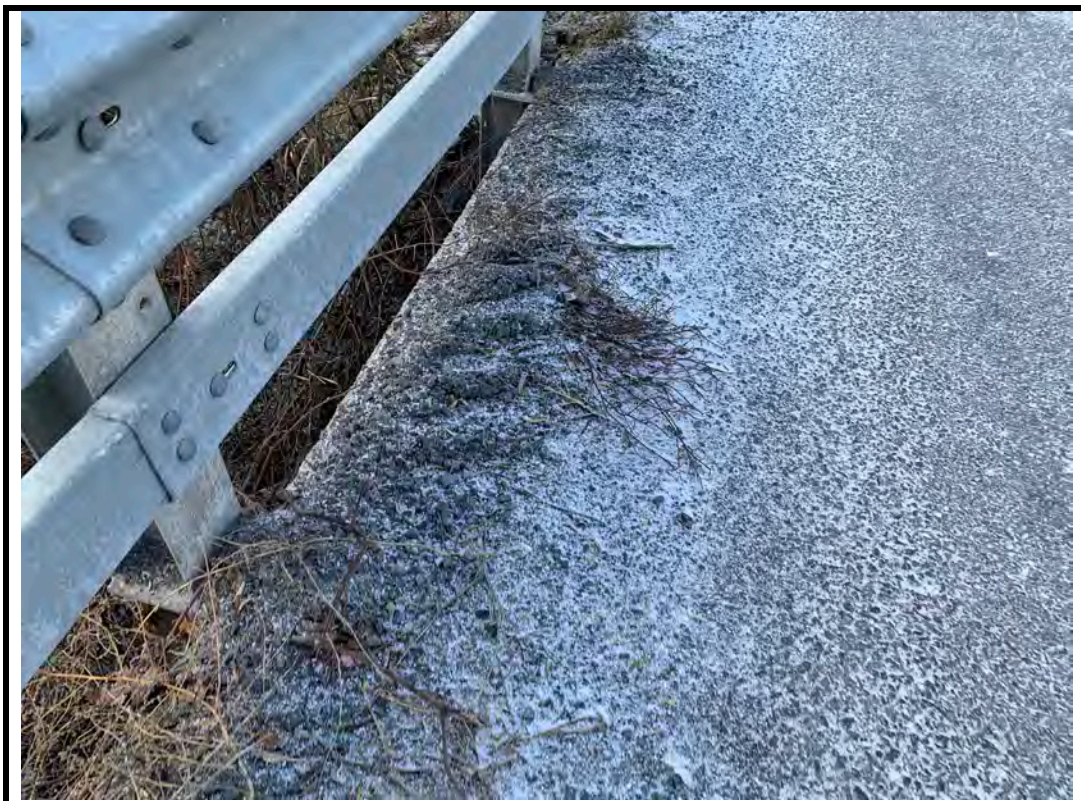
Photo 8 Vegetation growth at edges of roadway

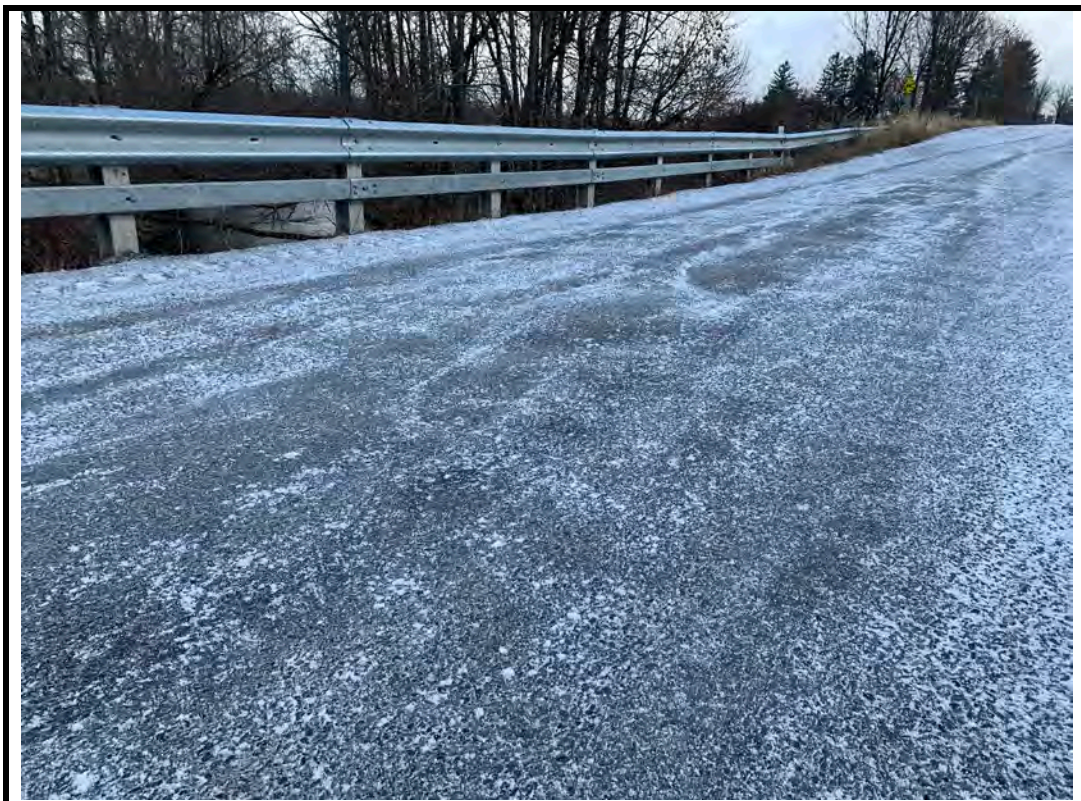
Photo 10 Moderate ravelling on deck wearing surface

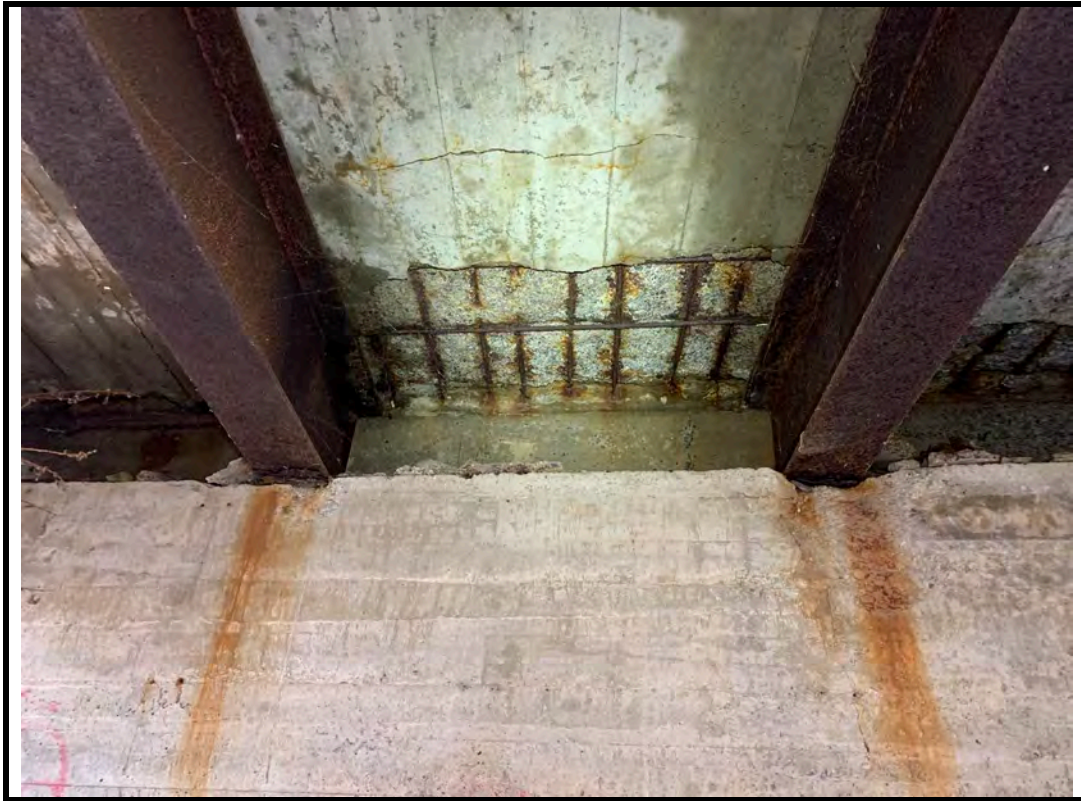
Photo 11 Large spall with ECR at west end of soffit

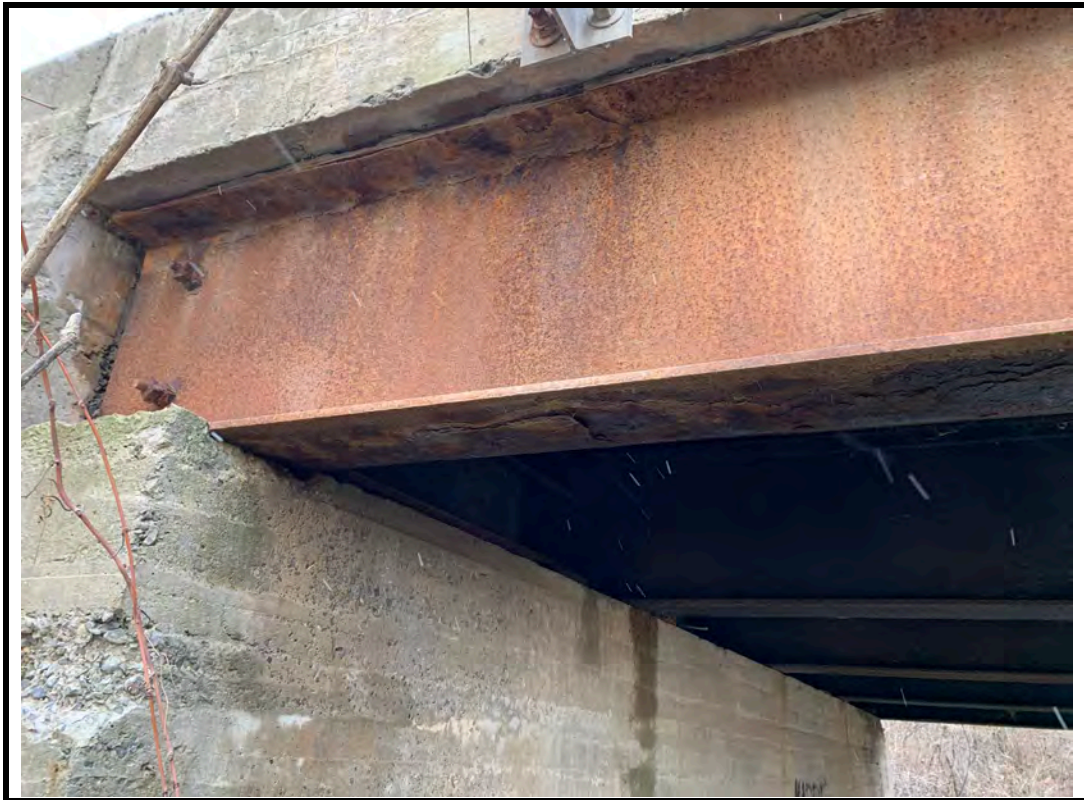
Photo 14 Flaking on bottom flange of exterior girder

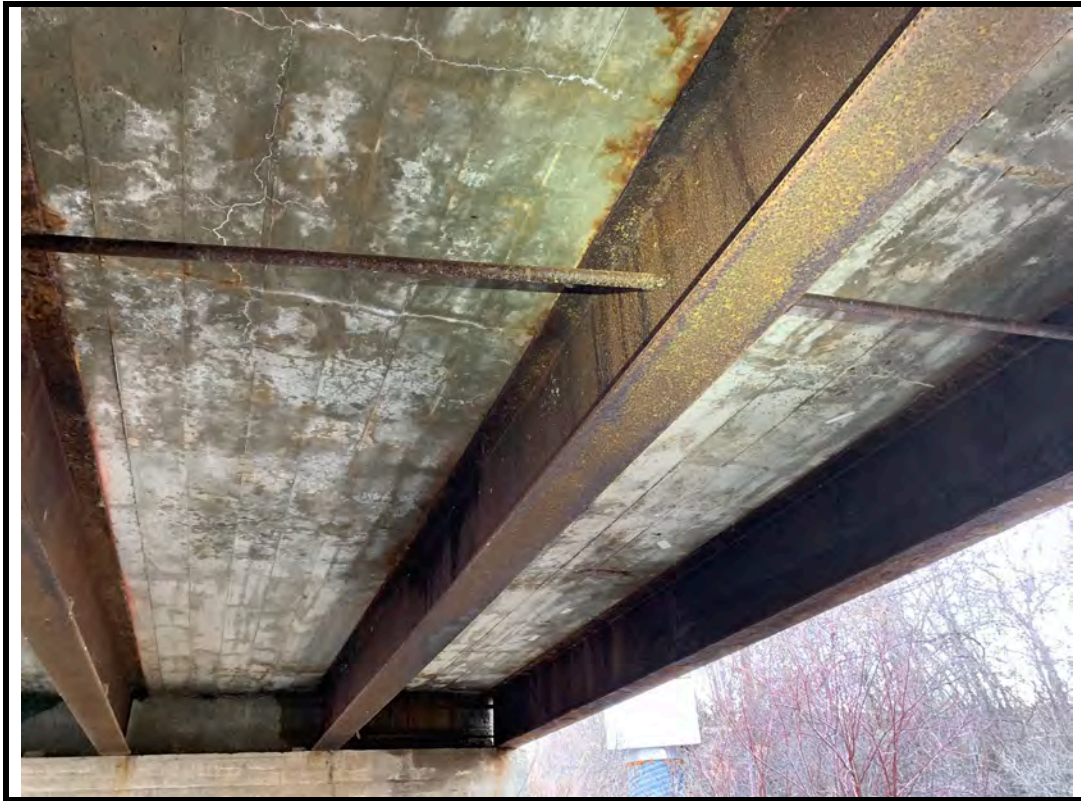
Photo 15 Corrosion on steel tie diaphragm

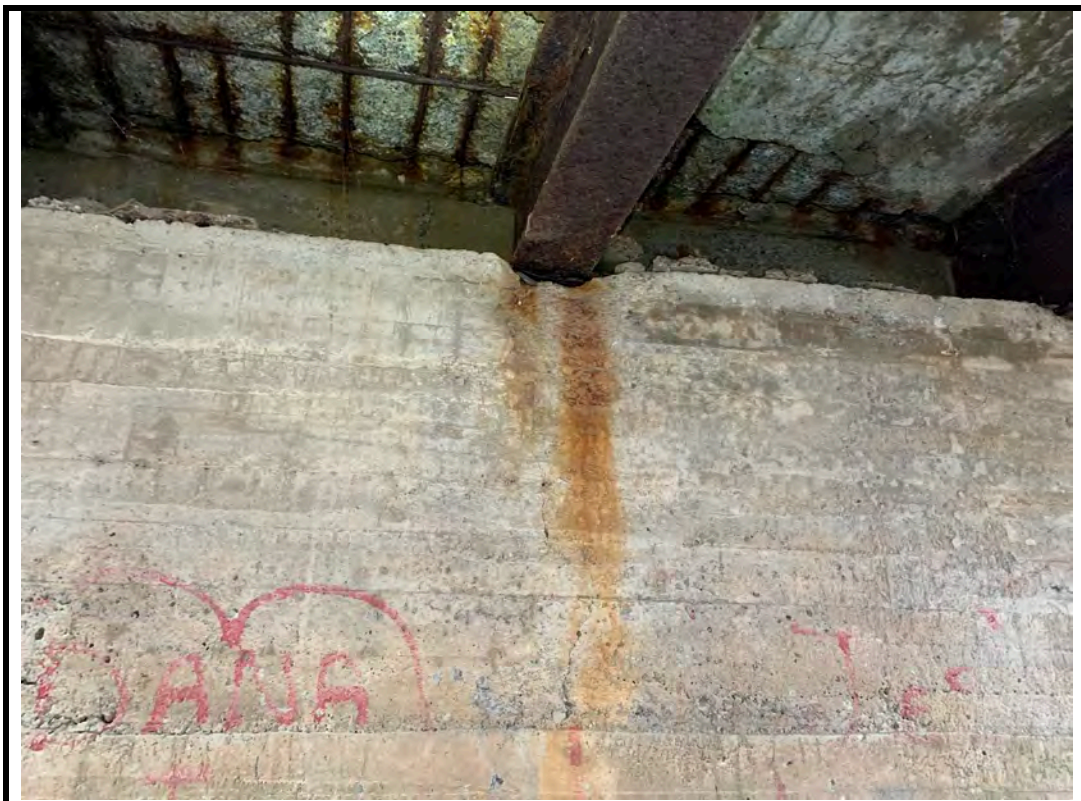
Photo 16 Spall and wide vertical crack below girder on west abutment wall
