THE TOWNSHIP OF NORTH DUNDAS

DRAFT BRIDGE MANAGEMENT STUDY REPORT 18 BRIDGES / 31 CULVERTS

March 2023

HP Engineering Inc.

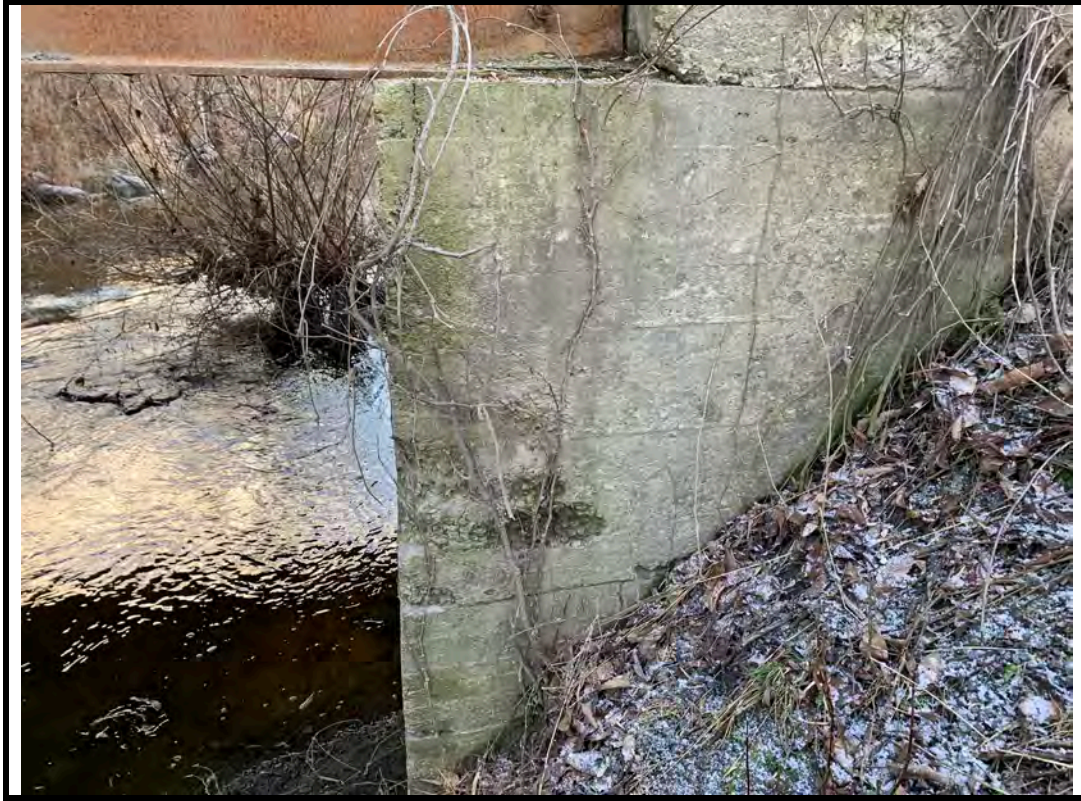
Photo 17 Severe honeycombing on northwest wingwall

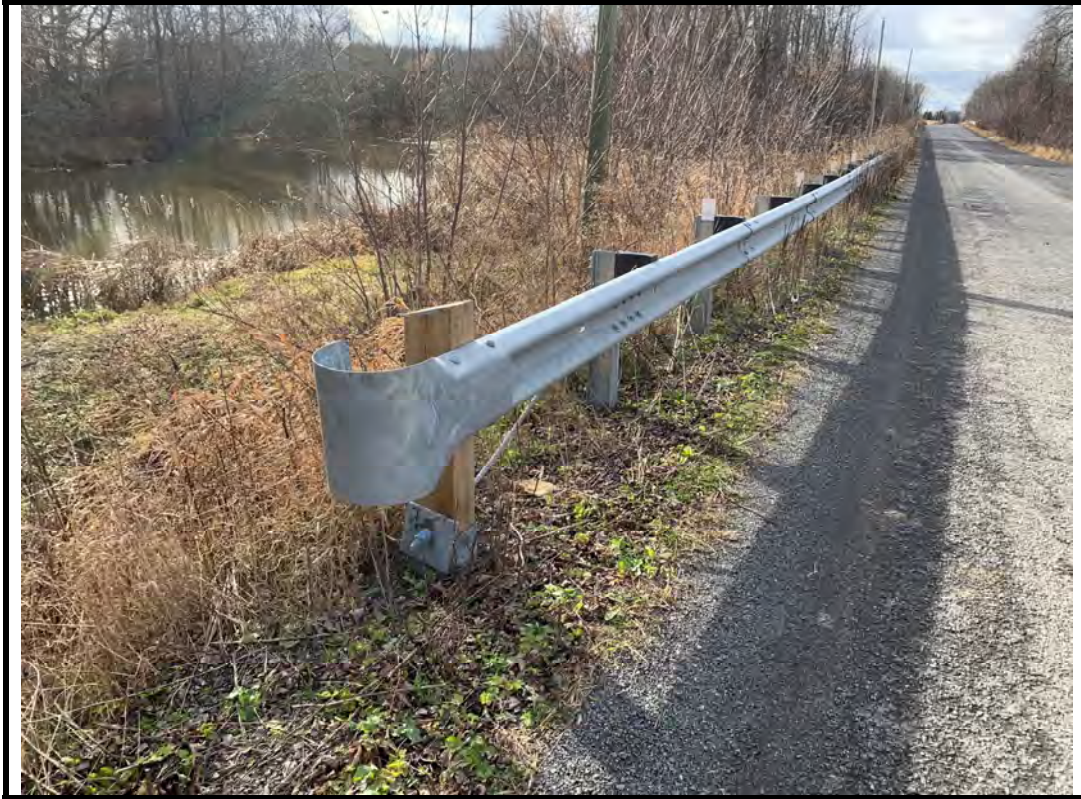
Photo 7 New end treatment at southeast corner

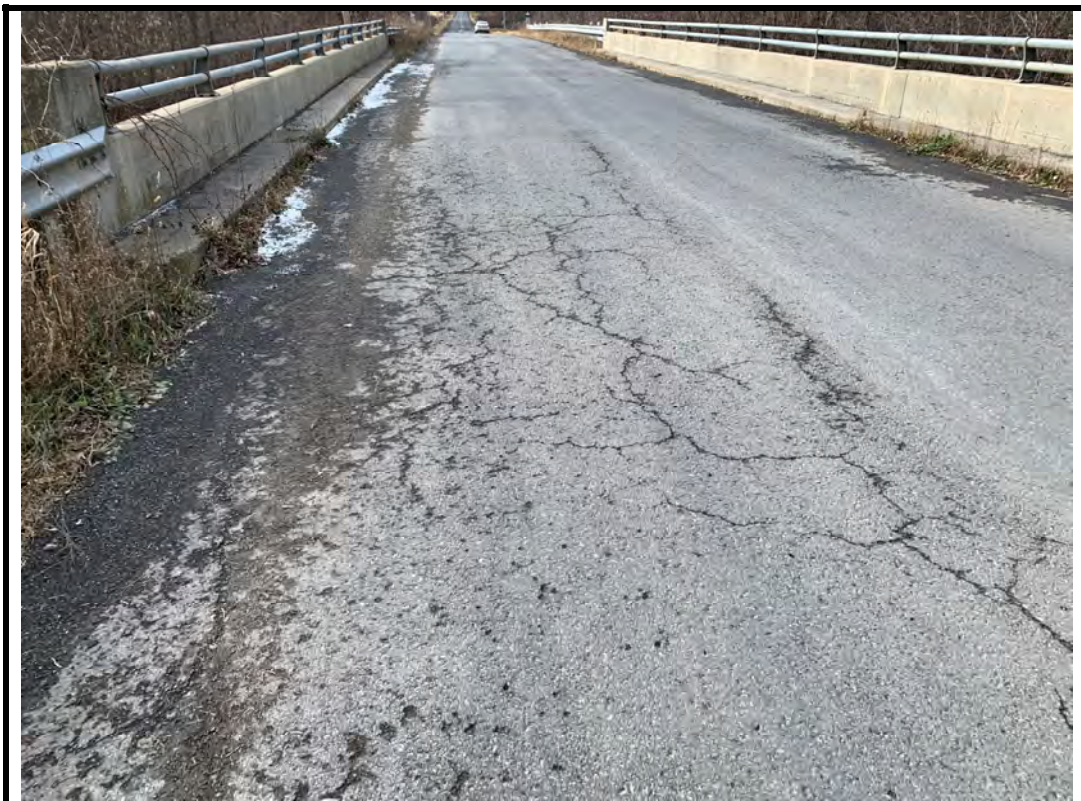
Photo 8 Medium pattern cracks on east approach wearing surface

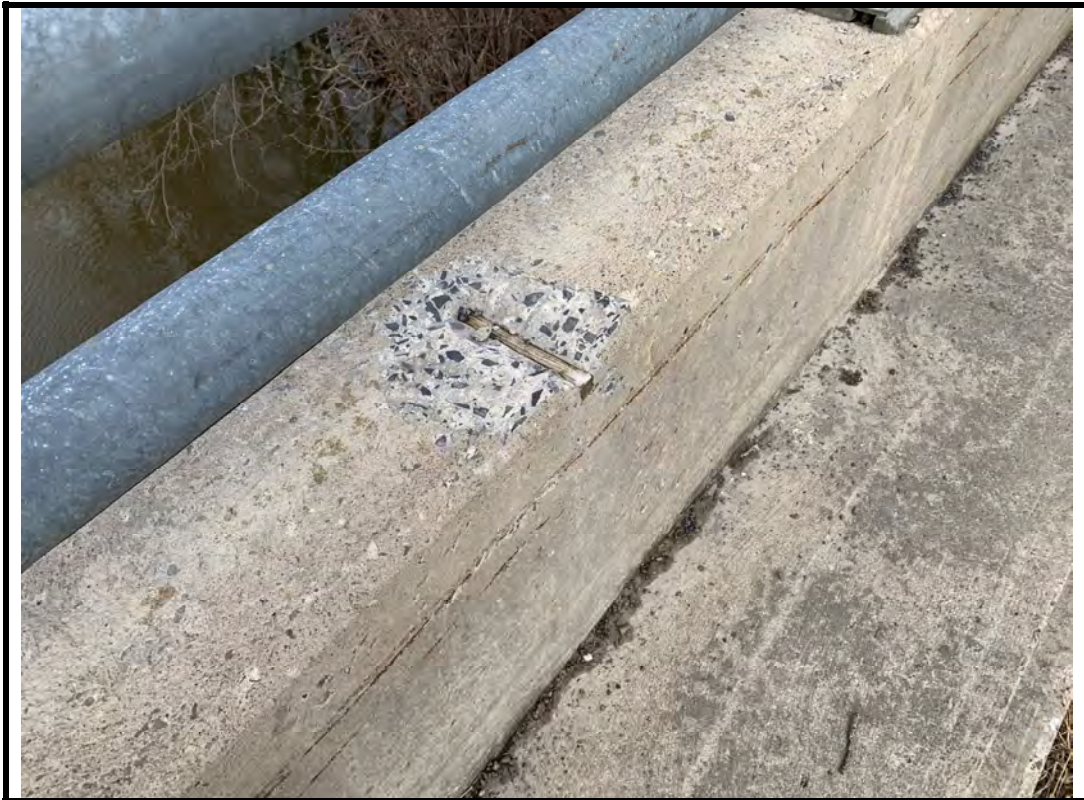
Photo 10 Spall on south barrier wall

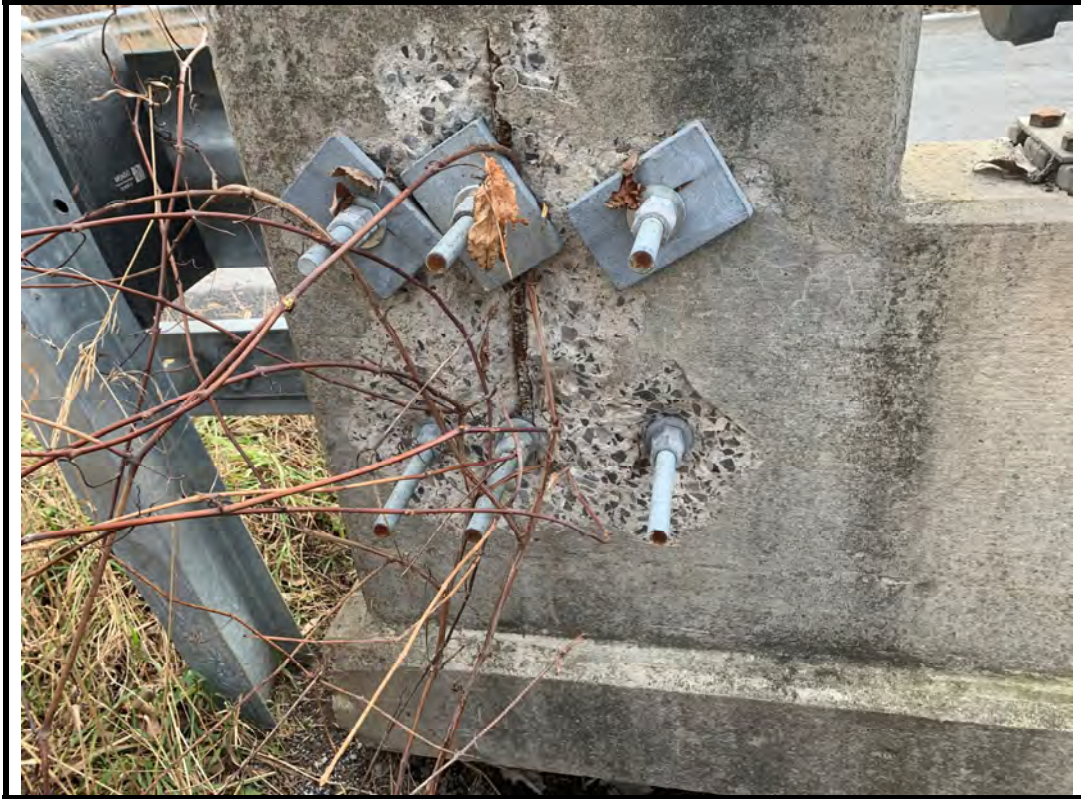
Photo 11 Spall on exterior of southwest end of barrier wall

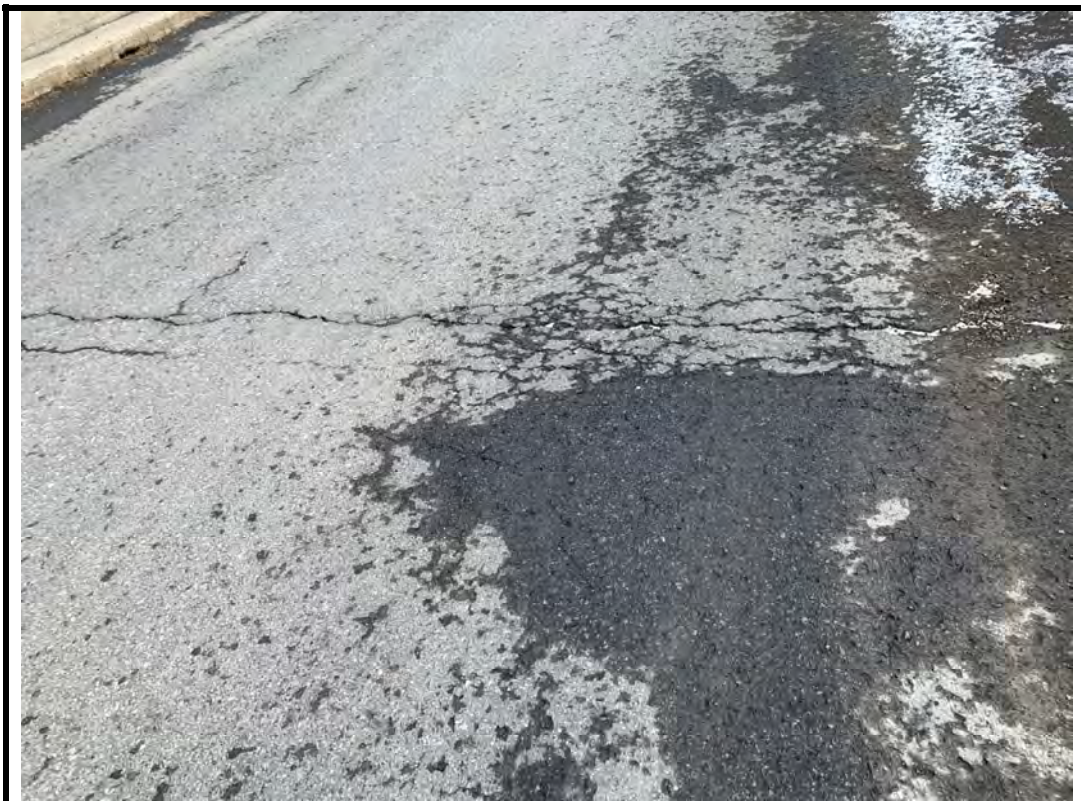
Photo 12 Wide crack at west end of deck

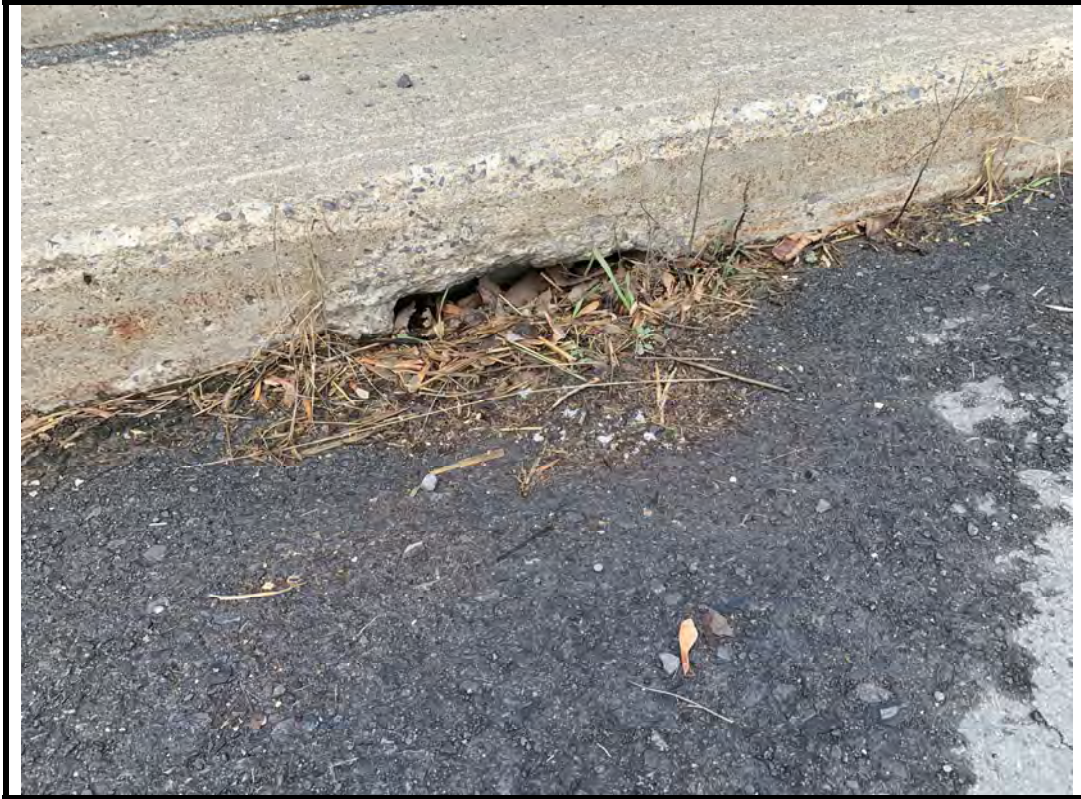
Photo 13 Debris blocking deck drain

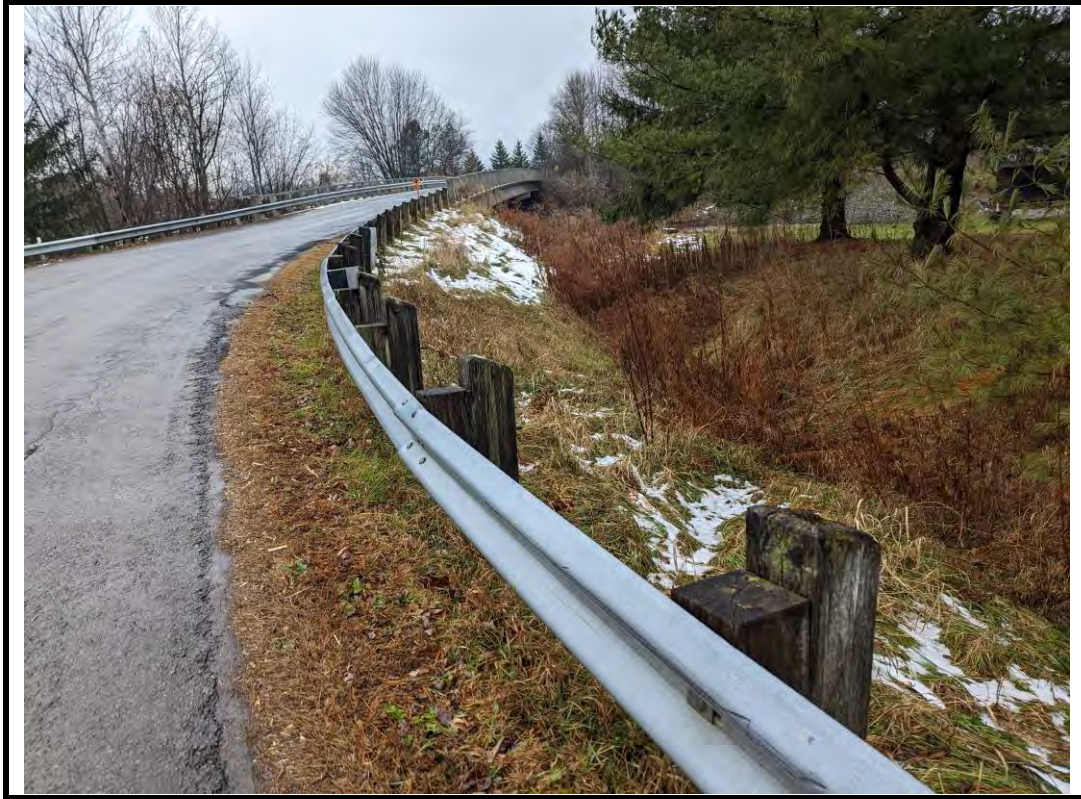
Photo 7 Abrasion and deformation on southeast approach barrier (typ.)

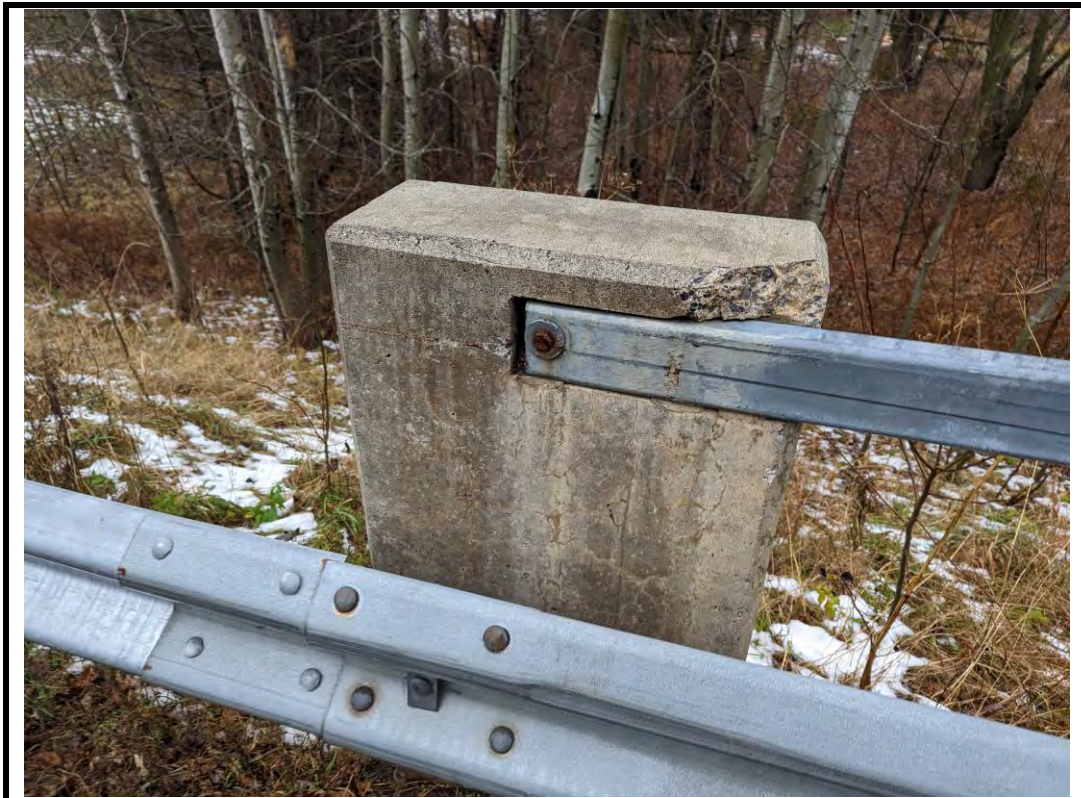
Photo 8 Spall on Northeast concrete end-post

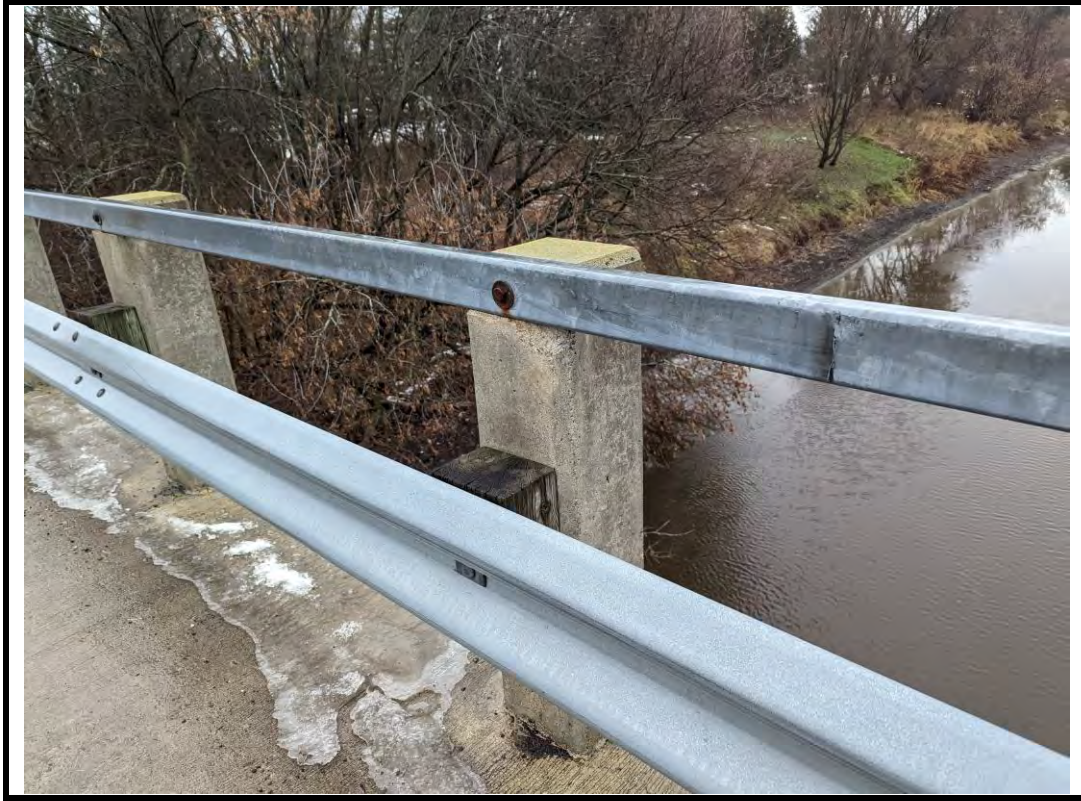
Photo 9 Spall on concrete deck post (typ.)

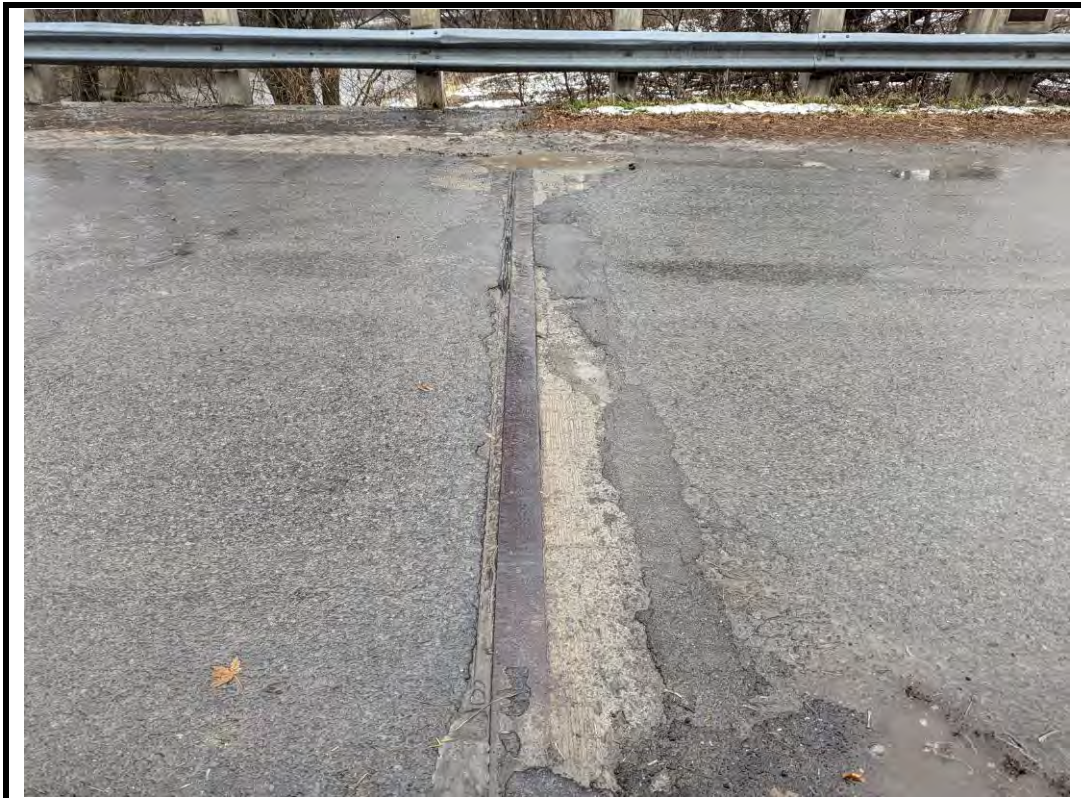
Photo 10 Partially covered expansion joint at north (typ.)

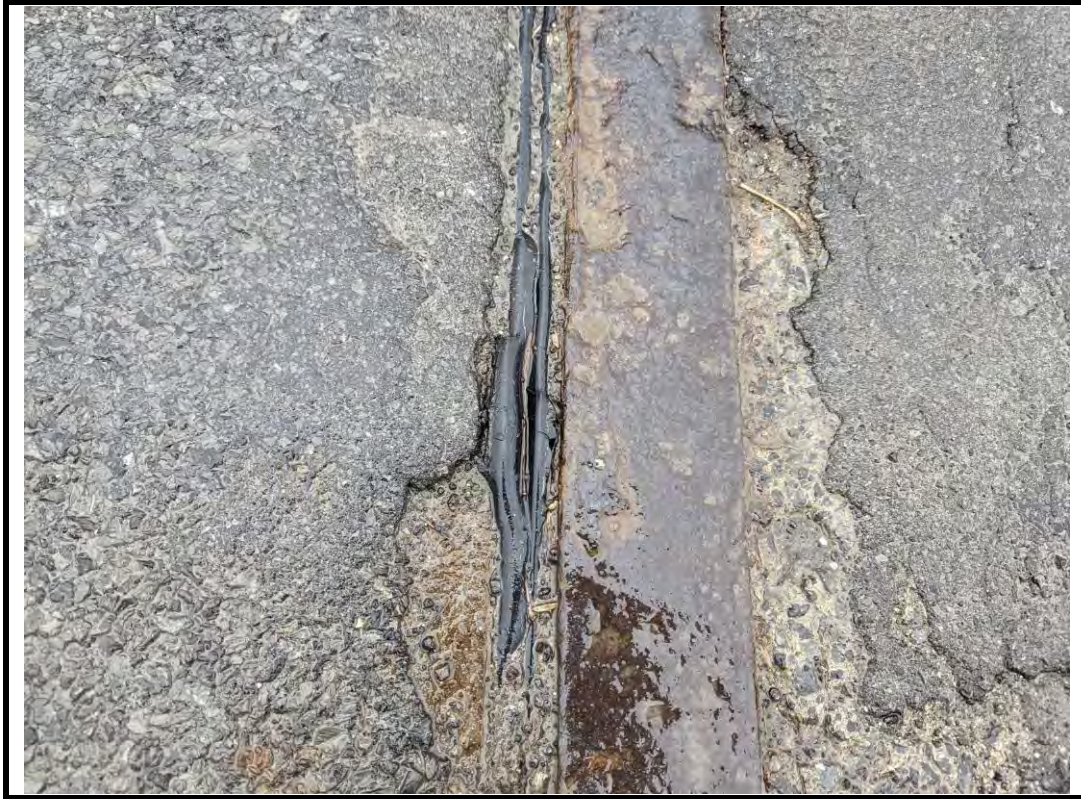
Photo 11 Rust, abrasion on armouring (typ.). Debris and failing deck seal at North

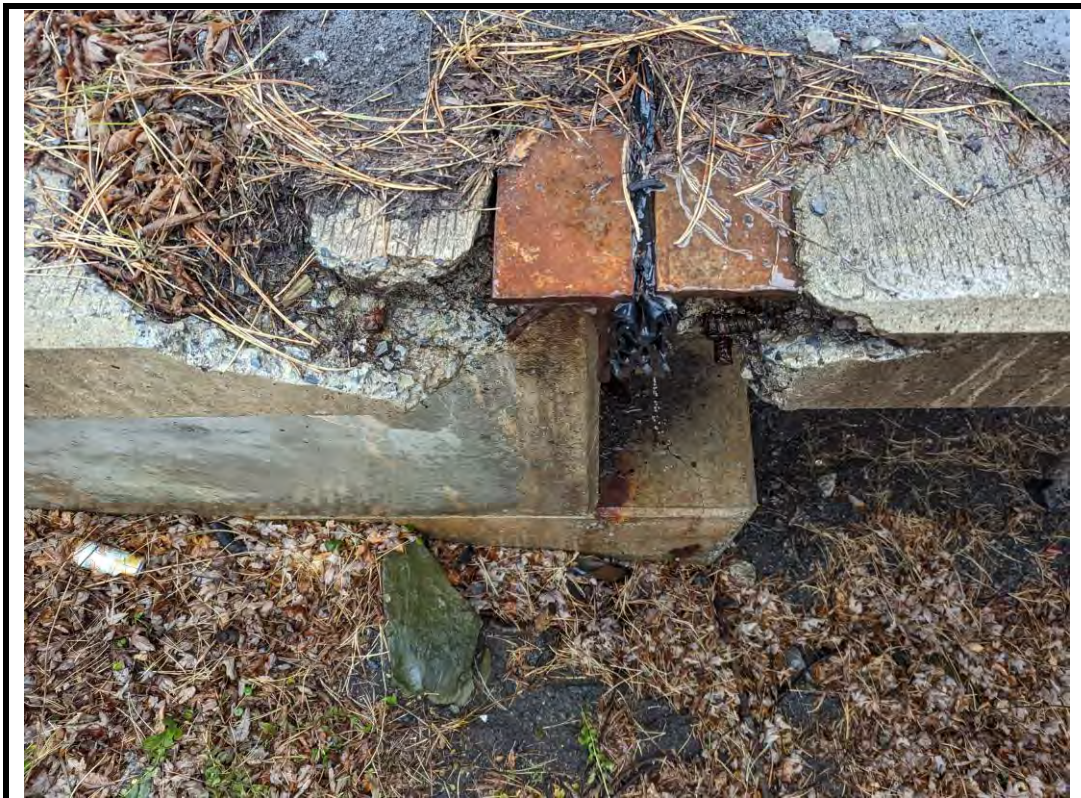
Photo 12 Spalls on deck fascia/soffit at north expansion joint, with squished seal

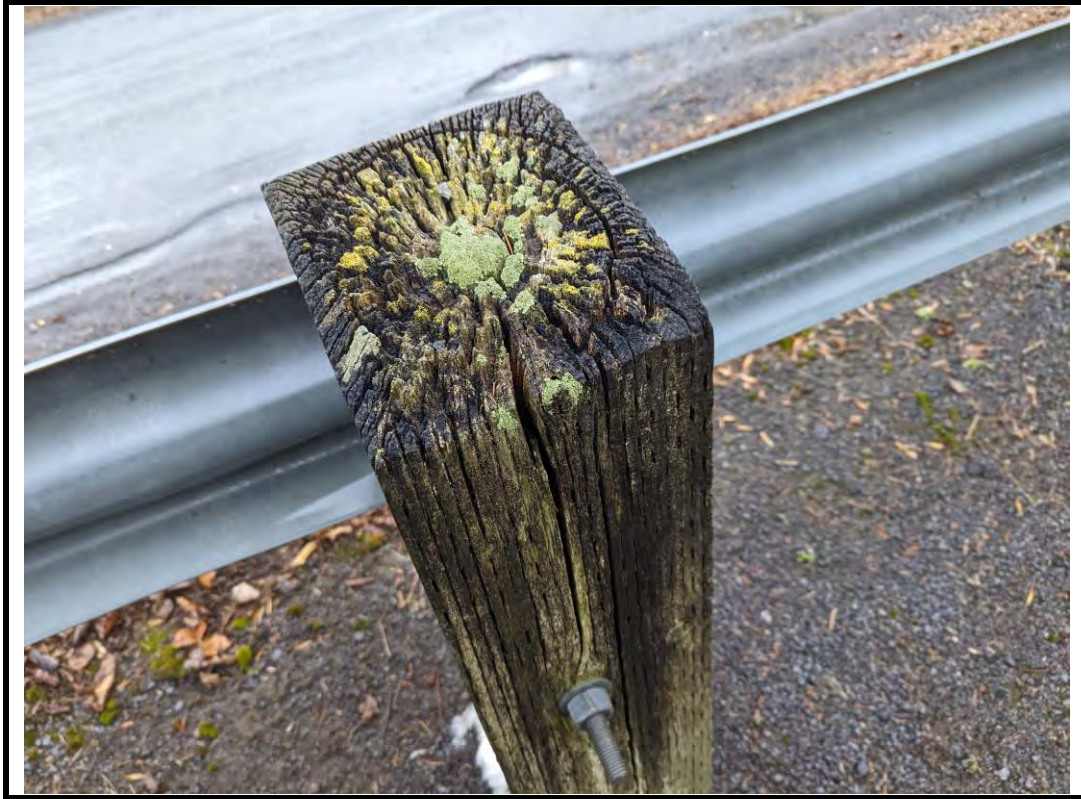
Photo 13 Rot, checks and splits at southwest approach barrier post (typ.)

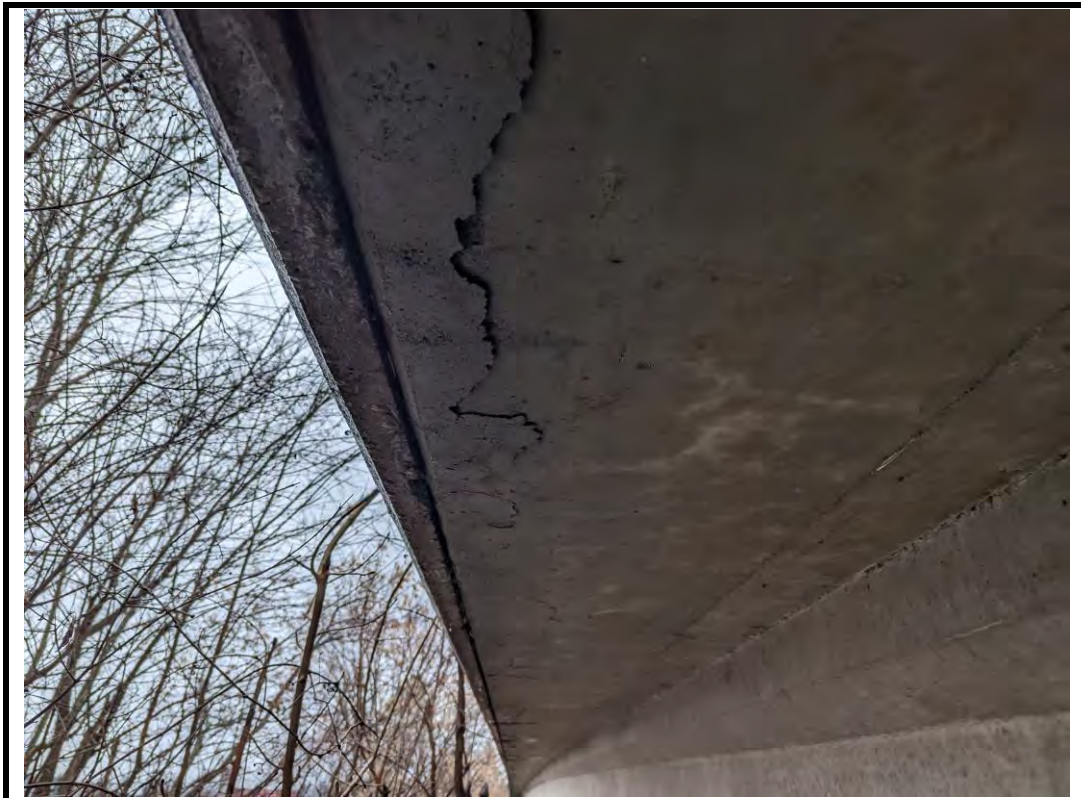
Photo 14 Delamination along west soffit overhang (typ.)

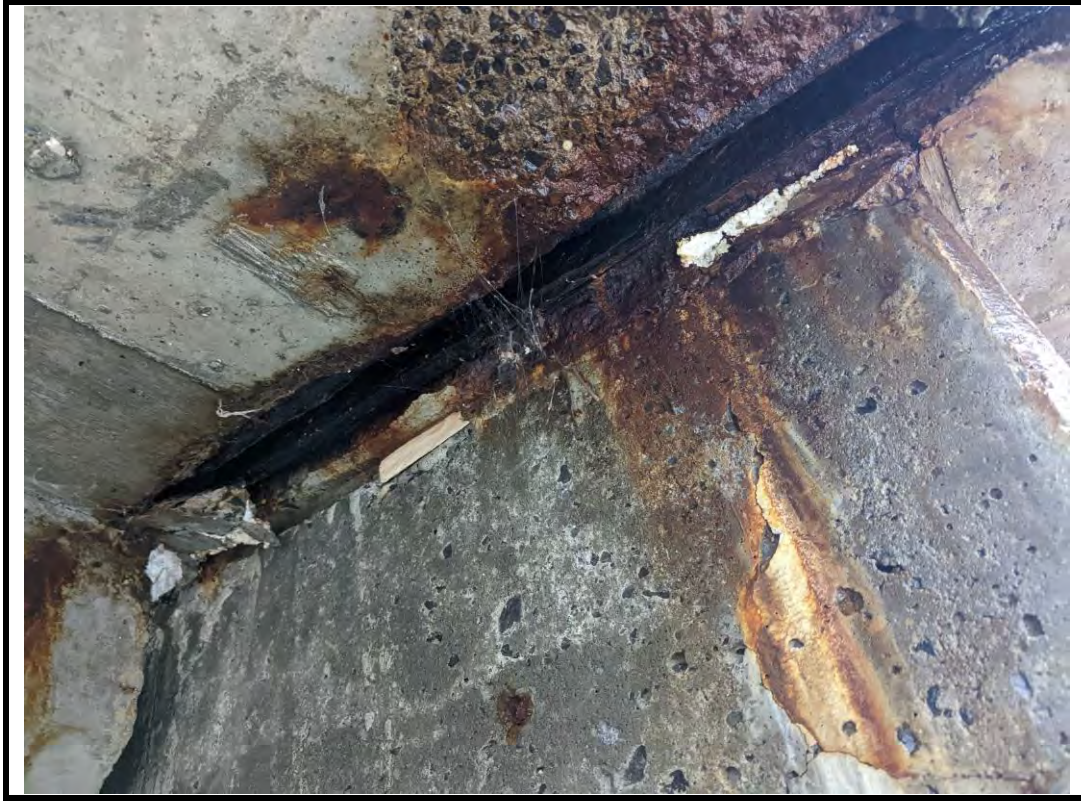
Photo 17 Evidence of failure at the south expansion joint with spalls and stains

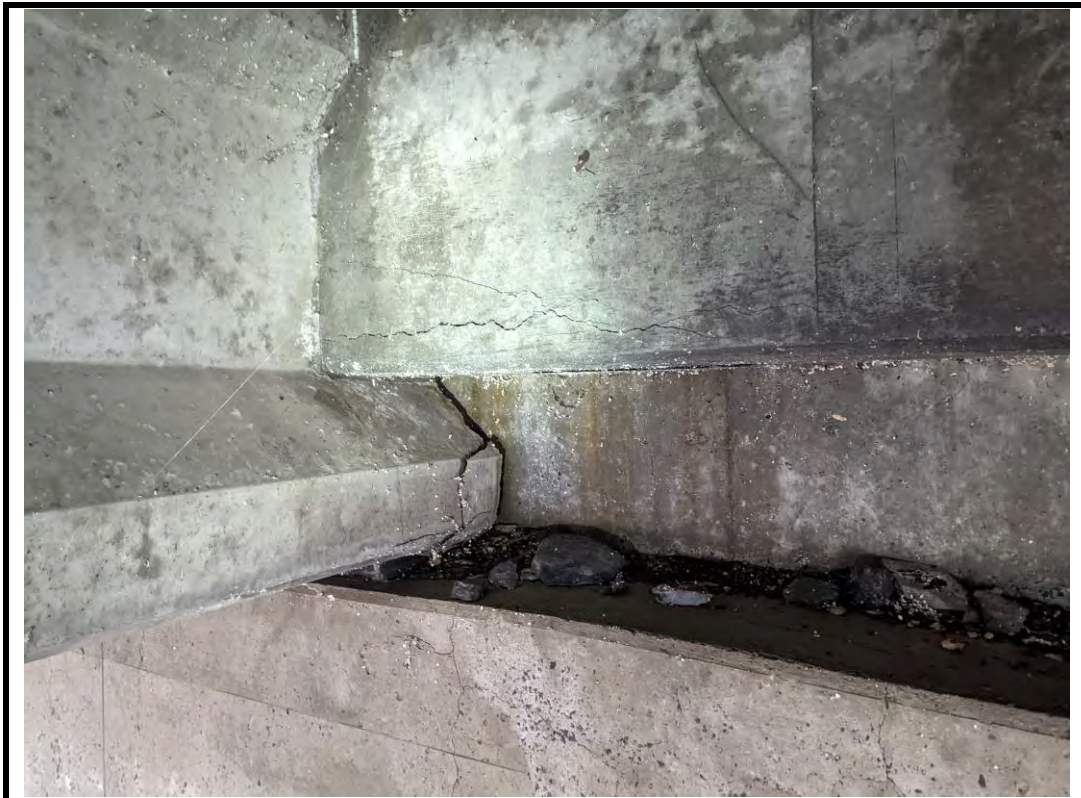
Photo 18 Cracks and delamination in south concrete girders and diaphragms

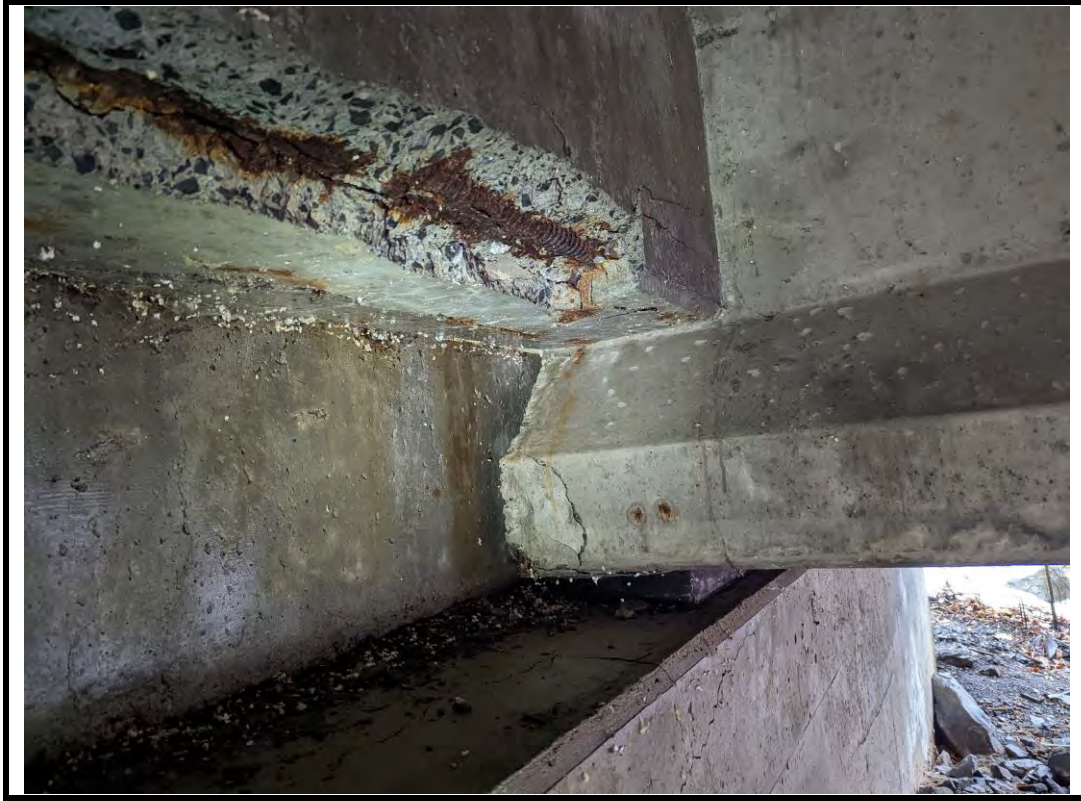
Photo 19 ECR and spalls at south girder ends and diaphragms

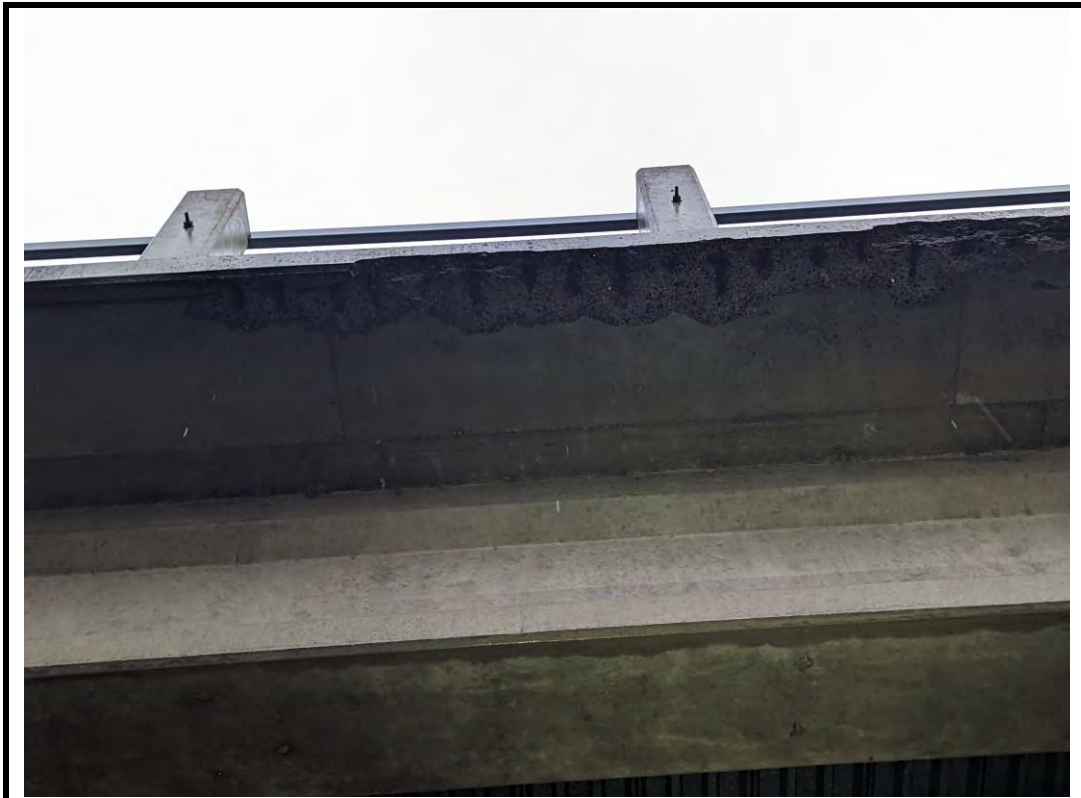
Photo 20 Spalls and ECR at northeast overhang (typ.)

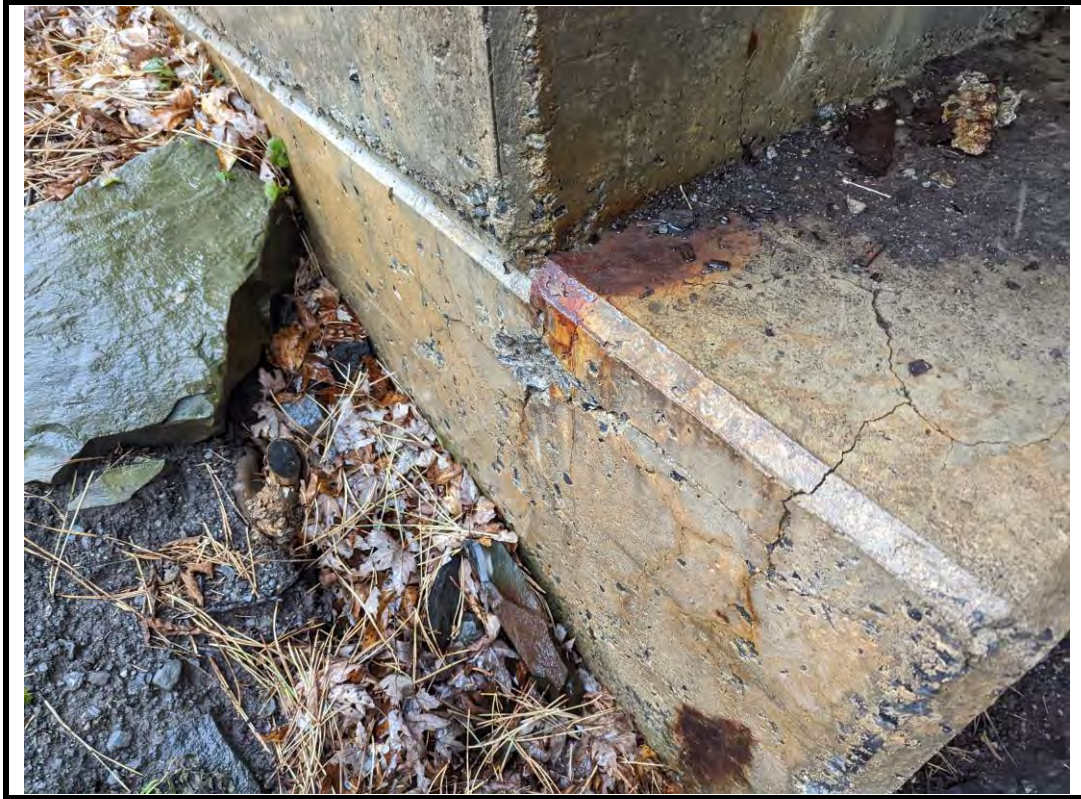
Photo 21 Crack and Spall at northwest wingwall

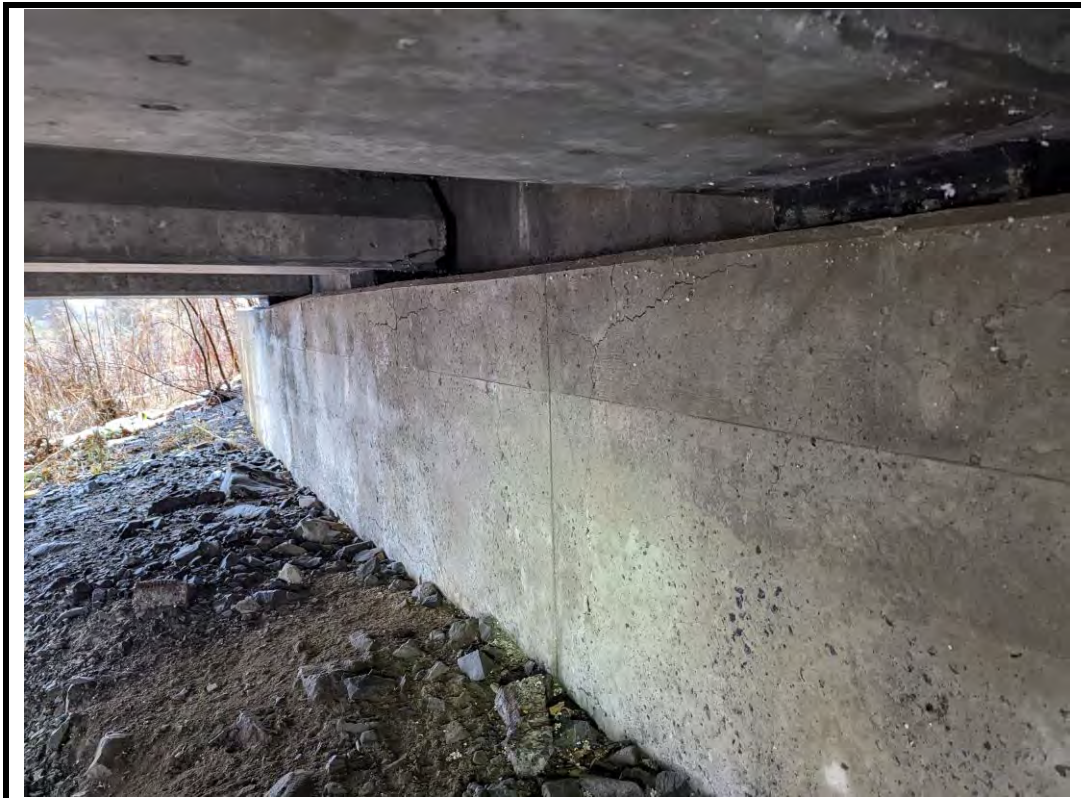
Photo 22 Cracks on South abutment wall.

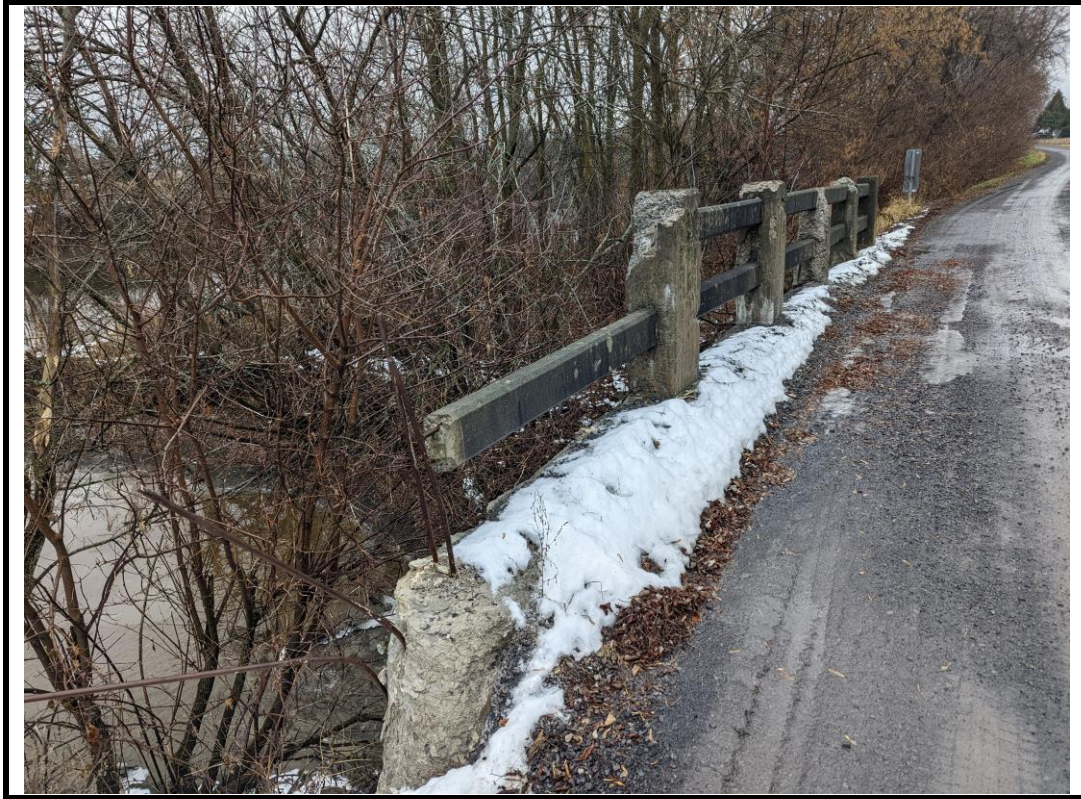
Photo 7 Deflection, section loss, spalls, ECR, and disintegration on north barrier (typ.)

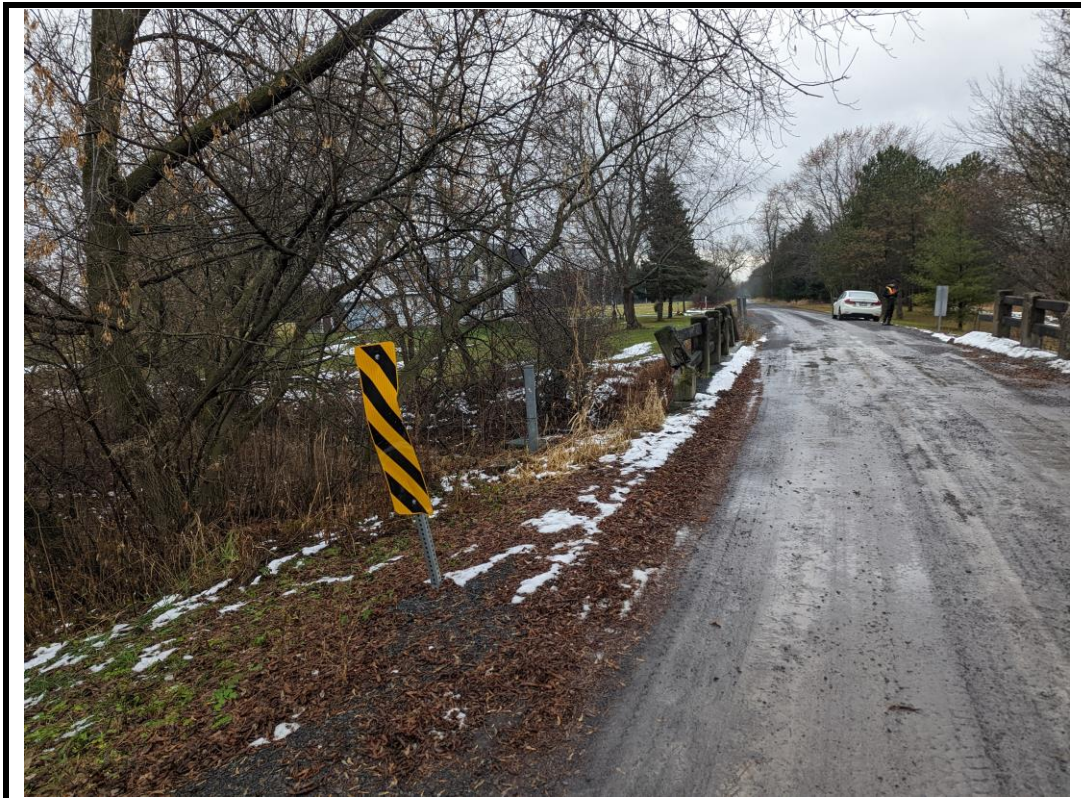
Photo 8 Deformed hazard sign at southeast

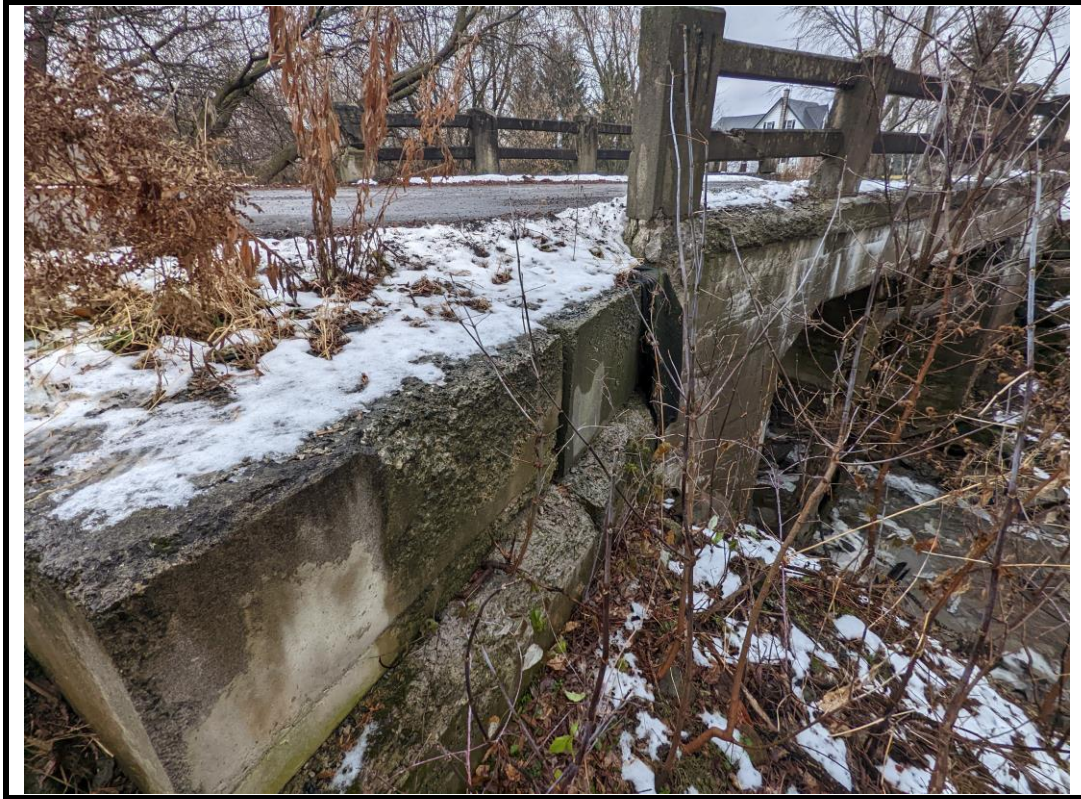
Photo9 Rotated and spalled concrete retaining walls at the northeast (typ.)

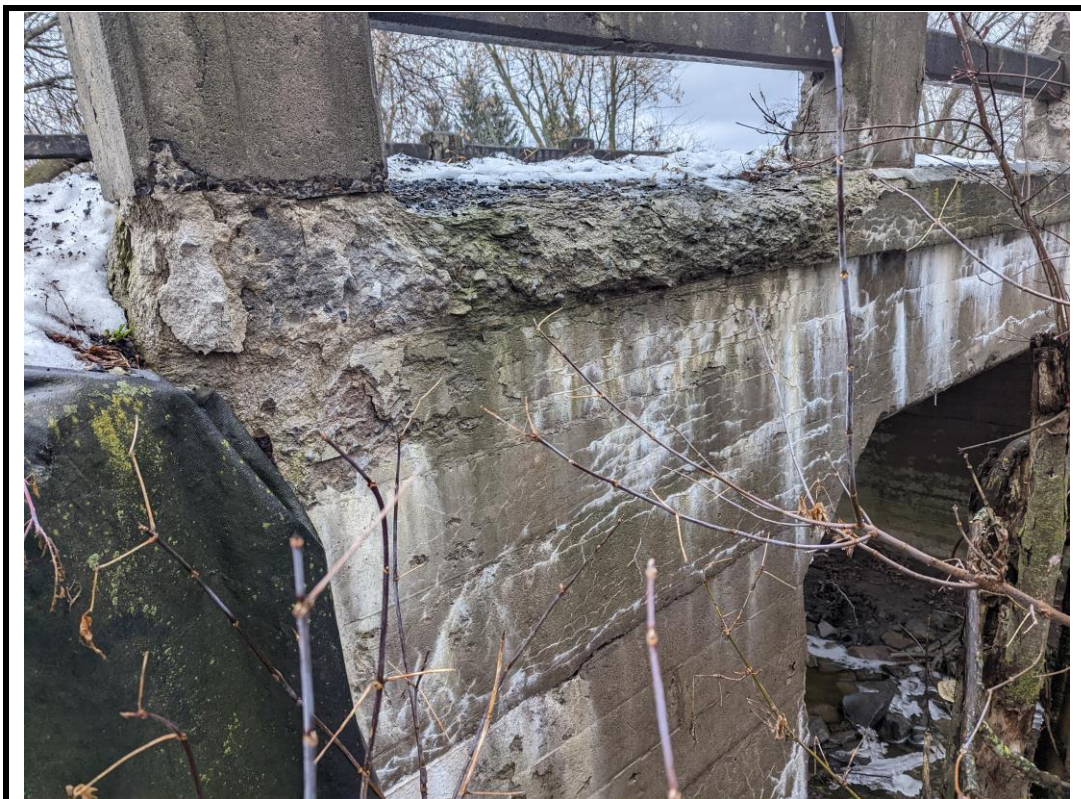
Photo 10 Spalls and efflorescence at northeast deck fascia/wingwall

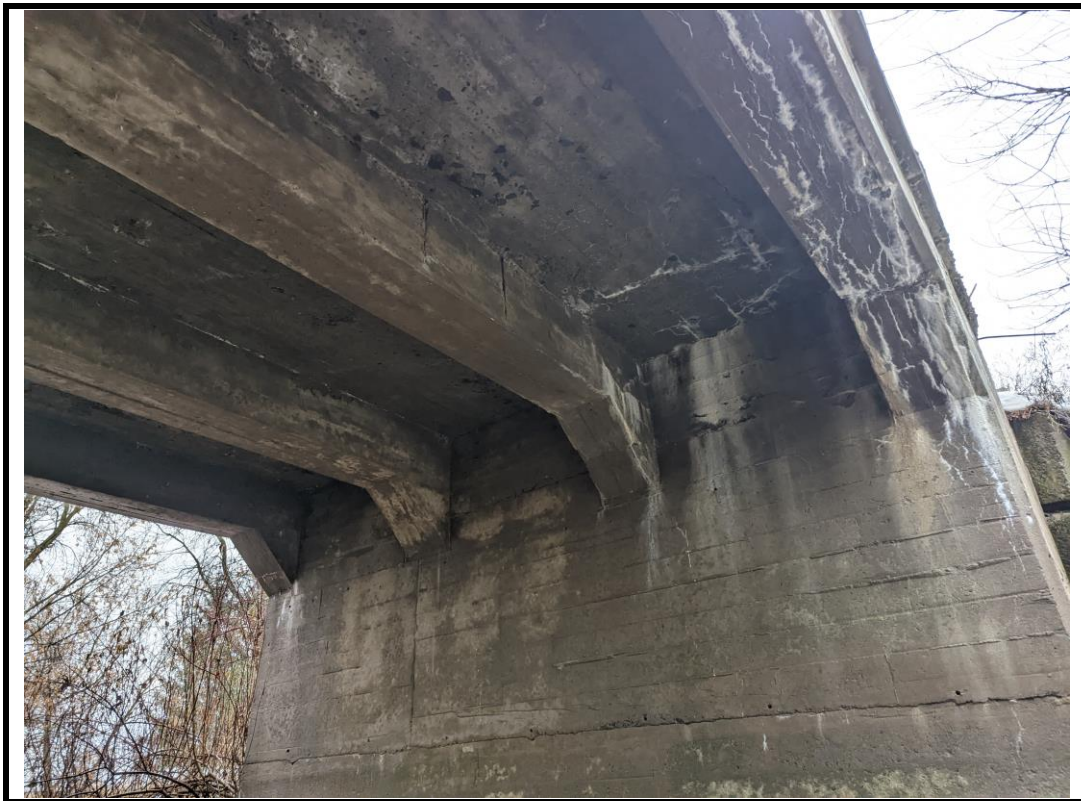
Photo 12 Efflorescence, damp stains, CR, cracks, and scaling on girders and abutment
