THE TOWNSHIP OF NORTH DUNDAS

DRAFT BRIDGE MANAGEMENT STUDY REPORT 18 BRIDGES / 31 CULVERTS

March 2023

HP Engineering Inc.

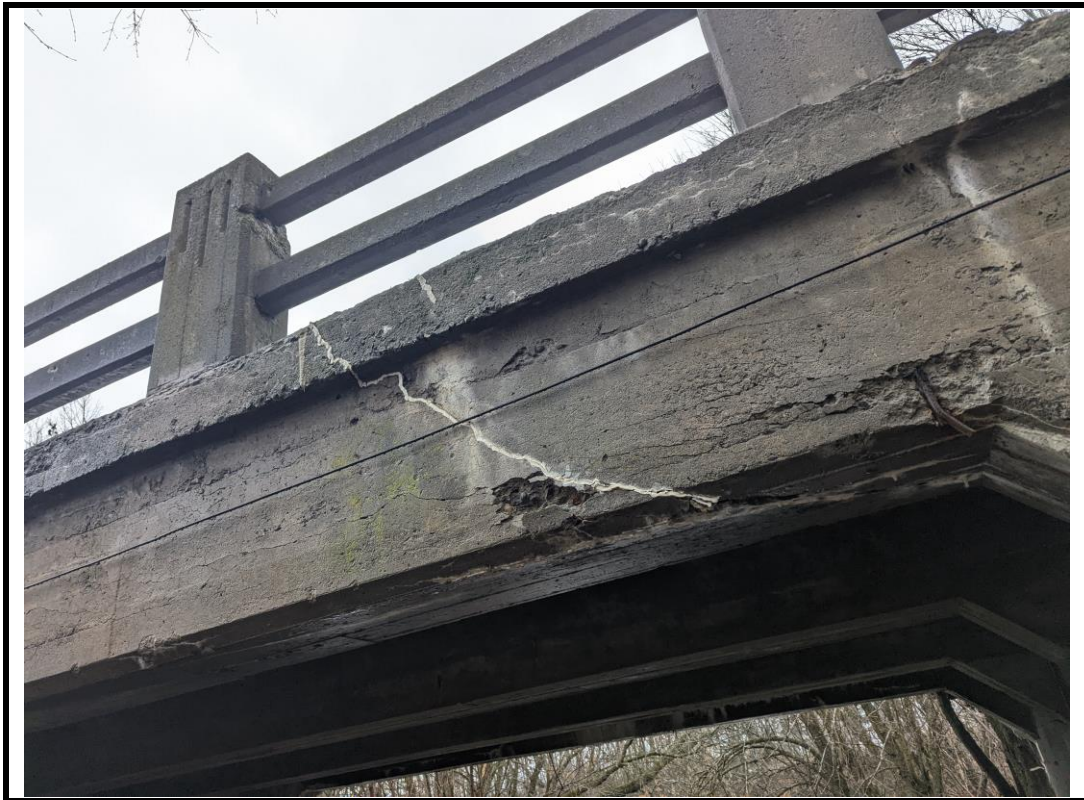
Photo 14 Cracks, scaling, spalls, and ECR on South fascia (typ.)

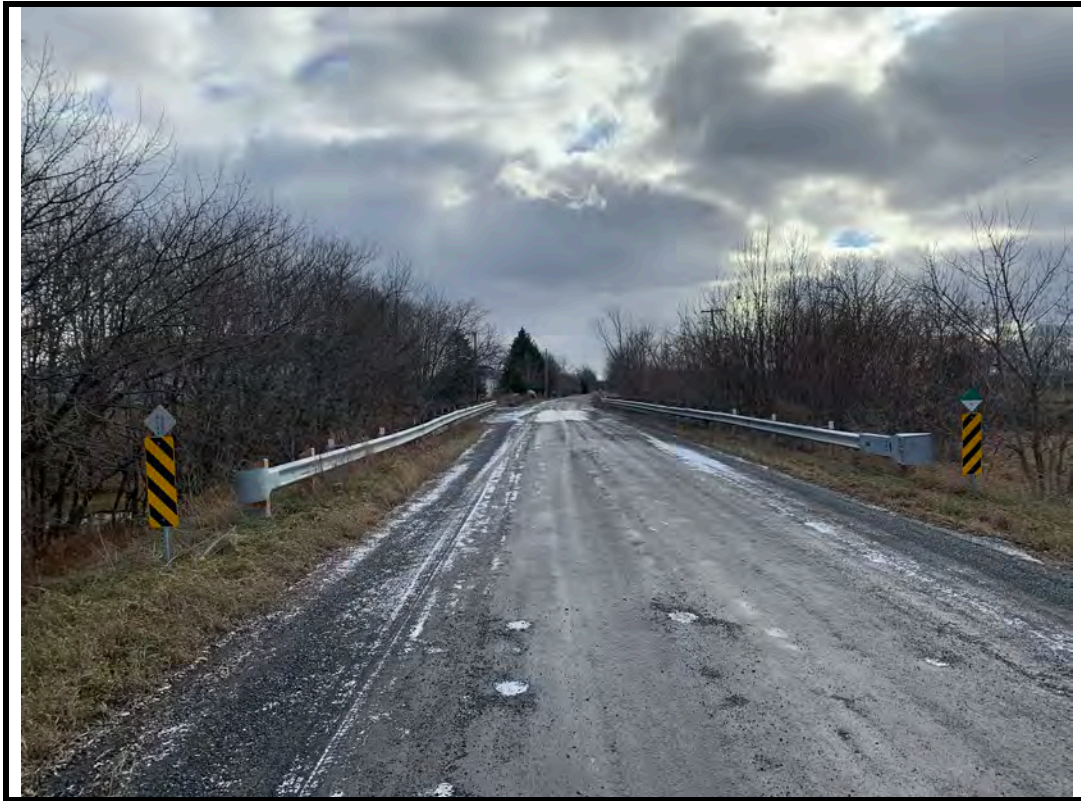
Photo 7 New end treatments installed on north approach

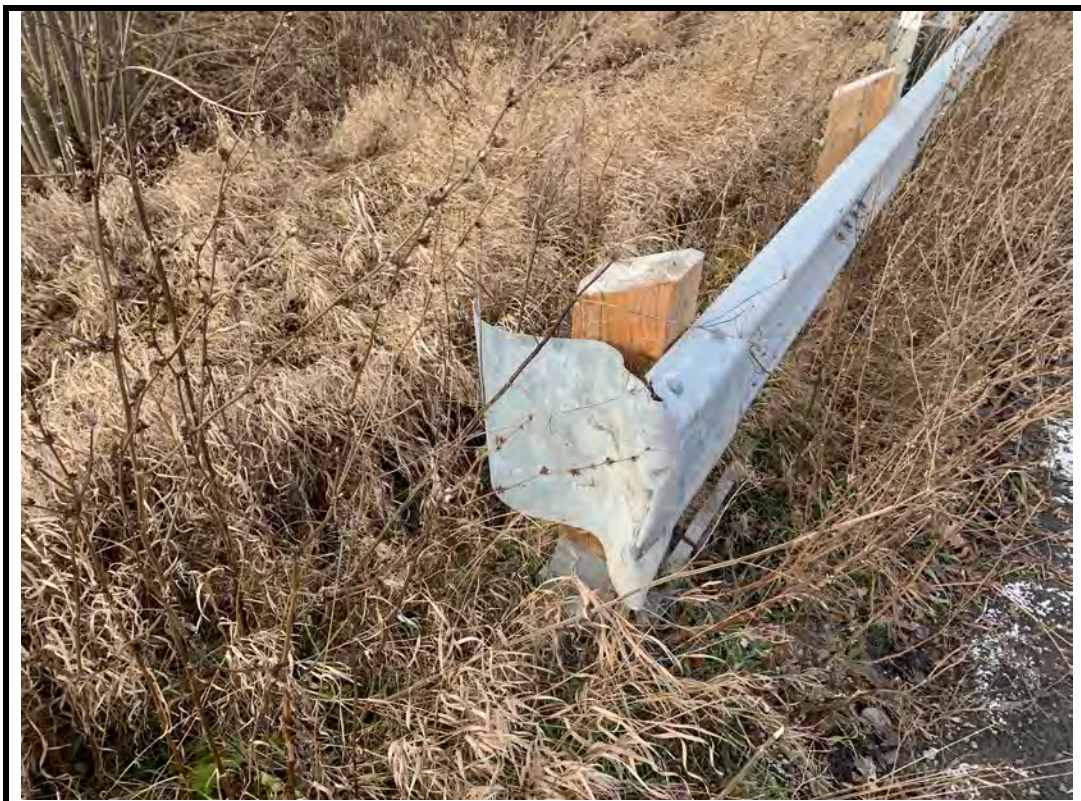
Photo 8 Collision damage at southwest end treatment

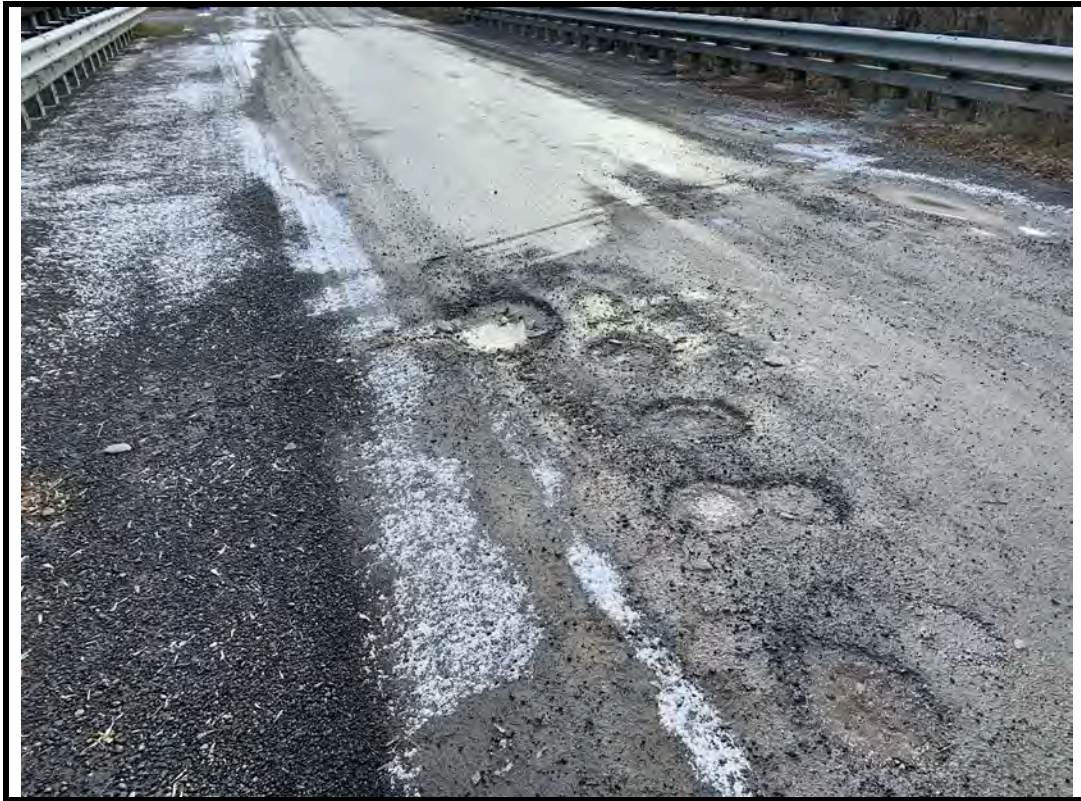
Photo 9 Large potholes on north approach

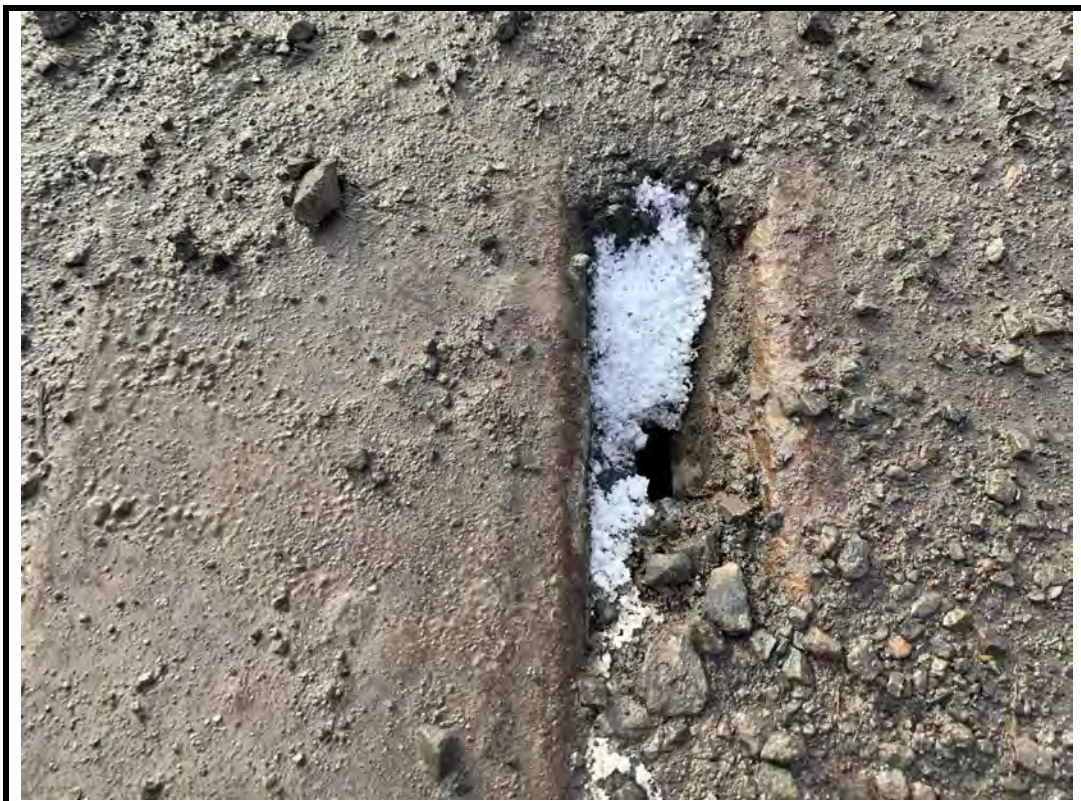
Photo 10 Damaged seal at north expansion joint

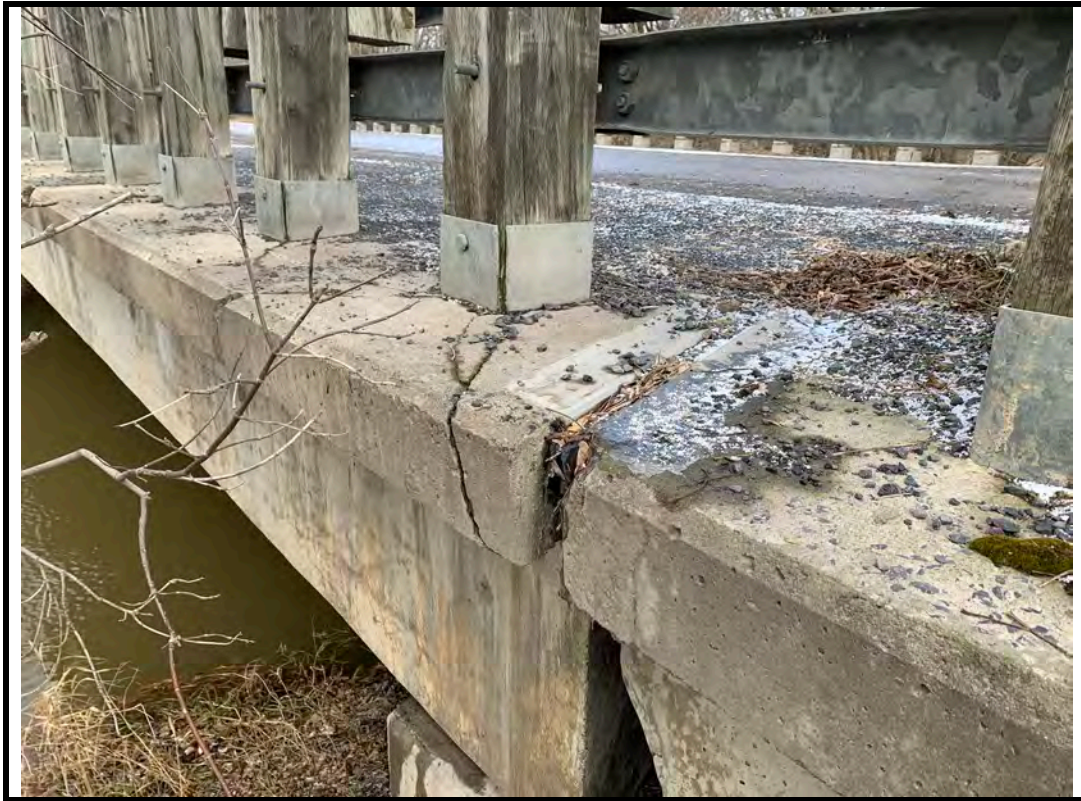
Photo 13 Crack at southwest corner of exterior soffit

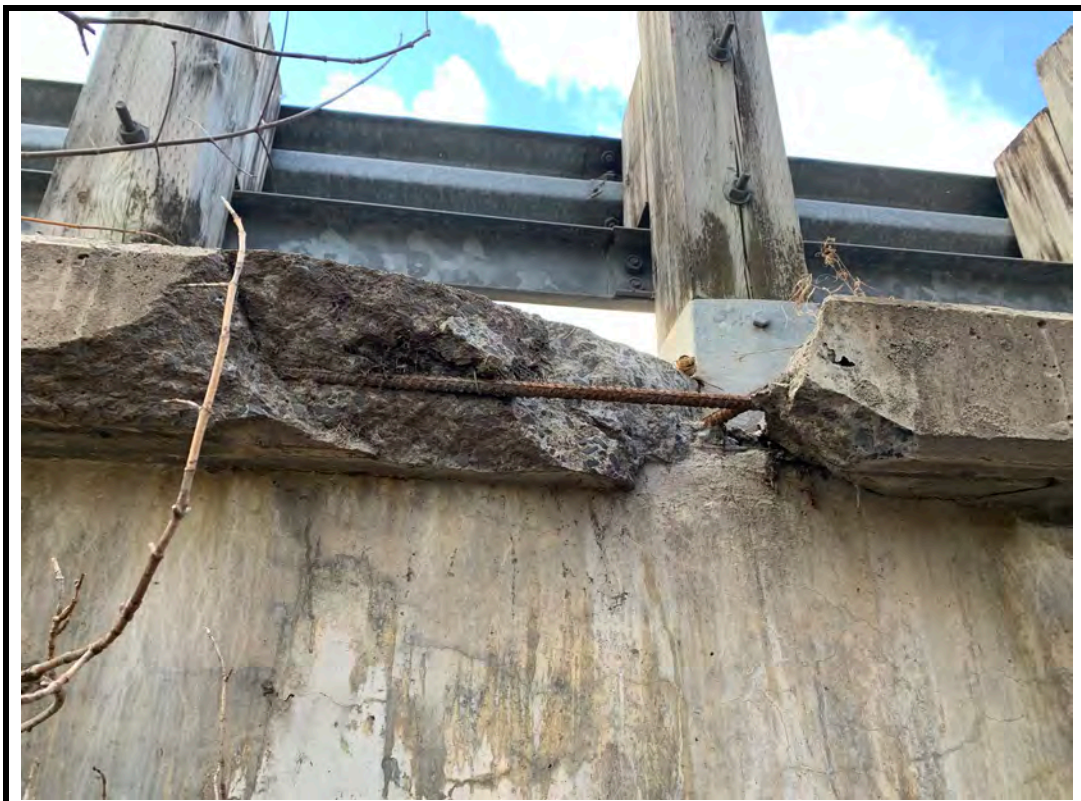
Photo 14 Spall with exposed corroded reinforcement on east fascia

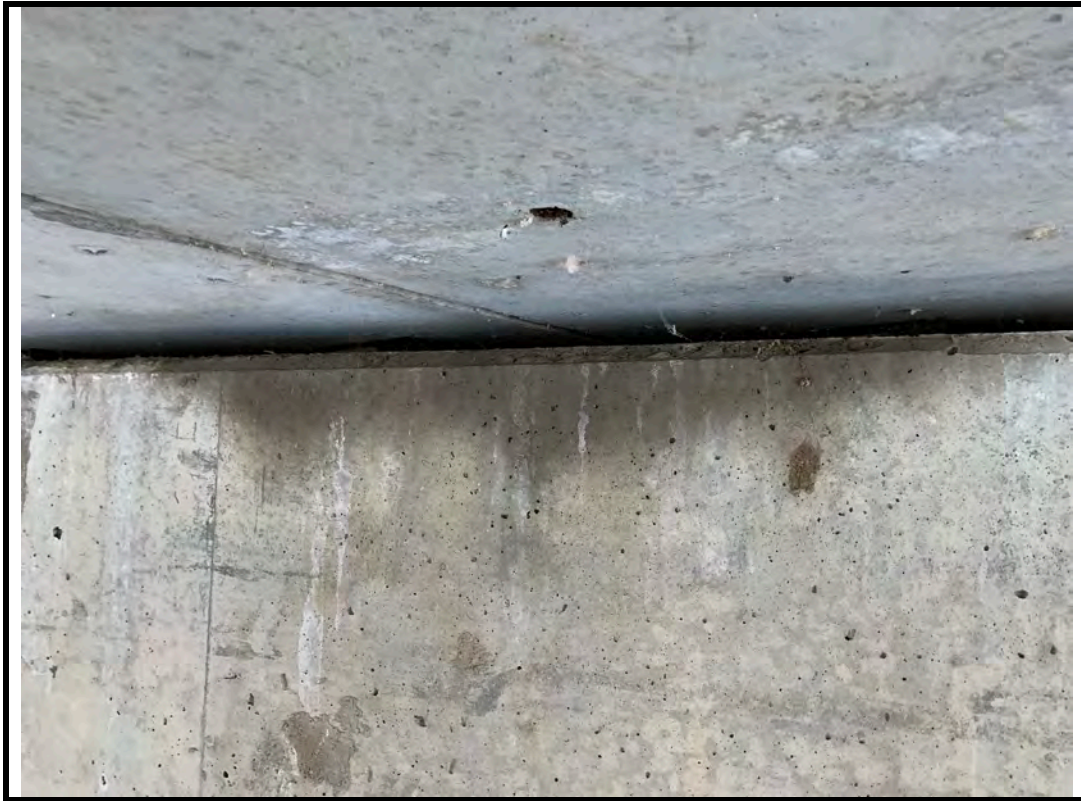
Photo 17 Damp staining and evidence of leakage on south abutment wall

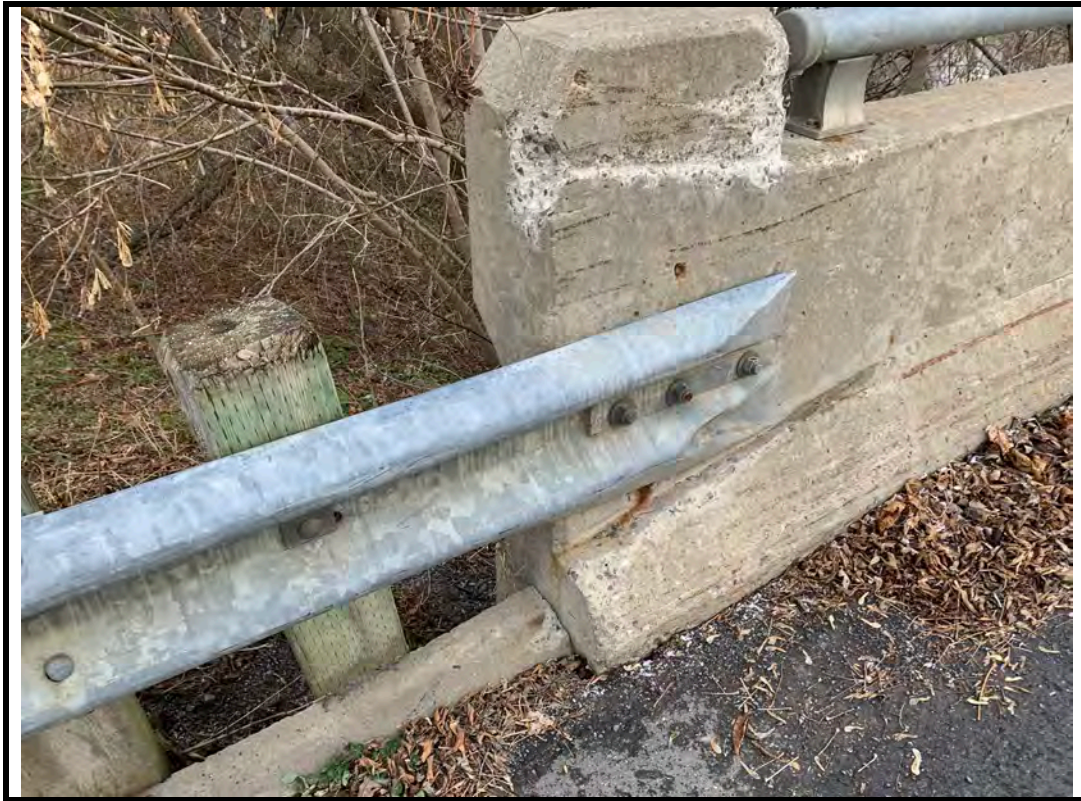
Photo 7 Light rust on southwest guiderail transition

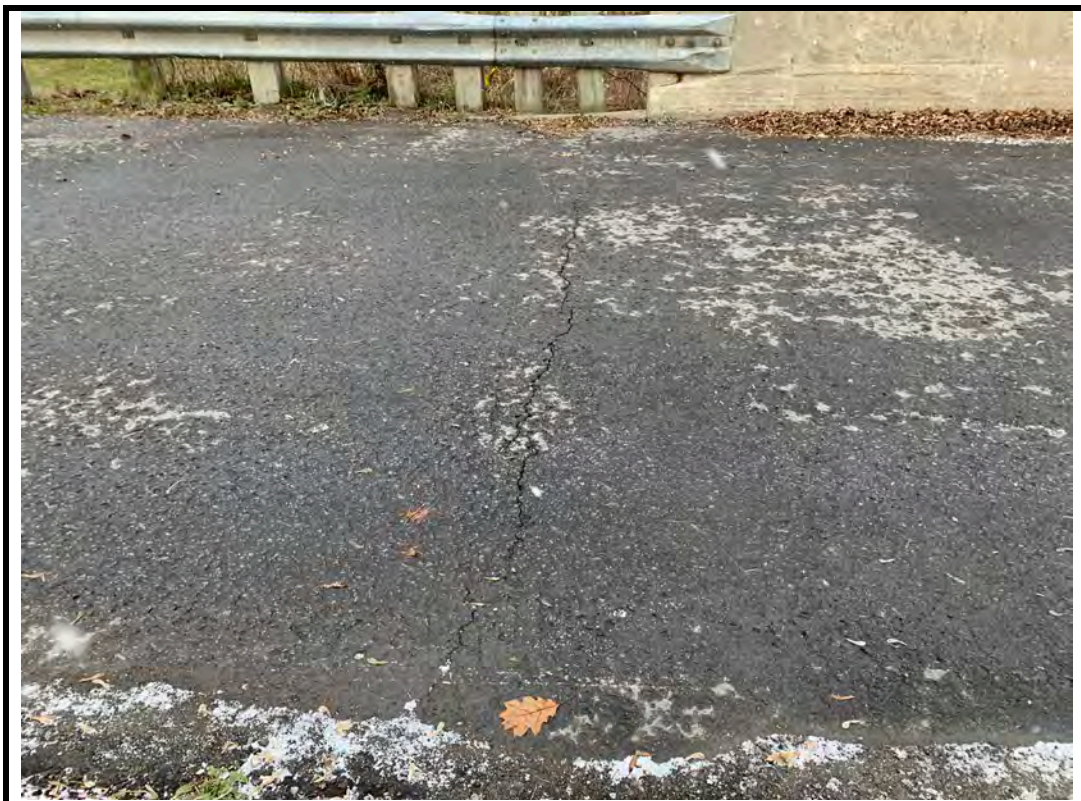
Photo 8 Wide crack on south approach wearing surface

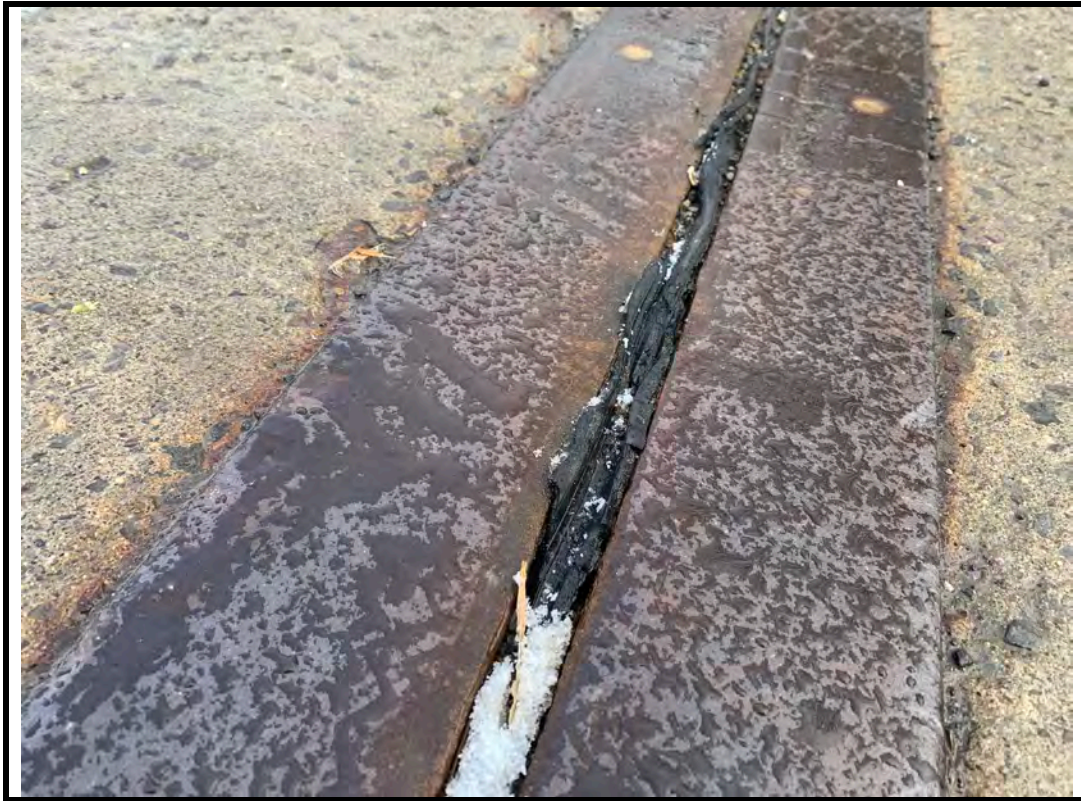
Photo 9 Damage on south joint seal

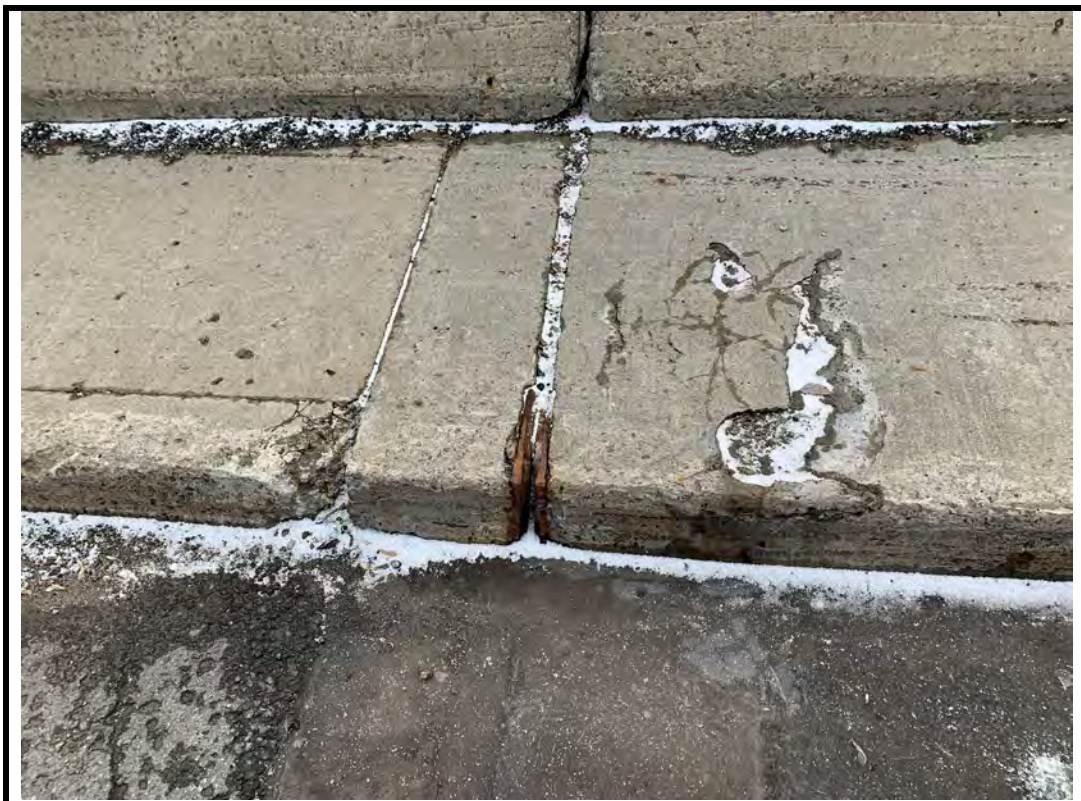
Photo 10 Spall on top face of concrete sidewalk

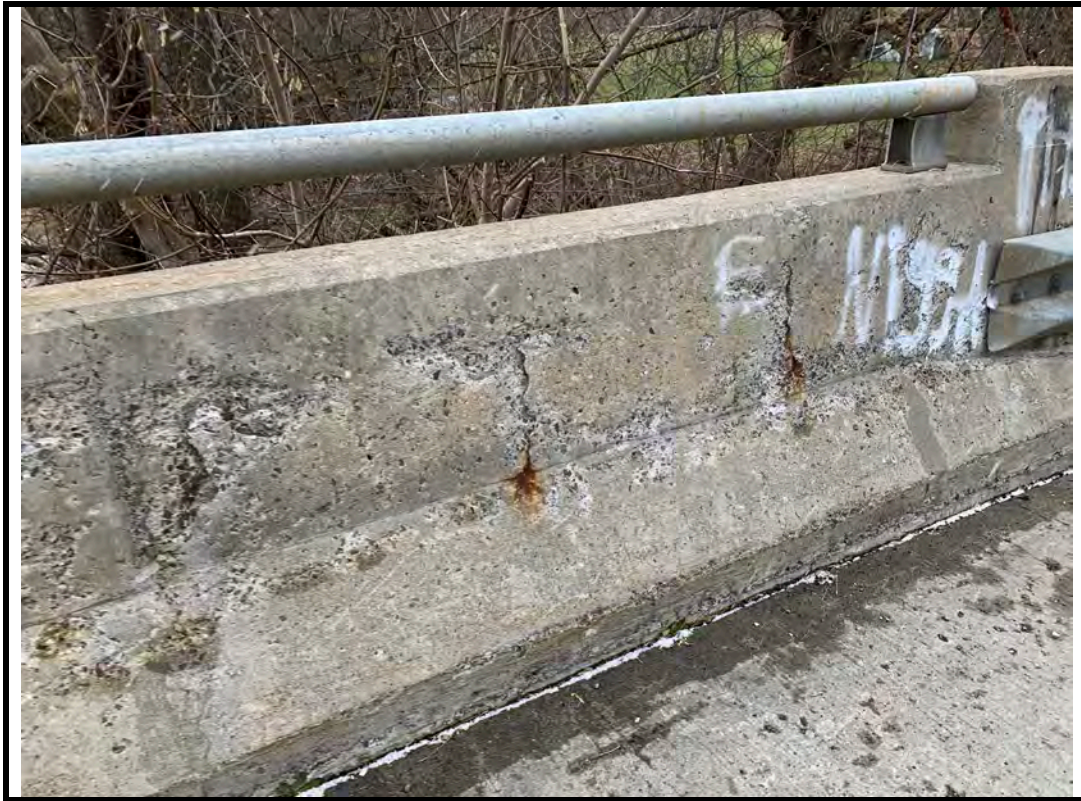
Photo 11 Spalls and disintegration noted on south end of east barrier wall

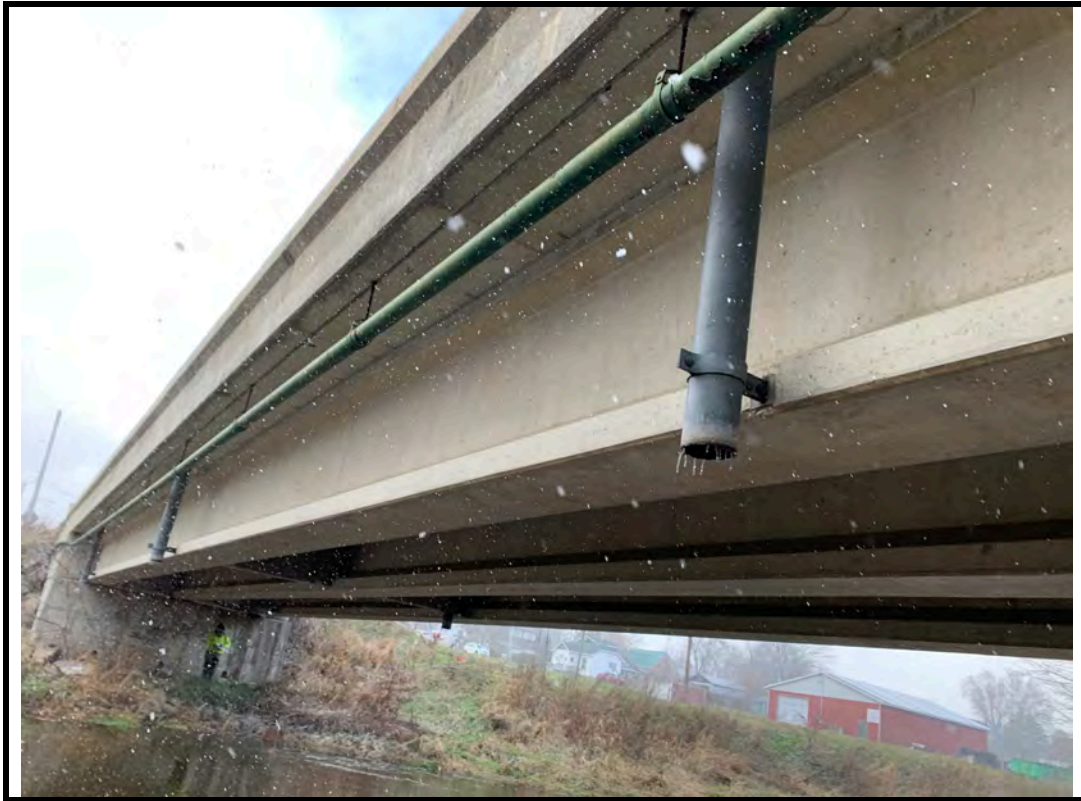
Photo 13 Typical view of west exterior soffit

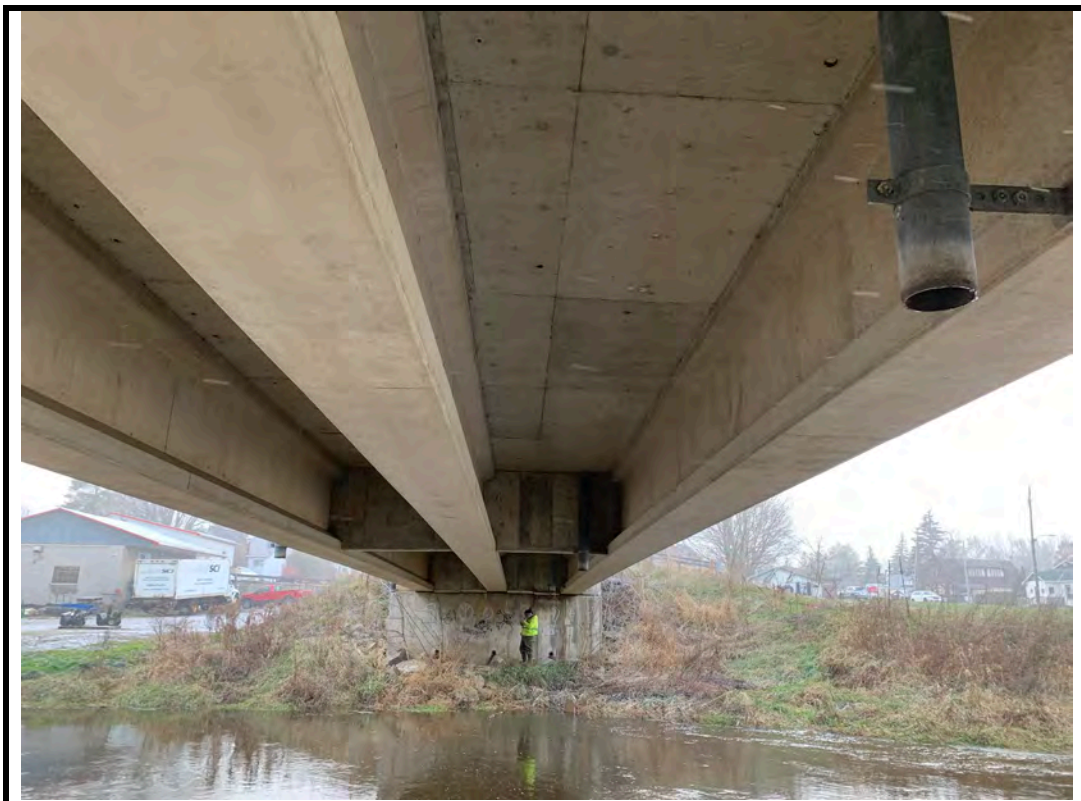
Photo 14 Typical view of interior soffit

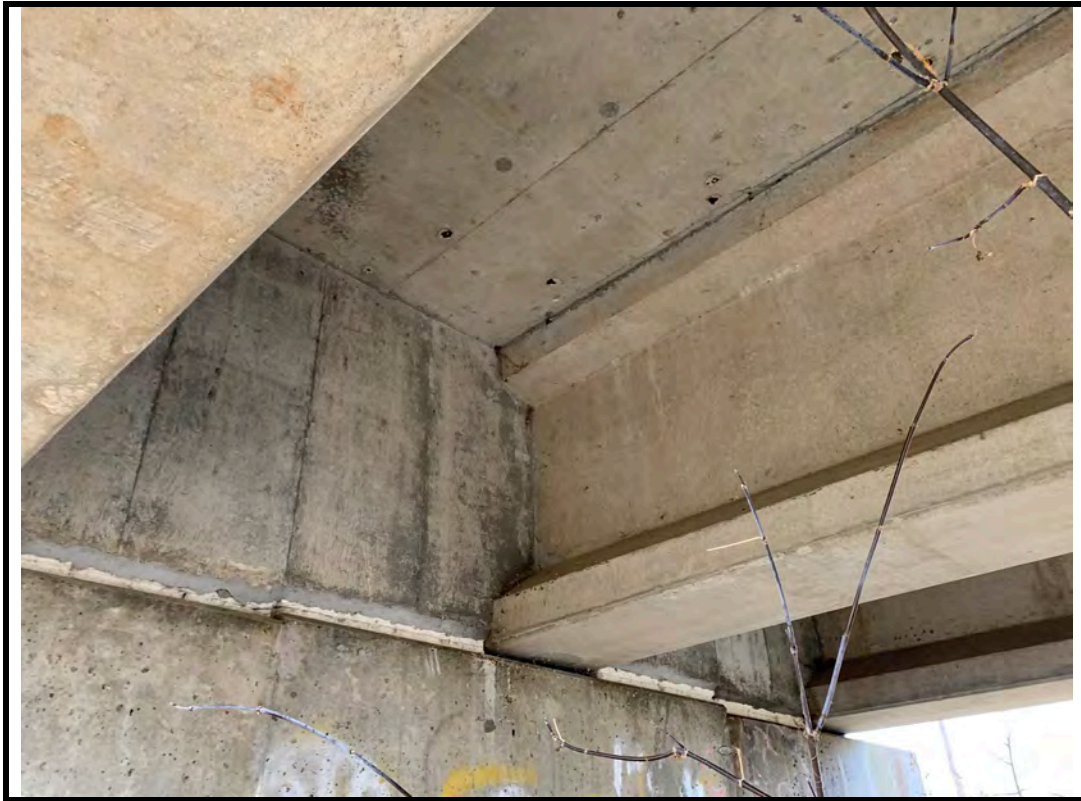
Photo 15 View of north end of interior girder

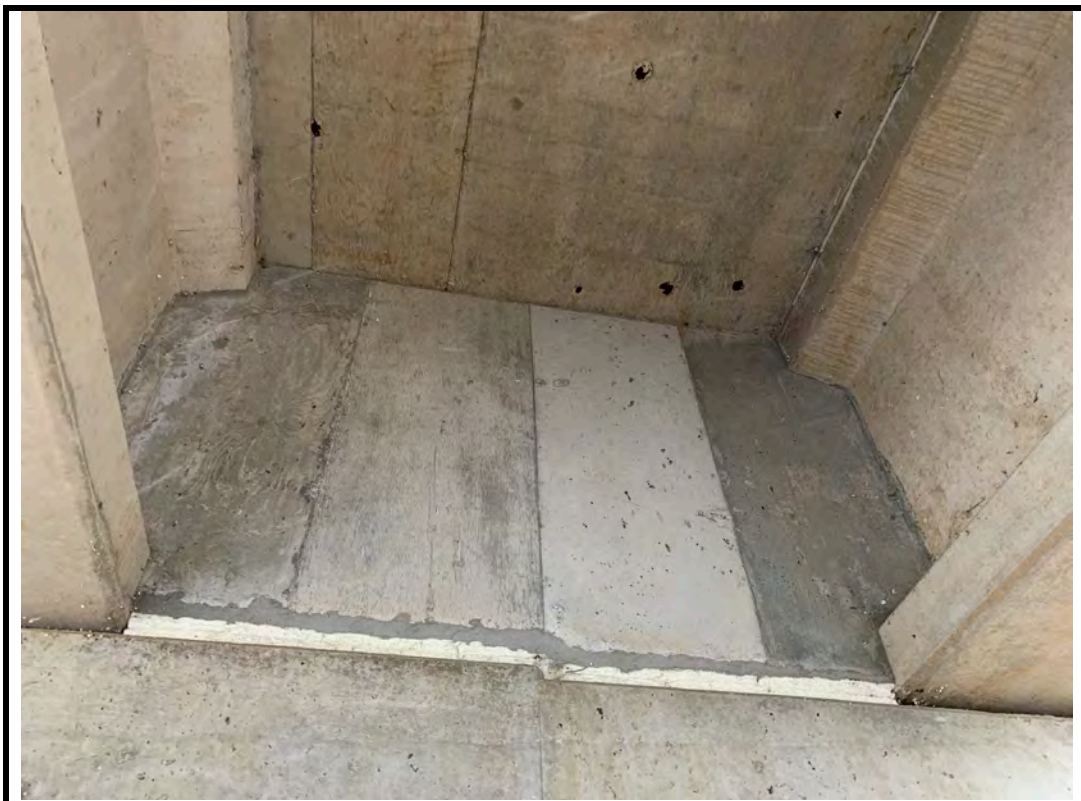
Photo 16 Typical view of end diaphragm

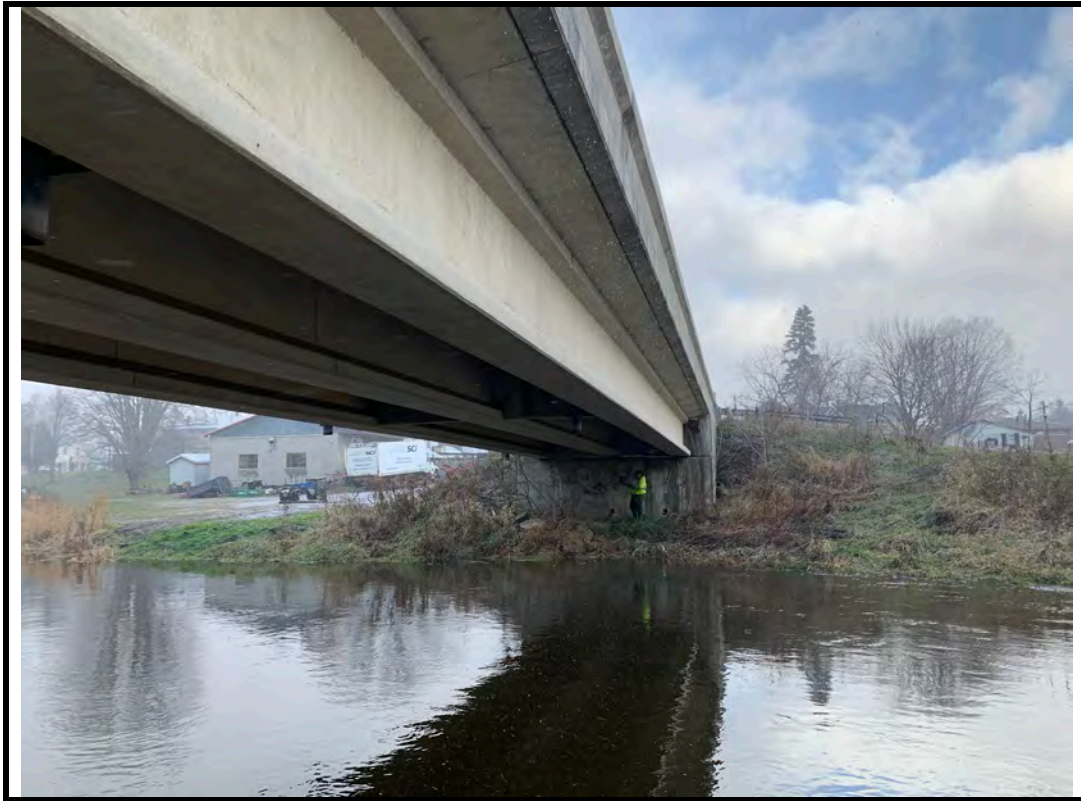
Photo 17 North Underside of Structure

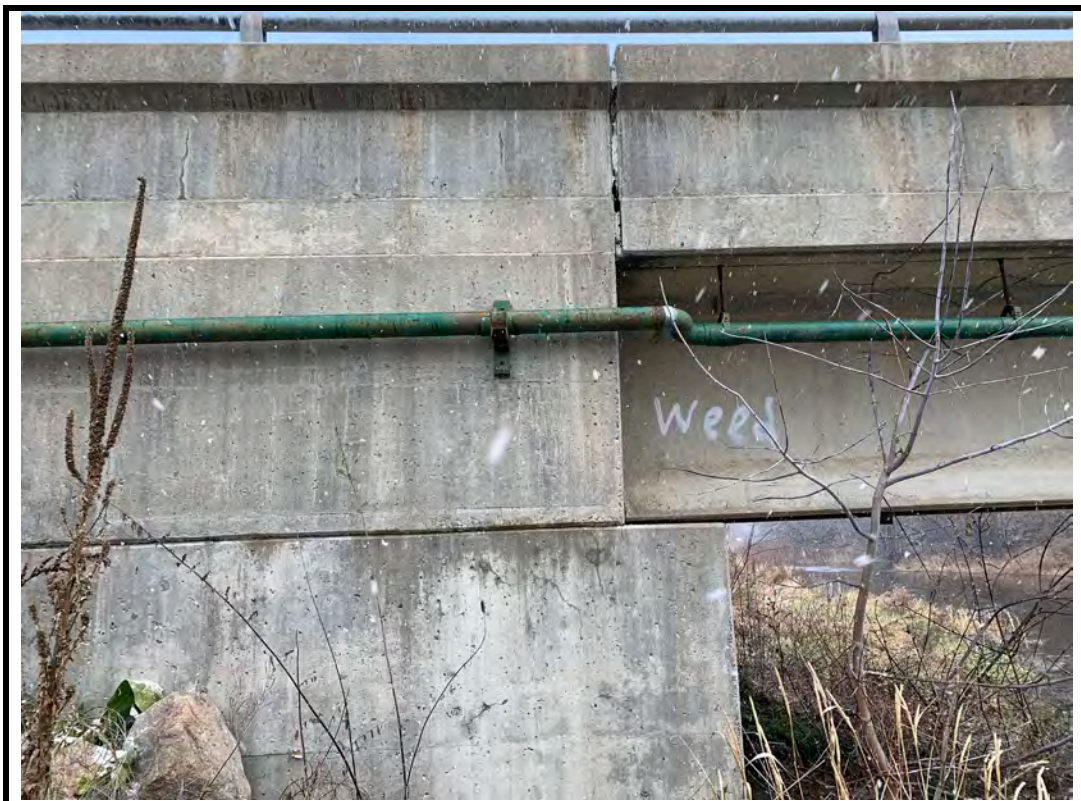
Photo 18 Elevation view of northwest wingwall

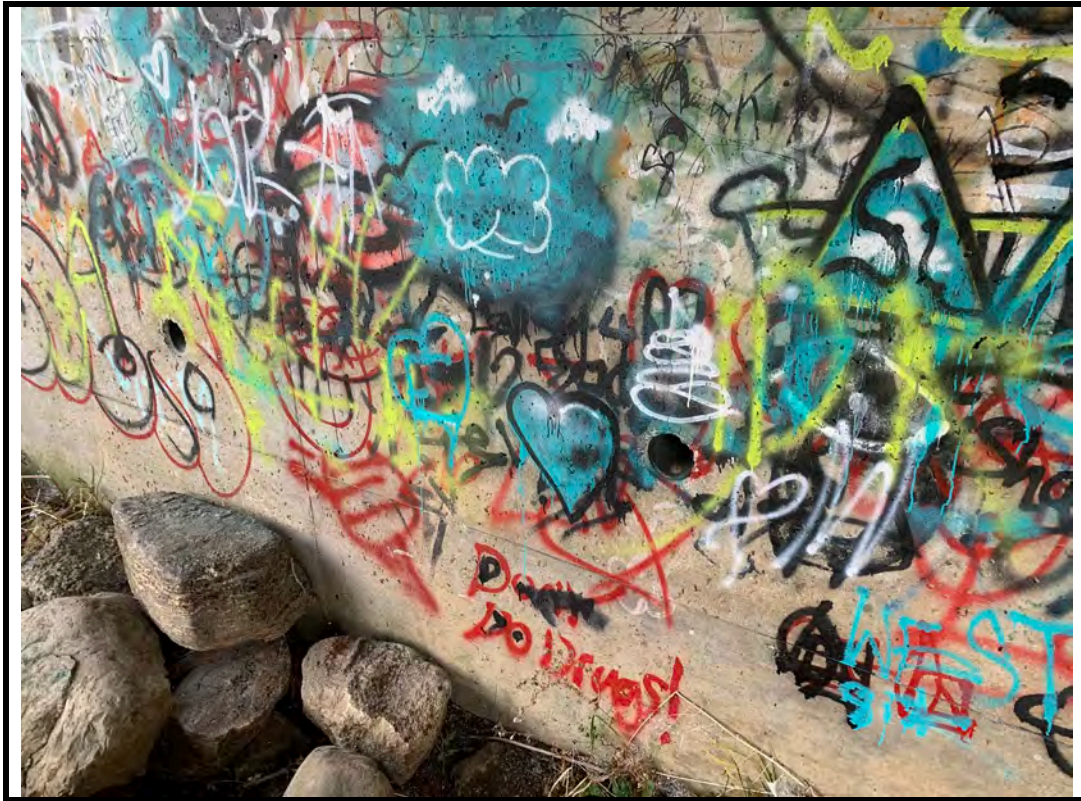
Photo 19 Scaling and graffiti around drains on abutment wall

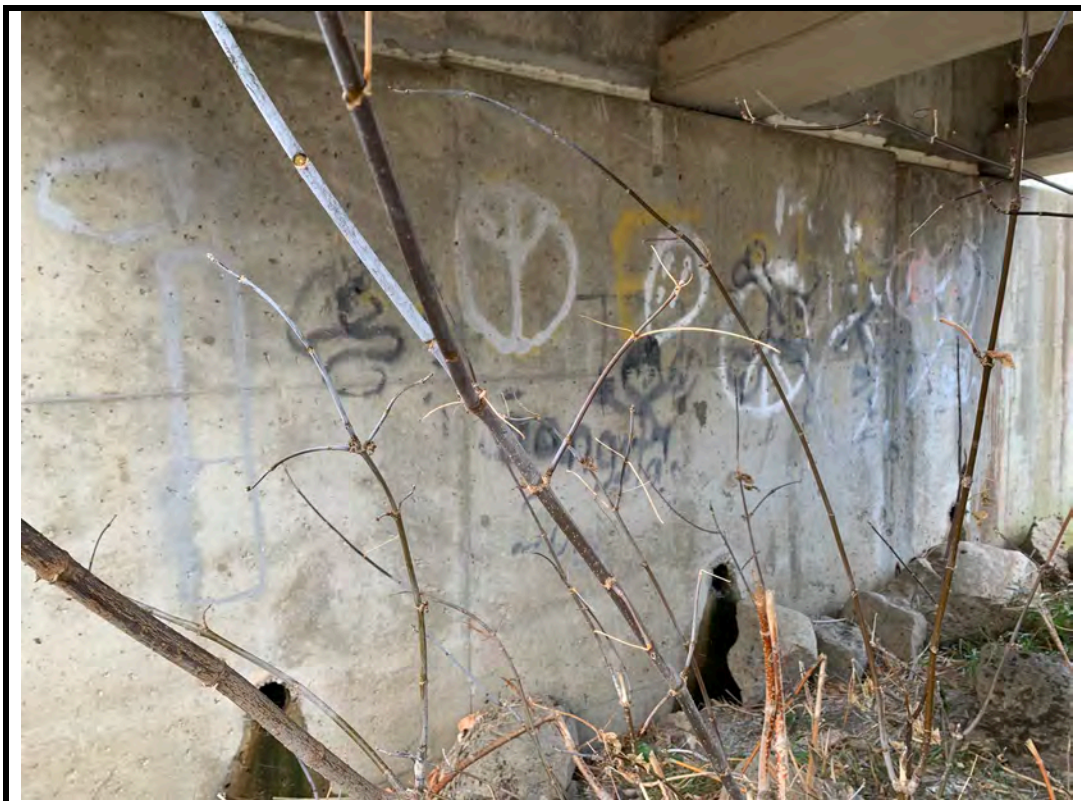
Photo 20 Typical view of north abutment wall

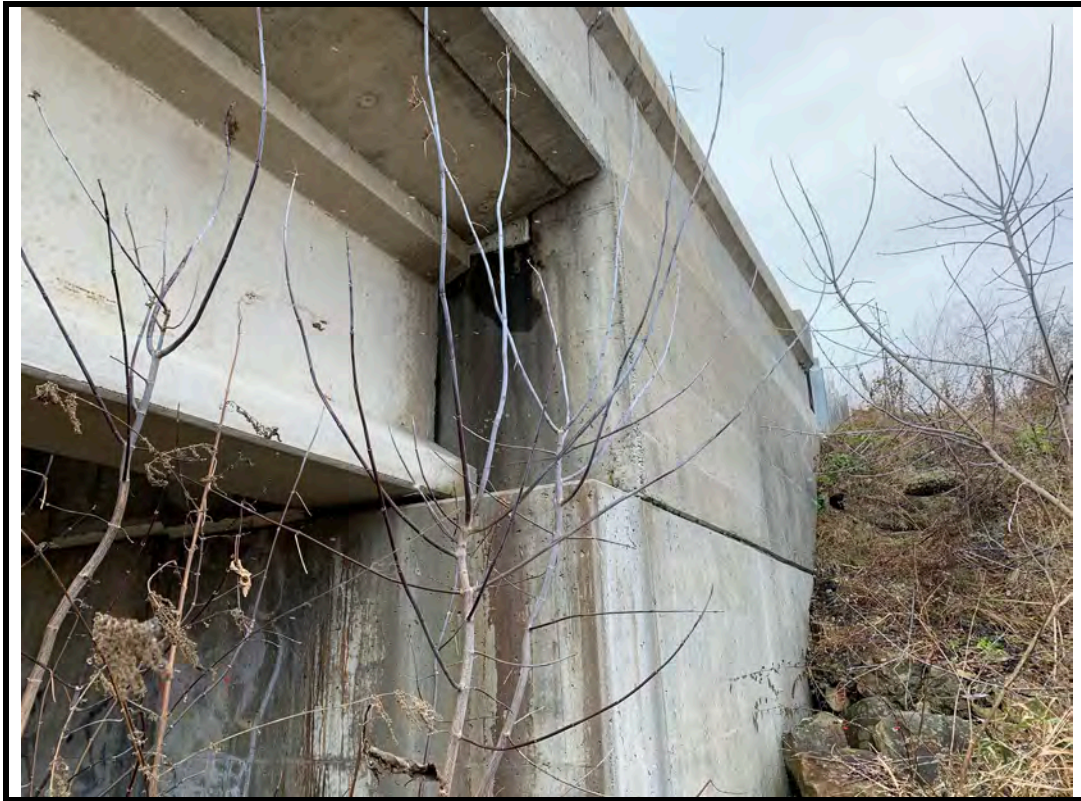
Photo 21 Damp stains and evidence of leaking seal on northeast corner of ballast wall

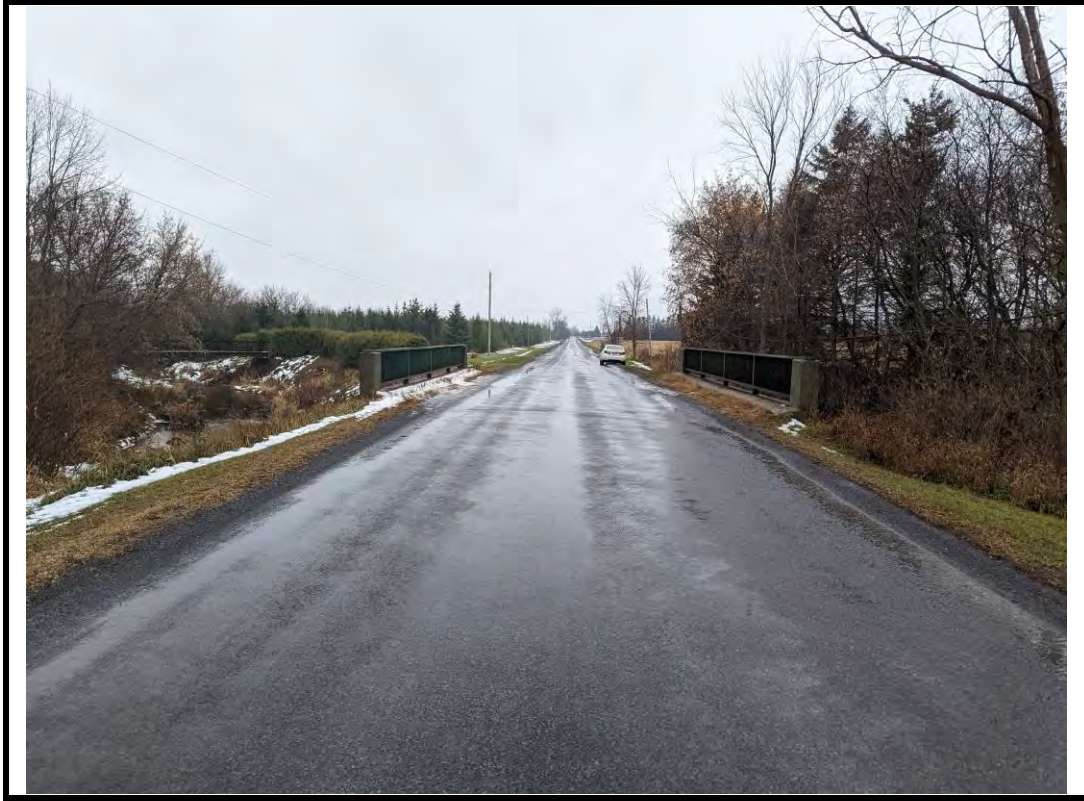
Photo 1 Structure from east approach

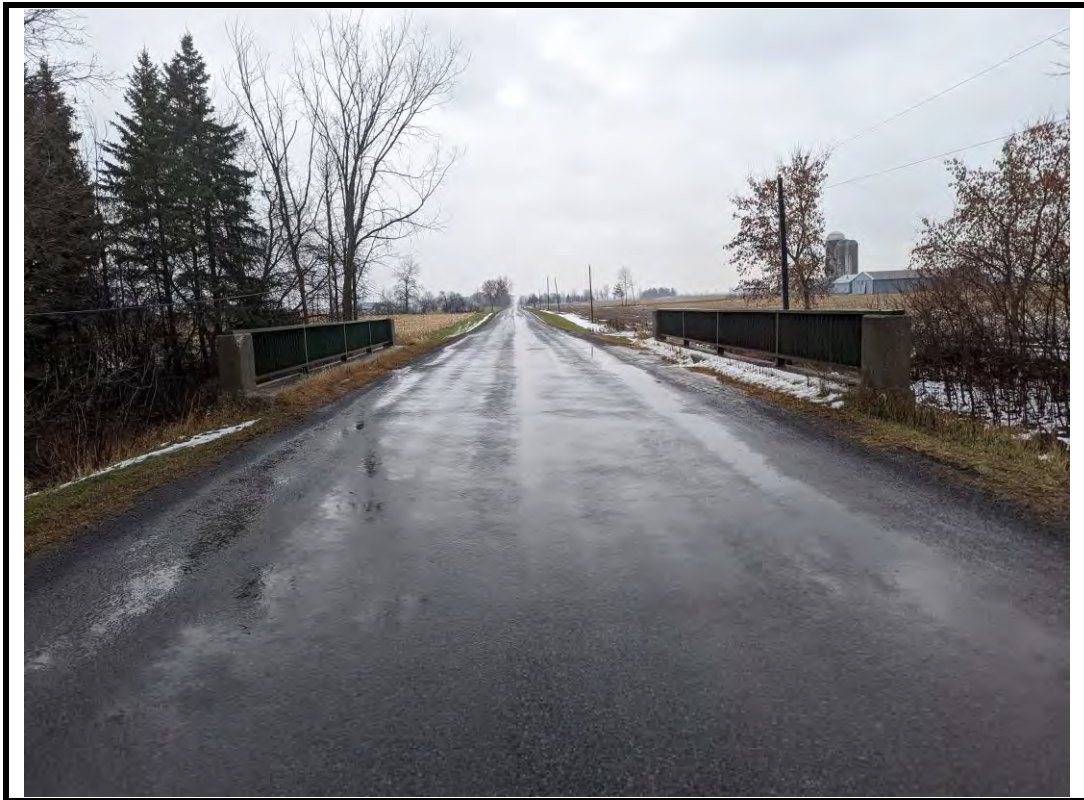
Photo 2 Structure from west approach

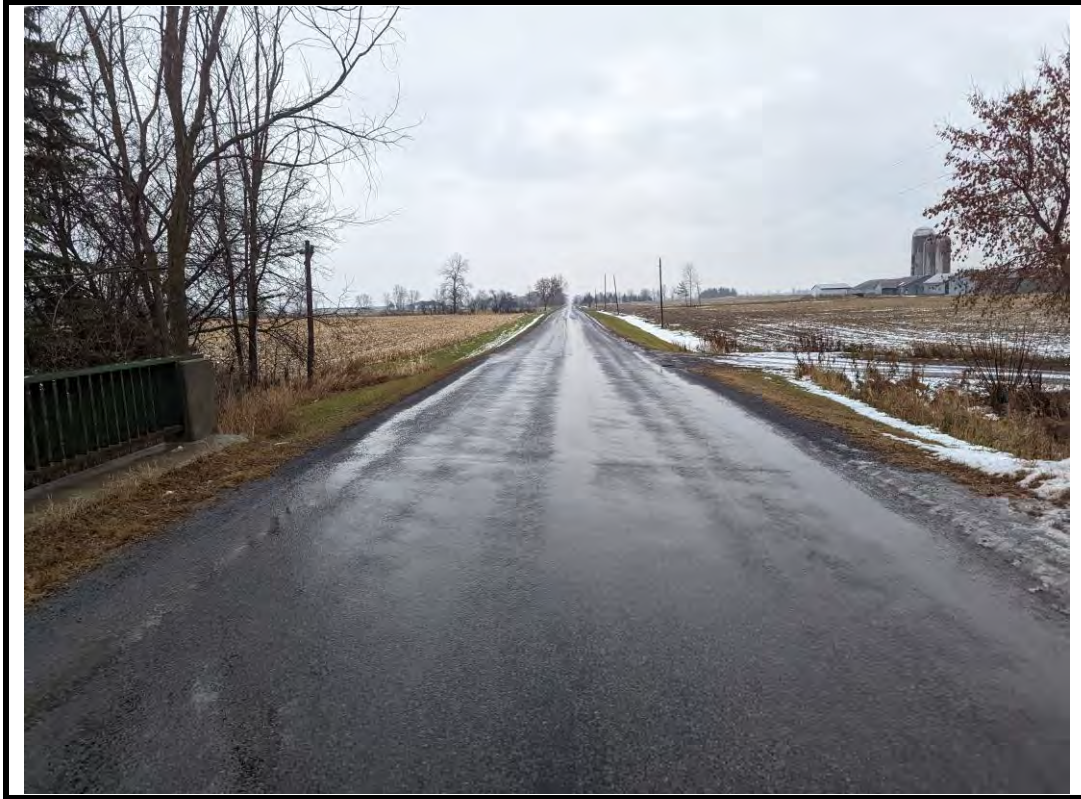
Photo 3 East approach from centre of structure

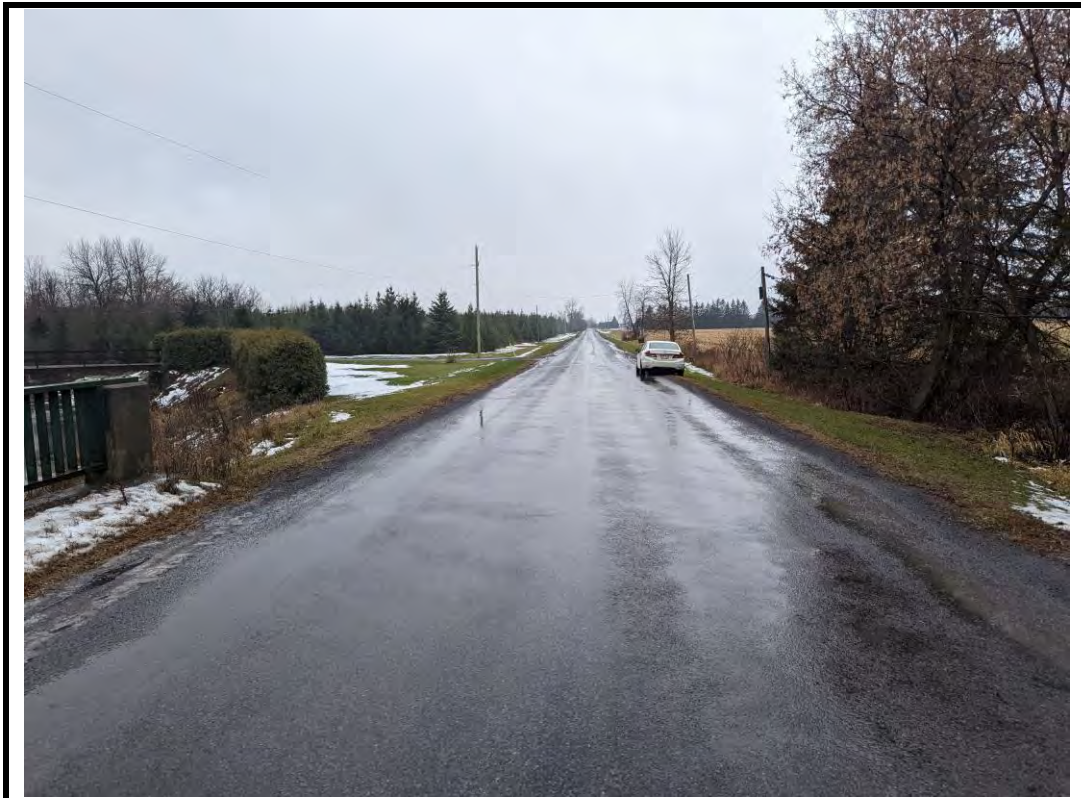
Photo 4 West approach from centre of structure
