THE TOWNSHIP OF NORTH DUNDAS

DRAFT BRIDGE MANAGEMENT STUDY REPORT 18 BRIDGES / 31 CULVERTS

March 2023

HP Engineering Inc.

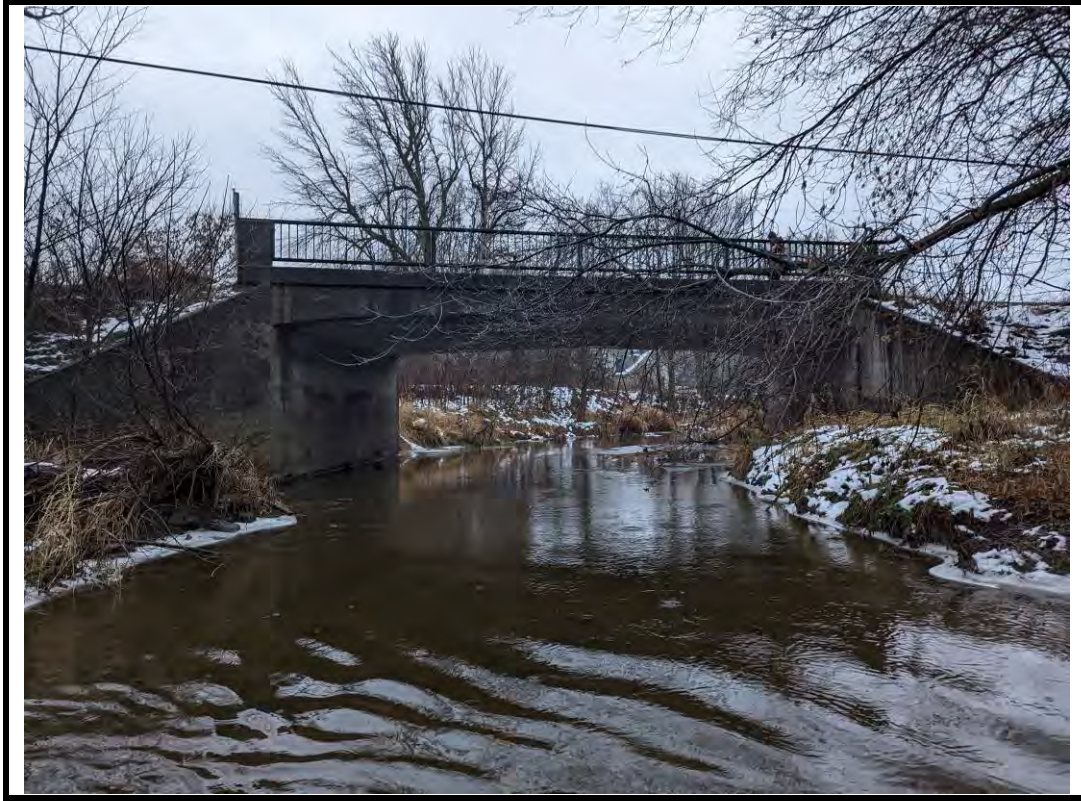
Photo 5 North elevation

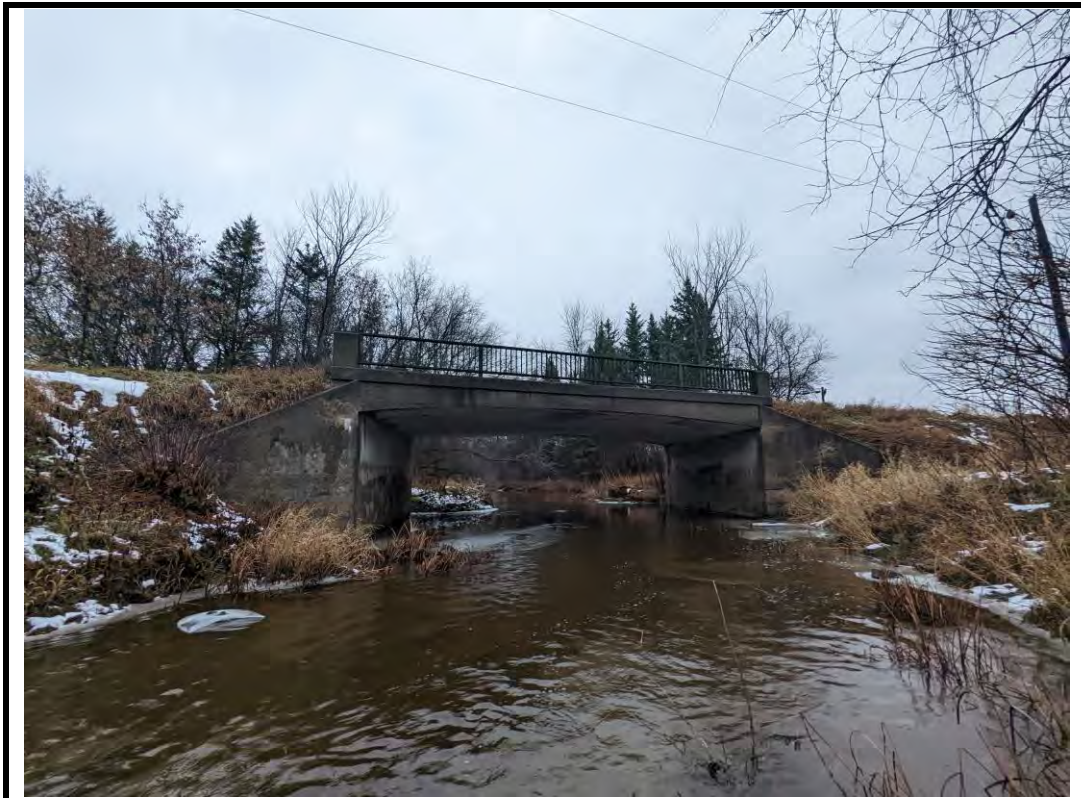
Photo 6 South elevation

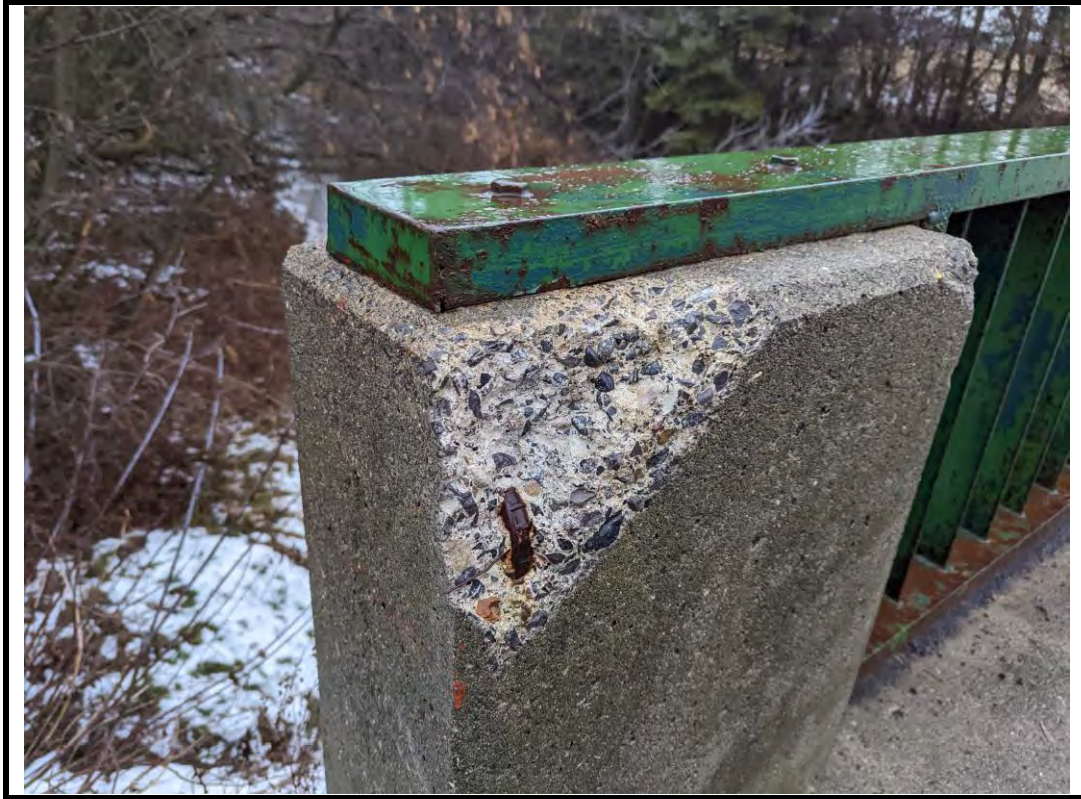
Photo 7 Spall at Northwest barrier end wall with ECR

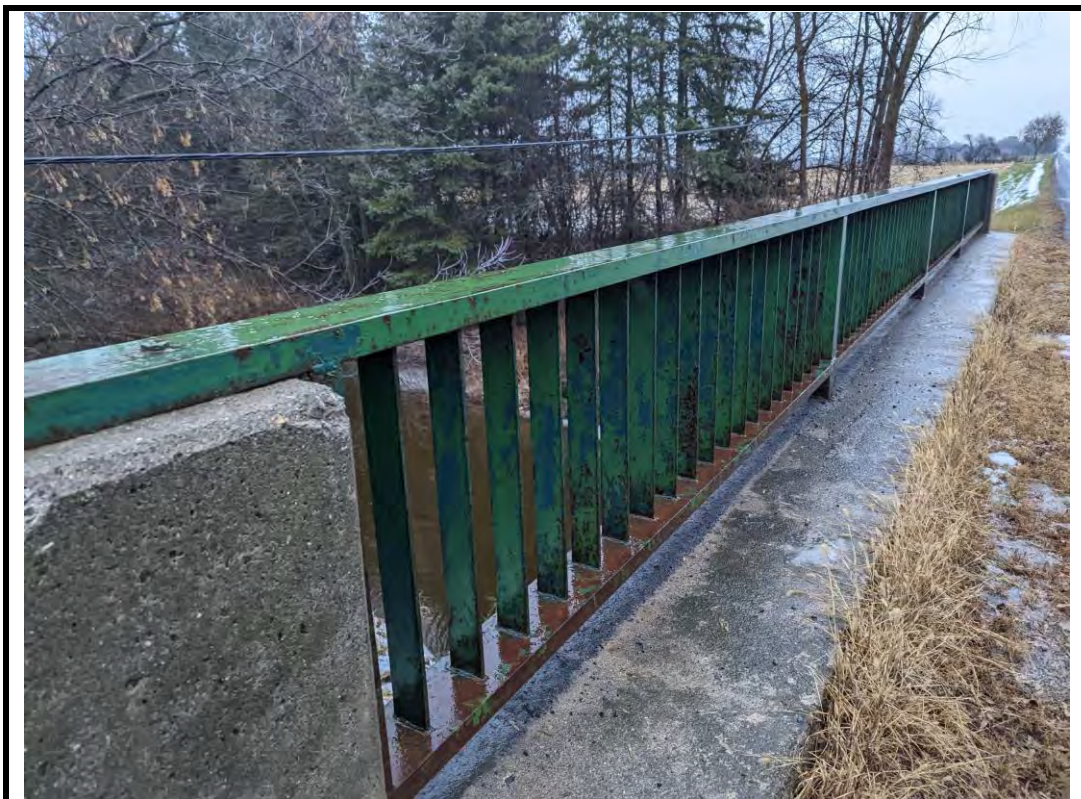
Photo 8 Corrosion and coating failure at north barrier railing (typical)

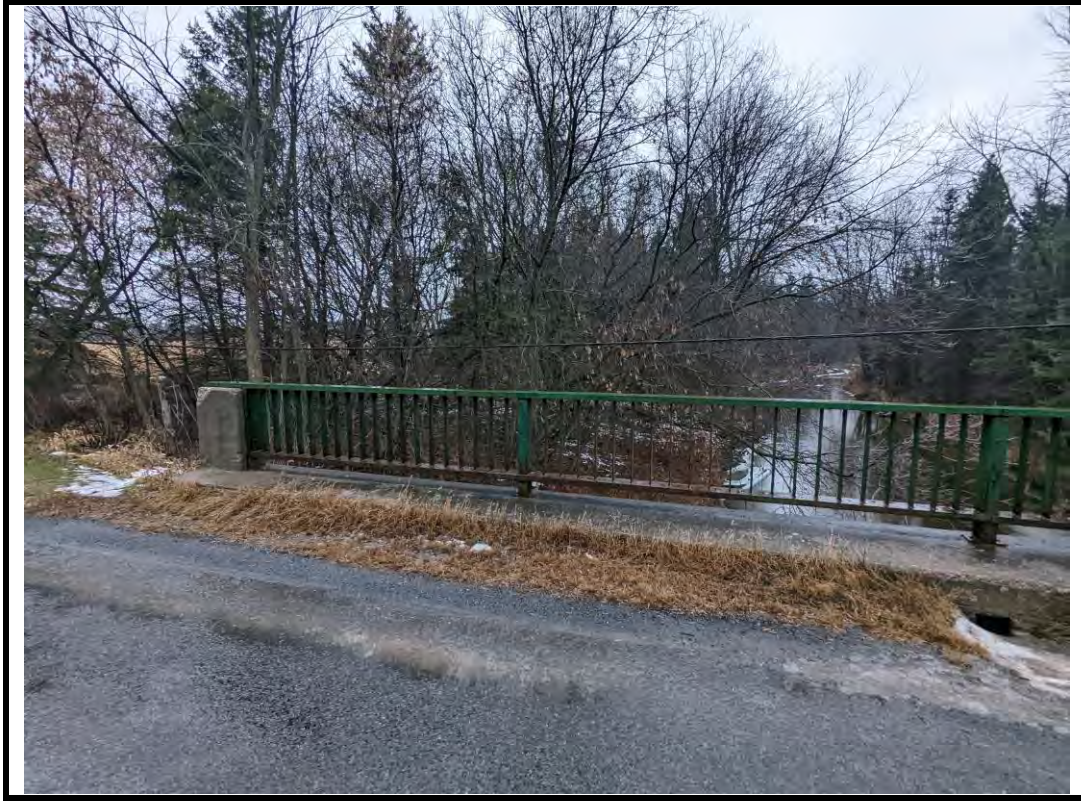
Photo 9 Vegetation along north edge of asphalt over deck (typical)

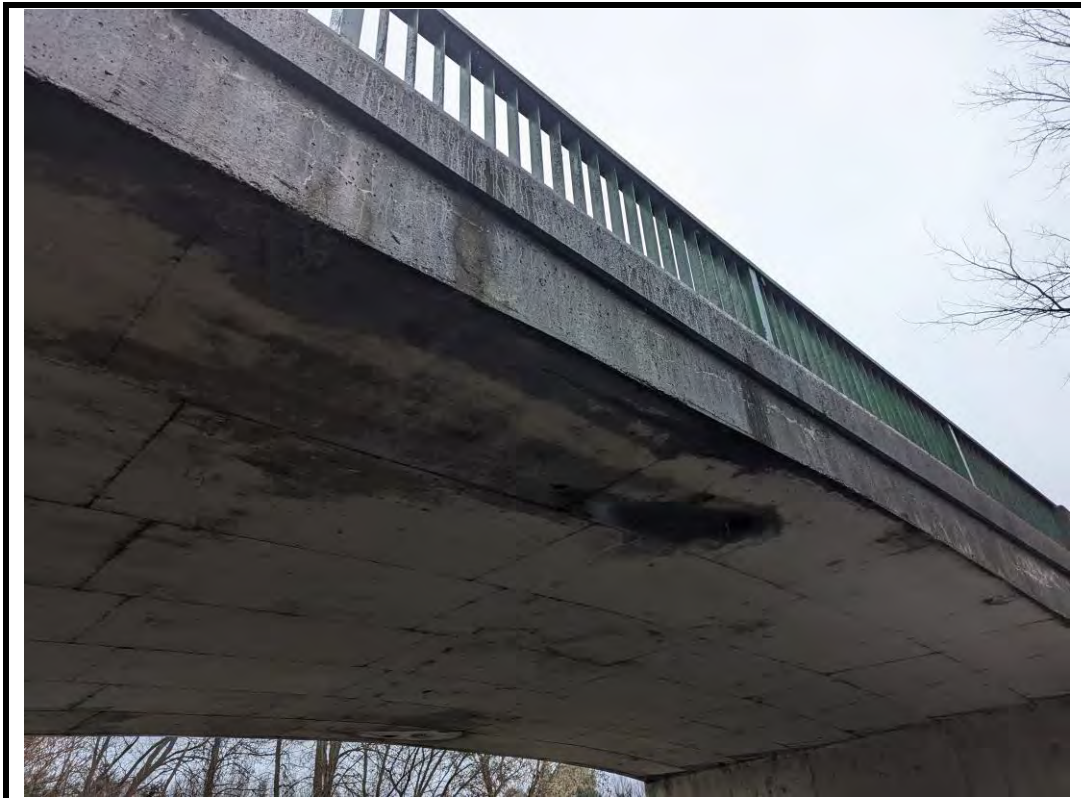
Photo 10 Wet areas around drain downspouts on soffit

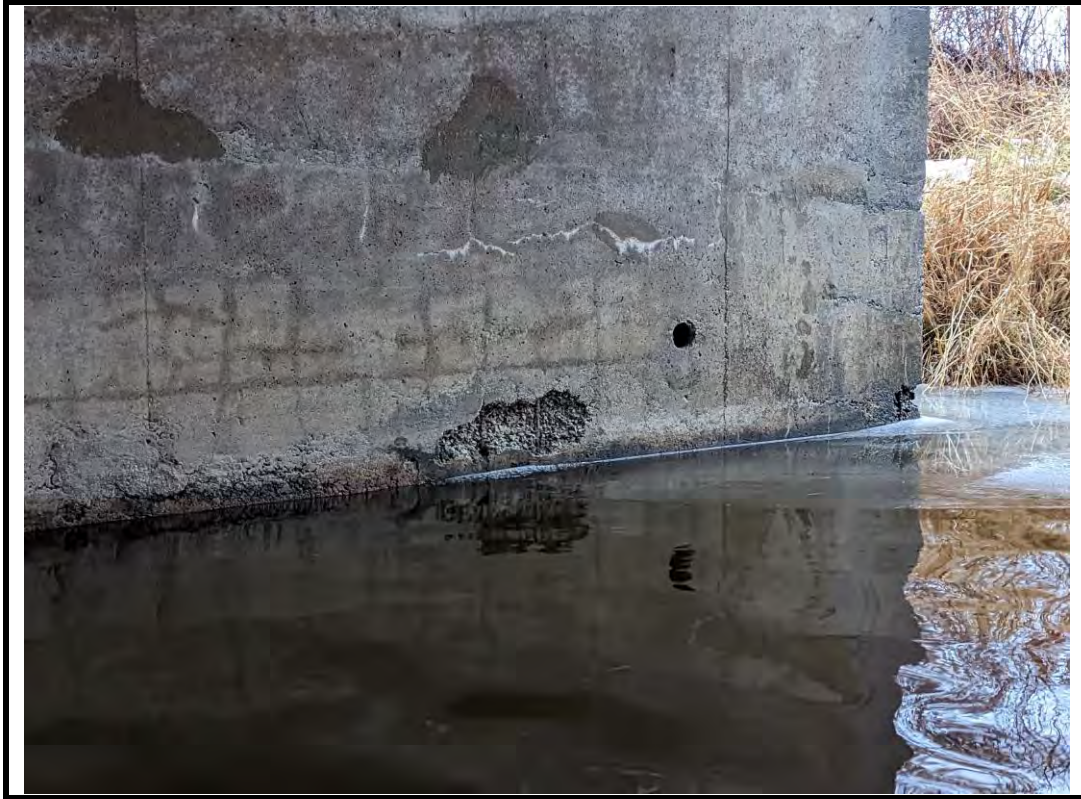
Photo 11 Spalls and honeycombing at springline along east abutment wall (typical)

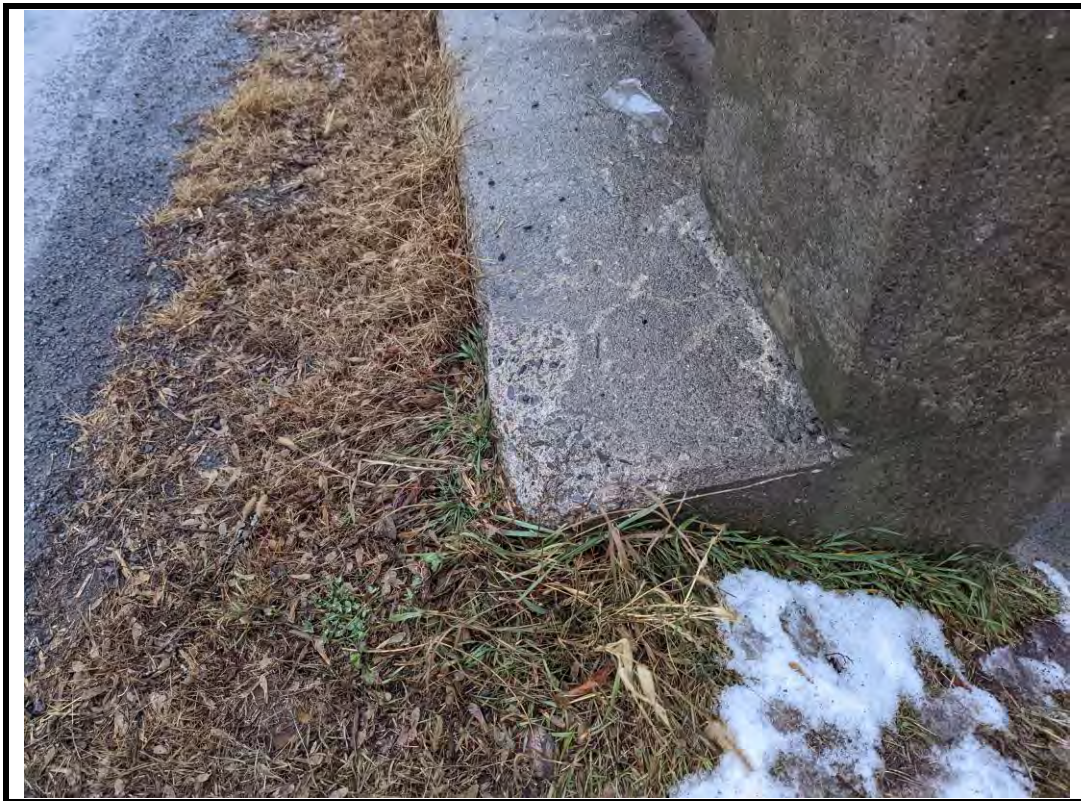
Photo 12 Spalling on east curb

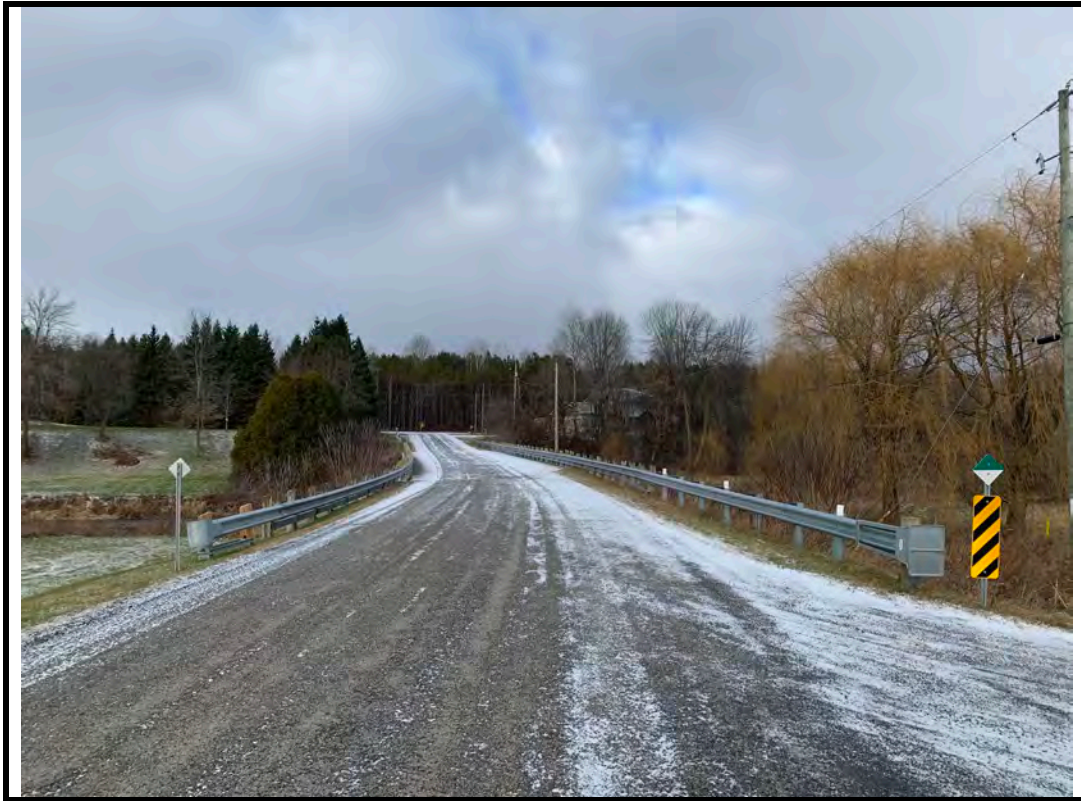
Photo 1 Structure from east approach

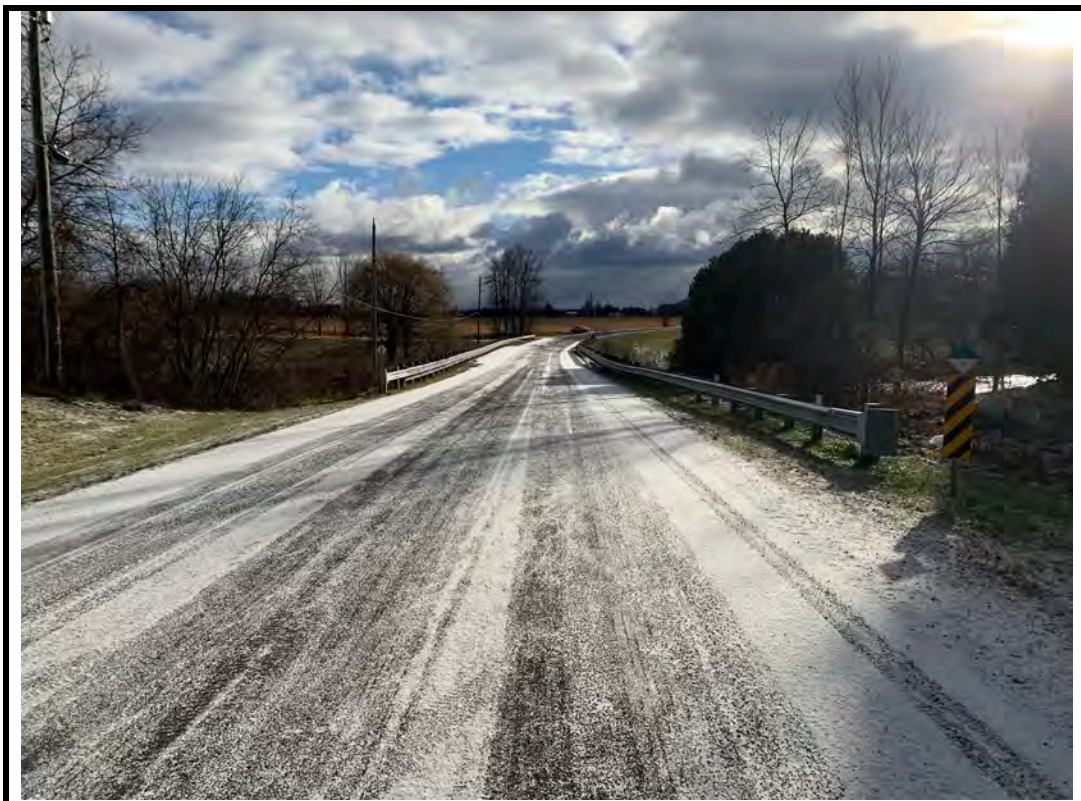
Photo 2 Structure from west approach

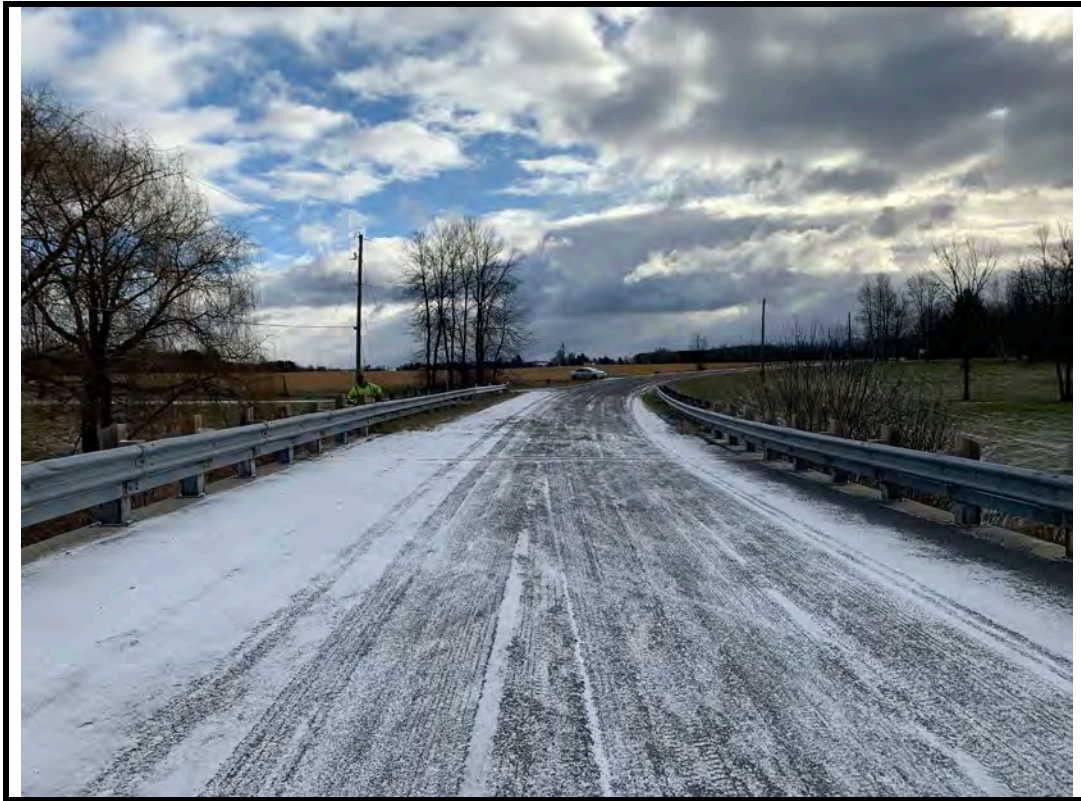
Photo 3 East approach from centre of structure

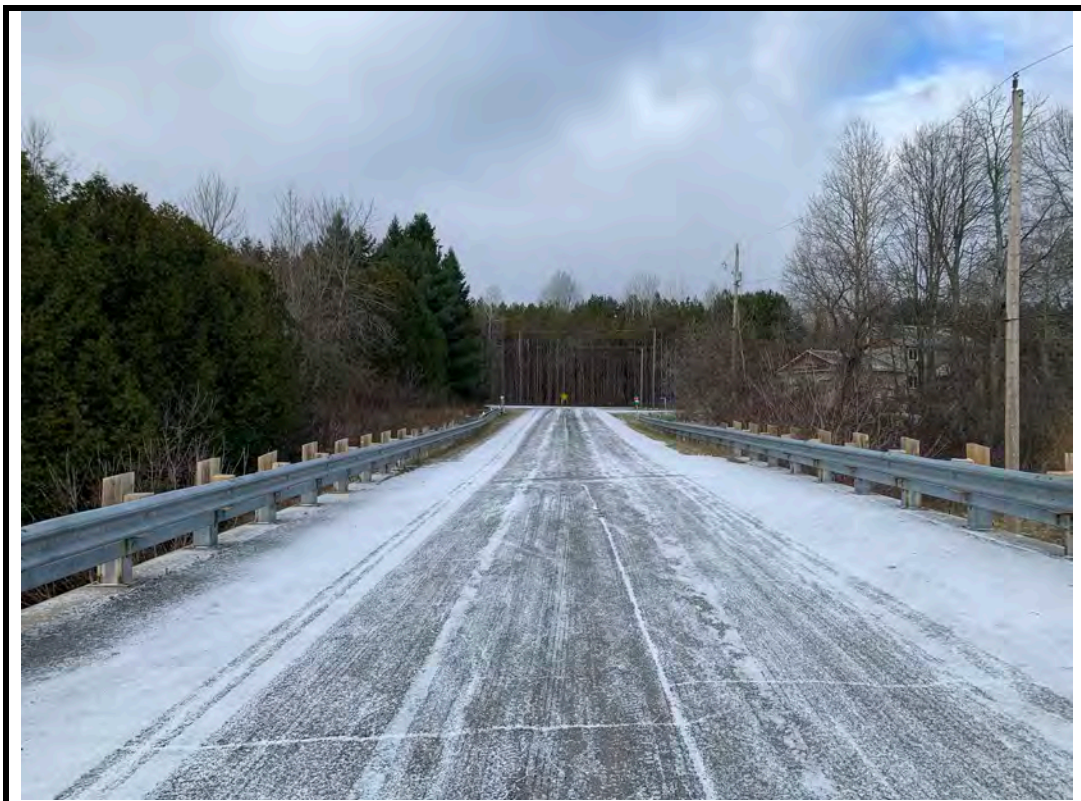
Photo 4 West approach from centre of structure

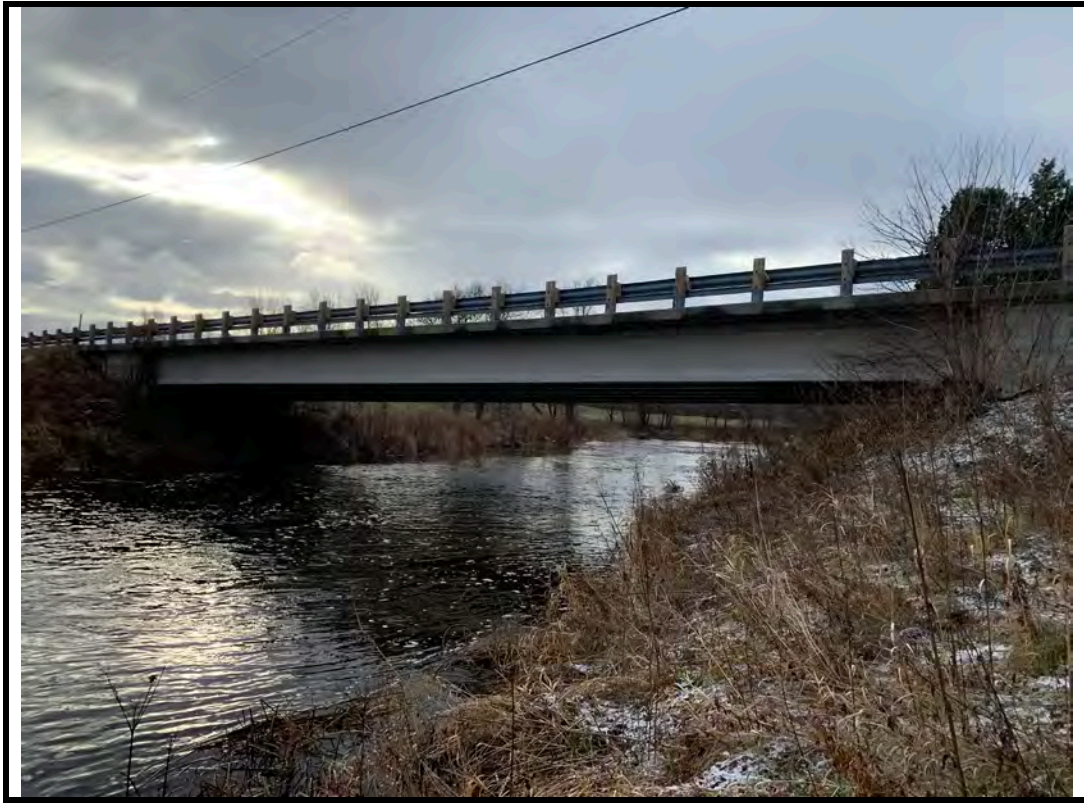
Photo 5 North elevation

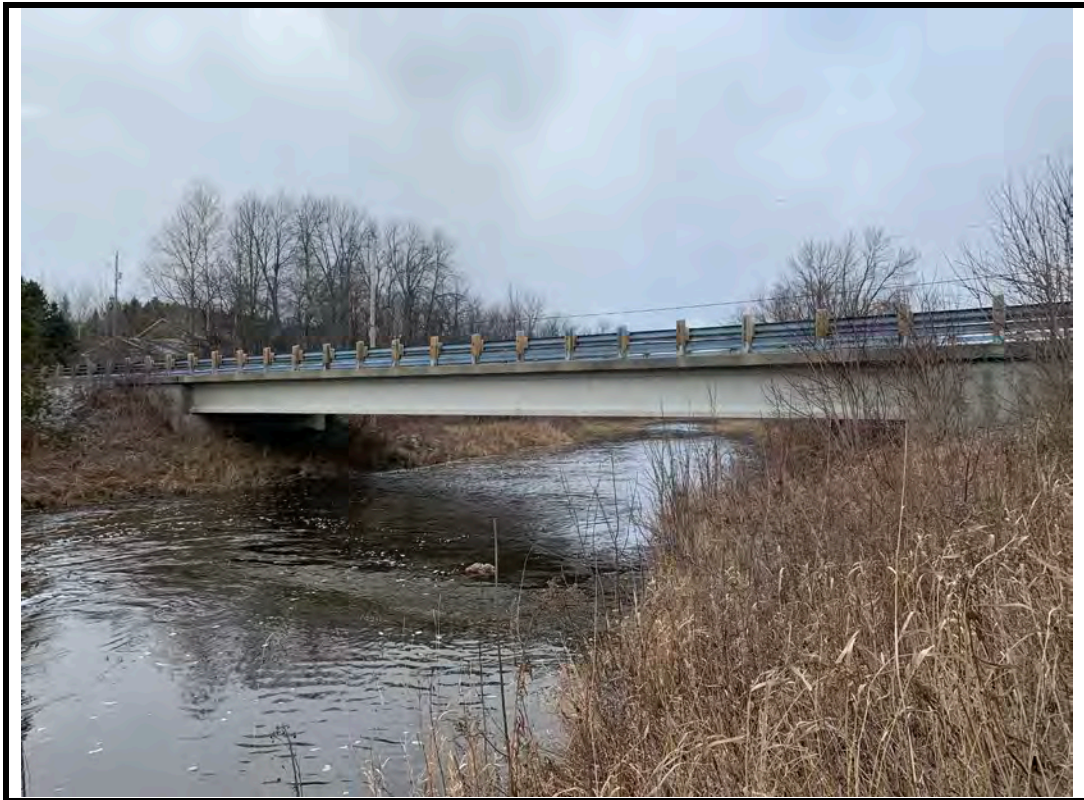
Photo 6 South elevation

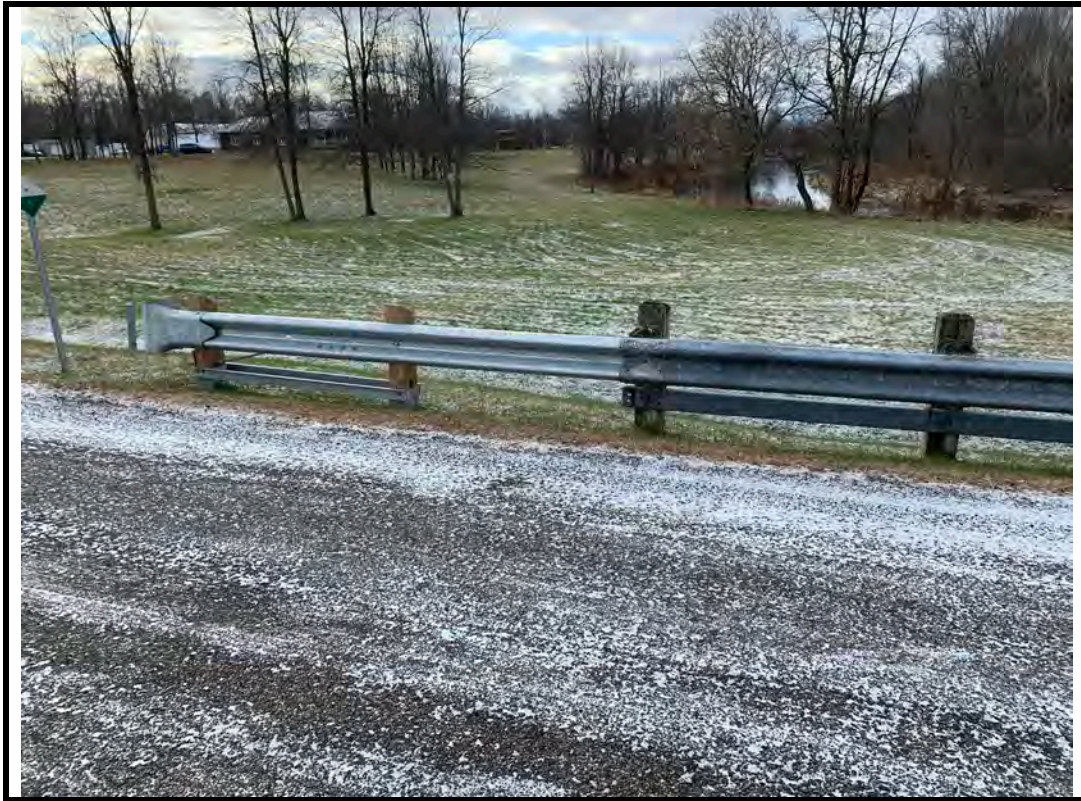
Photo 7 New end treatment at southeast corner

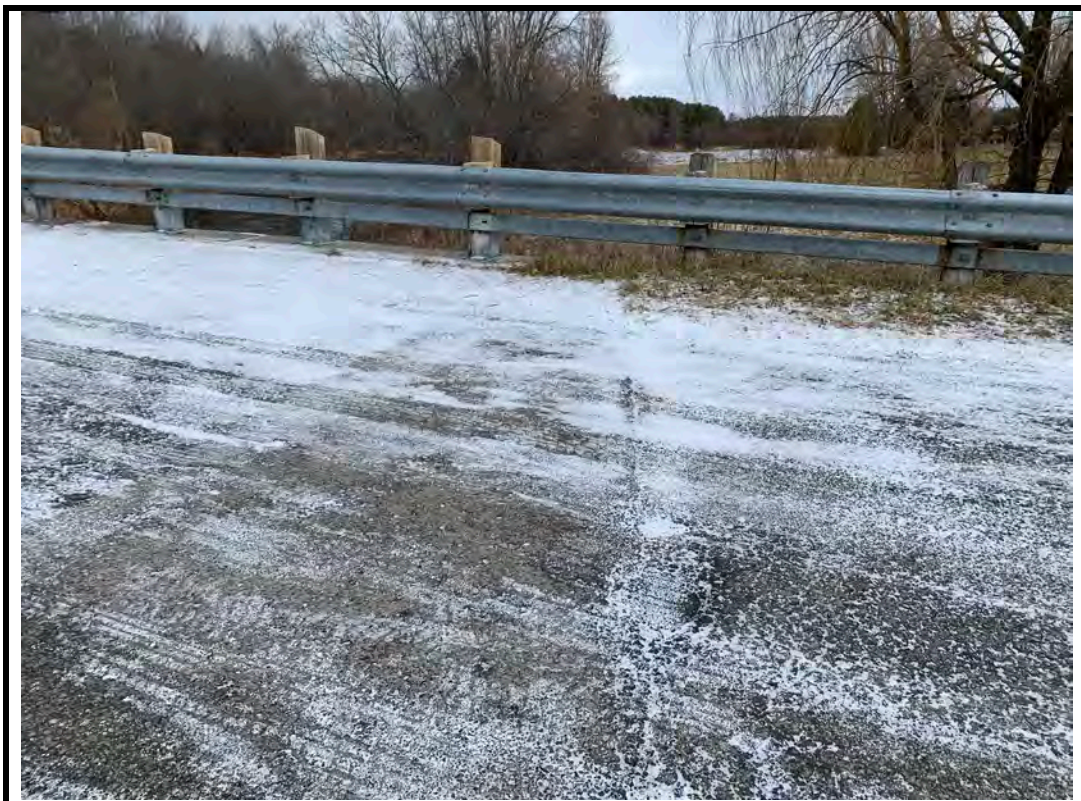
Photo 8 Wide crack at end of approach slab on east wearing surface

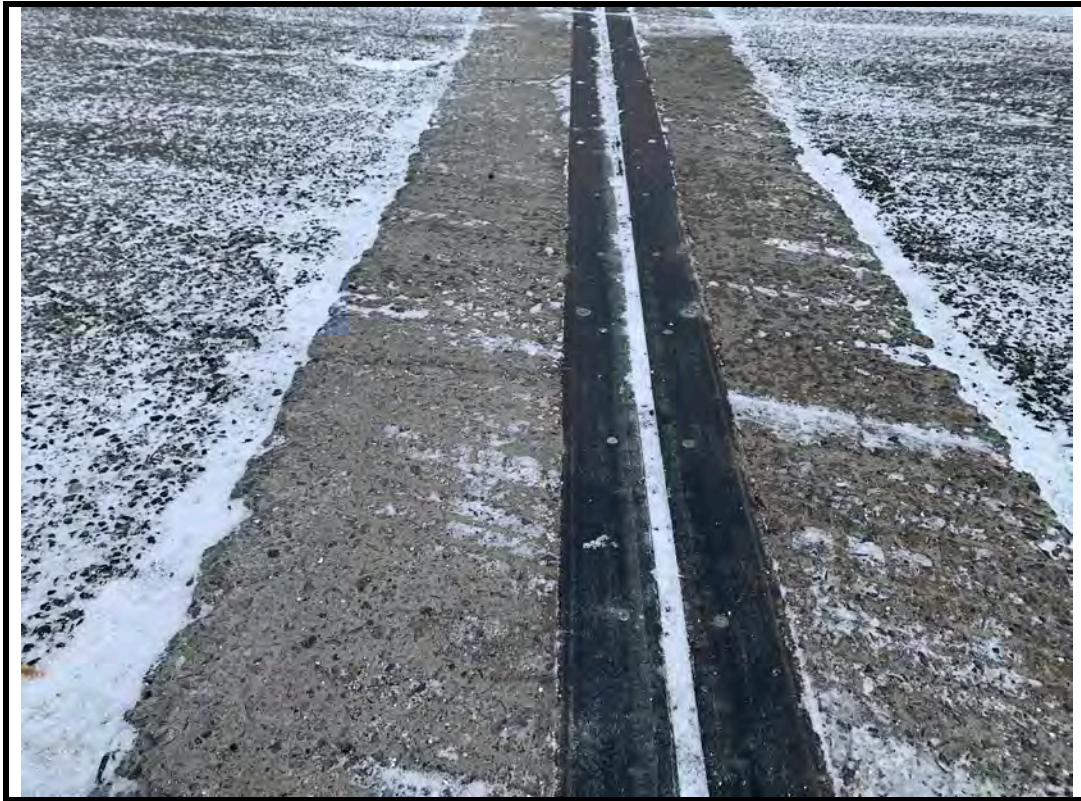
Photo 9 Abrasions on east joint armouring and scaling on concrete end dams

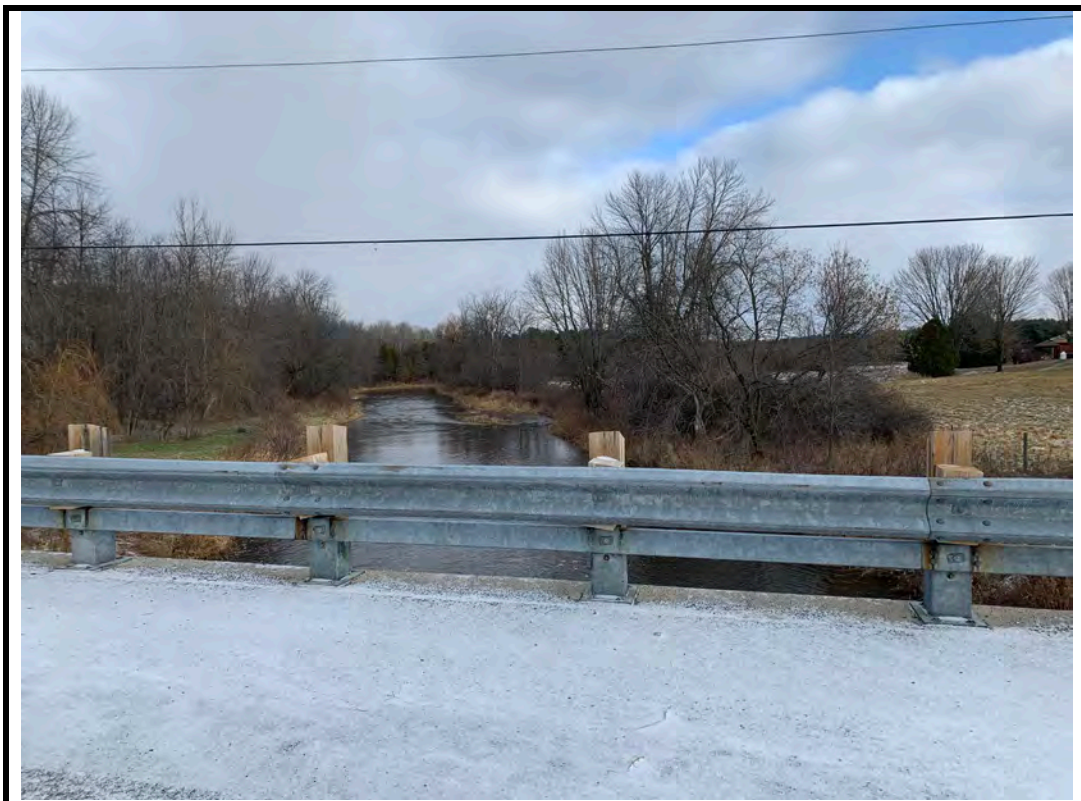
Photo 10 Typical elevation of deck barrier, north barrier shown

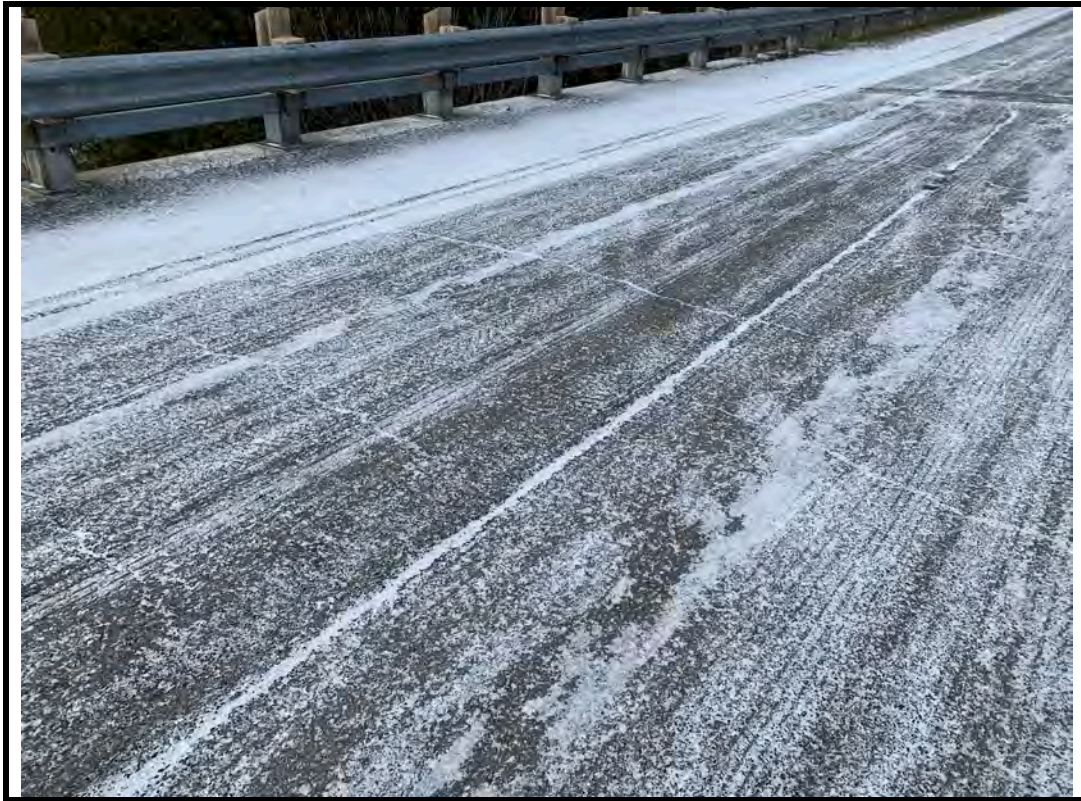
Photo 11 Wide longitudinal crack at centreline of deck wearing surface

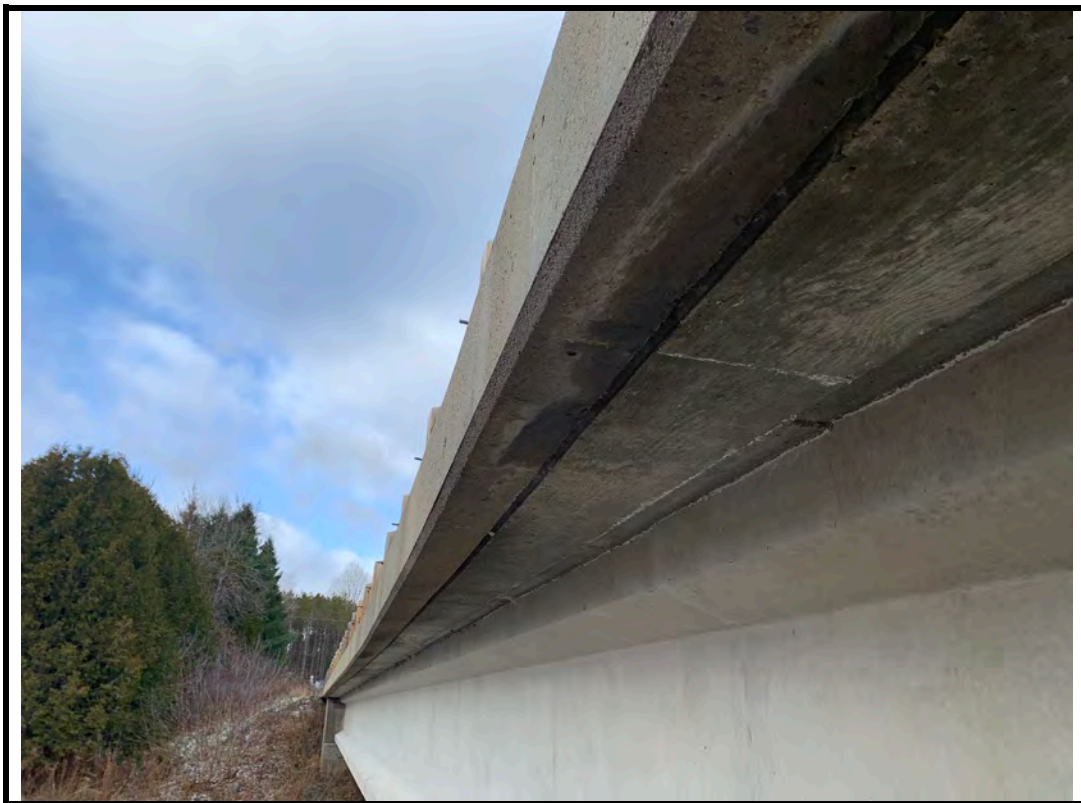
Photo 12 Typical view of north exterior soffit

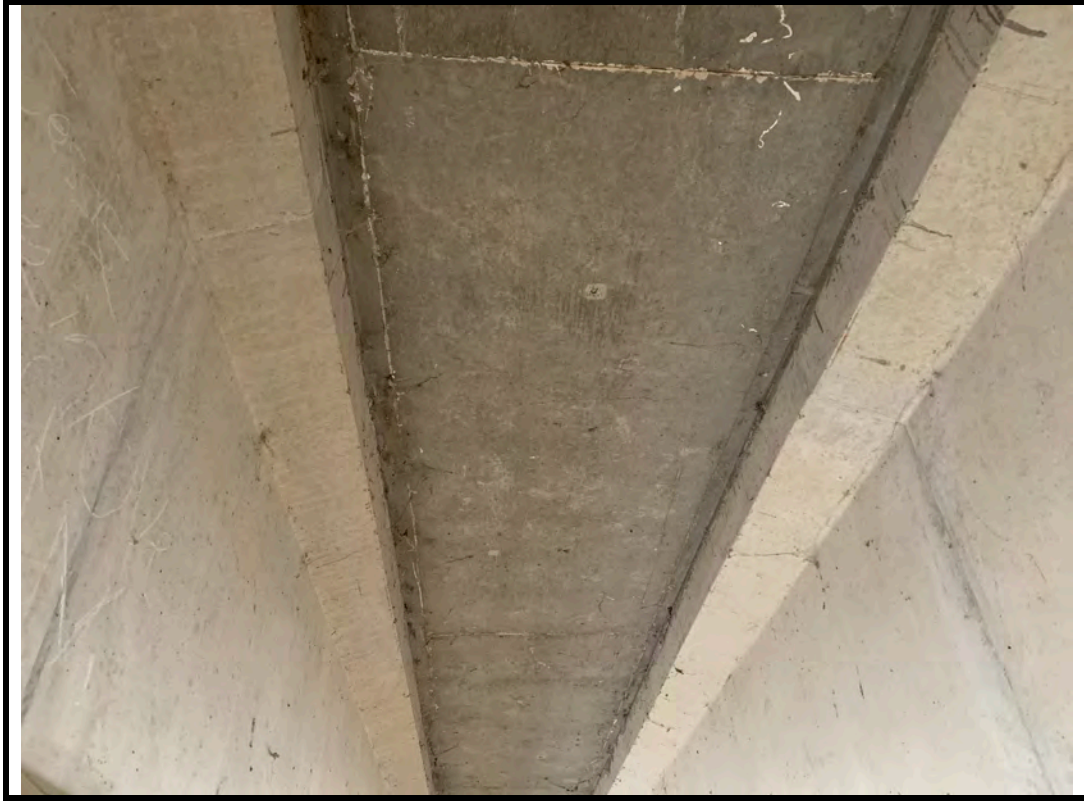
Photo 13 Typical view of interior soffit

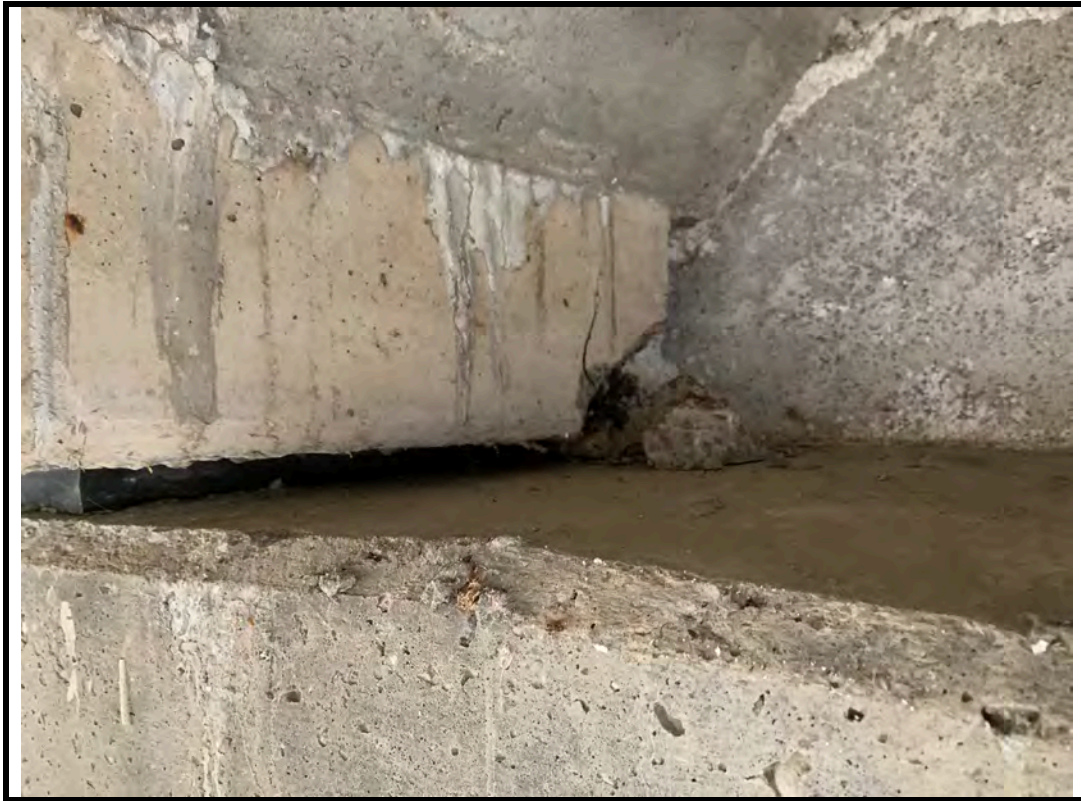
Photo 15 Spall at east end of interior girder

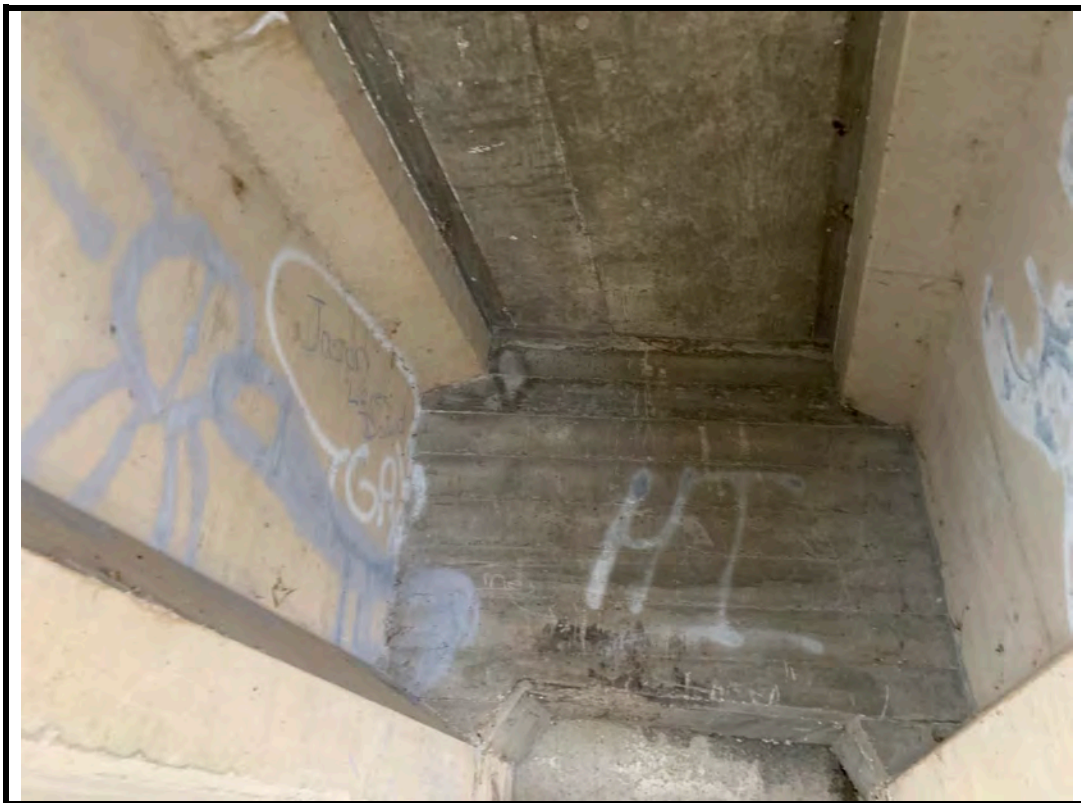
Photo 16 Graffiti on east end diaphragm

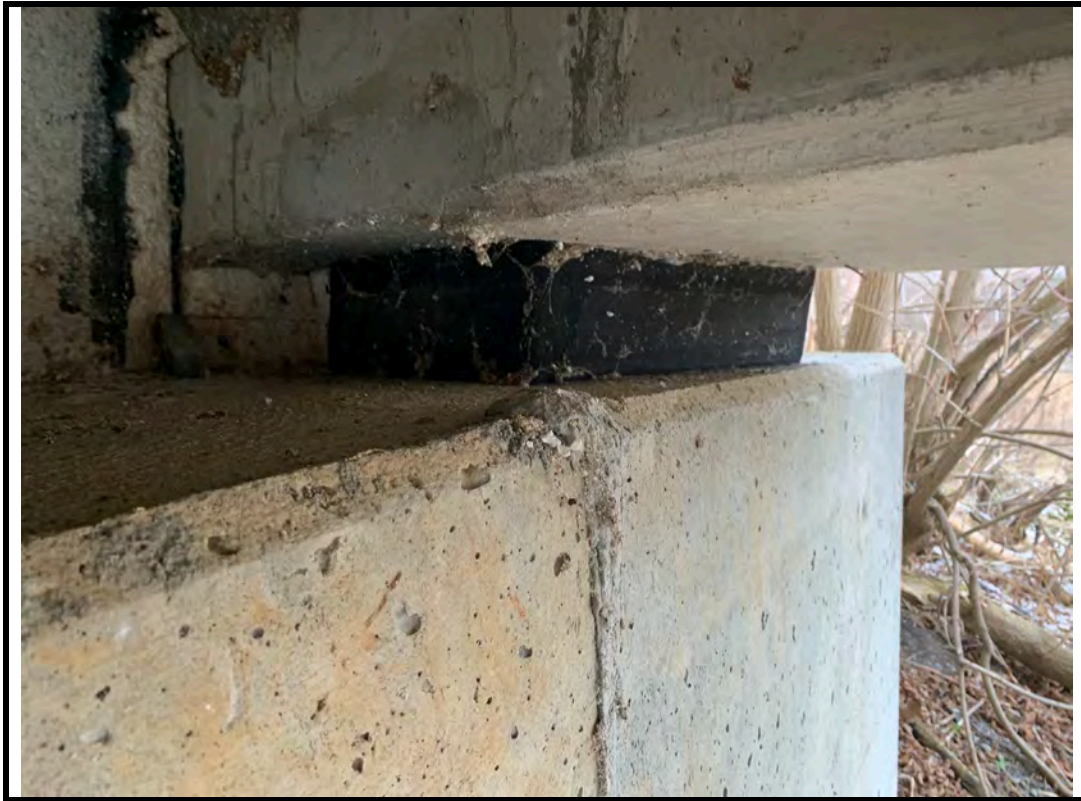
Photo 17 Bearing at northwest corner of structure

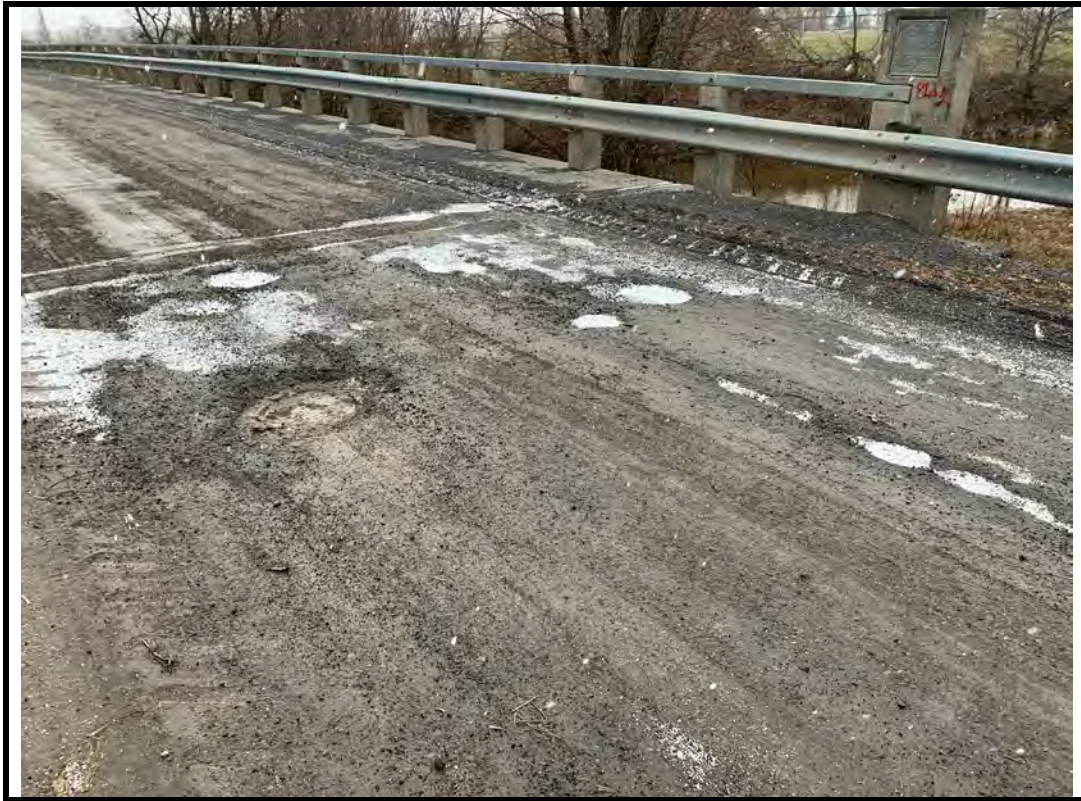
Photo 7 Settlement and large potholes on north wearing surface

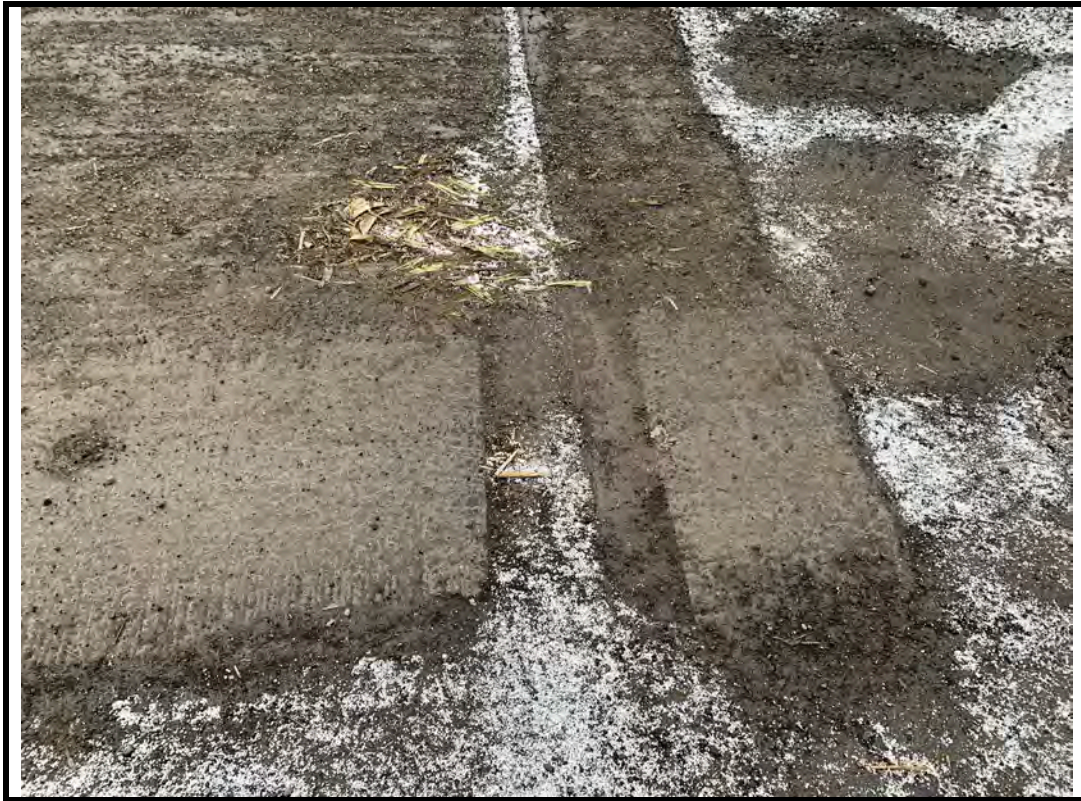
Photo 9 North expansion joint covered by debris
