THE TOWNSHIP OF NORTH DUNDAS

DRAFT BRIDGE MANAGEMENT STUDY REPORT 18 BRIDGES / 31 CULVERTS

March 2023

HP Engineering Inc.

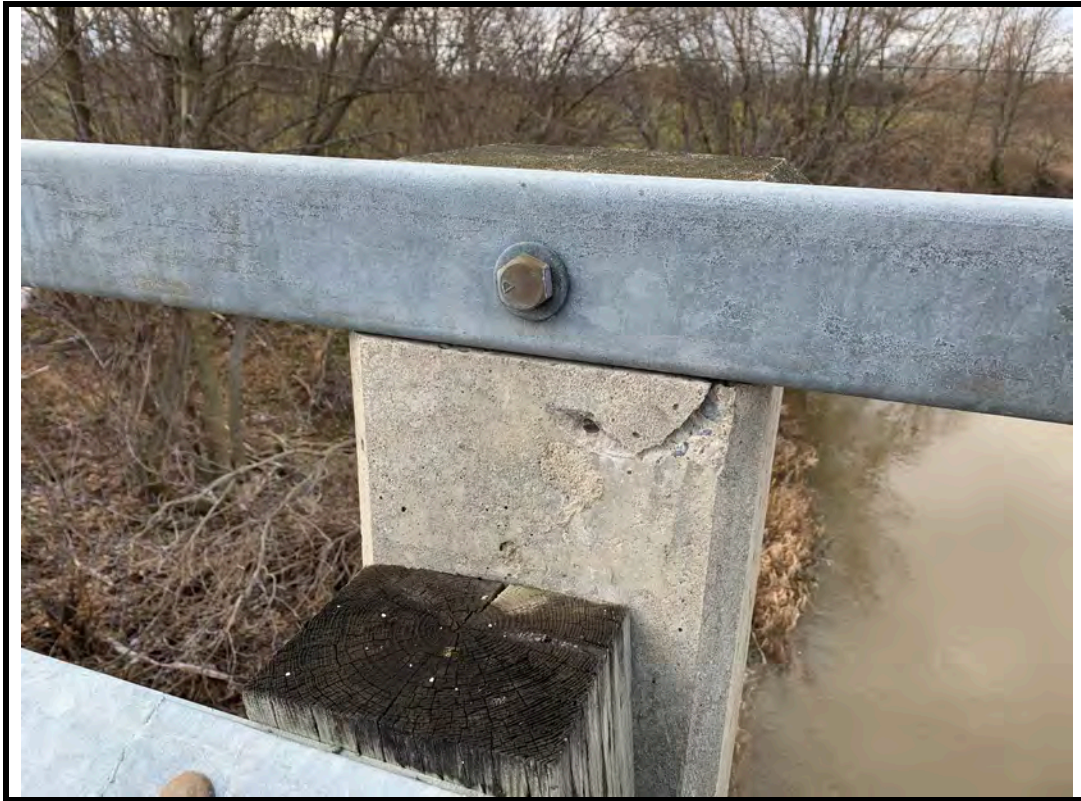
Photo 11 Small spall on concrete barrier post

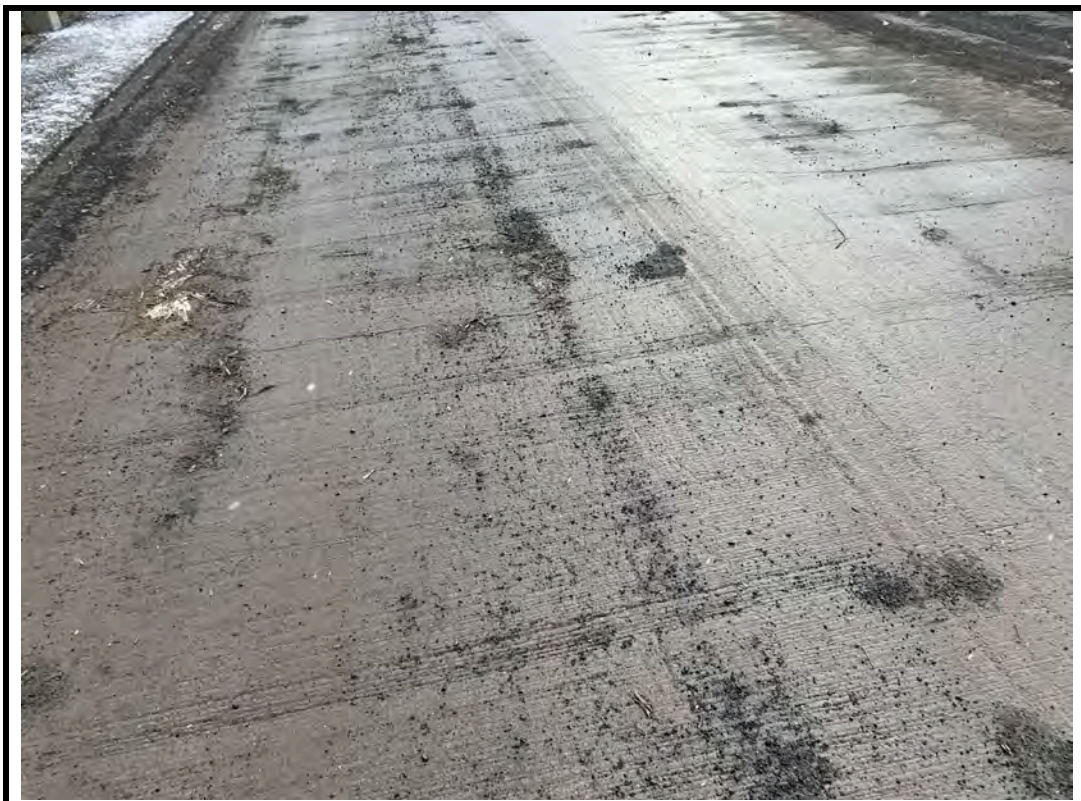
Photo 12 Wide transverse cracks and abrasions on deck top

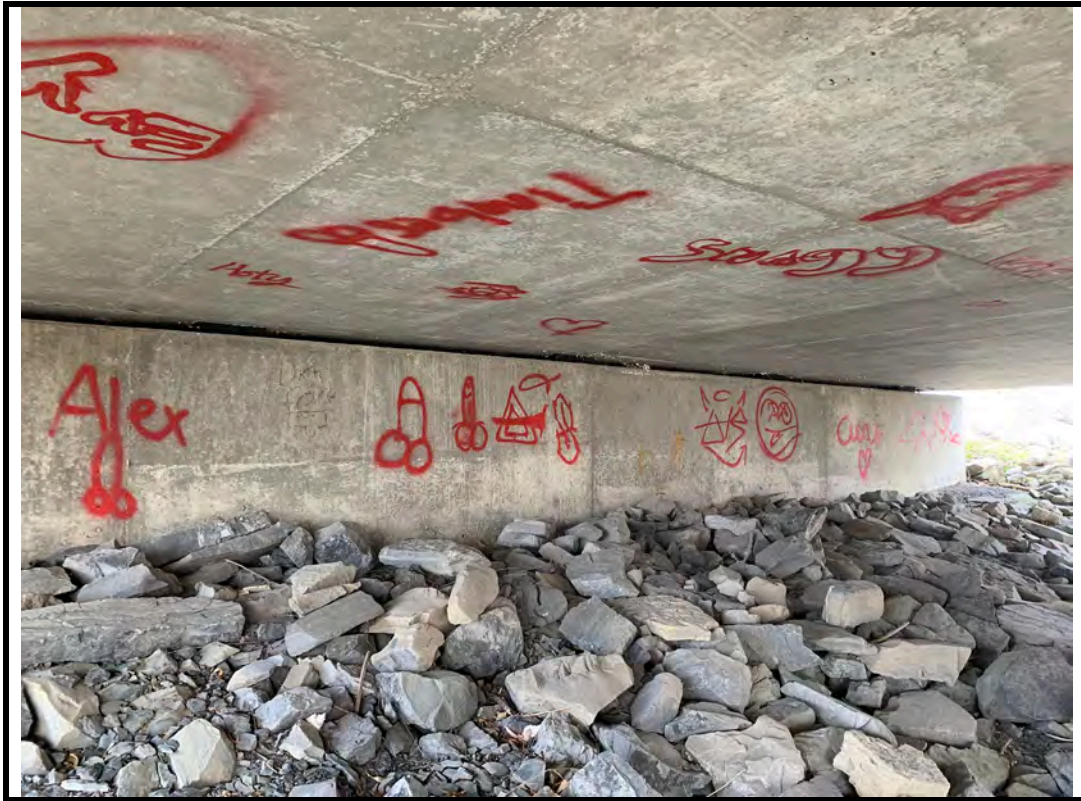
Photo 19 Graffiti on north underside of structure

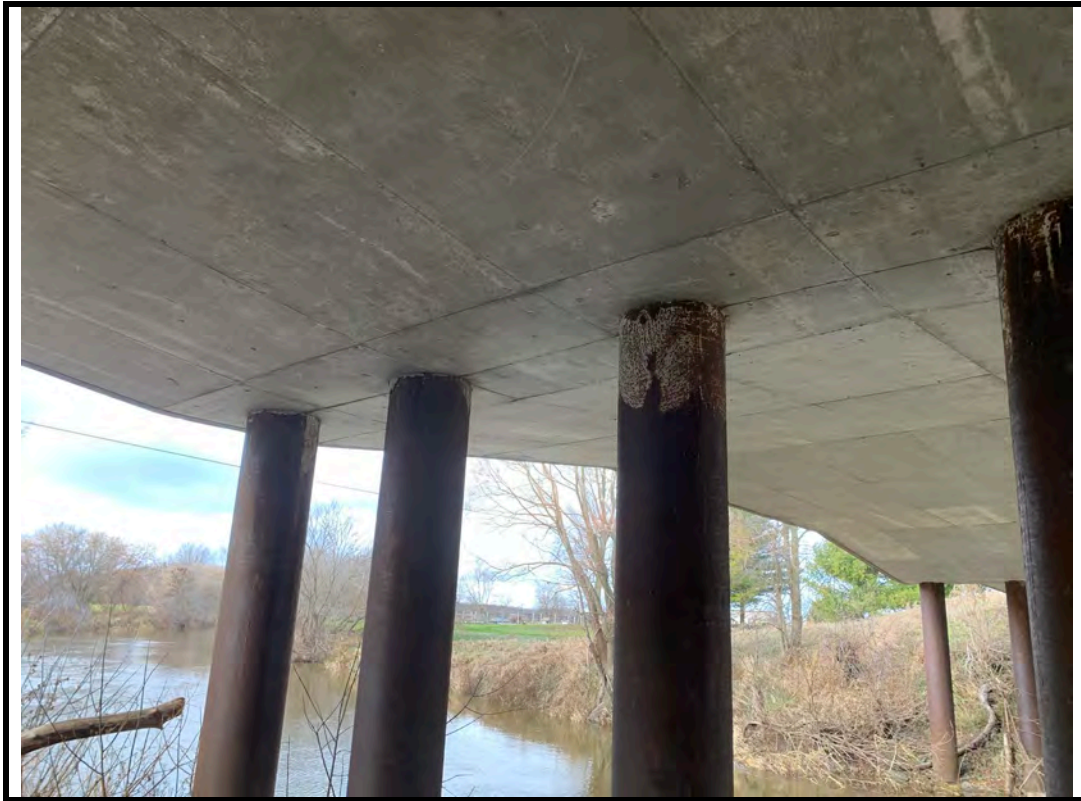
Photo 21 Staining on top of pier shafts

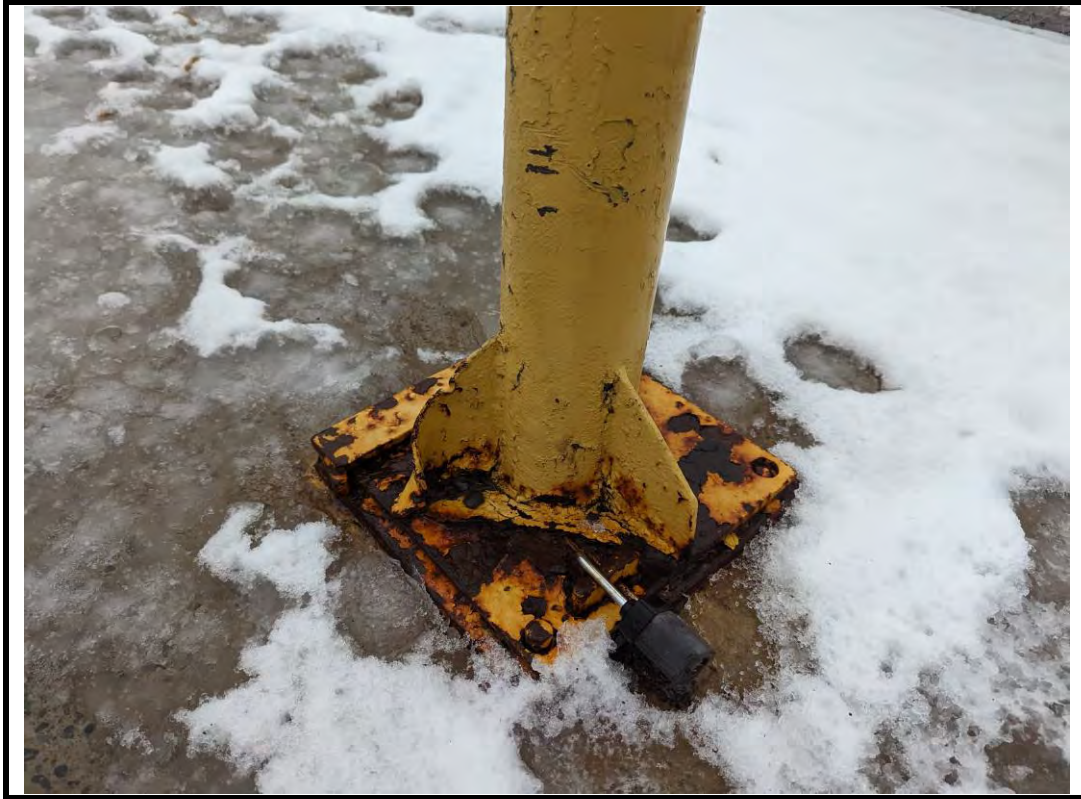
Photo 7 Corrosion and missing bolts at south bollard base (typical)

Element Group:	Accessories (Attachments and Signs)				Length:				
Element Name:	Other				Width:				
Location:	North and South side of Structure				Height:				
Material:	Steel				Count (items):	2			
Element Type:	Bollard				Total Quantity:	2.0 Each			
Environment:	Severe				Limited Inspection				
Protection System:	Coating				Perform. Deficiencies				
Condition Data:	Units	Exc.	Good	Fair					Poor*
	Each			2.0					
Comments:	Corrosion at baseplates with paint failure and missing bolts noted.								
Recommended Work:		Rehab		Replace	Maintenance Needs: 18				
		1-5 years		6-10 years		Urgent	X	1 year	2 years
					Replace missing bolts

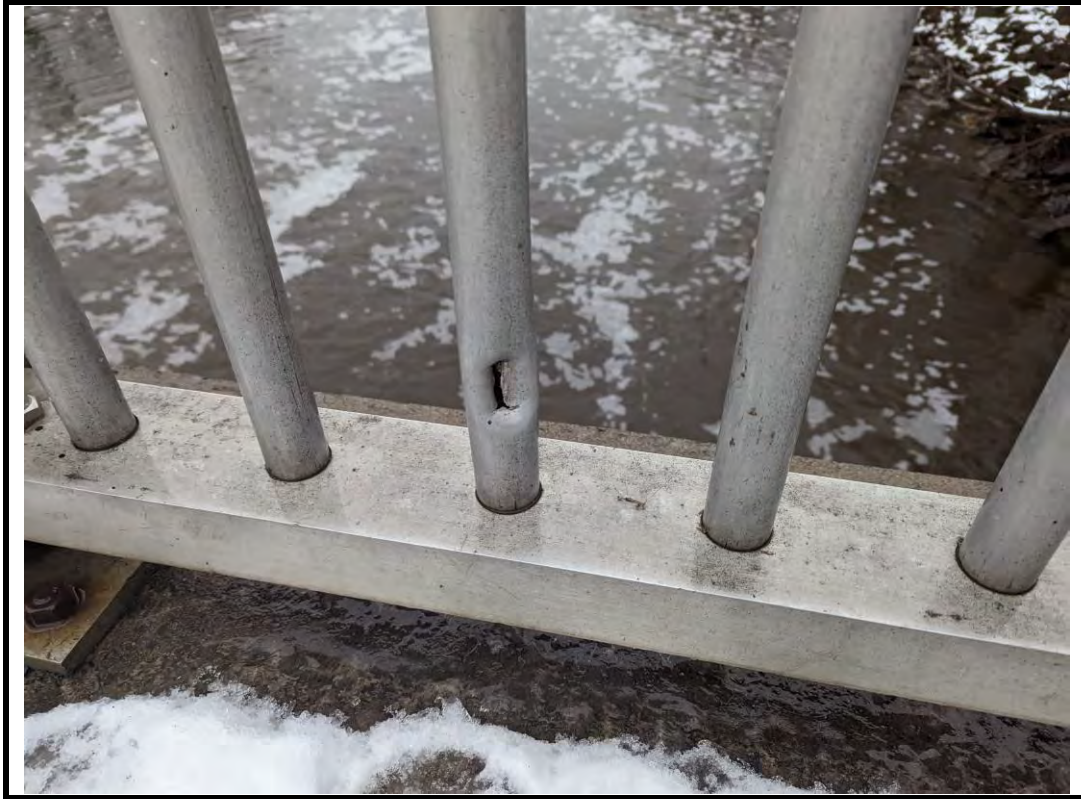
Photo 9 Perforation in deck barrier picket

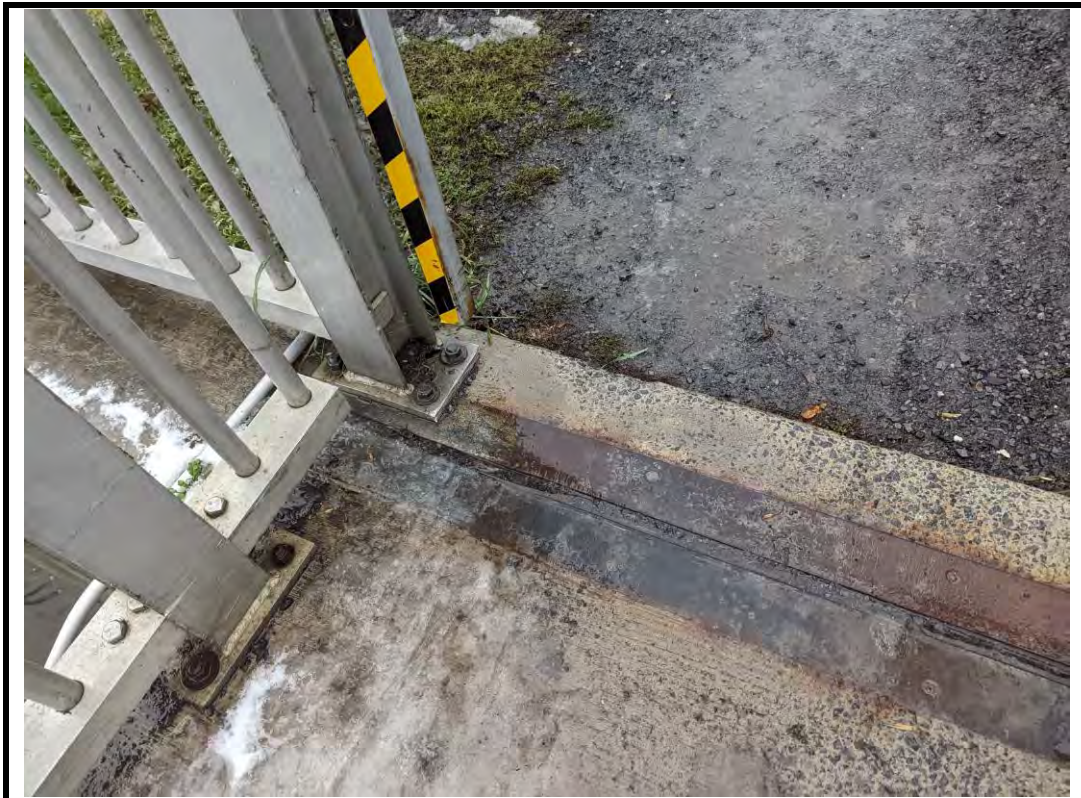
Photo 10 Corrosion and debris at South deck joint (typical)

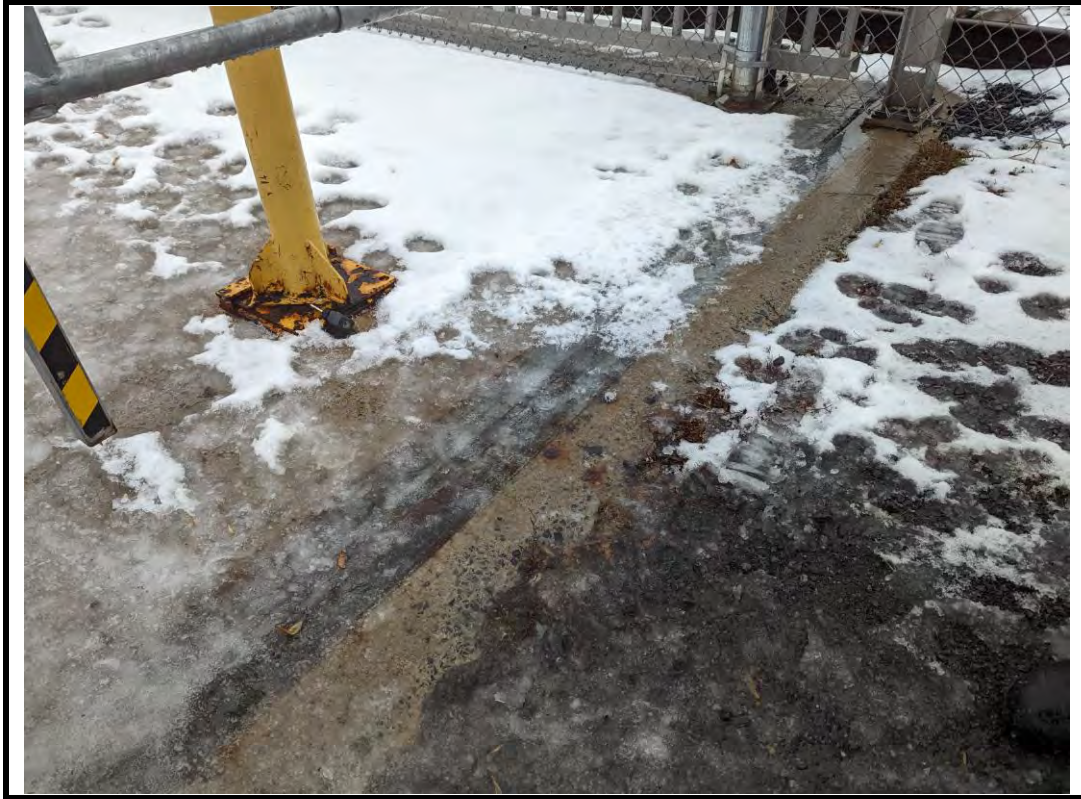
Photo 11 Abrasion at North end dam (Typical)

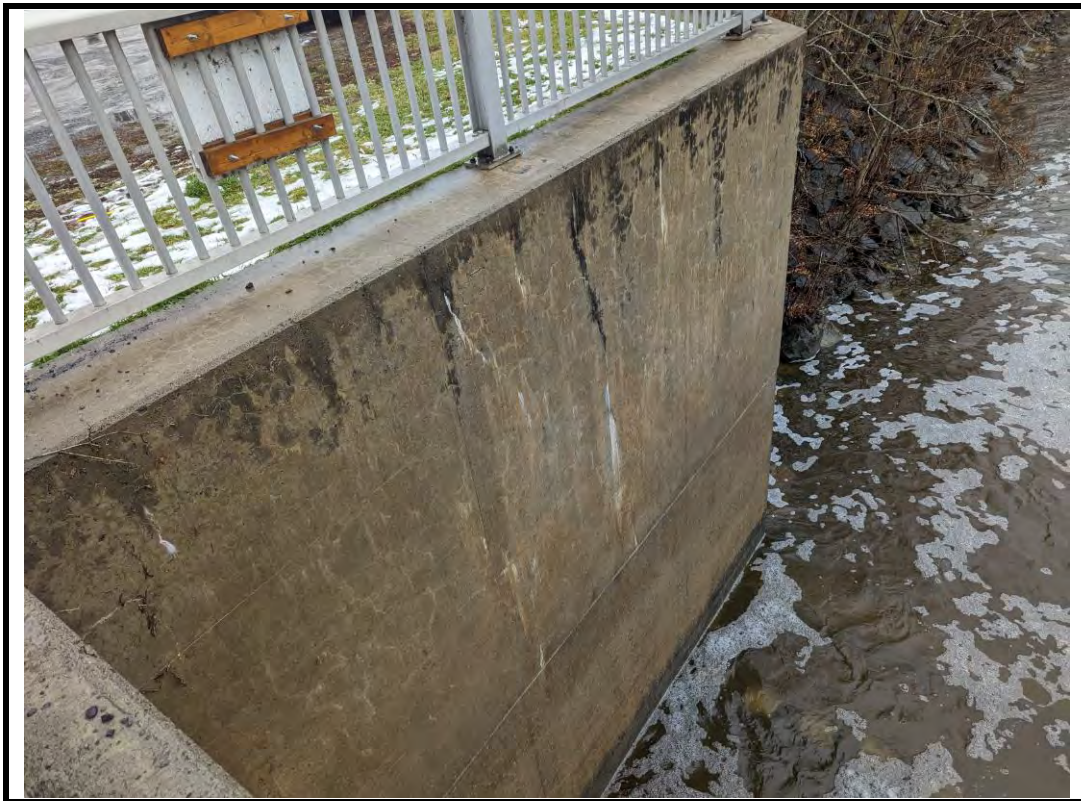
Photo 12 Map cracking on wingwalls (typical)

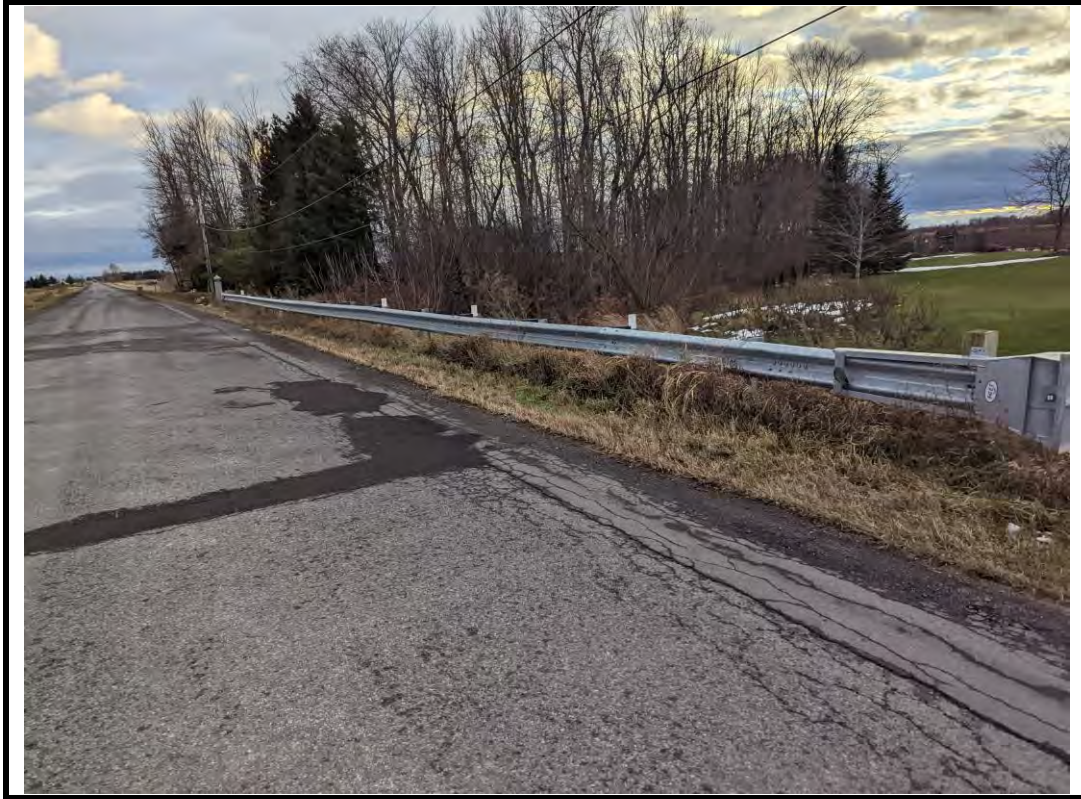
Photo 7 Longitudinal alligator cracks, with patches and raveling on wearing surface

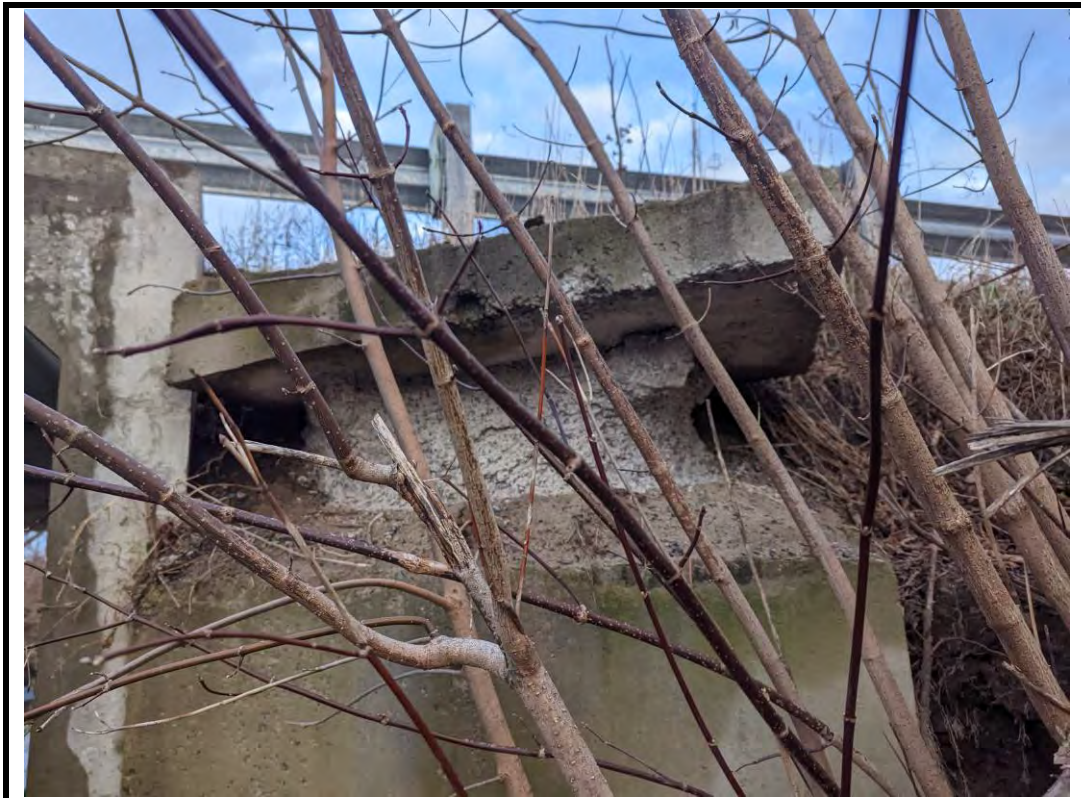
Photo 8 Severe disintegration at southwest retaining wall

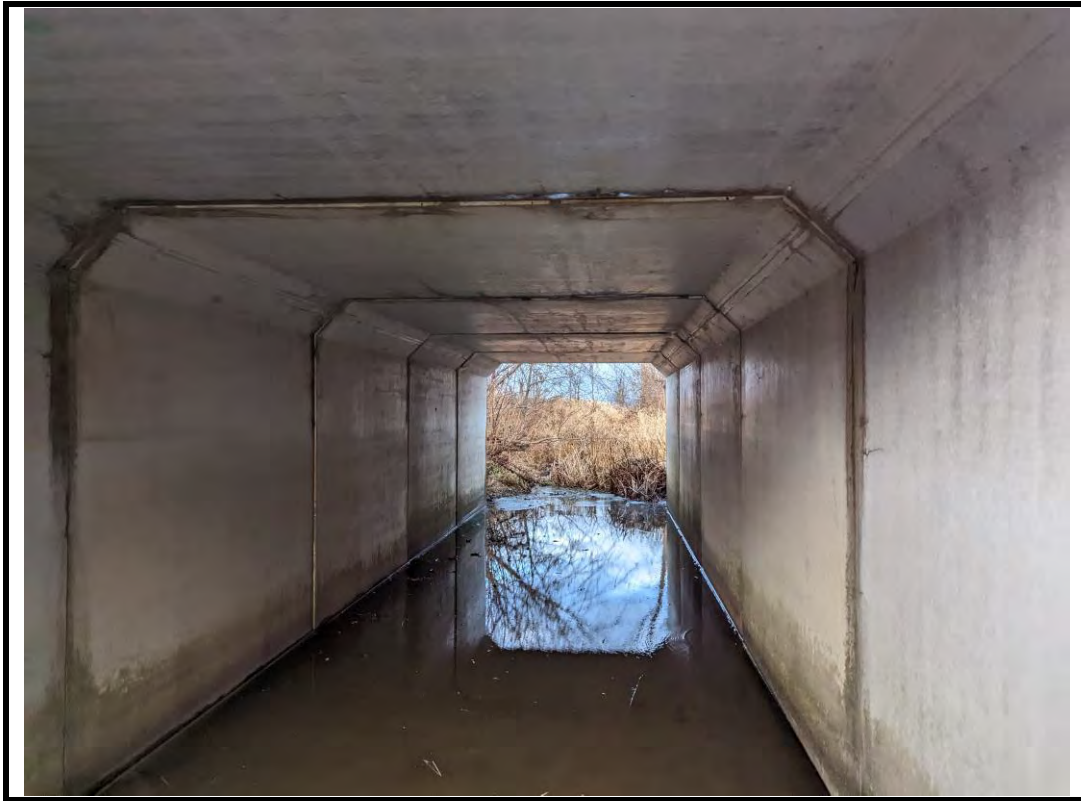
Photo 9 View through barrel and leaking at segment joints

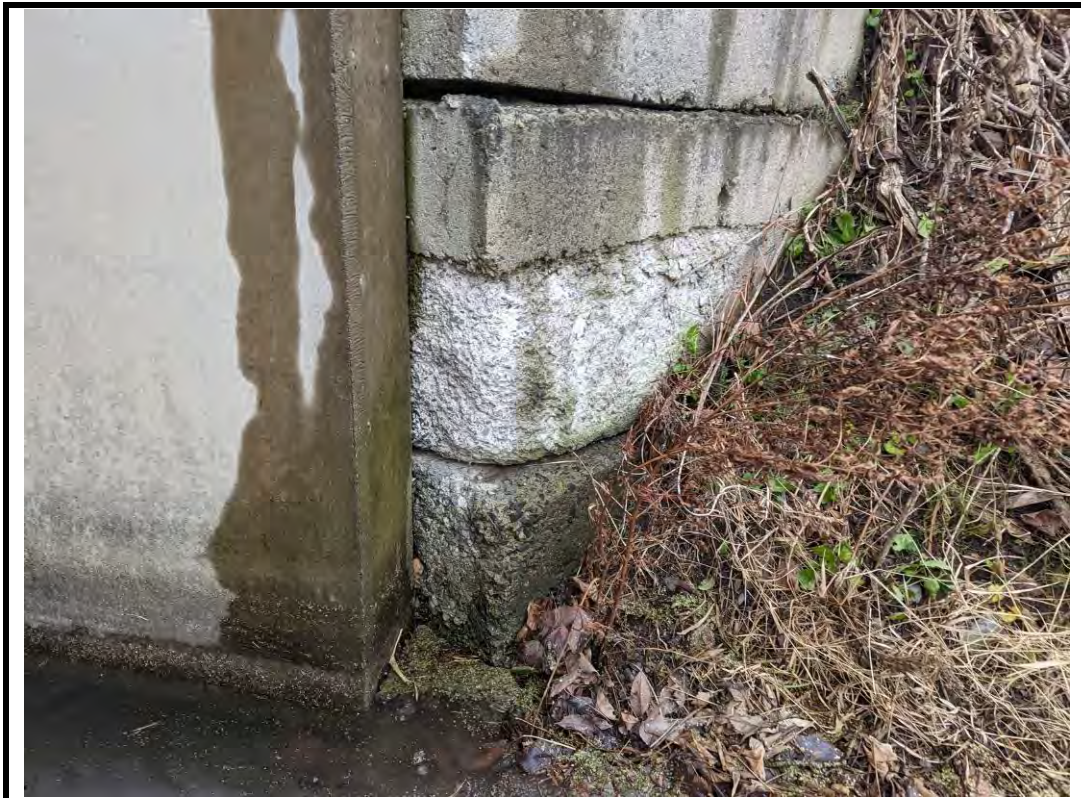
Photo 10 Scaling/disintegration on northeast retaining wall

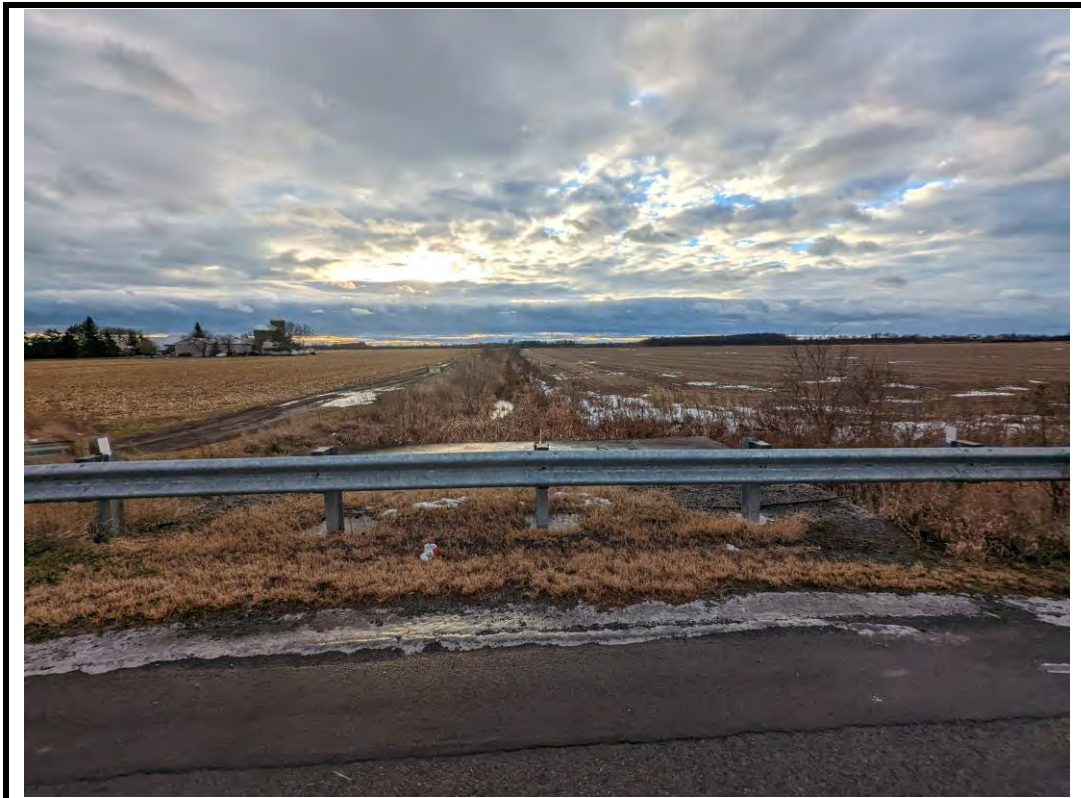
Photo 8 Ponding at barrier posts above structure

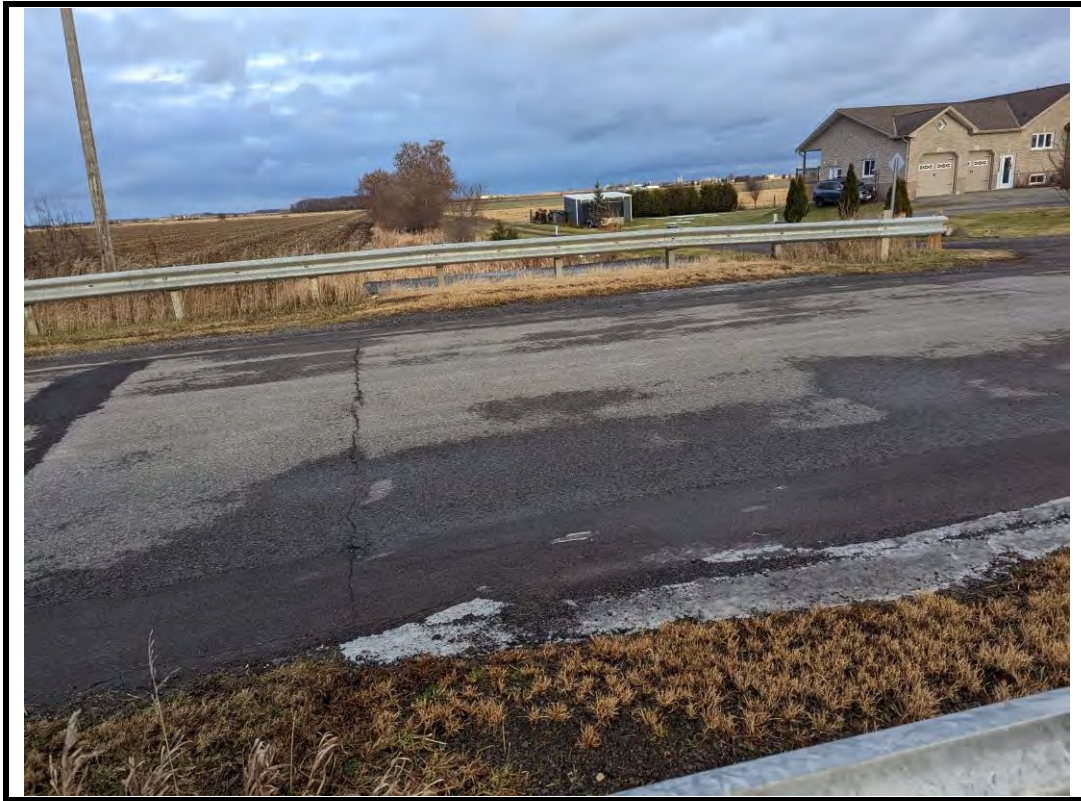
Photo 9 Wide transverse crack in wearing surface above structure with scaling and patches

Element Group:	Approaches	Length:	60
Element Name:	Wearing Surface	Width:	6
Location:	Over Culvert	Height:	
Material:	Asphalt	Count (items):	
Element Type:	Asphalt Wearing Surface	Total Quantity:	360.0 m2
Environment:	Severe	Limited Inspection	
Protection System:	None		
Condition Data:	Units m2	Exc.	Good 352.00
			Fair 4.00
			Poor* 4.00
Comments:	Wide transverse cracks, alligator cracks, and sealed cracks/patches noted on asphalt wearing surface, with some small-medium sized potholes.		
Recommended Work:	Rehab	Replace	Maintenance Needs: 15
	1-5 years	6-10 years	Urgent X 1 year 2 years
	Rout and seal asphalt wearing surface

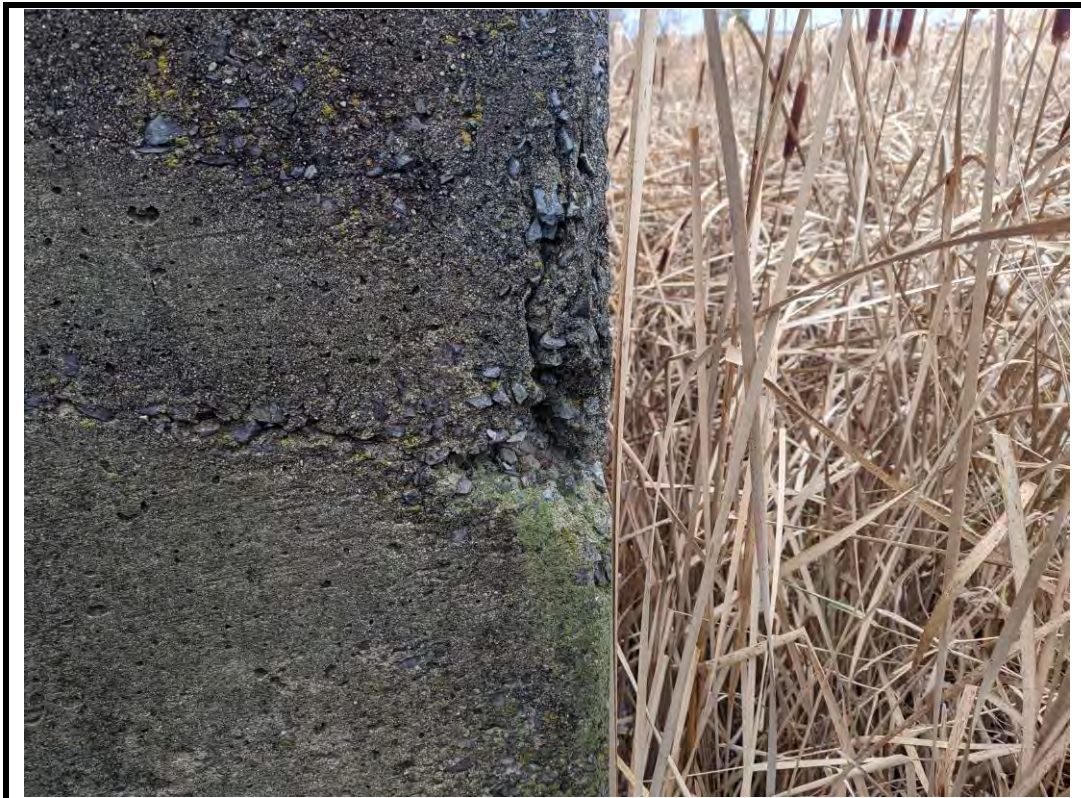
Photo 10 Spall/honeycombing at southeast of barrel

Element Group:	Culverts	Length:	19.5
Element Name:	Barrels	Width:	6.1
Location:	Below Roadway	Height:	2.8
Material:	Cast-in-place concrete	Count (items):	1
Element Type:	RC Rigid Frame Barrel (Open footing)	Total Quantity:	228.15 m2
Environment:	Benign	Limited Inspection	
Protection System:	None		
Condition Data:	Units m2	Exc.	Good 225.15
			Fair 1.50
			Poor* 1.50
Comments:	Honeycombing and localized spall present on both ends of barrel with light scaling throughout.		
Recommended Work:	Rehab	Replace	Maintenance Needs: 8
	1-5 years	6-10 years	Urgent x 1 year 2 years
Concrete repairs	Concrete repairs to barrel

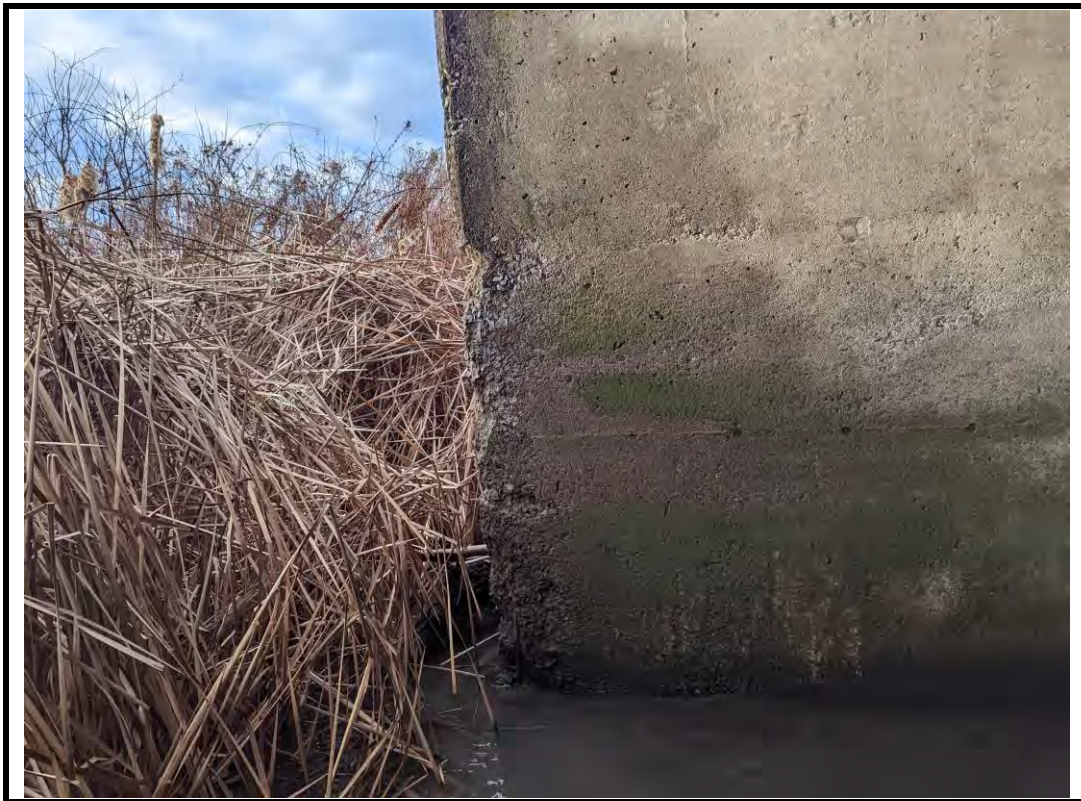
Photo 12 Spalls and honeycombing at the northwest of barrel.

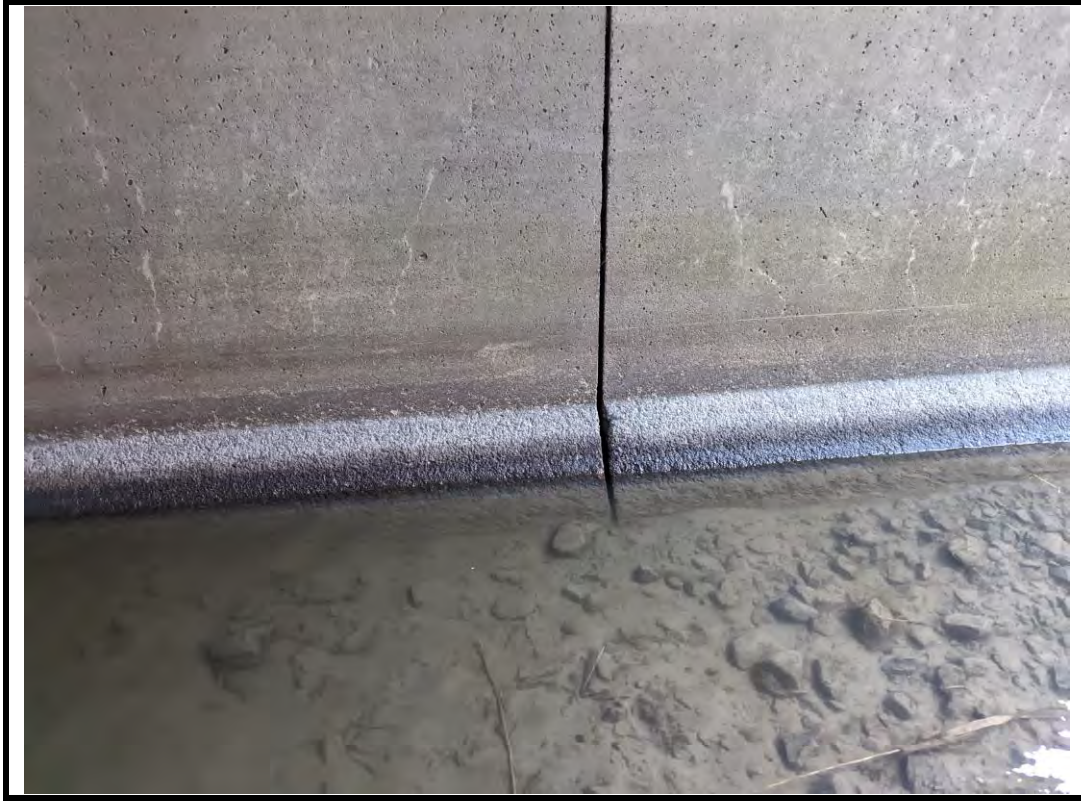
Photo 7 Light scaling along bottom haunches of culvert (typical)

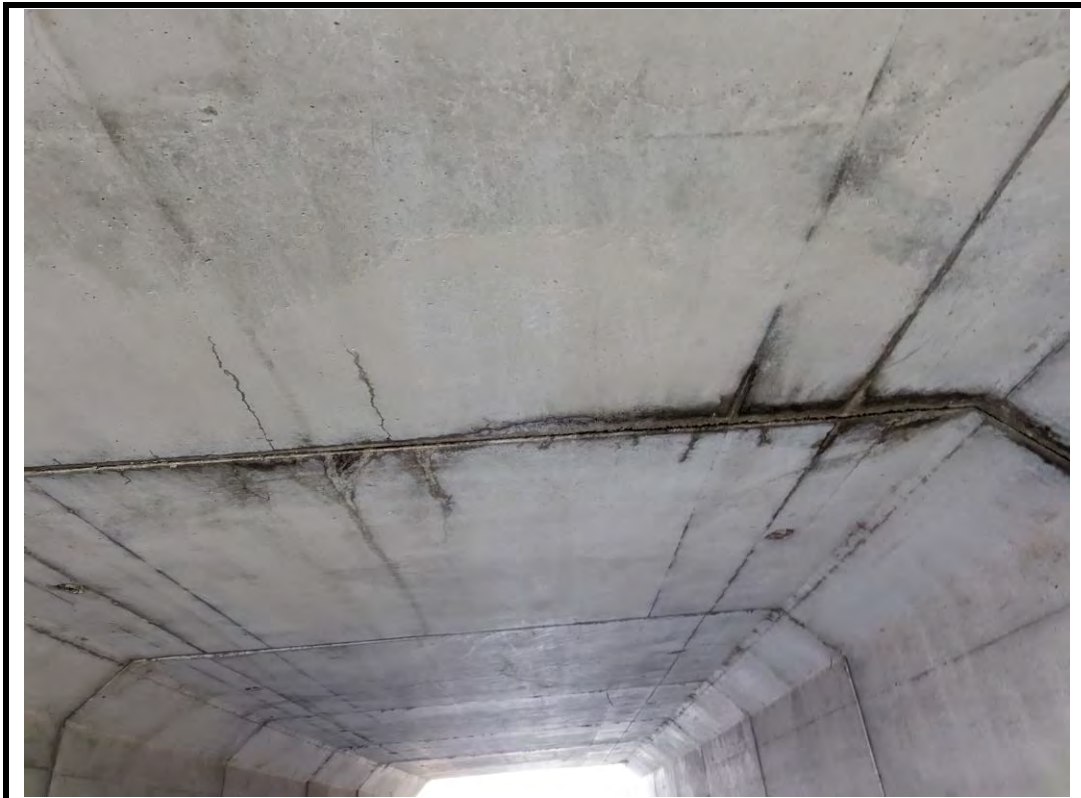
Photo 8 Leaking at second joint from the south

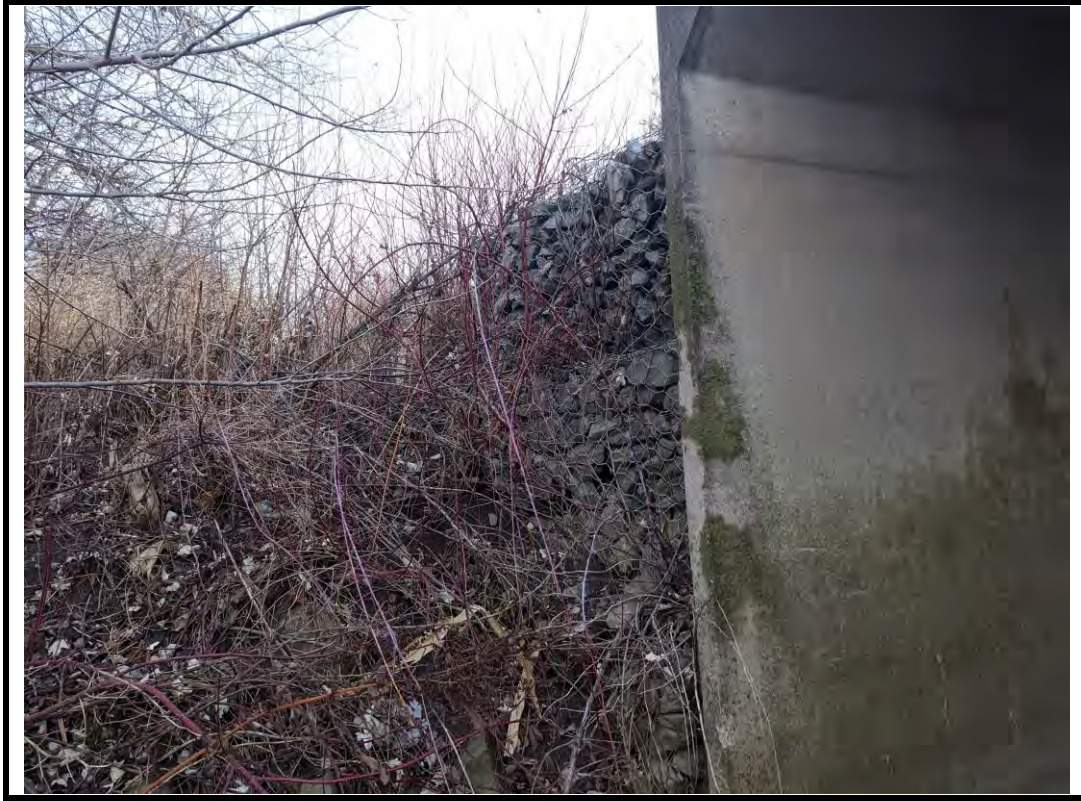
Photo 9 Light spalls on North end of culvert (typical throughout)

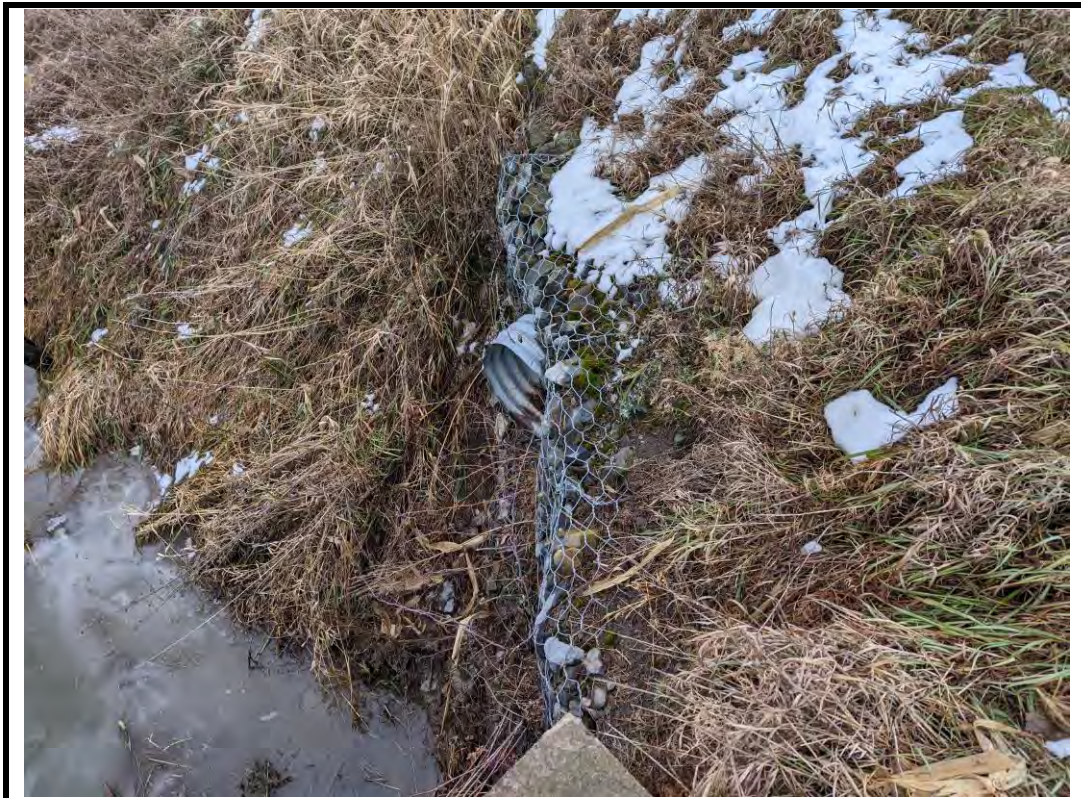
Photo 10 Southwest gabion wall leaning towards channel

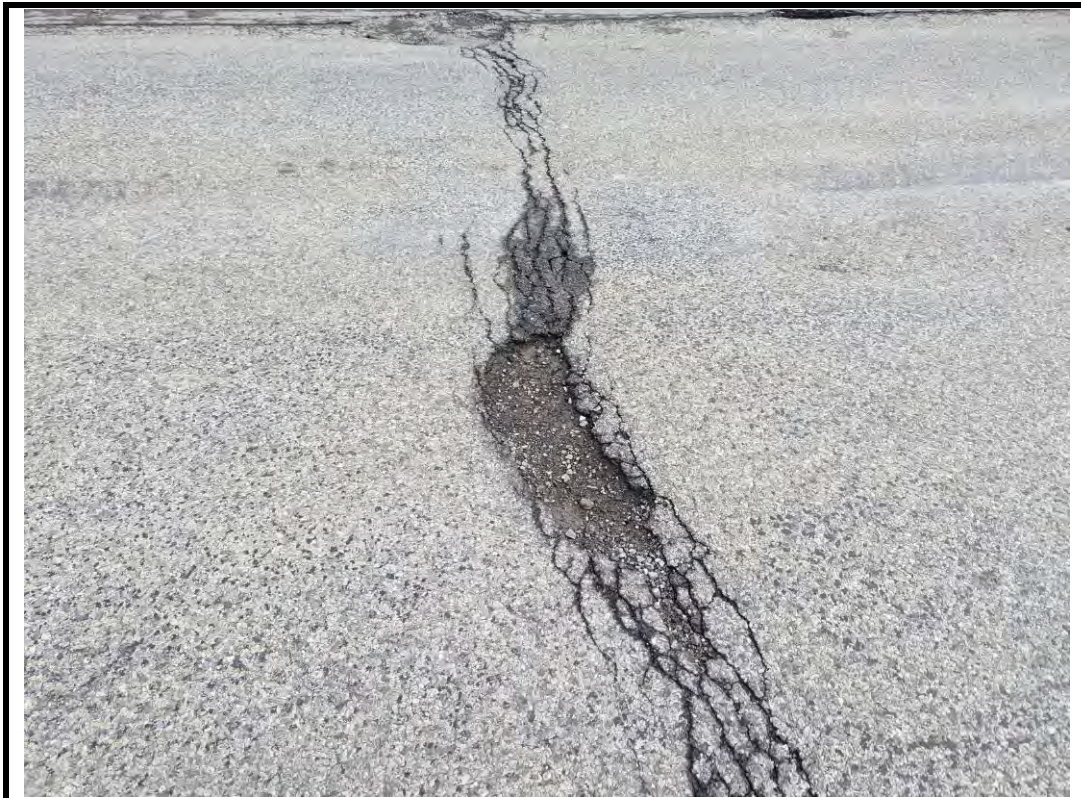
Photo 8 Medium pothole and transverse alligator cracks in approach wearing surface

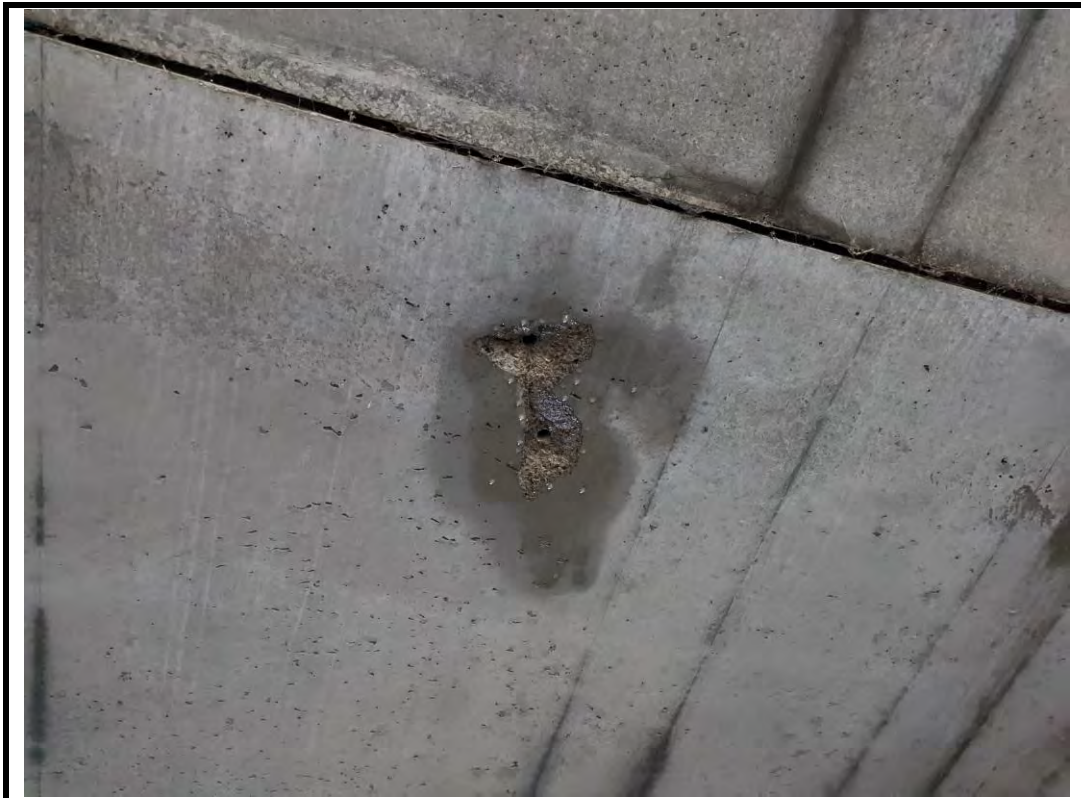
Photo 10 Spall with damp stain on north barrel soffit (typical)

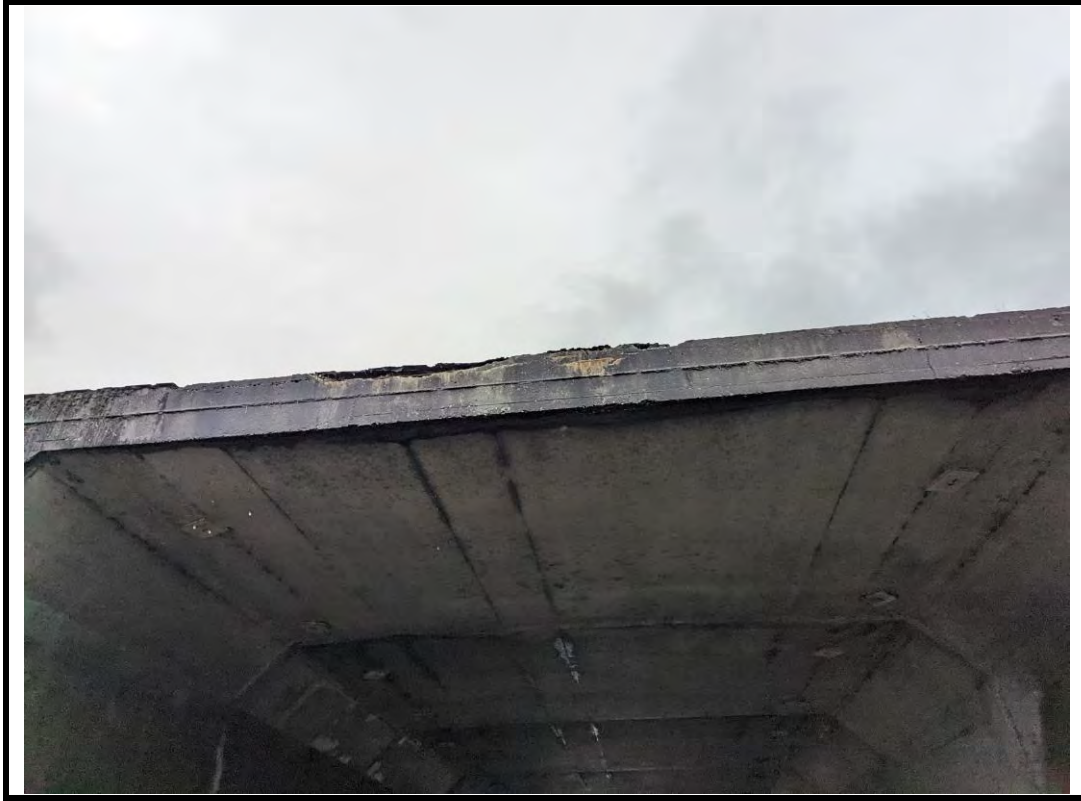
Photo 11 Spall with ECR at northeast barrel end

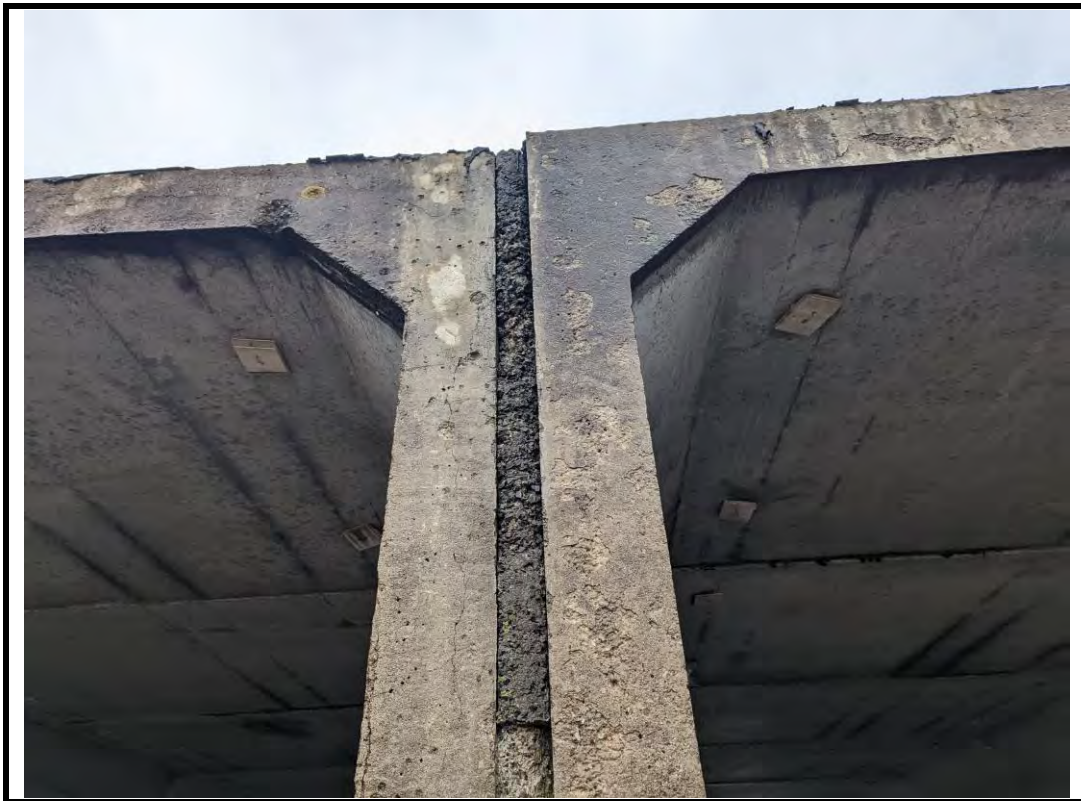
Photo 12 Scaling and cracks at west barrel ends (typical)
