THE TOWNSHIP OF NORTH DUNDAS

DRAFT BRIDGE MANAGEMENT STUDY REPORT 18 BRIDGES / 31 CULVERTS

March 2023

HP Engineering Inc.

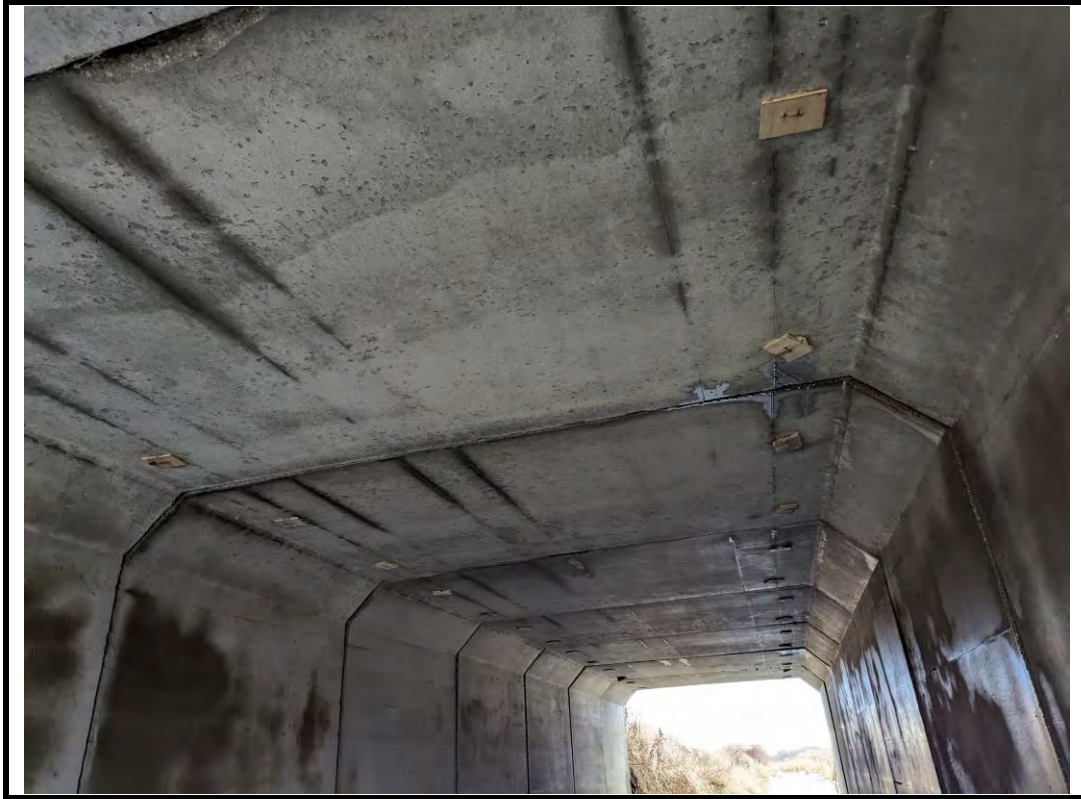
Photo 13 Leaking at second joint from East

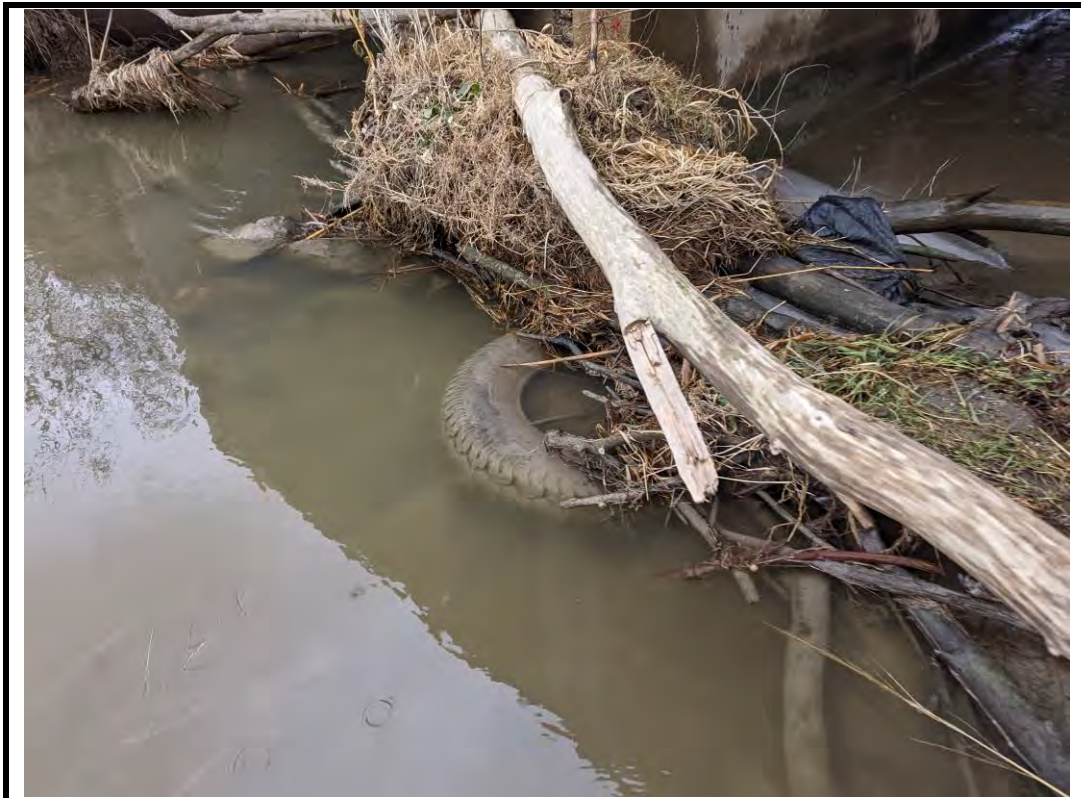
Photo 14 Heavy/Large obstructions at culvert inlet

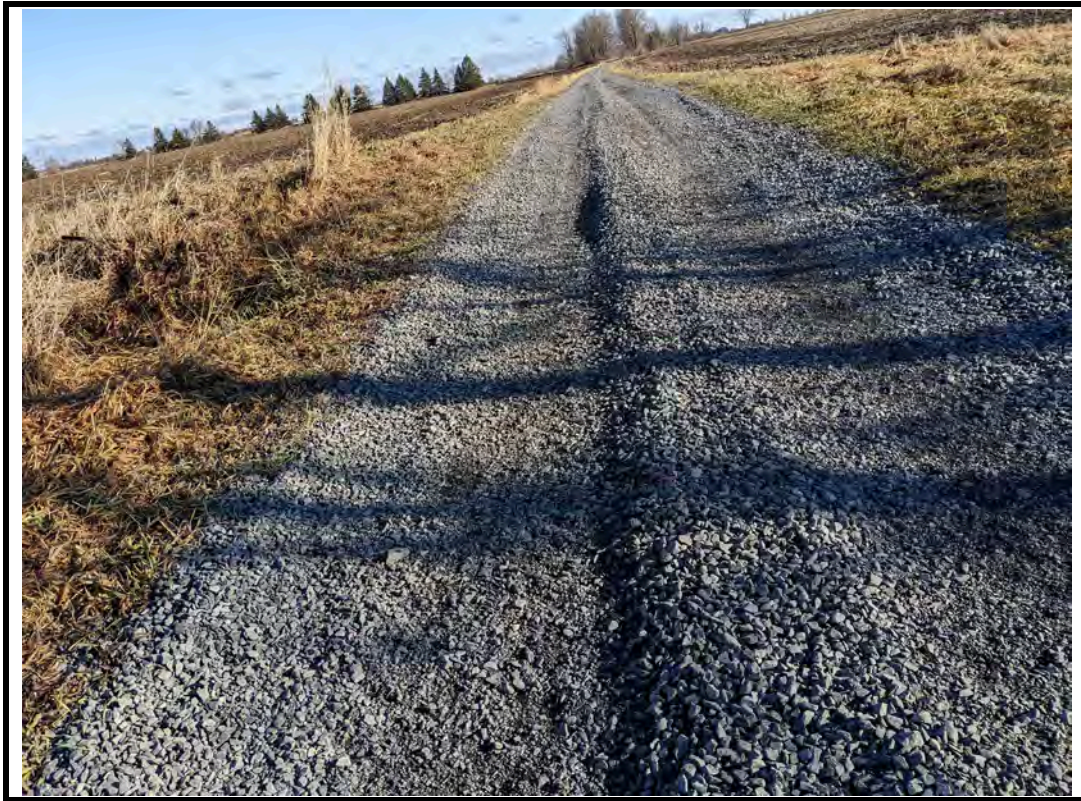
Photo 7 Severe settlement on east approach wearing surface

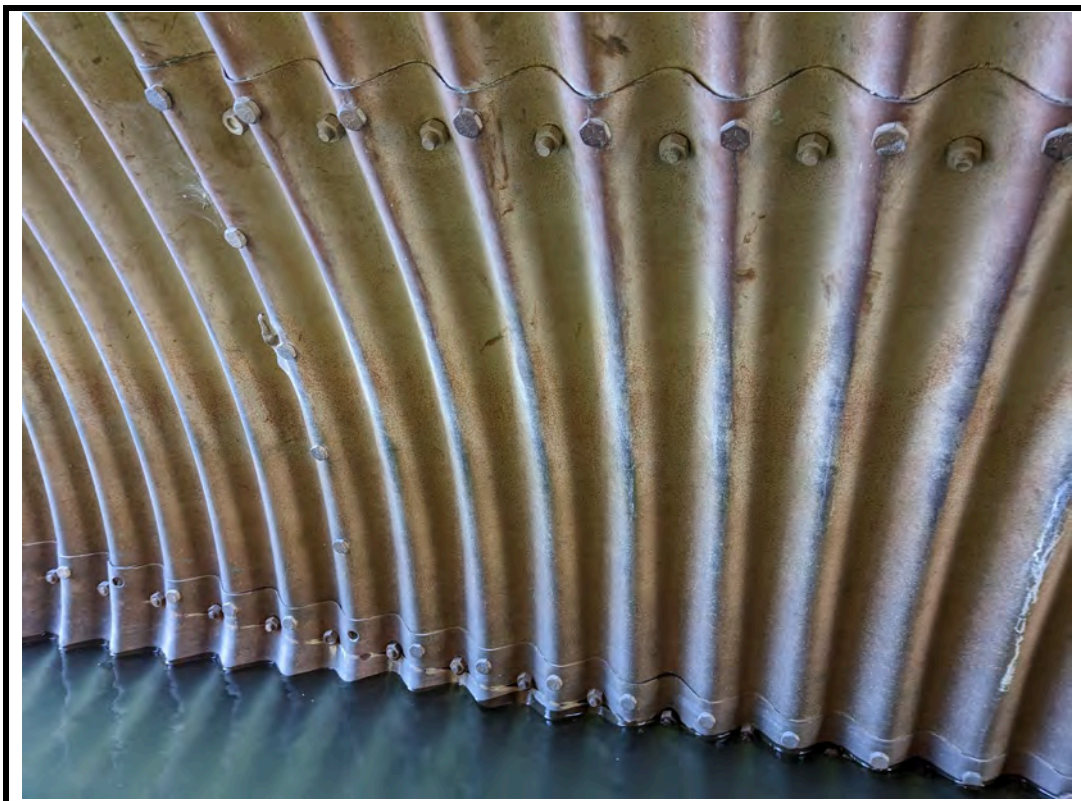
Photo 10 Cracks at bolt line at barrel wall

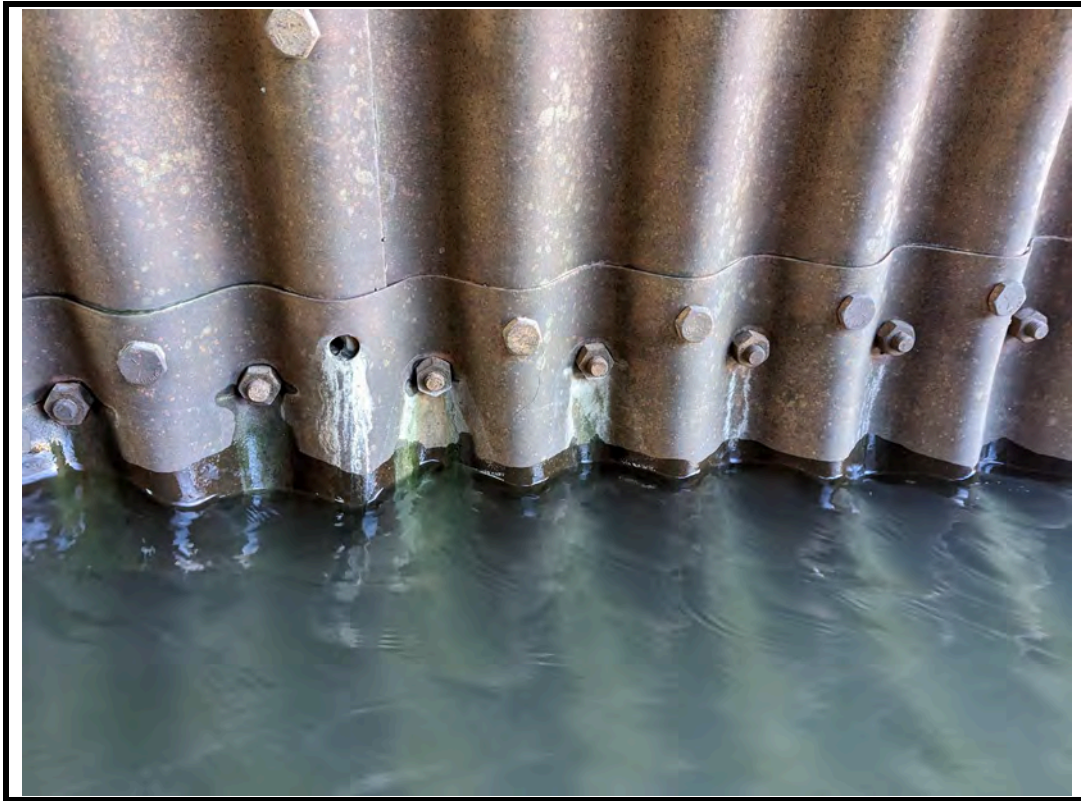
Photo 11 Evidence of leakage and efflorescence at bolt line on west barrel wall

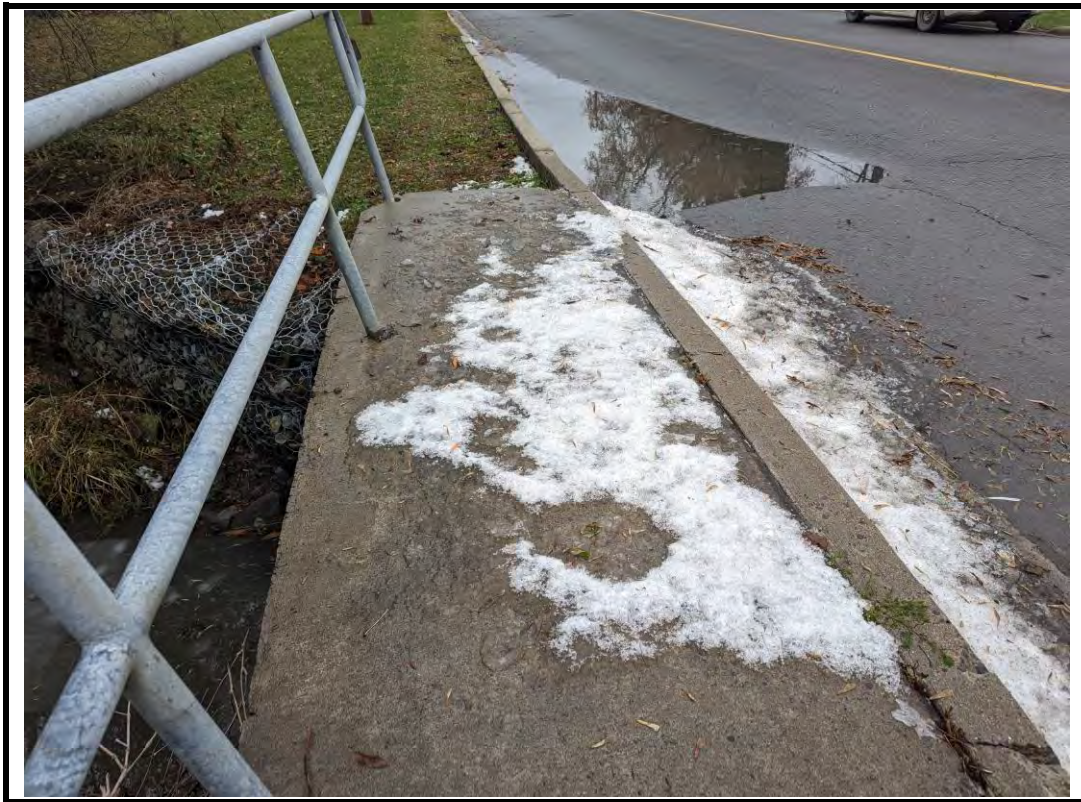
Element Group:	Barriers	Length:	5
Element Name:	Railing Systems	Width:	
Location:	North & South side of structure	Height:	
Material:	Steel	Count (items):	2
Element Type:	Steel railing	Total Quantity:	10 m
Environment:	Severe	Limited Inspection	
Protection System:	None		
Condition Data:	Units m	Exc.	Good 5.00
			Fair 5.00
			Poor*
Comments:	Generally in good to fair condition - North barrier is leaning outwards. No approach barriers present - A code compliant barrier and end-treatments should be installed above structure.		
Recommended Work:	Rehab	Replace	Maintenance Needs:
	1-5 years	6-10 years	Urgent 1 year 2 years

Photo 7 North barrier railing leaning outwards

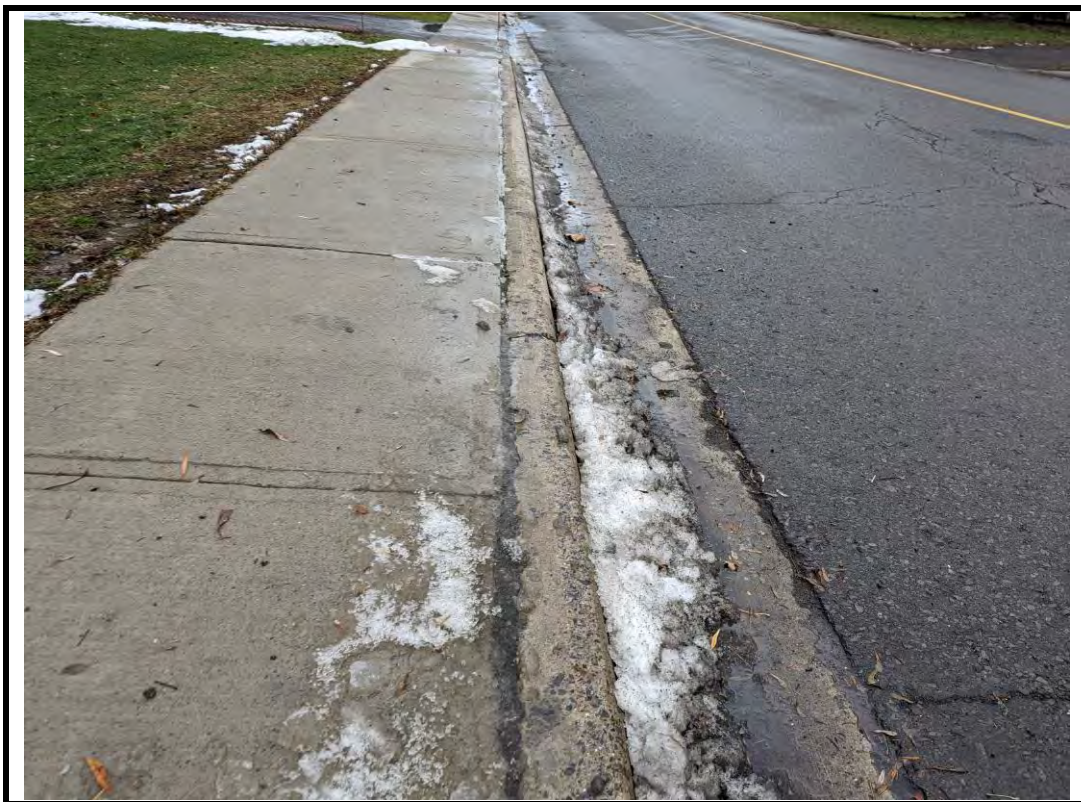
Element Group:	Approached	Length:	12
Element Name:	Curb and Gutters	Width:	
Location:	North and South sides of structure	Height:	
Material:	Cast-in-place concrete	Count (items):	2
Element Type:	Curb and Gutters	Total Quantity:	24 m
Environment:	Severe	Limited Inspection	
Protection System:	None		
Condition Data:	Units m	Exc.	Good 21.00
			Fair 2.00
			Poor* 1.00
Comments:	Medium scaling and wide cracks noted throughout.		
Recommended Work:	Rehab	Replace	Maintenance Needs:
	1-5 years	6-10 years	Urgent 1 year 2 years

Photo 8 Scaling and cracks on southwest approach curb and gutter (typical)

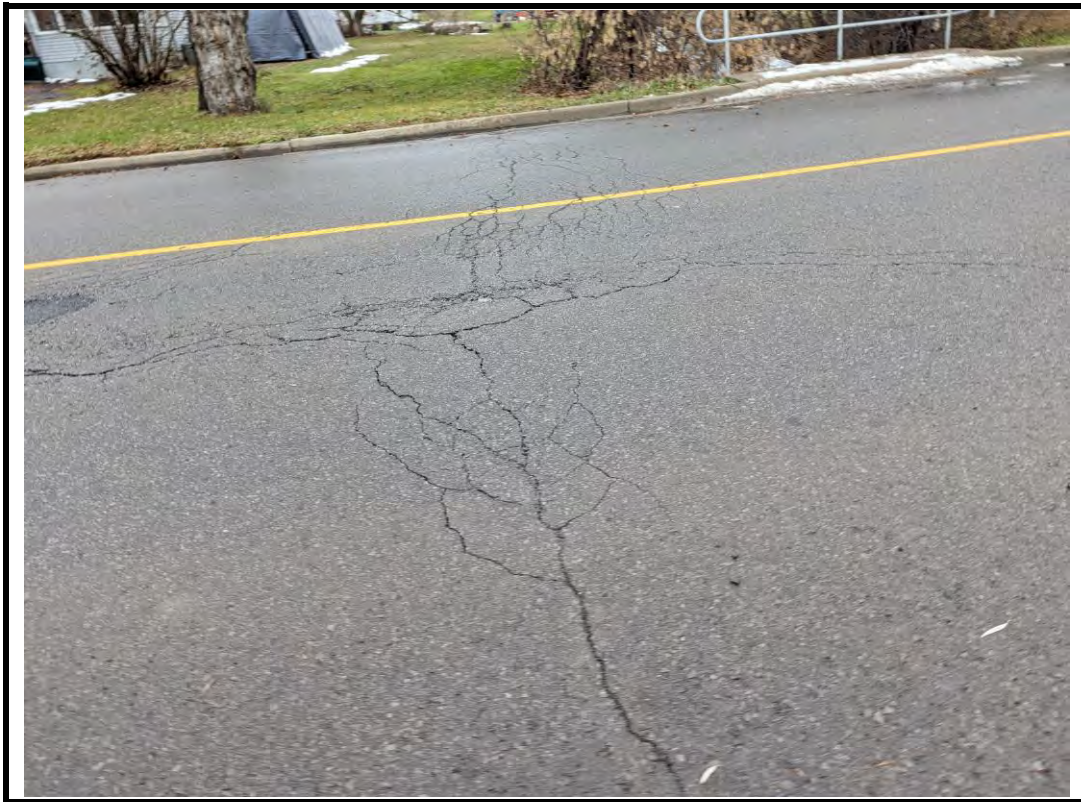
Element Group:	Approaches	Length:	60
Element Name:	Wearing Surface	Width:	9.8
Location:	Over Culvert	Height:	
Material:	Asphalt	Count (items):	
Element Type:	Asphalt Wearing Surface	Total Quantity:	588.0 m2
Environment:	Severe	Limited Inspection	
Protection System:	None		
Condition Data:	Units m2	Exc.	Good 579.18
			Fair 5.88
			Poor* 2.95
Comments:	Wide map cracking was noted above the structure, with ponding observed at the north above the structure		
Recommended Work:	Rehab	Replace	Maintenance Needs: 15
	1-5 years	6-10 years	Urgent X 1 year 2 years
	Rout and seal asphalt wearing surface

Photo 9 Map cracking on west approach wearing surface

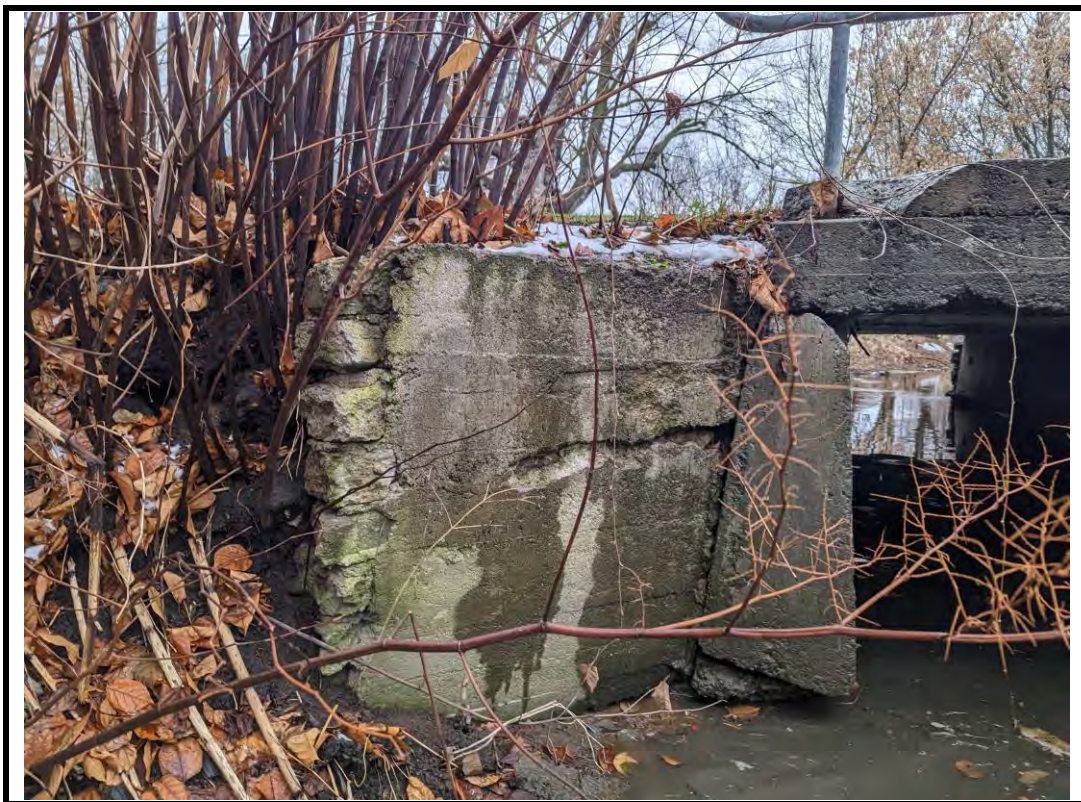
Element Group:	Culvert	Length:							
Element Name:	Inlet Components	Width:							
Location:	Southwest side of structure	Height:							
Material:	Cast-in-place Concrete	Count (items):							
Element Type:	Reinforced concrete wingwalls	Total Quantity:	4.80	m2					
Environment:	Moderate	Limited Inspection							
Protection System:	None								Perform. Deficiencies
Condition Data:	Units m2	Exc.	Good 3.20	Fair 1.20	Poor*	0.40			
Comments:	Medium erosion/degradation and spalls noted throughout.								
Recommended Work:	X	Rehab		Replace	Maintenance Needs:				
	X	1-5 years		6-10 years		Urgent		1 year	2 years
Concrete repairs

Photo 10 Scaling, degradation, and spalls on SW concrete retaining wall

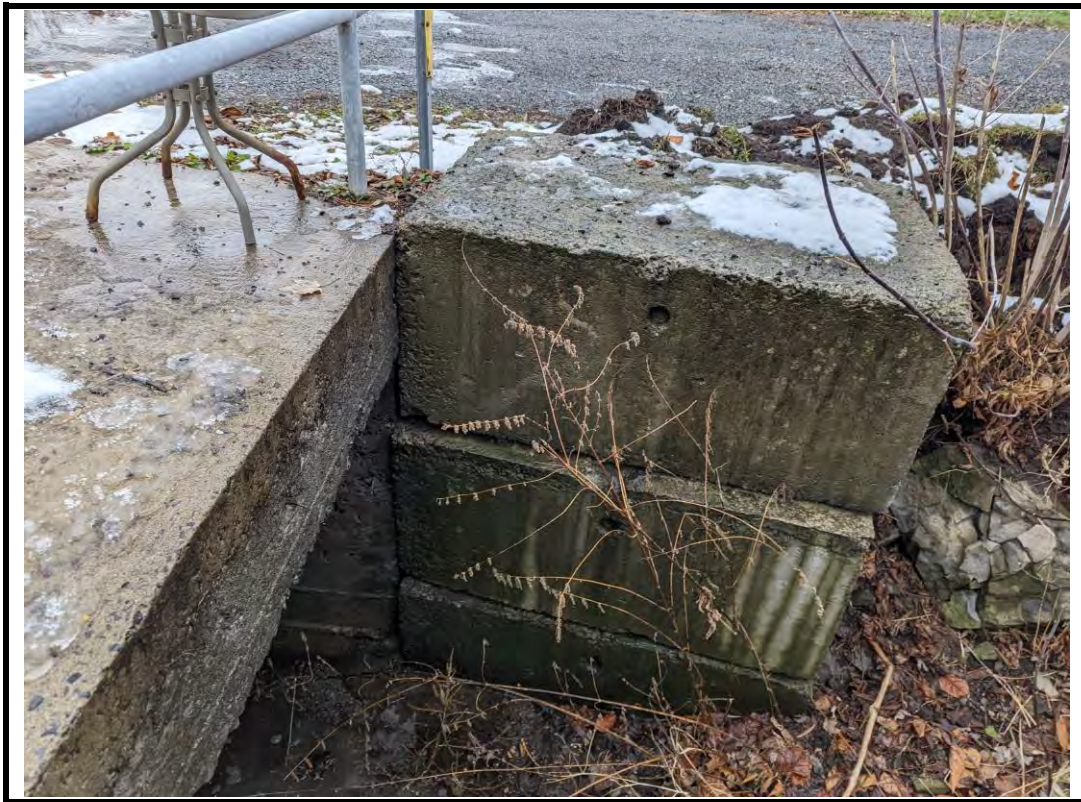
Element Group:	Culverts	Length:							
Element Name:	Inlet Components	Width:							
Location:	Southeast Side of Structure	Height:							
Material:	Precast Concrete	Count (items):							
Element Type:	Stacked Concrete Block Retaining Wall	Total Quantity:	20.00	m2					
Environment:	Moderate	Limited Inspection							
Protection System:	None								Perform. Deficiencies
Condition Data:	Units m2	Exc.	Good 2.40	Fair 1.40	Poor*	0.2			
Comments:	Light to medium erosion/degradation and moderate scaling noted								
Recommended Work:	X	Rehab		Replace	Maintenance Needs:				
	X	1-5 years		6-10 years		Urgent		1 year	2 years
Concrete repairs

Photo 11 Scaling on SE concrete block retaining wall

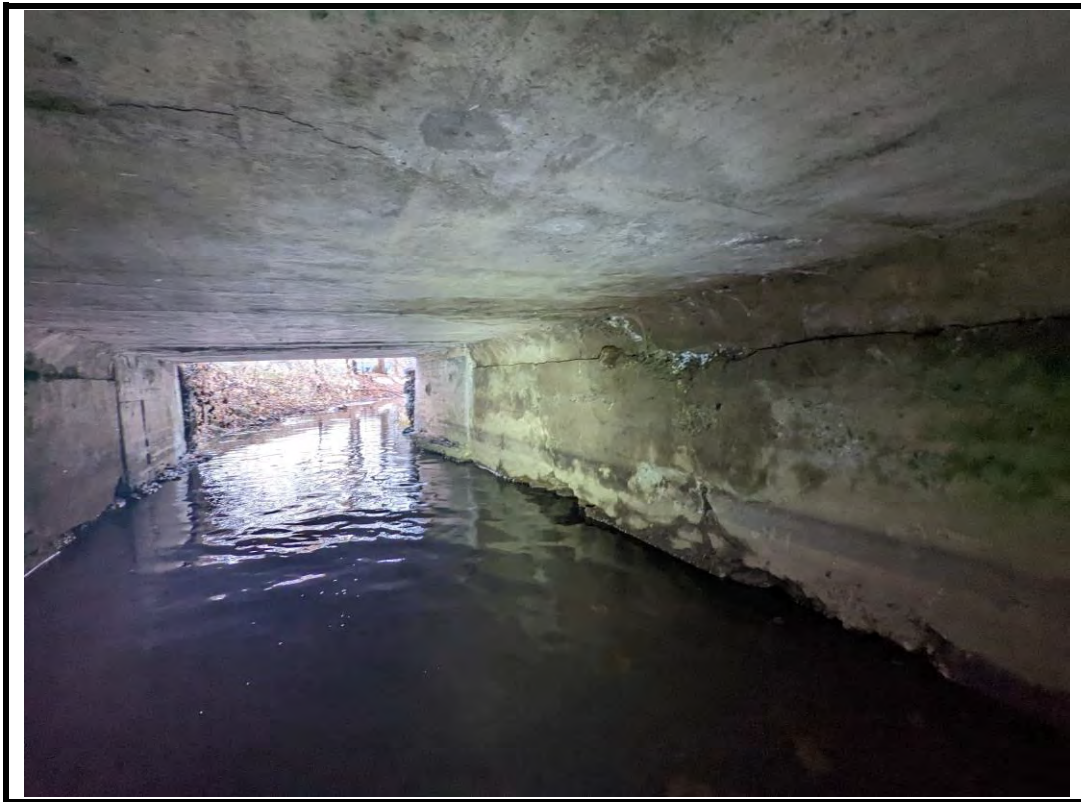
Element Group:	Culverts	Length:	15.3						
Element Name:	Barrels	Width:	3.1						
Location:	Below Roadway	Height:	1.5						
Material:	Cast-in-place concrete	Count (items):	1						
Element Type:	Concrete Rigid Frame (Open footing)	Total Quantity:	93.33	m2					
Environment:	Benign	Limited Inspection							
Protection System:	None								Perform. Deficiencies
Condition Data:	Units m2	Exc.	Good 58.33	Fair 24.00	Poor*	11.00			
Comments:	Severe scaling, spalling, and scour noted throughout the culvert barrel. Severe localized scour noted at the southwest barrel wall near inlet retaining wall. Rust and corrosion stains noted at and around steel in barrel soffit.								
Recommended Work:	X	Rehab		Replace	Maintenance Needs:				
	X	1-5 years		6-10 years		Urgent		1 year	2 years
Concrete repairs

Photo 13 Cracks, scaling, spalls, staining, and scour throughout culvert (typ.)

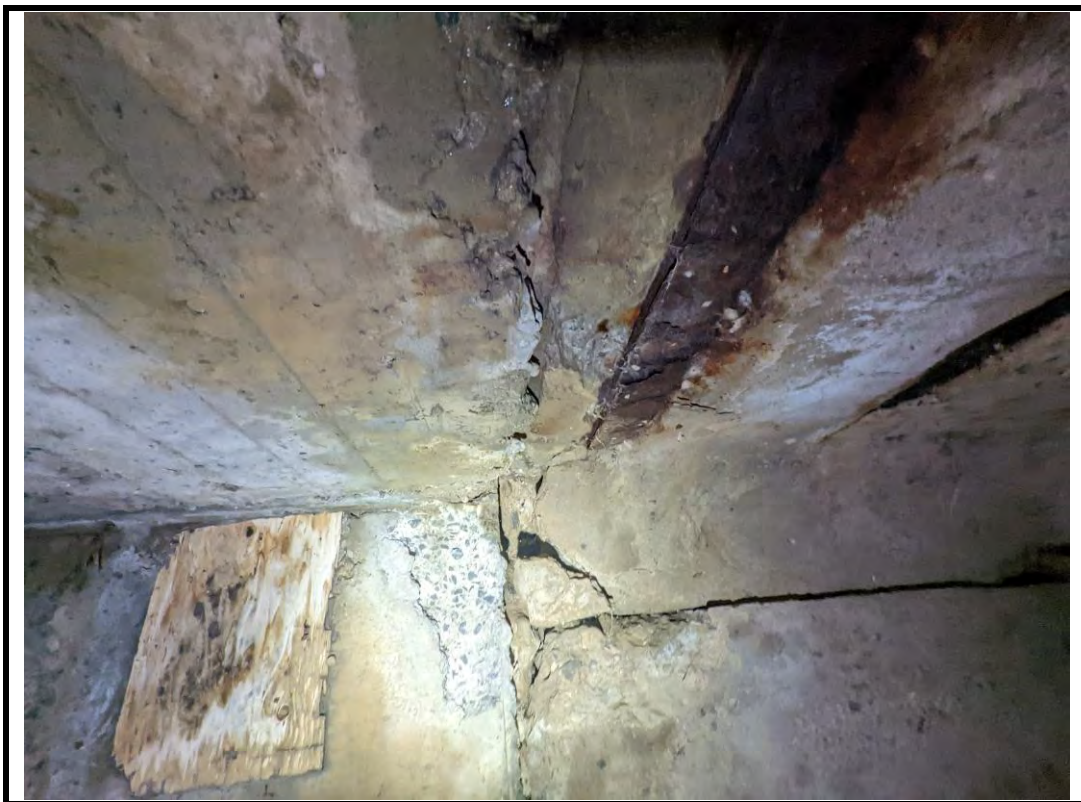
Photo 14 Rust and corrosion stains on soffit at section joints

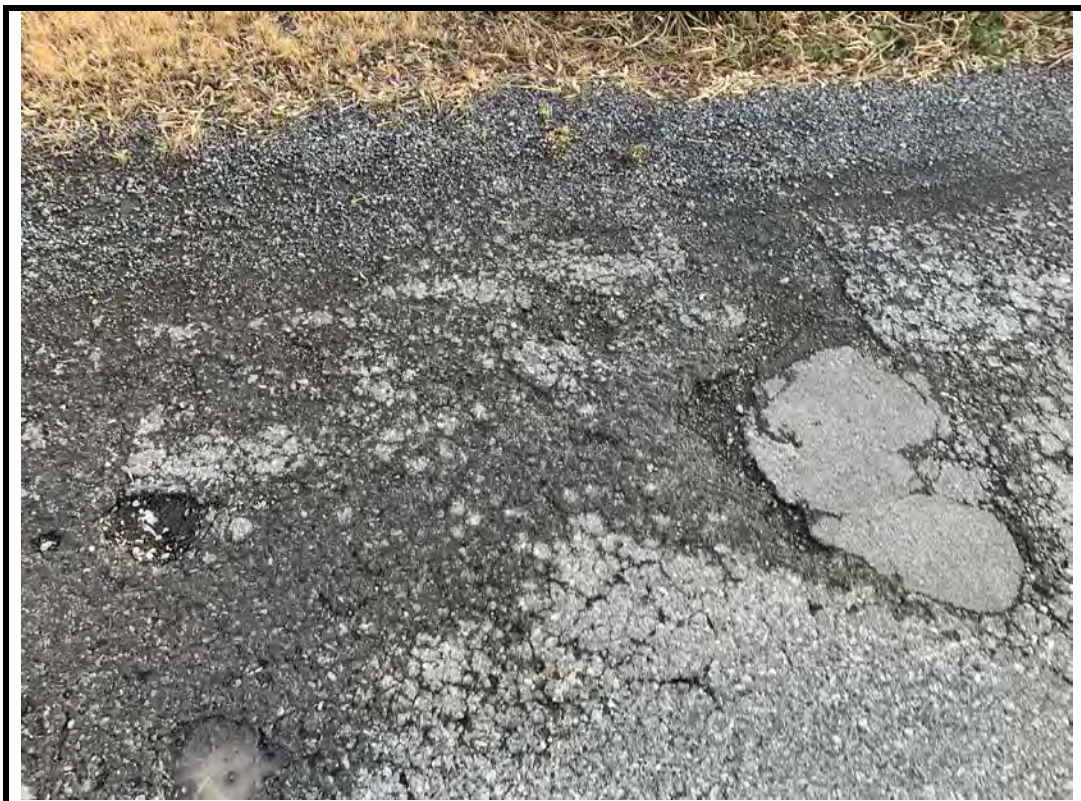
Photo 6 Potholes and alligator cracks on south edge of wearing surface

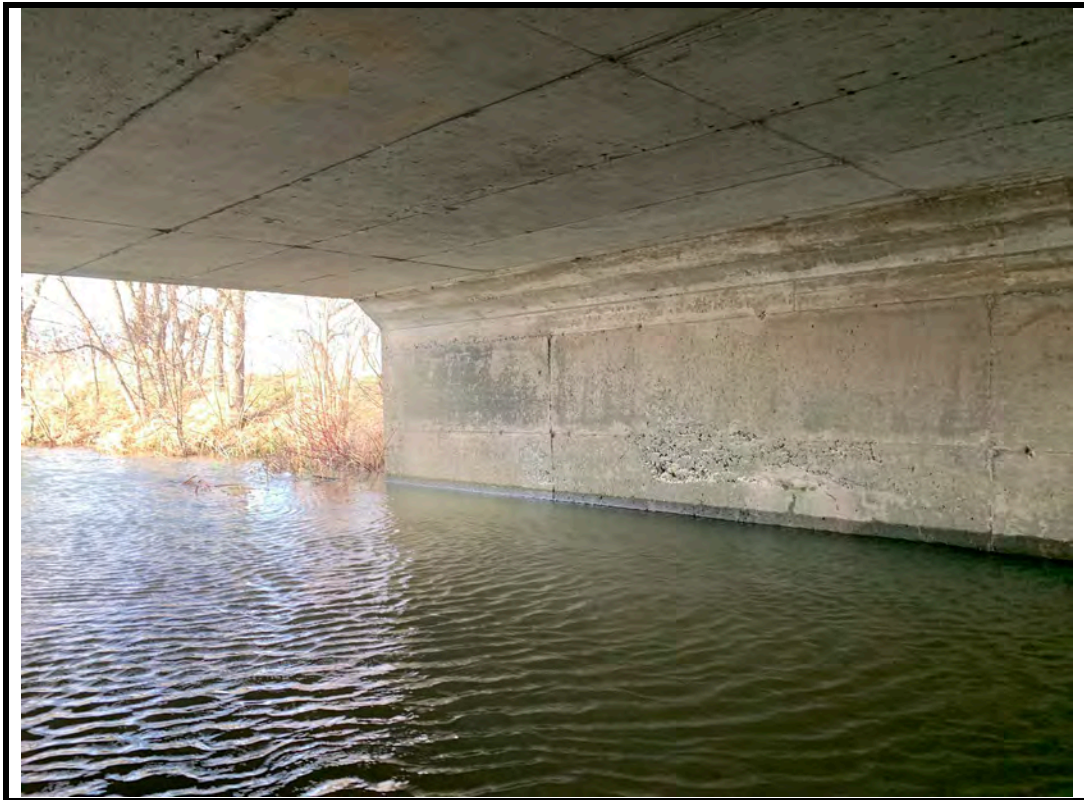
Photo 8 Honeycombing on east wall

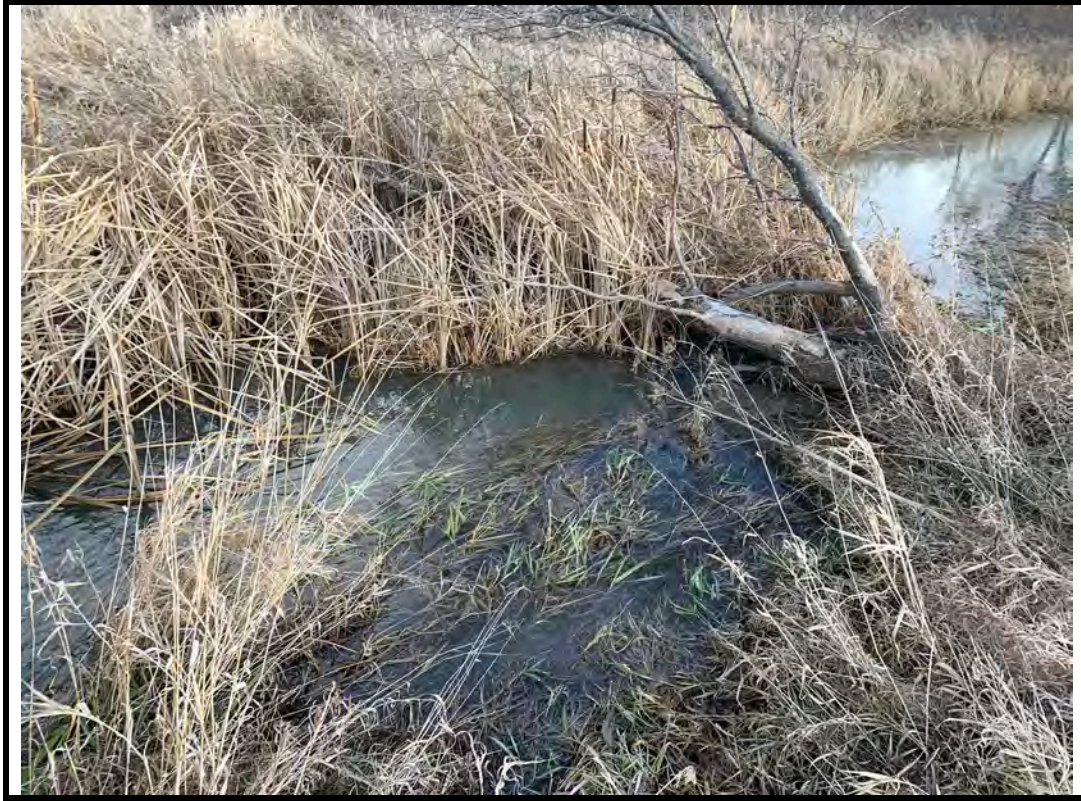
Photo 9 Debris blocking outlet of structure

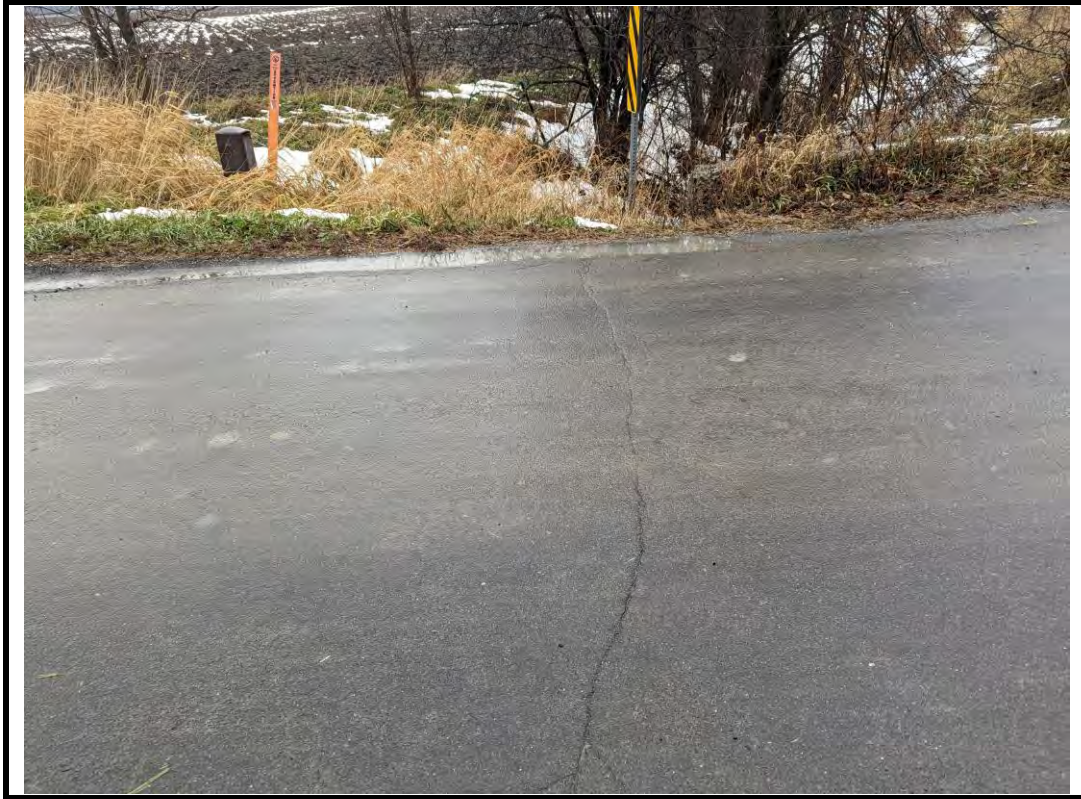
Photo 7 Transverse crack in asphalt approach wearing surface above structure

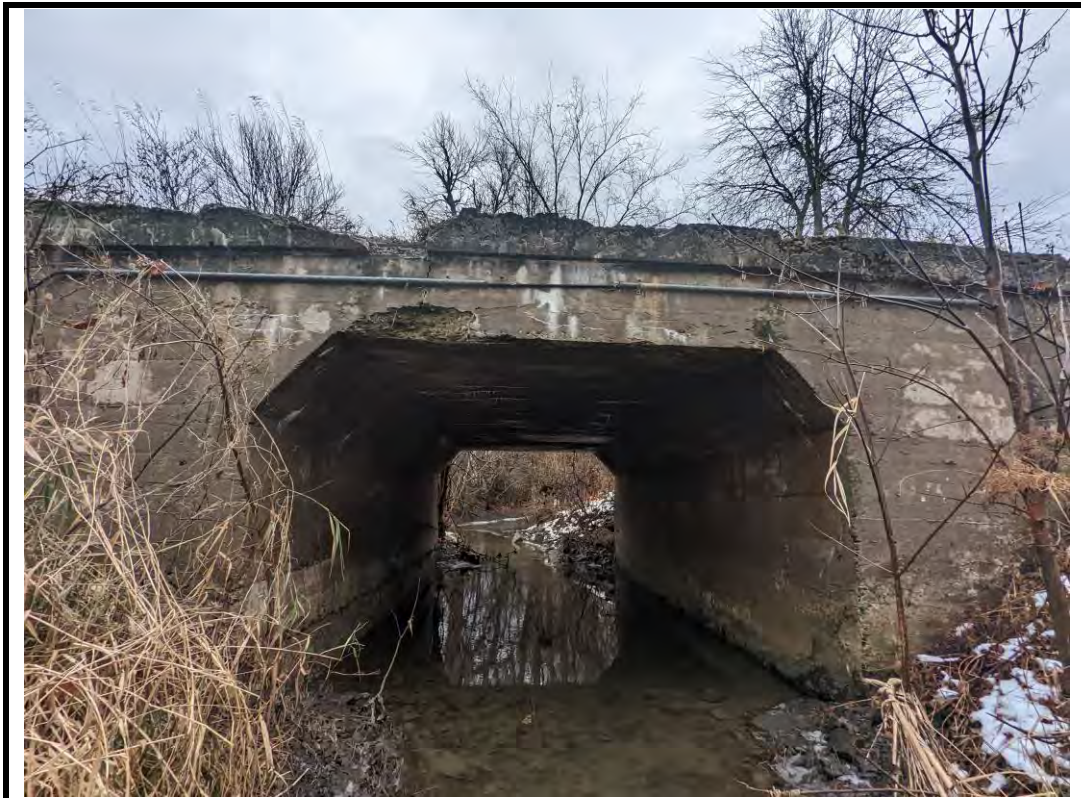
Photo 8 Spalling, honeycombing, and efflorescence at north end of barrel (Typ.)

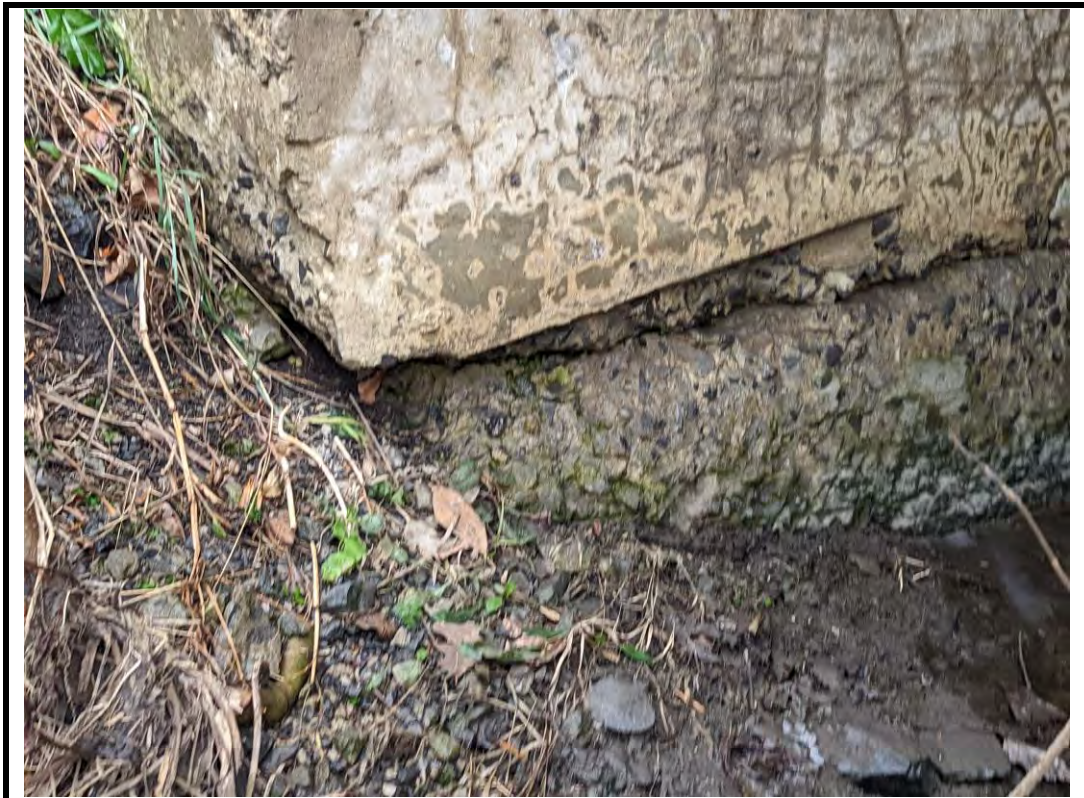
Photo 10 Scour/ severe scaling along concrete barrel walls (typ.)

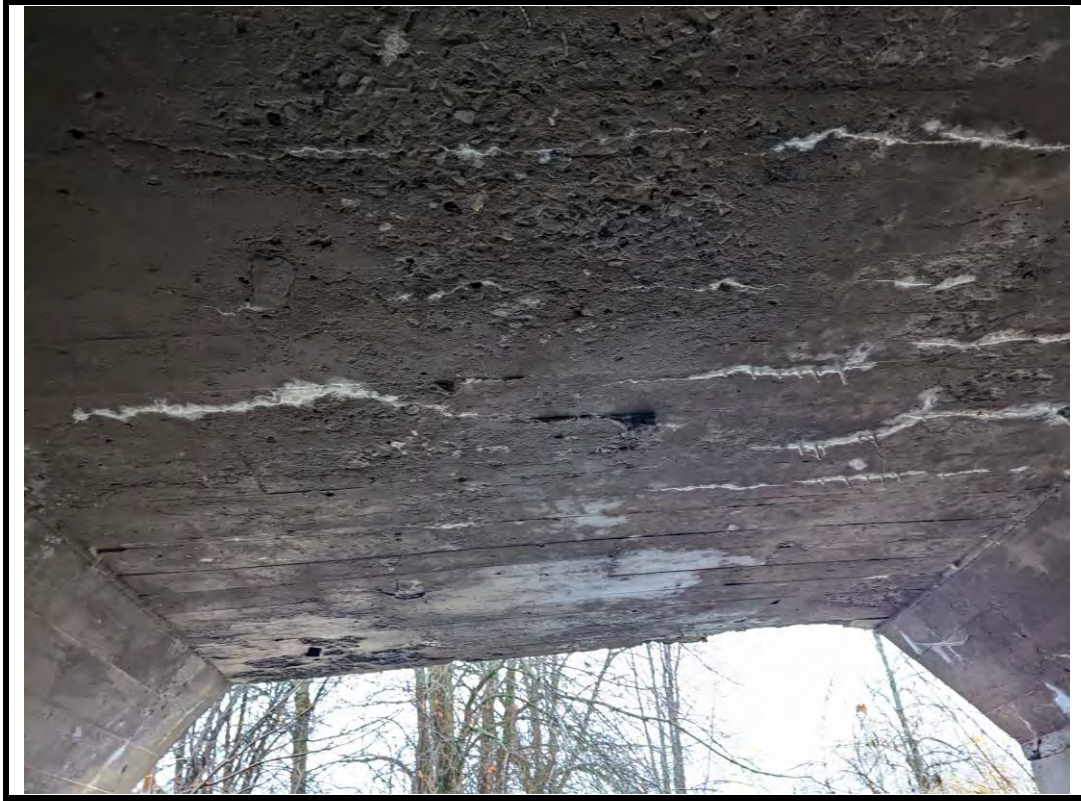
Photo 11 Efflorescence and scaling on barrel soffit (typ.)

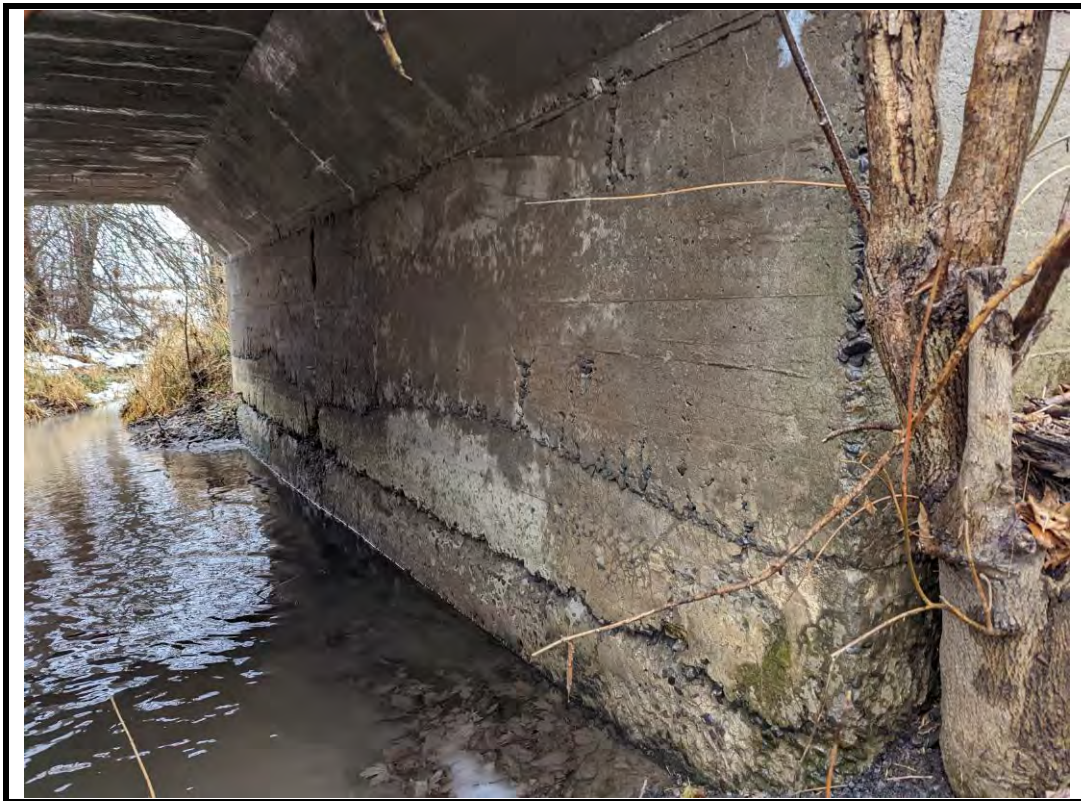
Photo 12 Severe scour/deterioration along barrel walls (typical)

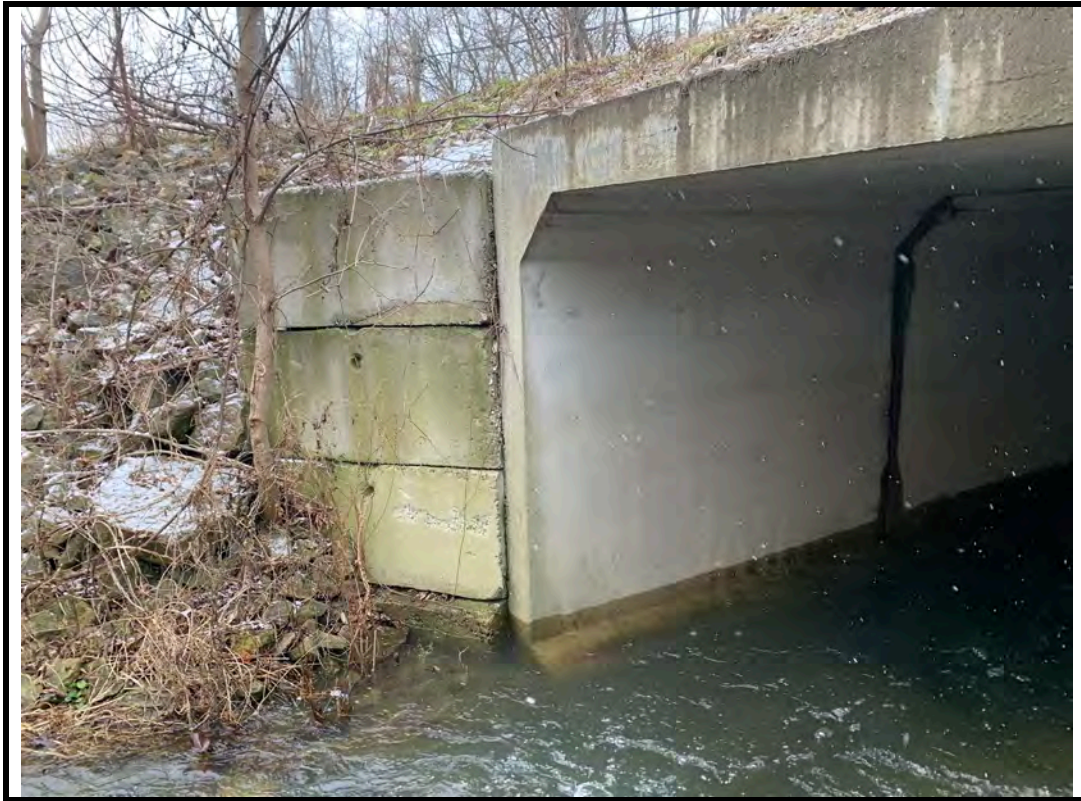
Photo 9 Honeycombing at northwest block wall

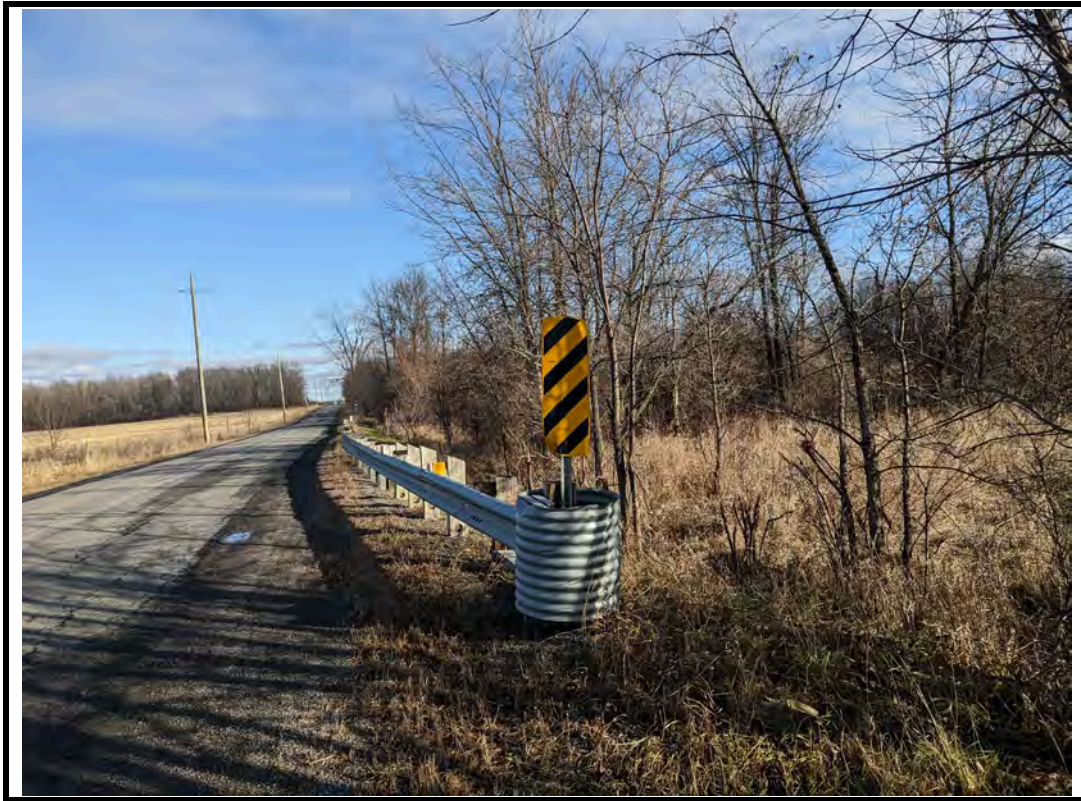
Photo 7 Eccentric end loader at southwest corner of approach

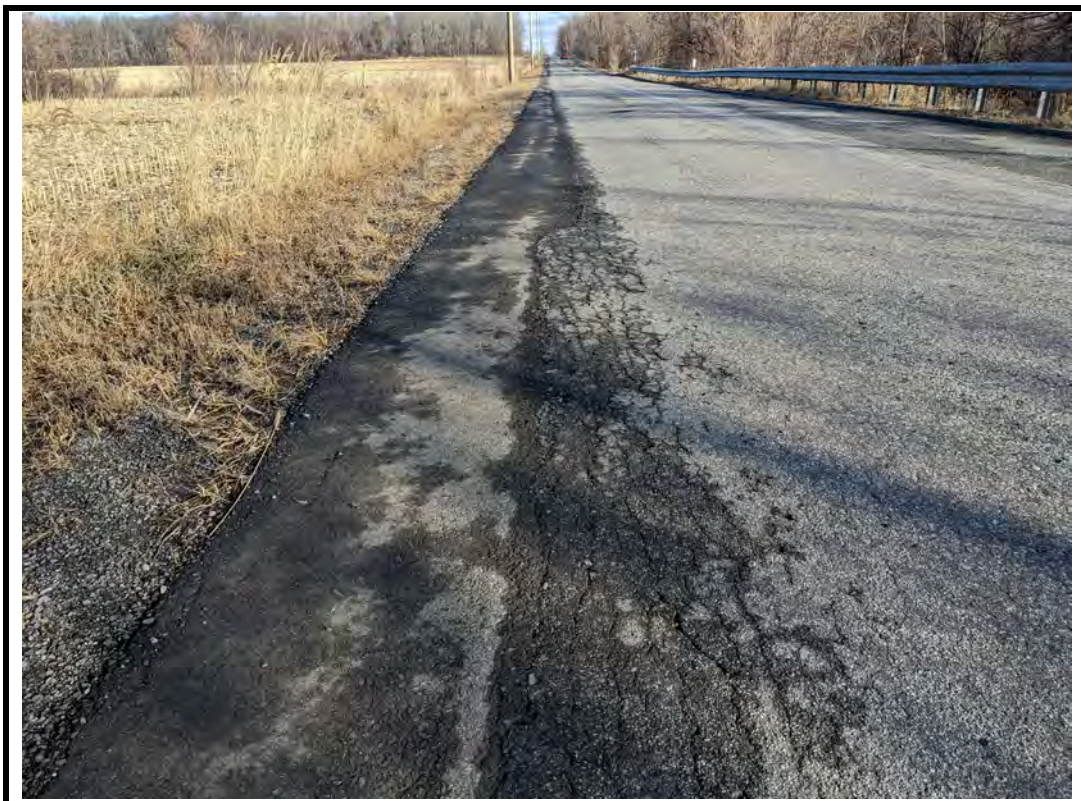
Photo 8 Edge cracking on northwest edge of approach

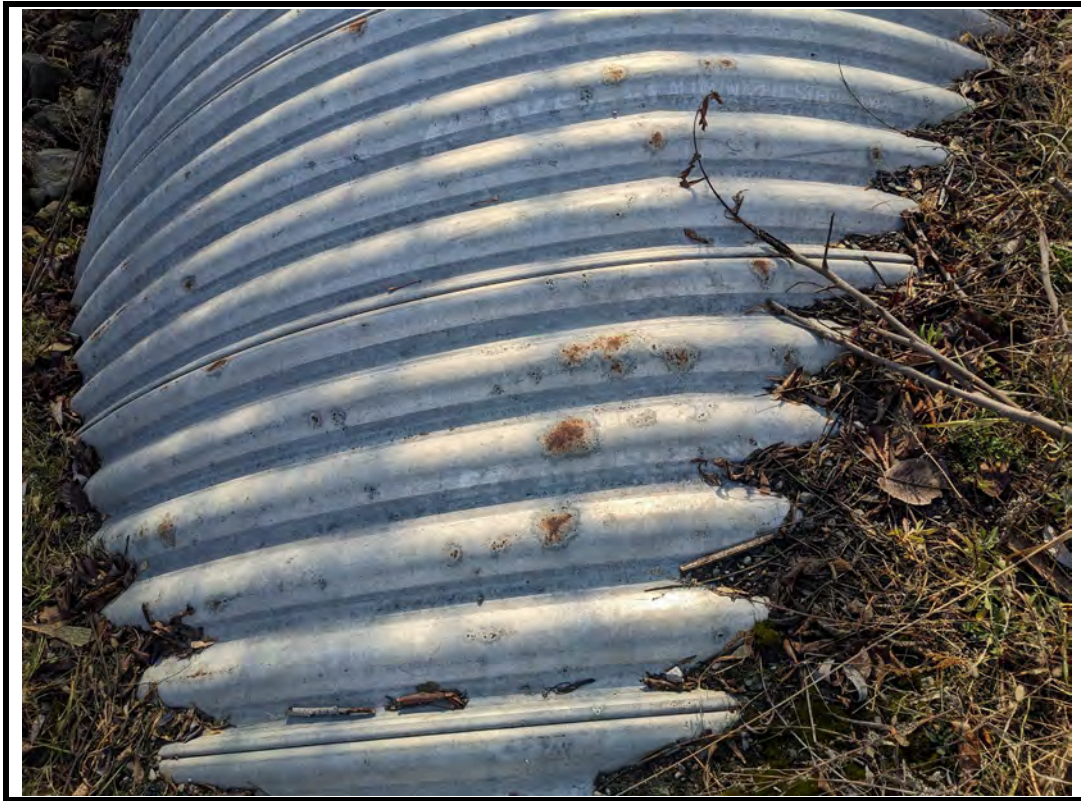
Photo 9 Localized rust spots on exterior of barrel at south end

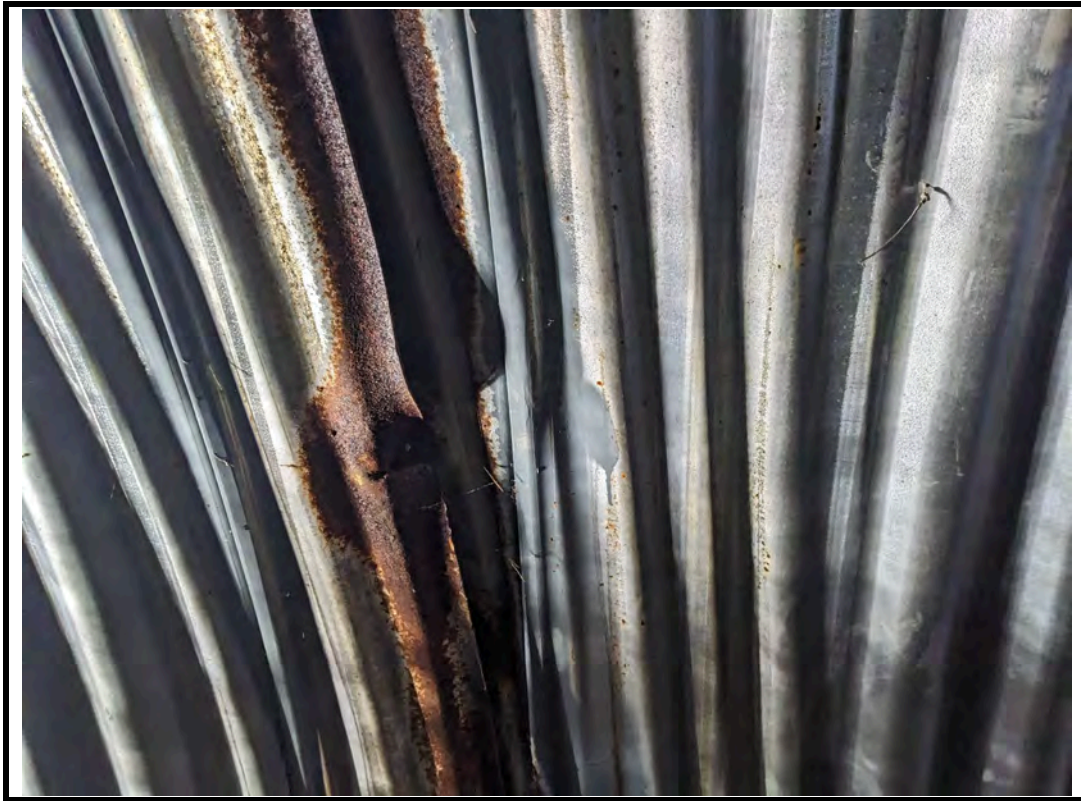
Photo 11 Minor separation at plate connection at south end of barrel
