THE TOWNSHIP OF NORTH DUNDAS

DRAFT BRIDGE MANAGEMENT STUDY REPORT 18 BRIDGES / 31 CULVERTS

March 2023

HP Engineering Inc.

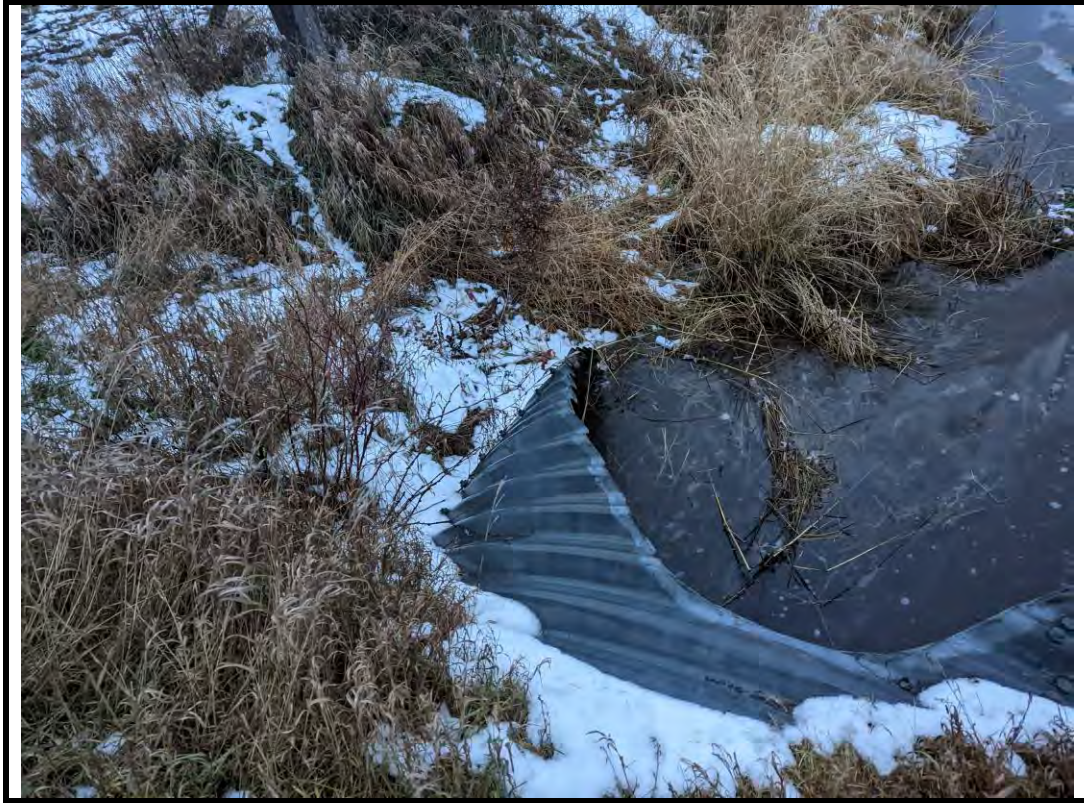
Photo 9 Loss of Rip-Rap at embankments (Typical)

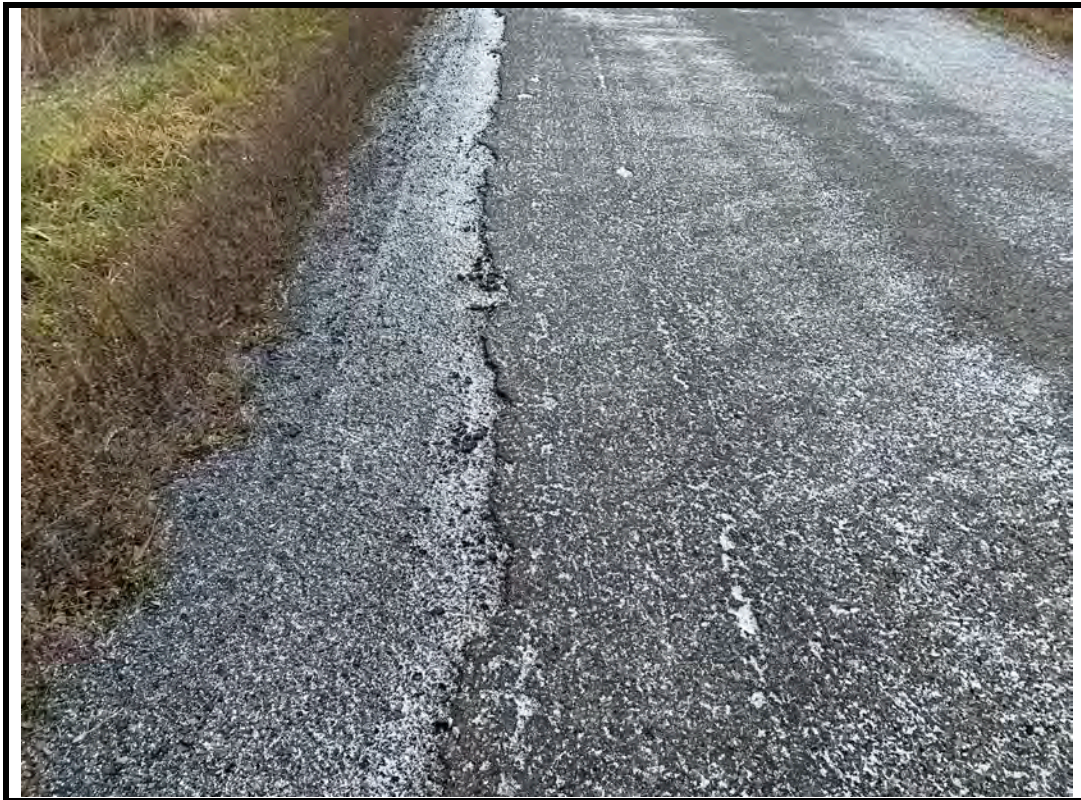
Photo 7 Section loss at east edge of north wearing surface

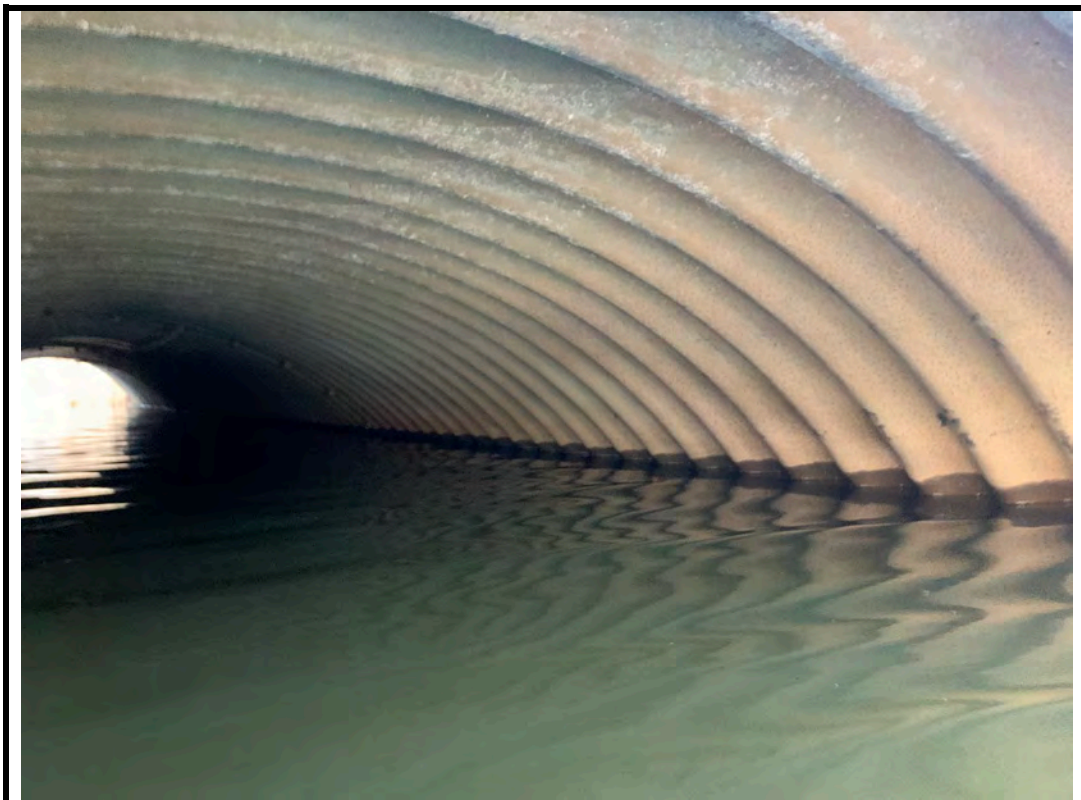
Photo 8 Light corrosion at waterline at east end of barrel

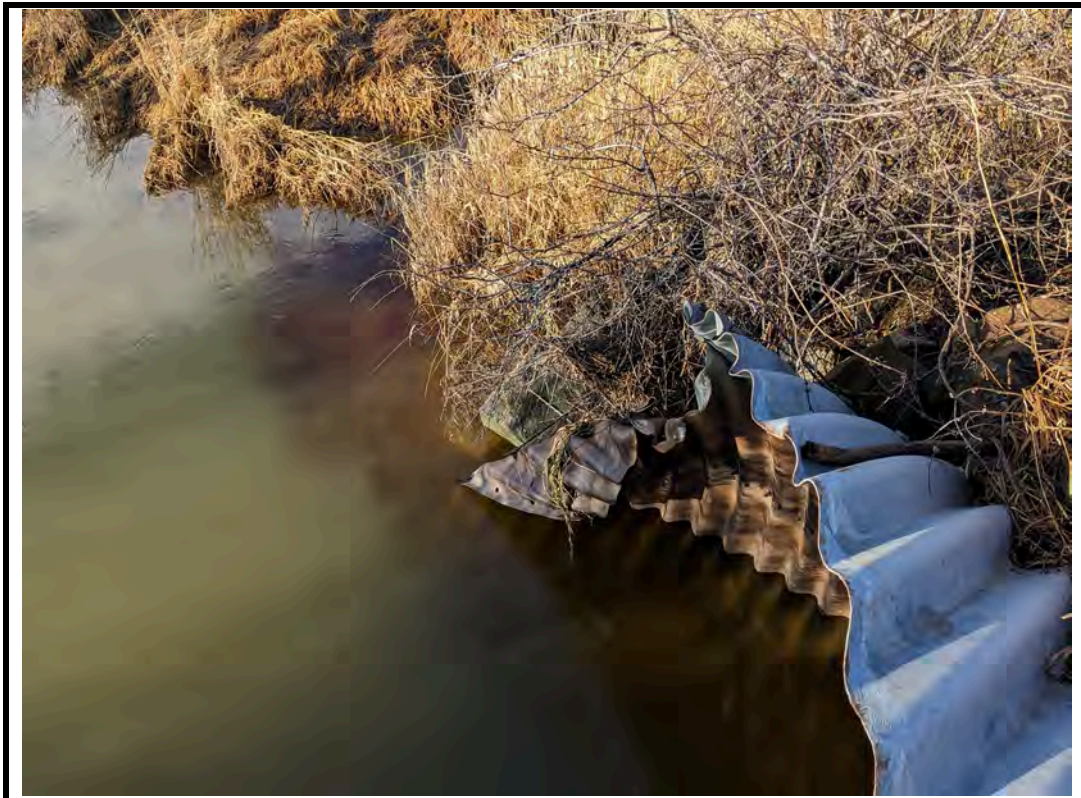
Photo 8 Deformation at northwest corner of structure

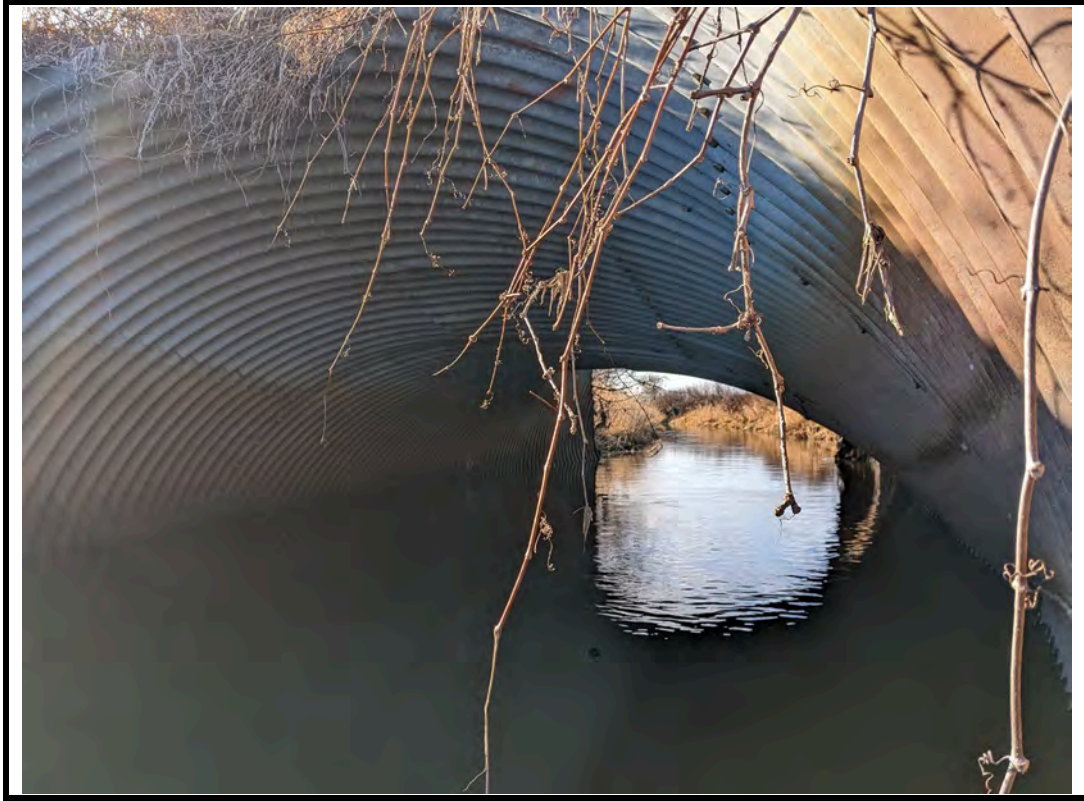
Photo 9 Interior of barrel from east end of structure

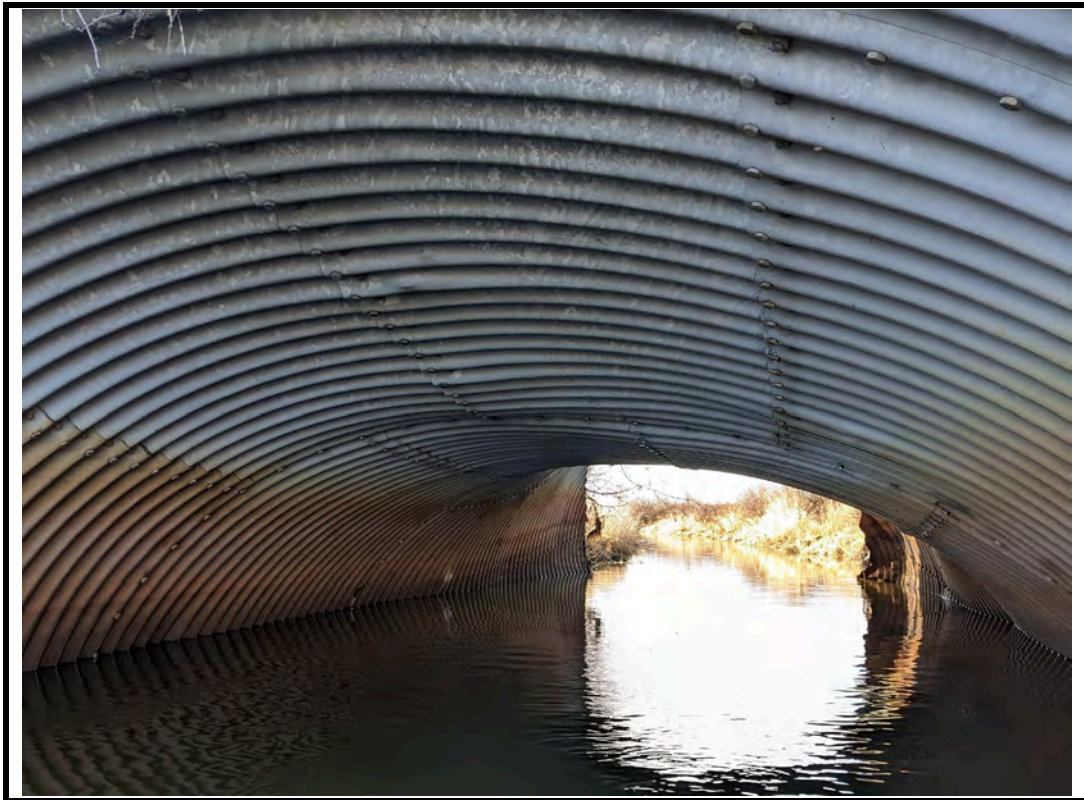
Photo 10 Severe sag in middle of barrel

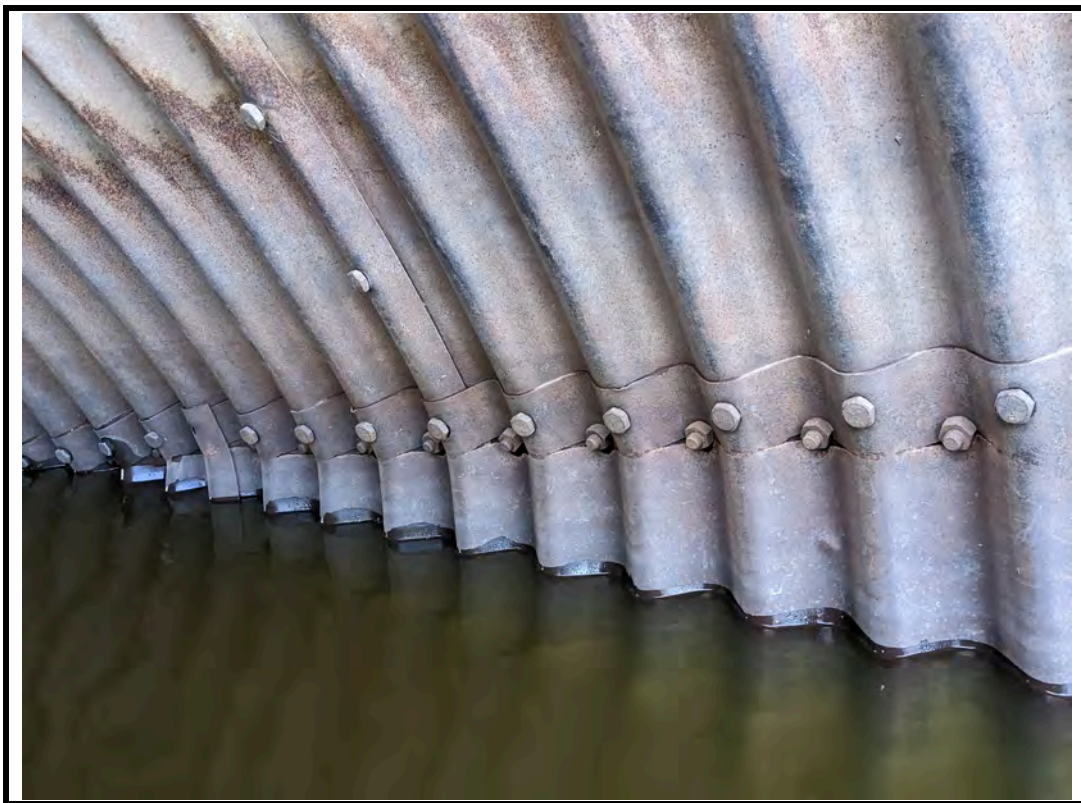
Photo 11 Wide horizontal cracks at bolt line at northeast corner of barrel

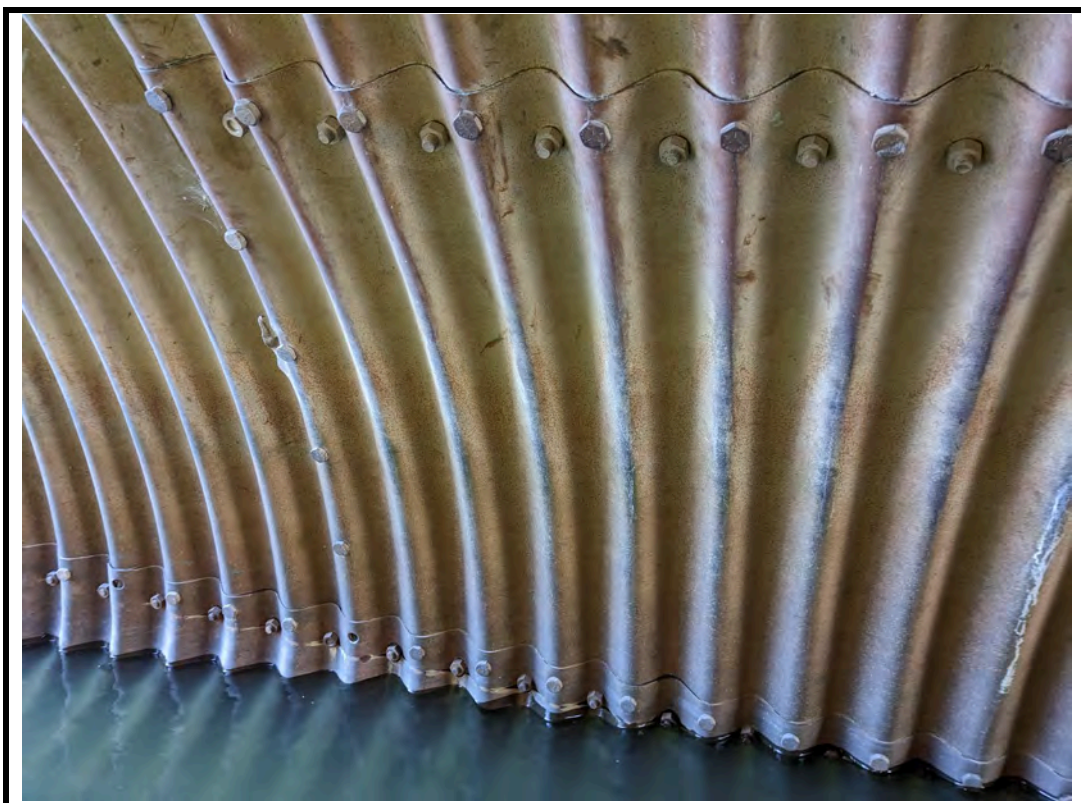
Photo 10 Cracks at bolt line at barrel wall

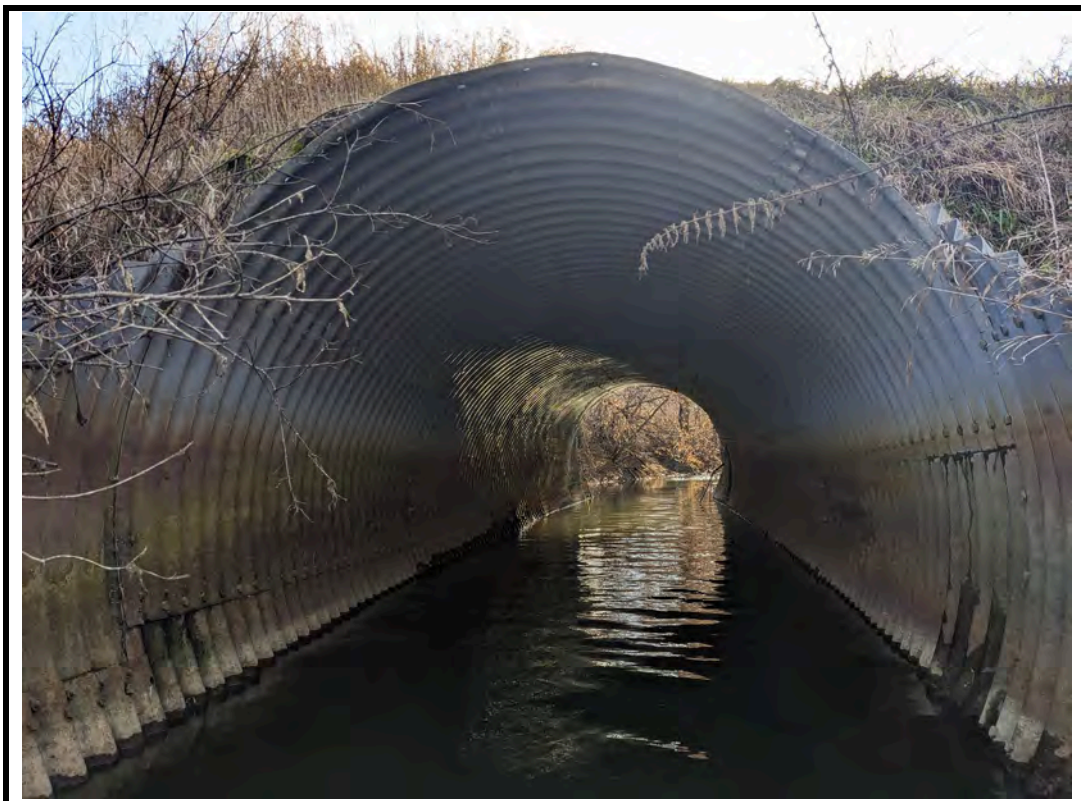
Photo 9 Perforation and separation on west barrel wall of structure

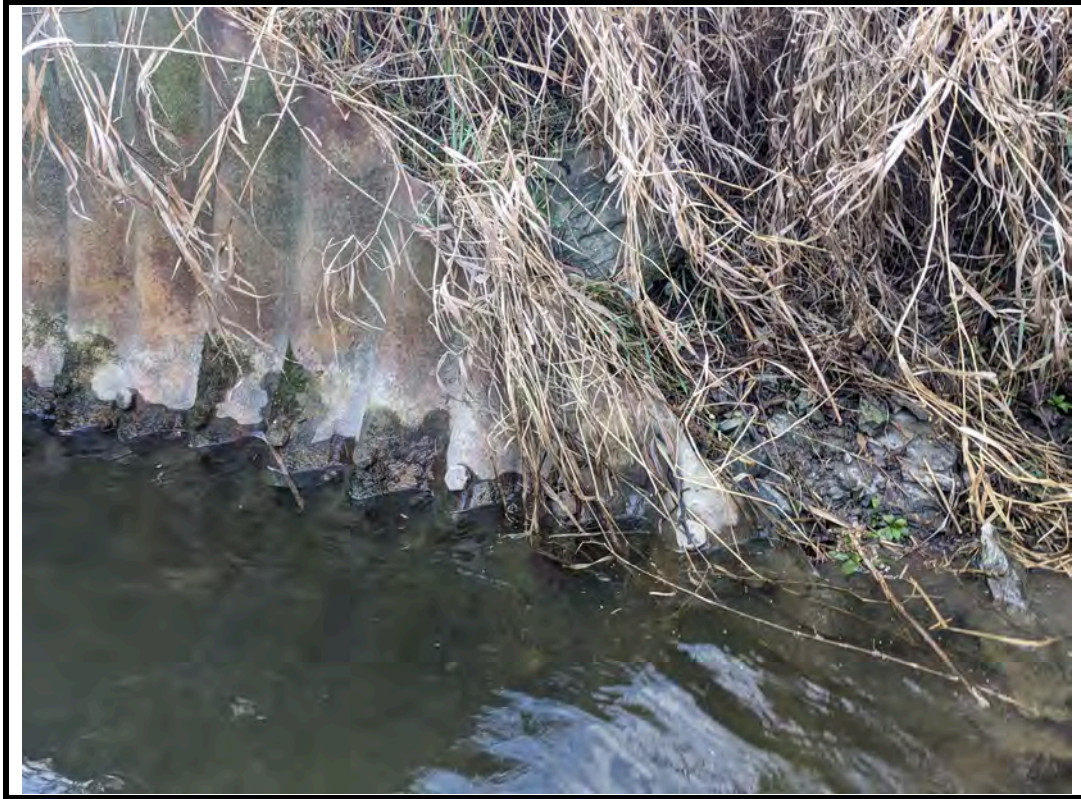
Photo 12 Erosion and washout noted on southwest embankment

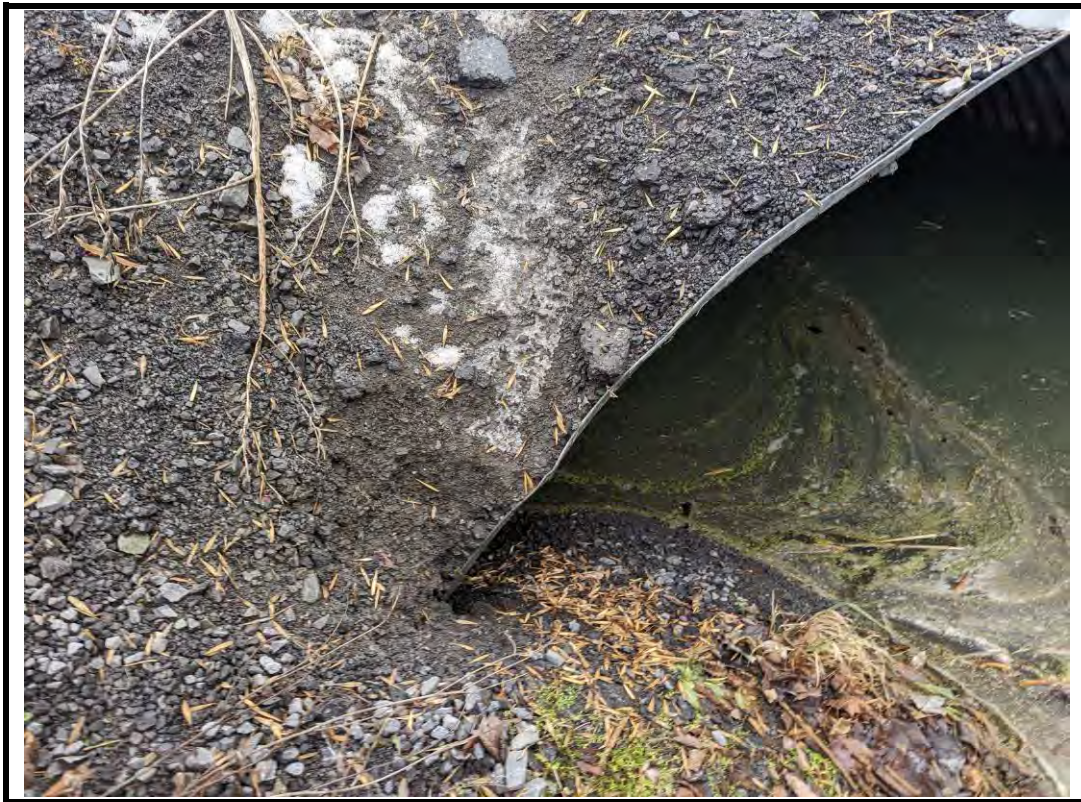
Photo 11 Erosion and encroachment into barrel at the northwest

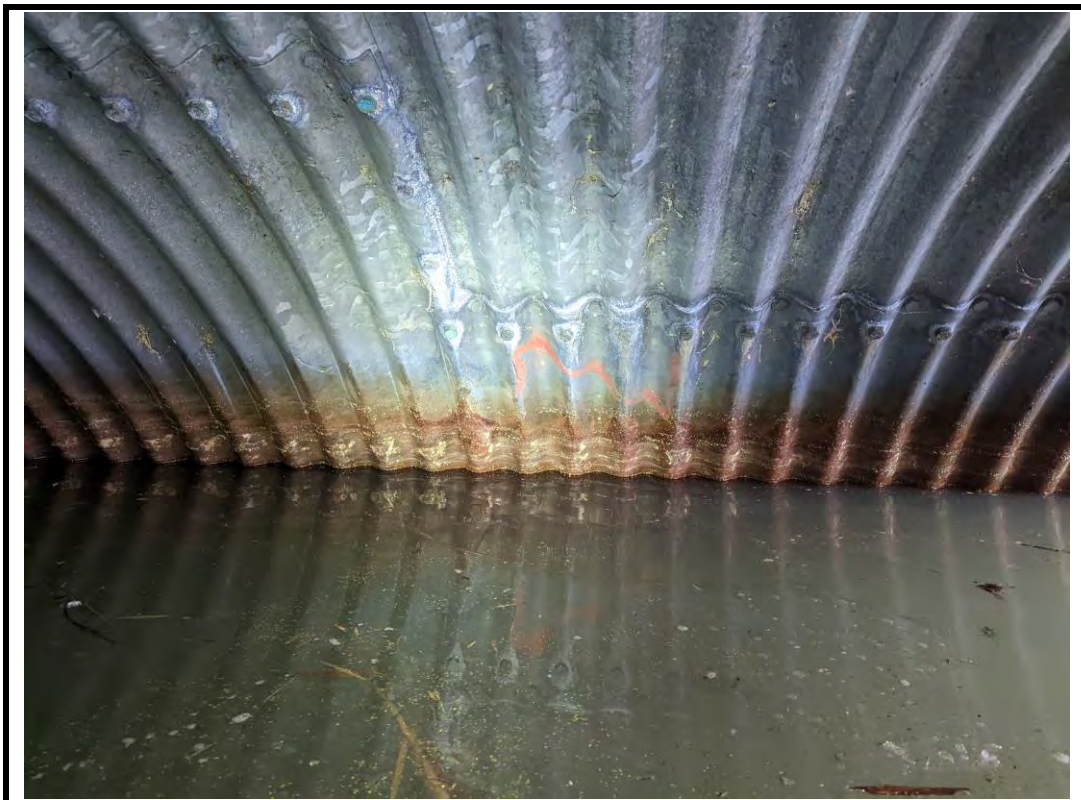
Photo 12 Corrosion on pipe arch walls (typ.)

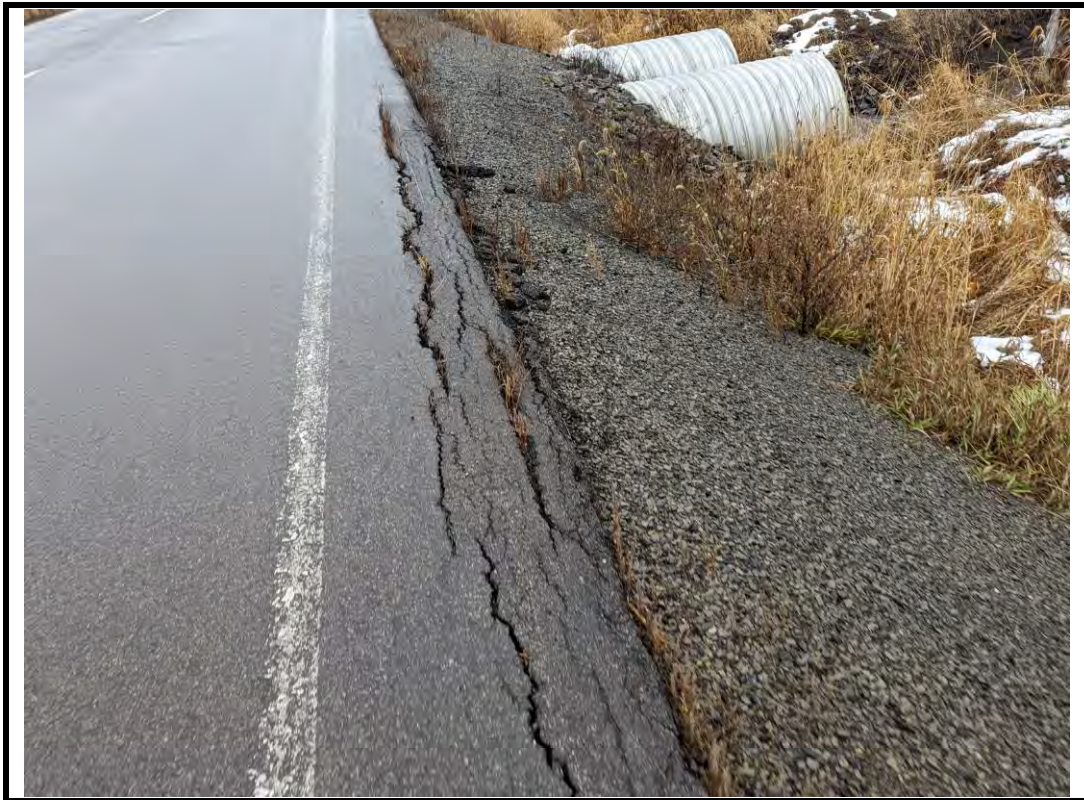
Photo 8 Longitudinal edge cracks and grade difference at shoulders

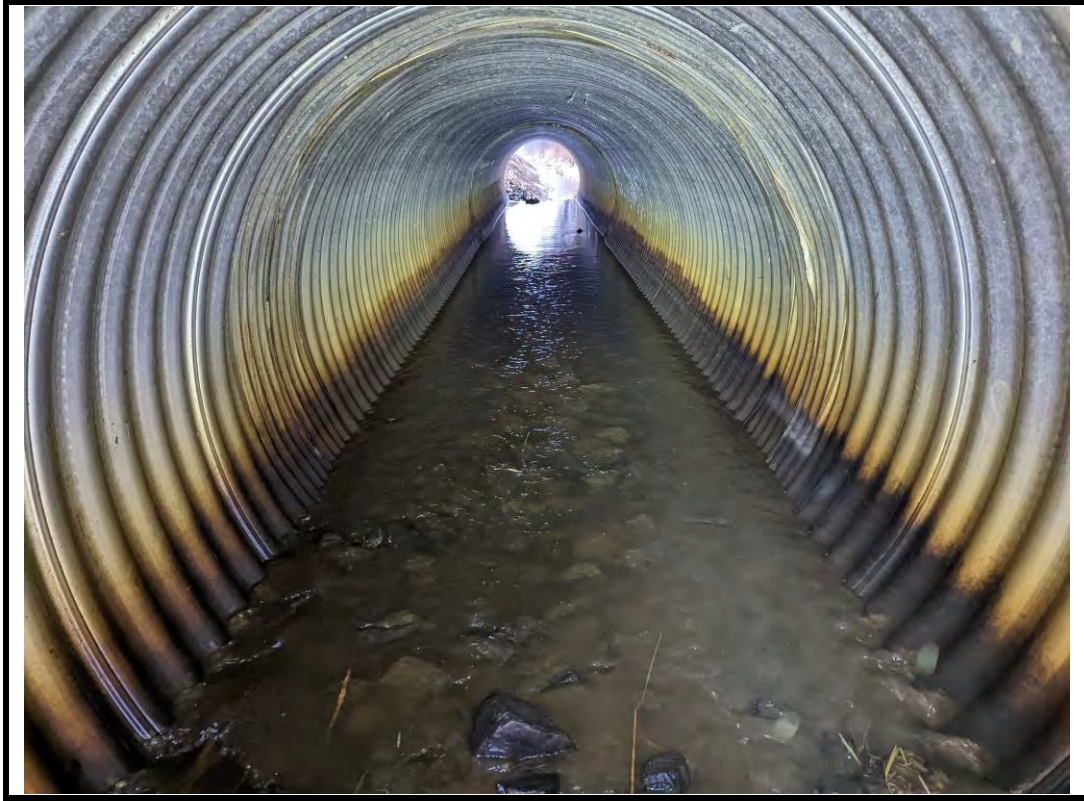
Photo 9 View through east barrel, looking south

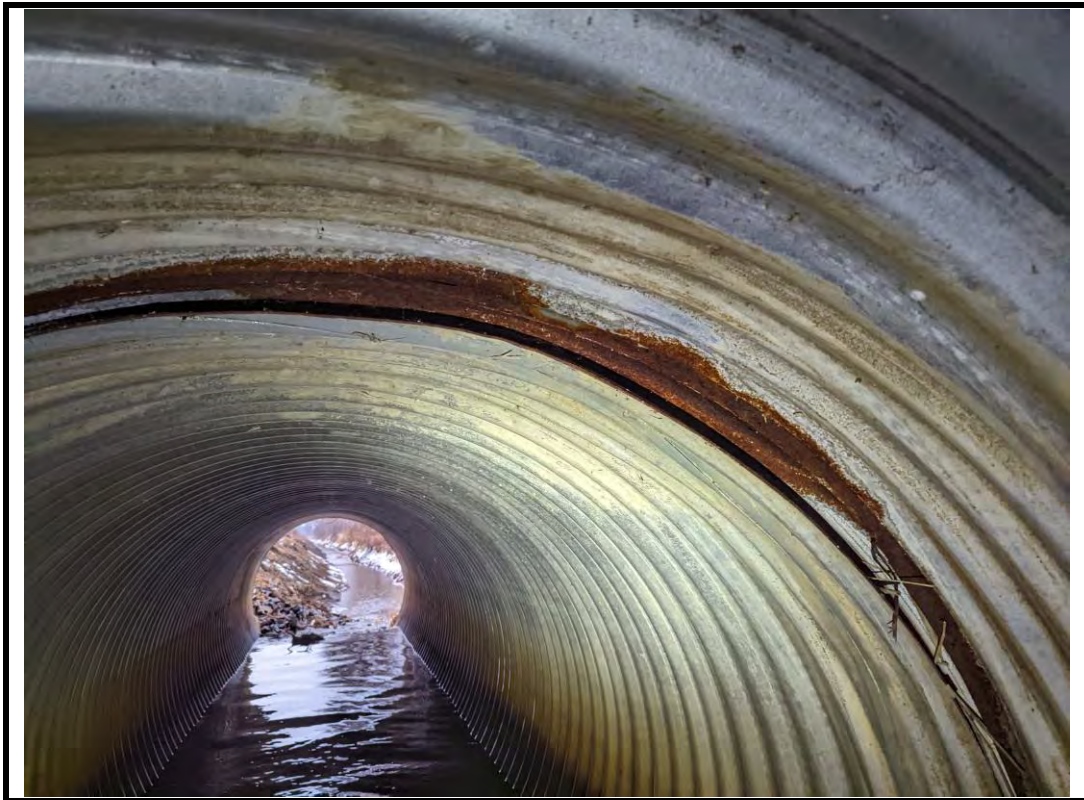
Photo 10 Misalignment of joint in east barrel and localized corrosion

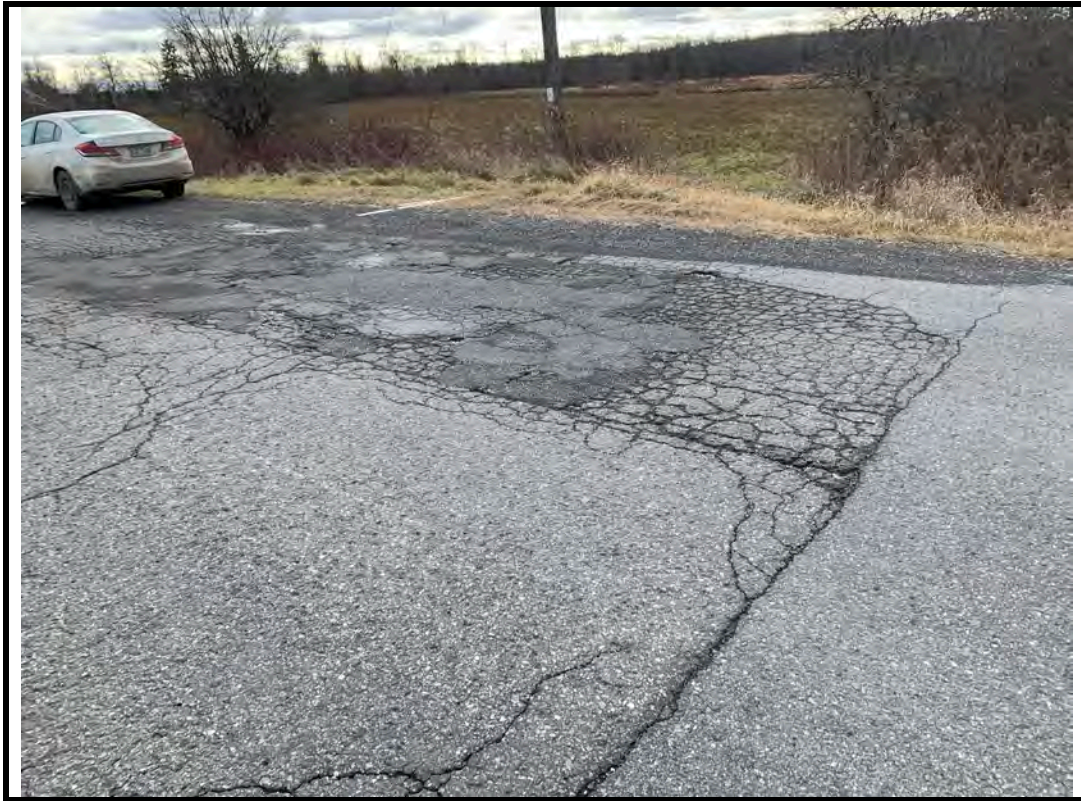
Photo 7 Wide pattern cracks, asphalt patches and potholes on south wearing surface

Element Group:	Approaches	Length:	60					
Element Name:	Wearing Surface	Width:	6.4					
Location:	Over Structure	Height:						
Material:	Asphalt	Count (items):						
Element Type:	Asphalt Surface Treatment	Total Quantity:	384.0 m ²					
Environment:	Severe	Limited Inspection						
Protection System:	None							Perform. Deficiencies
Condition Data:	Units	Exc.	Good	Fair	Poor*			
	m ²		337.92	30.72	15.36			
Comments:	Medum edge cracking, and potholes noted on wearing surface. Patched potholes noted and some minor settlement noted on both approaches.							
Recommended Work:	X	Rehab		Replace	Maintenance Needs:			
	X	1-5 years		6-10 years		Urgent	1 year	2 years
					Repair asphalt surface treatment and patch pothole

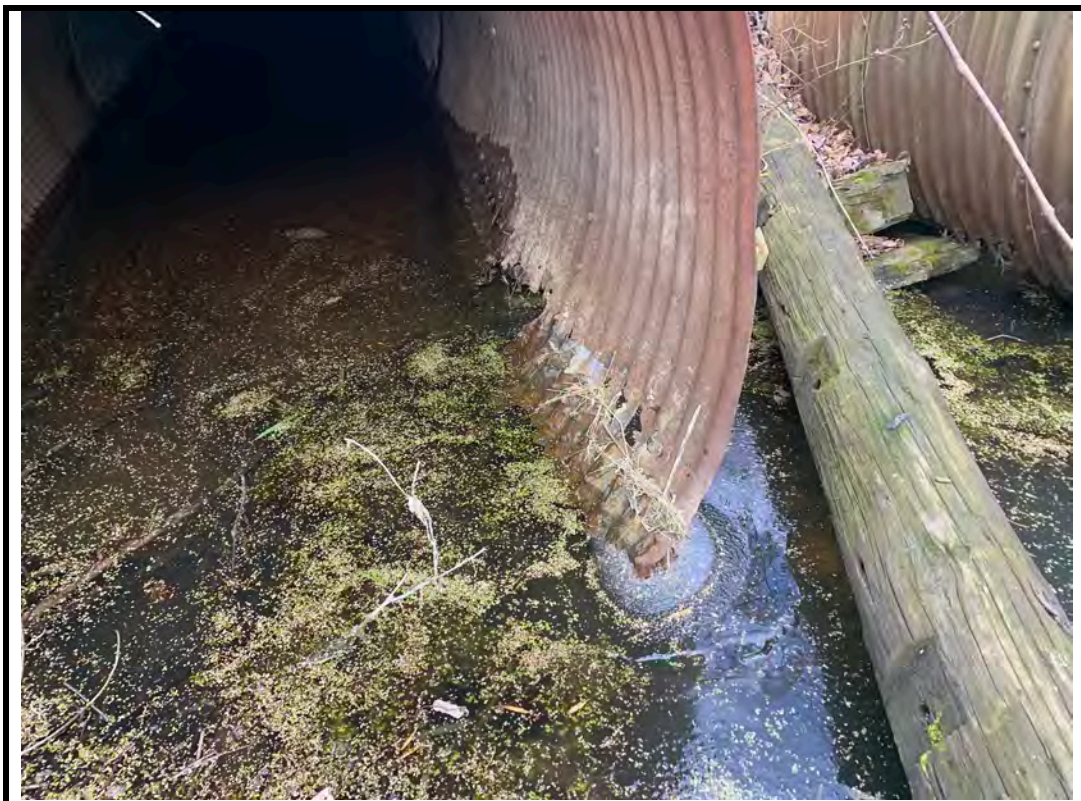
Photo 8 Severe corrosion and perforations in south barrel

Repair and Rehabilitation Required:		Priority			Estimated Cost
Element	Repair and Rehabilitation Required	6-10 Years	1-5 Years	< 1 Year	
Approaches	Install Approach Barrier			X	\$ -
Barrel	Replace Structure		X		\$ 367,000.00
					\$ -
					\$ -
					\$ -
					\$ -
					\$ -
					\$ -
					\$ -
Total Cost:					\$ 367,000.00

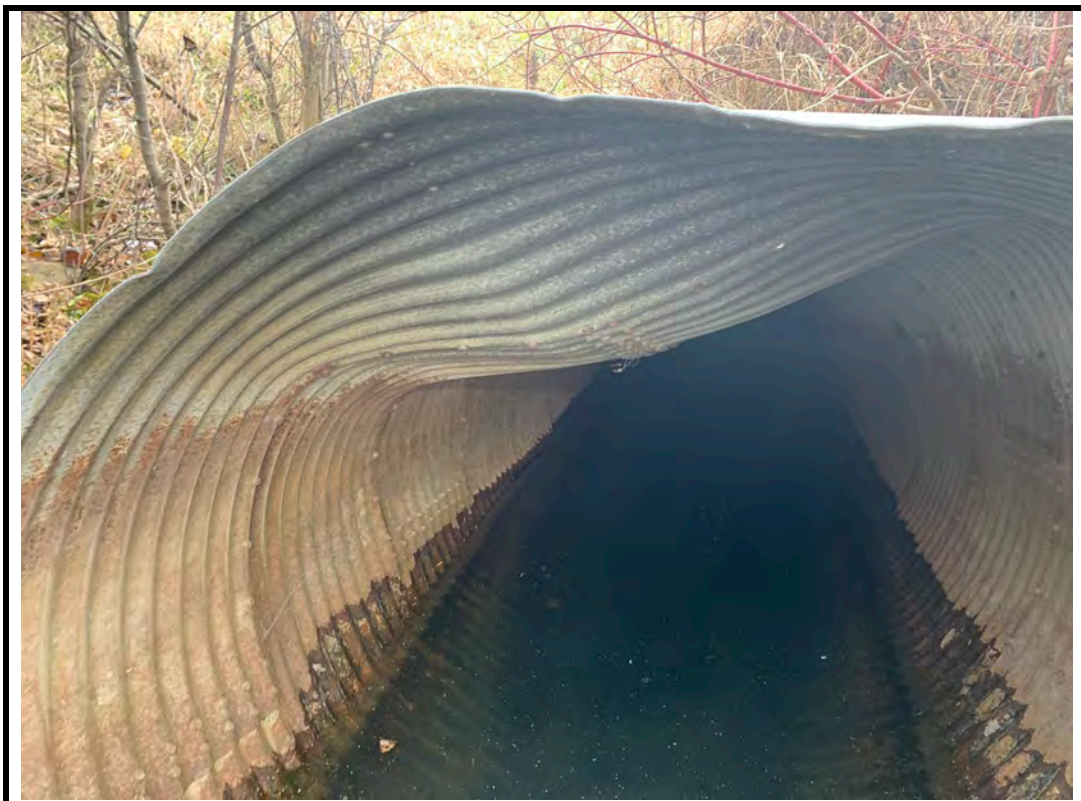
Photo 10 Large dents in east end of south barrel

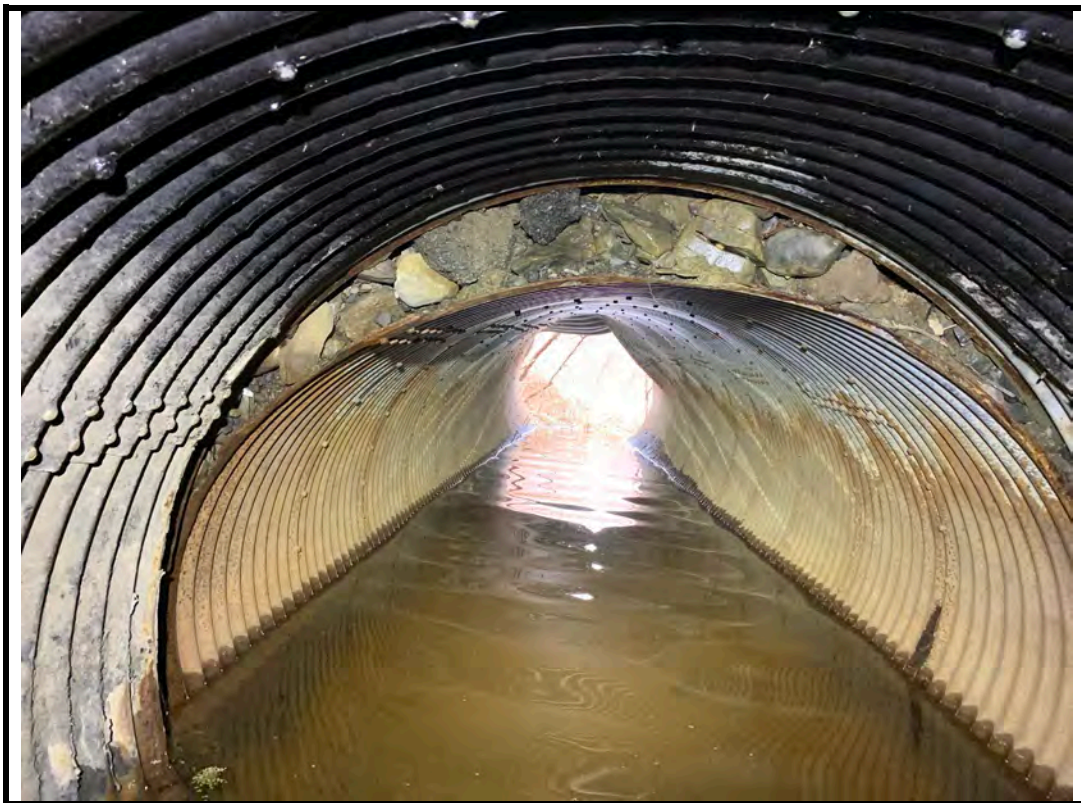
Photo 12 Separation and partial collapse of north barrel

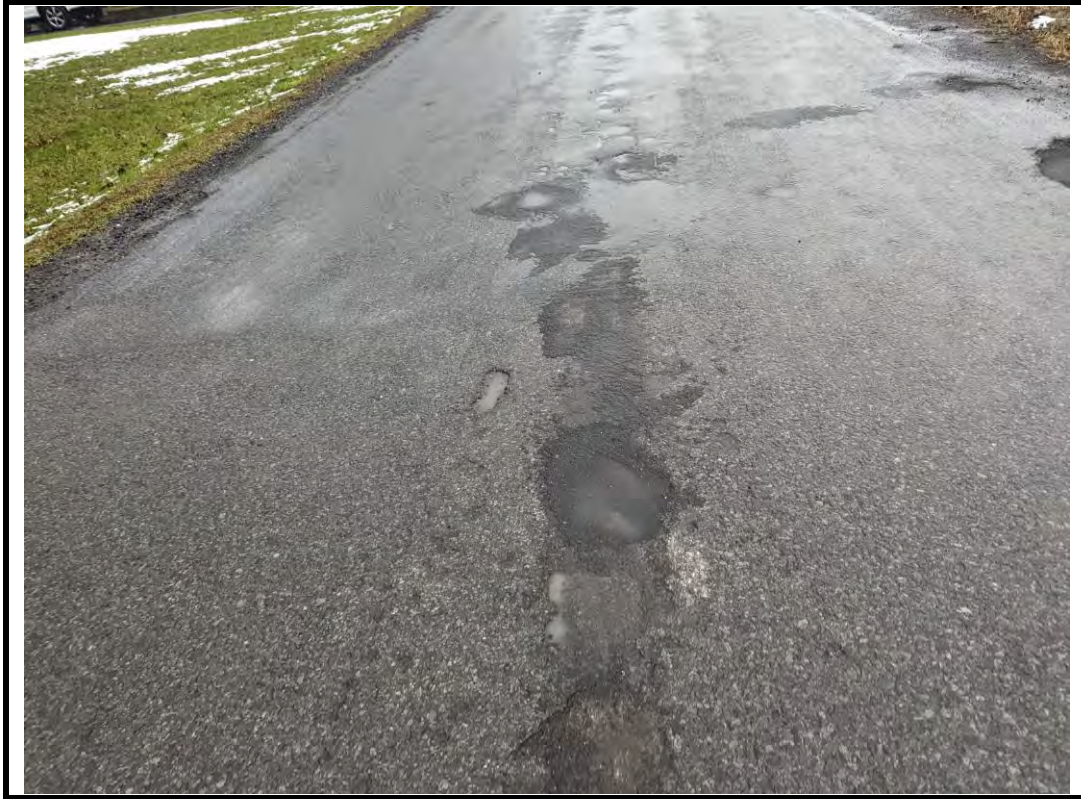
Photo 7 Small potholes forming on asphalt wearing surface above structure

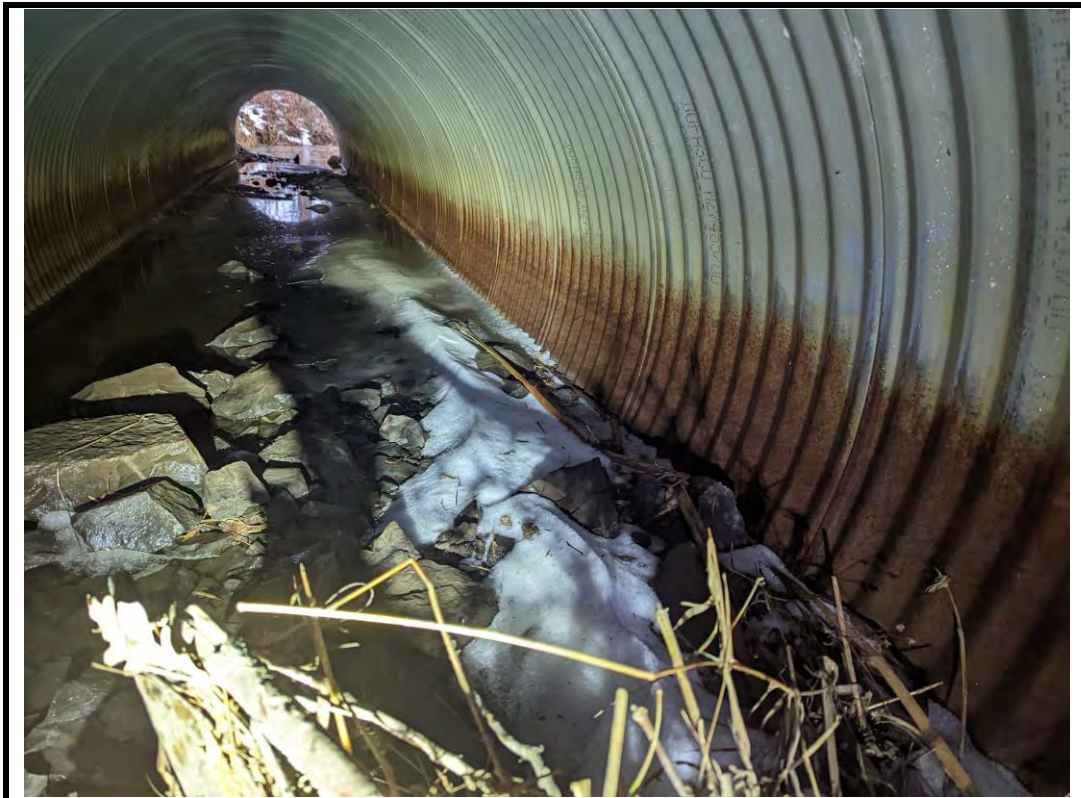
Photo 8 Corrosion and debris within east barrel

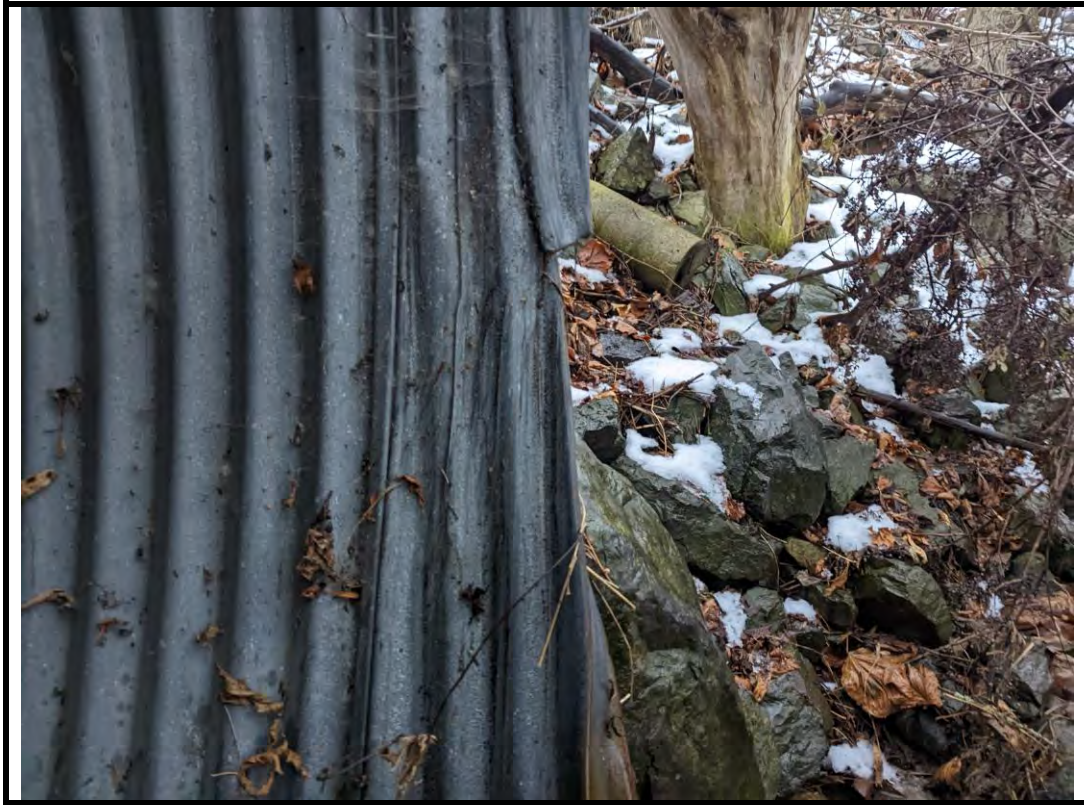
Photo 9 Light deformation at east barrel end

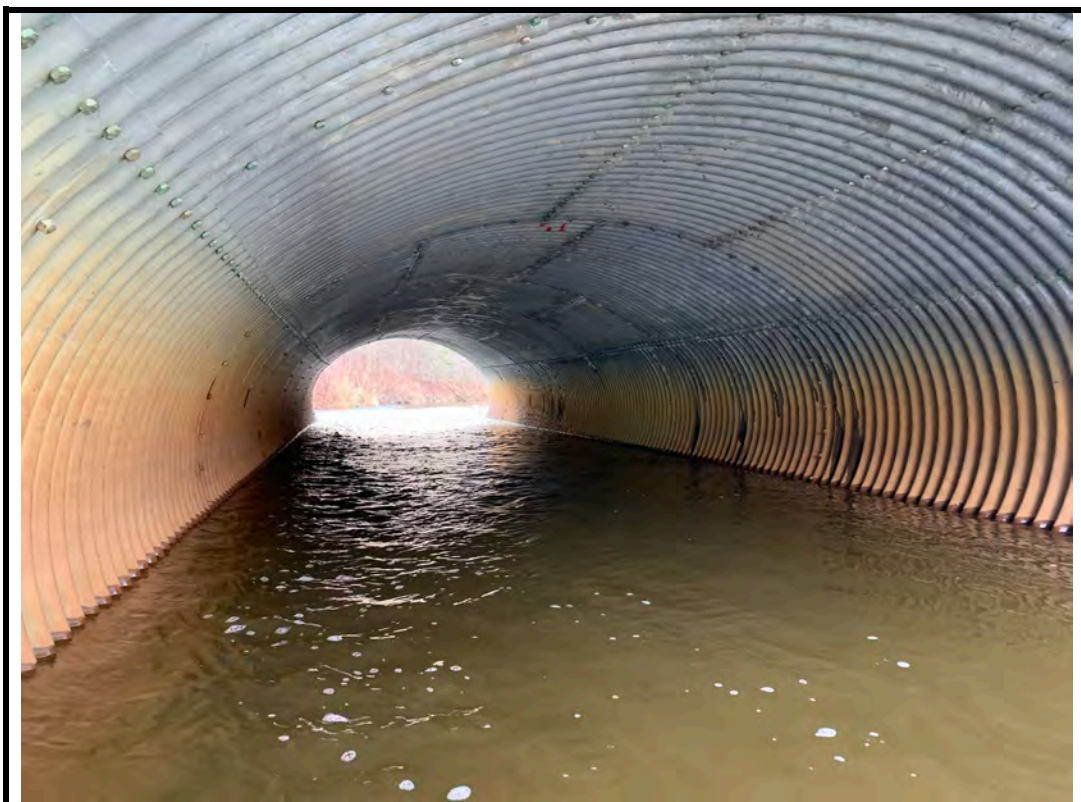
Photo 13 Interior view of east barrel from north end of structure

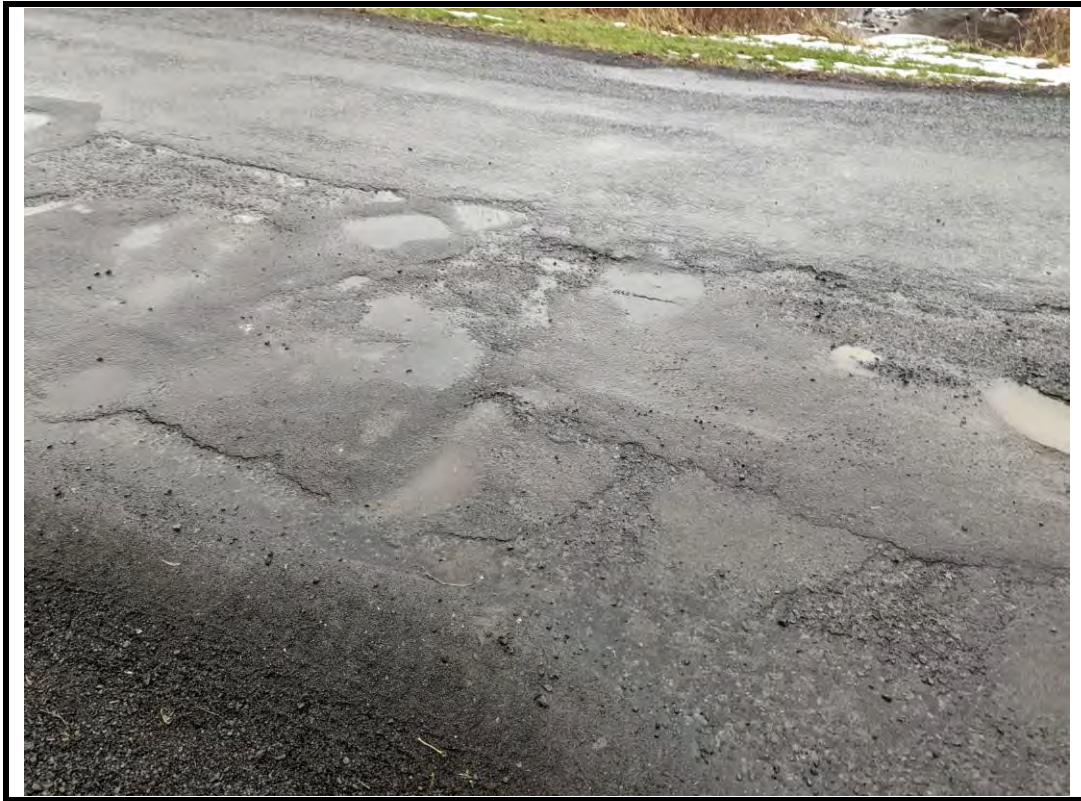
Photo 7 Roadway depression above structure, potholes, and raveling

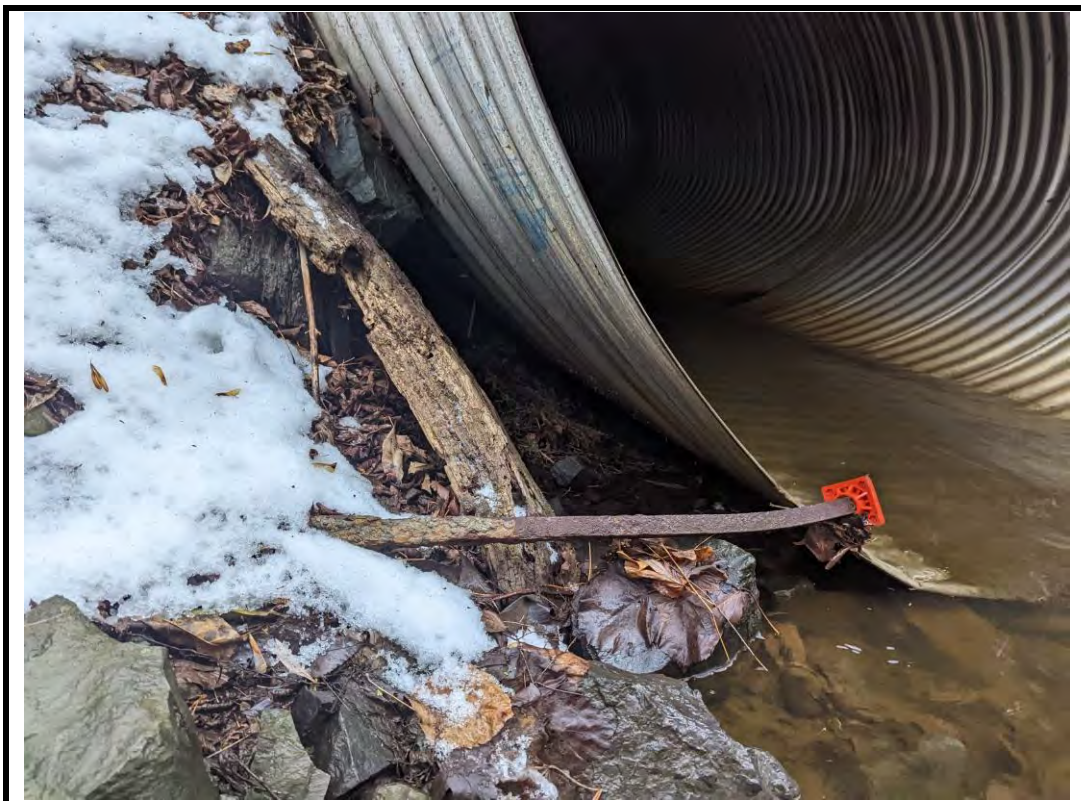
Photo 8 Typical scour / undermining of culvert (North inlet shown)

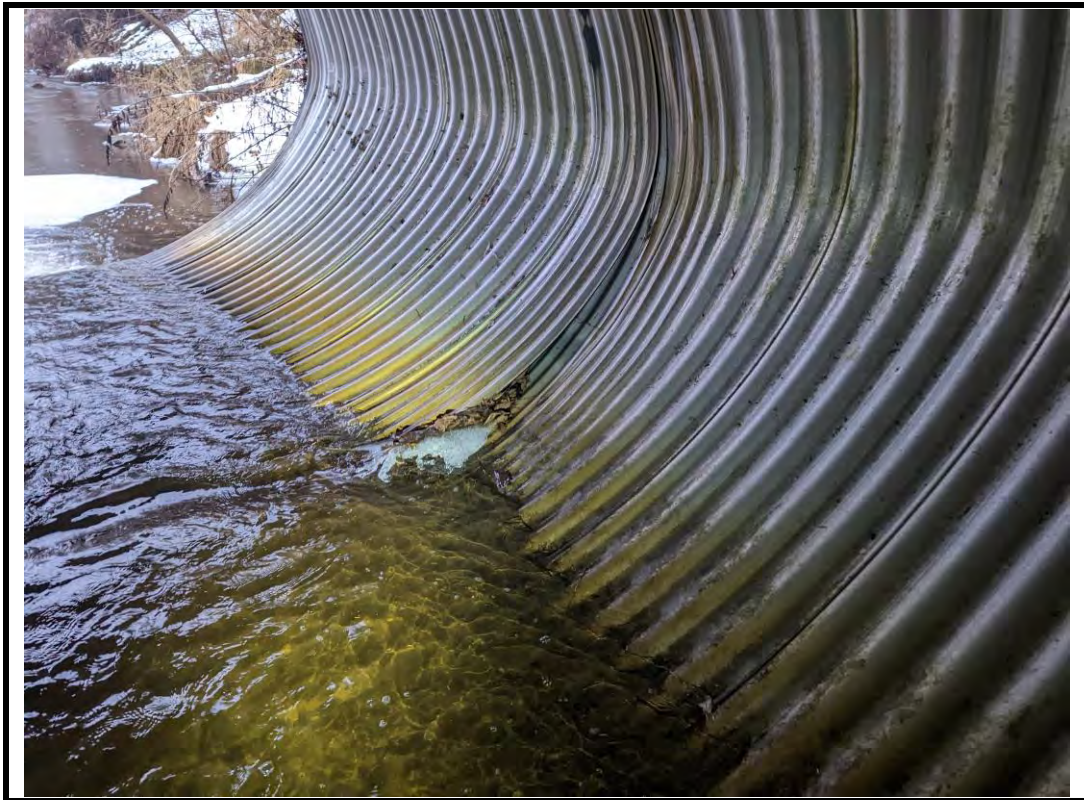
Photo 10 Separation of south barrel segment causing scour/piping
