THE TOWNSHIP OF NORTH DUNDAS

DRAFT BRIDGE MANAGEMENT STUDY REPORT 18 BRIDGES / 31 CULVERTS

March 2023

HP Engineering Inc.

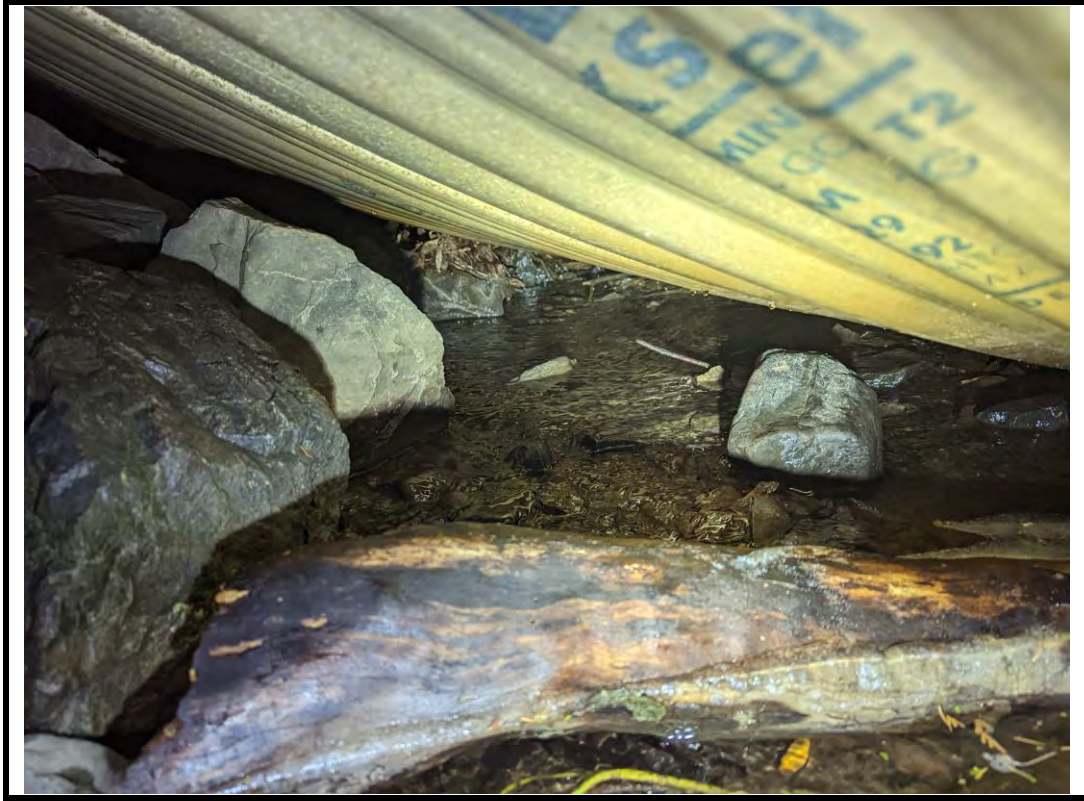
Photo 11 Undermining below south pipe segment

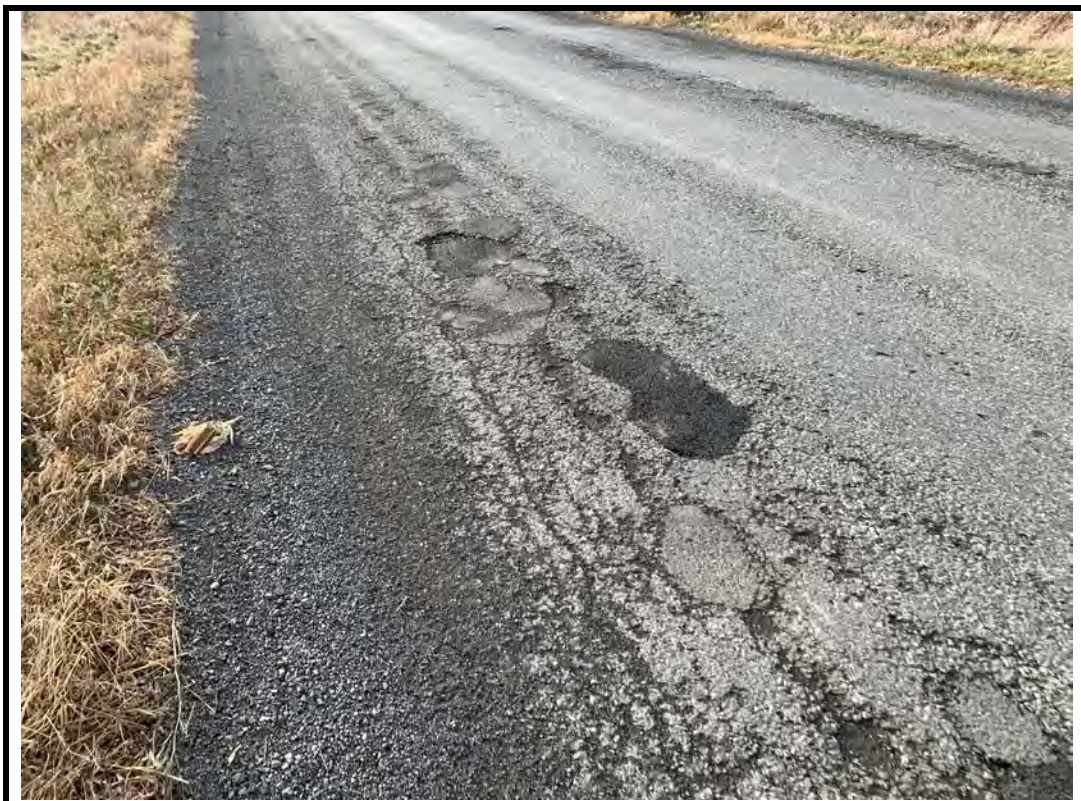
Photo 6 Potholes, and alligator cracks on edge of east wearing surface

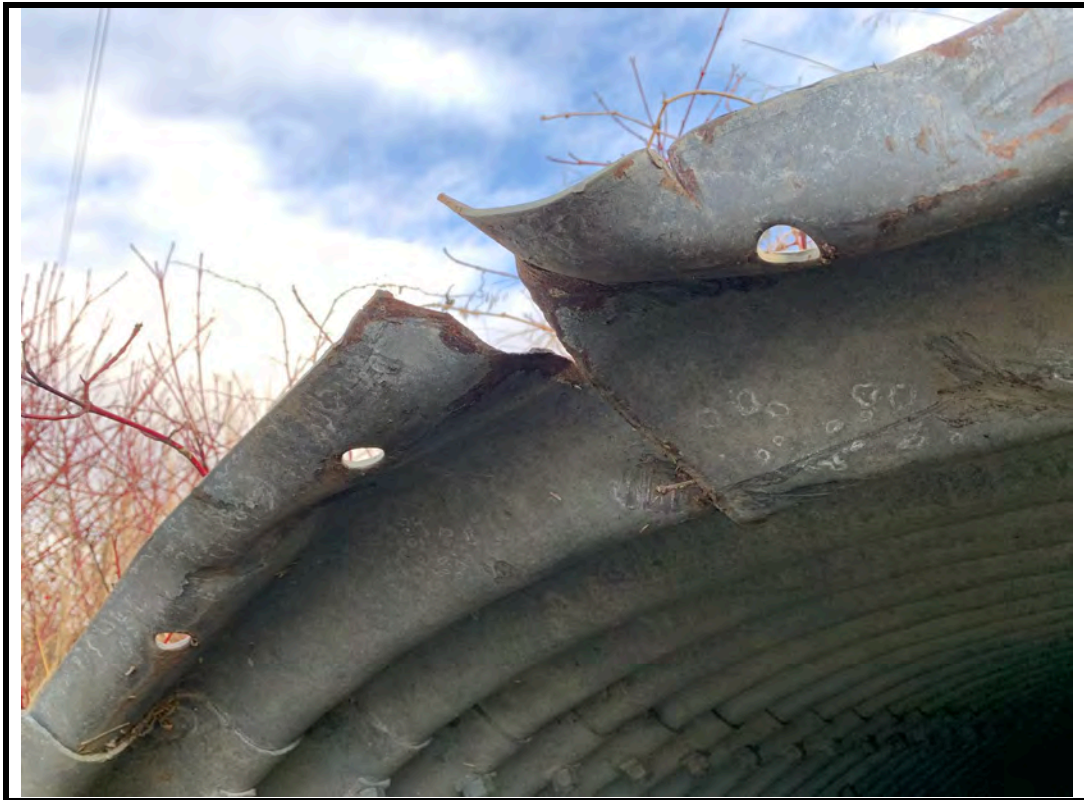
Photo 8 Perforations at north end of barrel

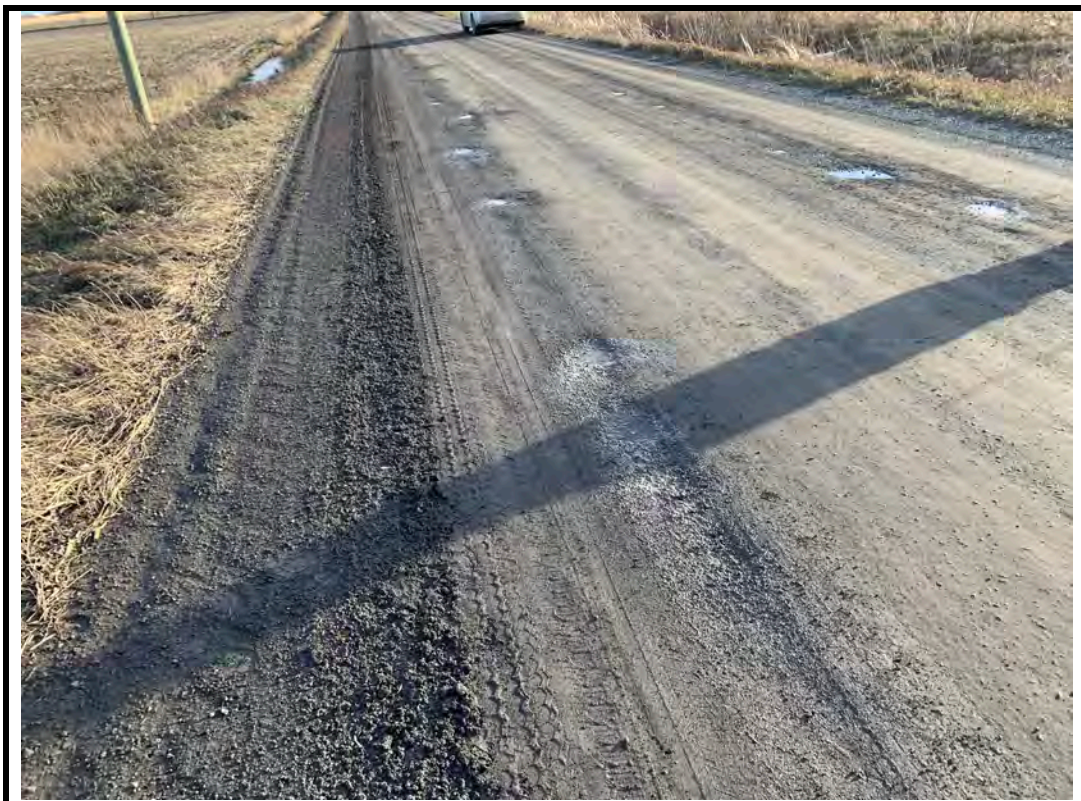
Photo 6 Potholes forming on south wearing surface

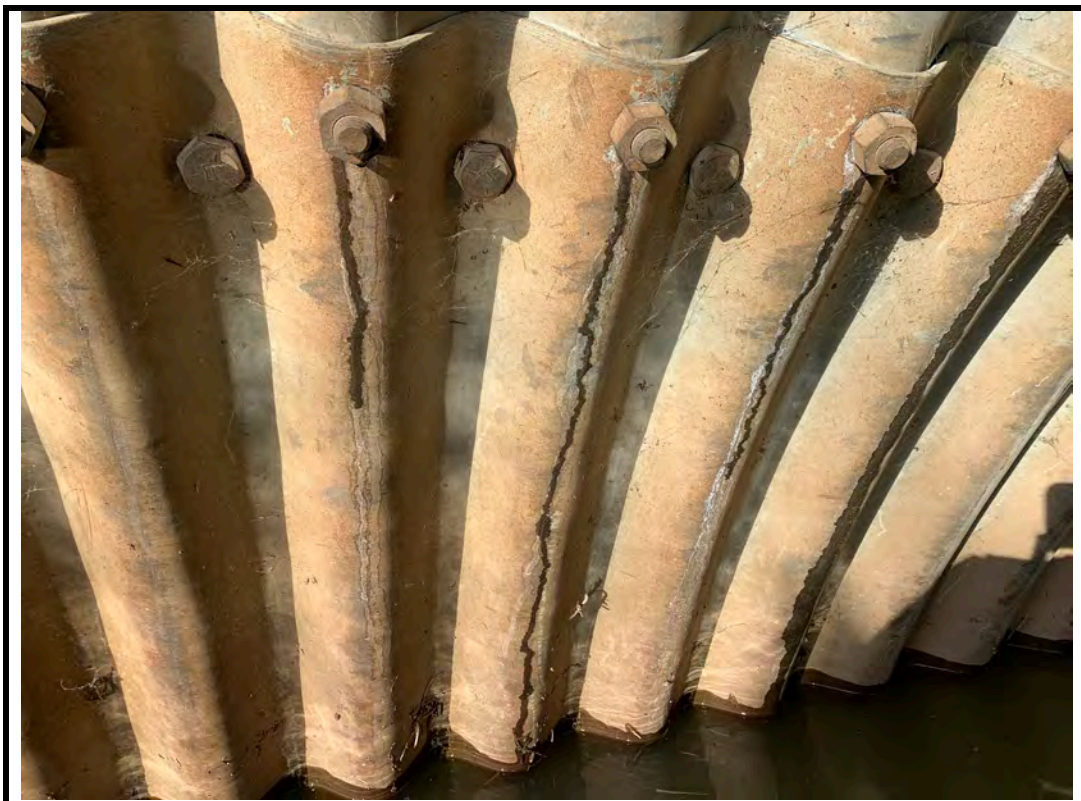
Photo 8 Evidence of leakage from bolt lines at northwest corner of barrel

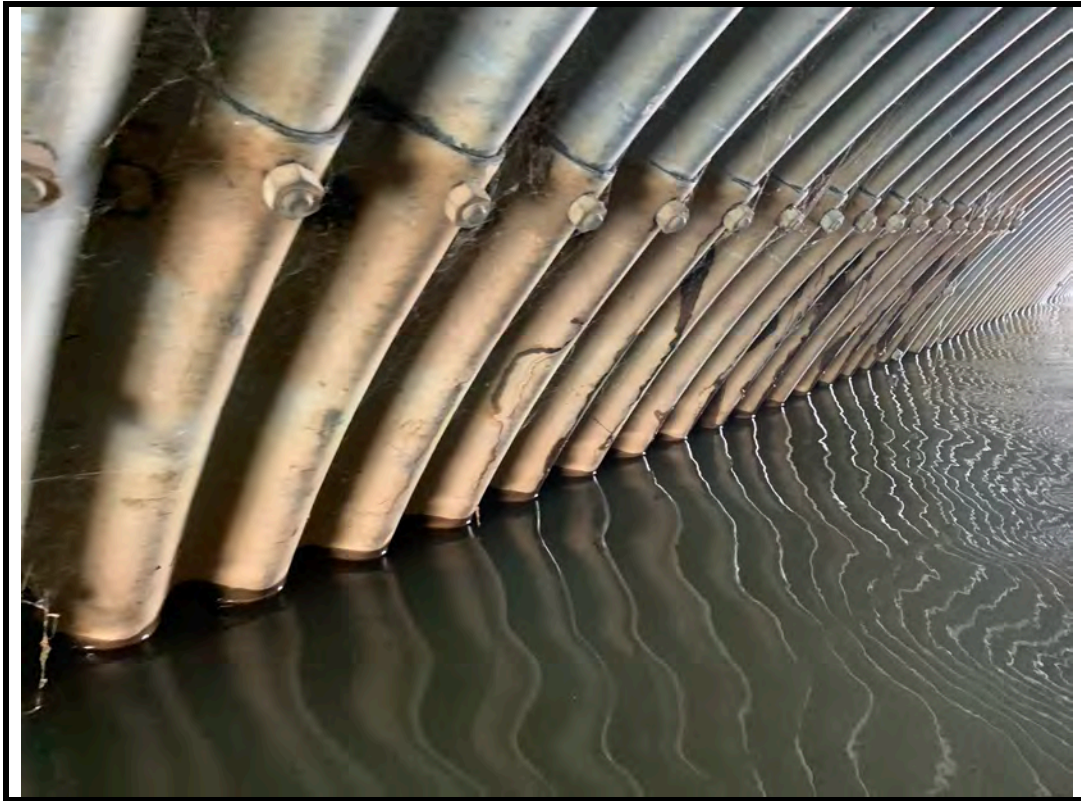
Photo 9 Light corrosion and evidence of leakage on barrel wall

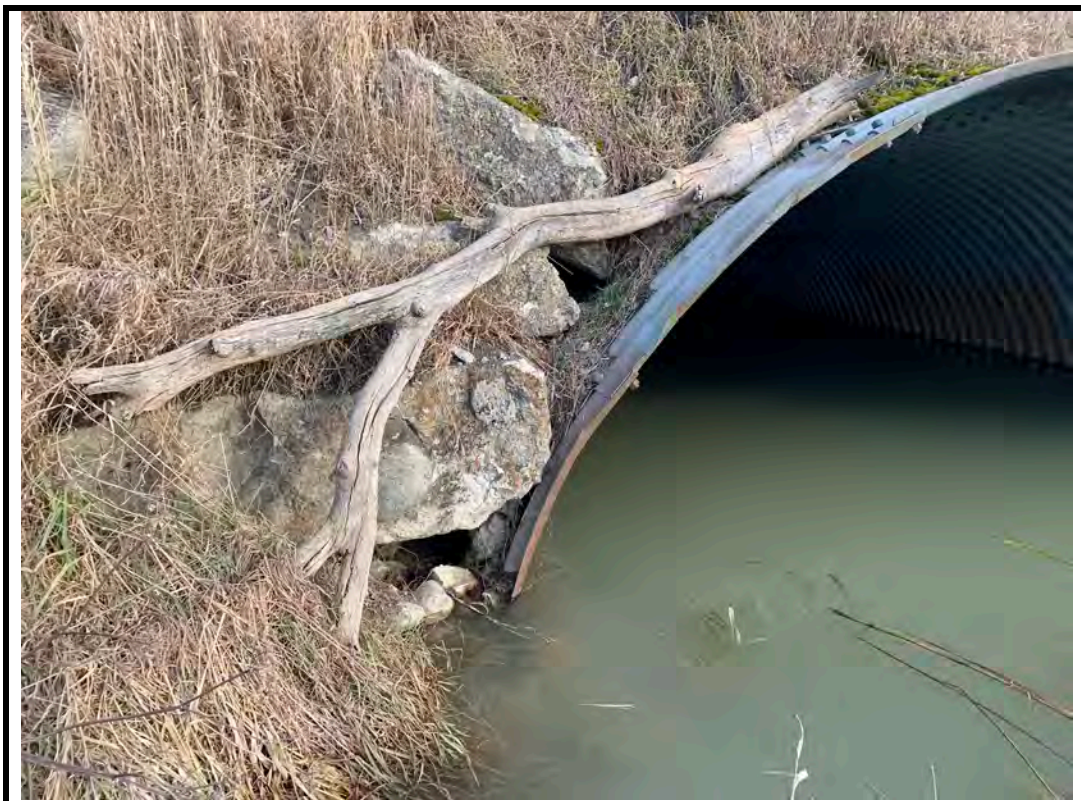
Photo 10 Some fill loss around barrel

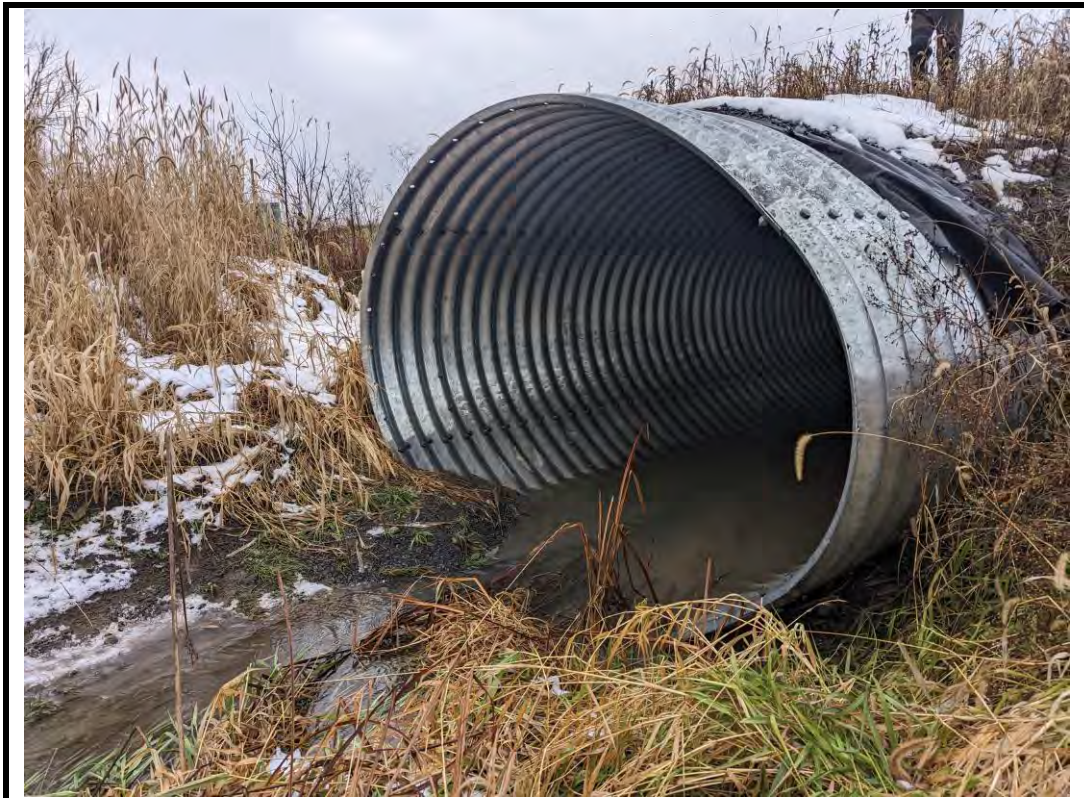
Photo 8 South culvert barrel end and encroachment of washout (inlet)

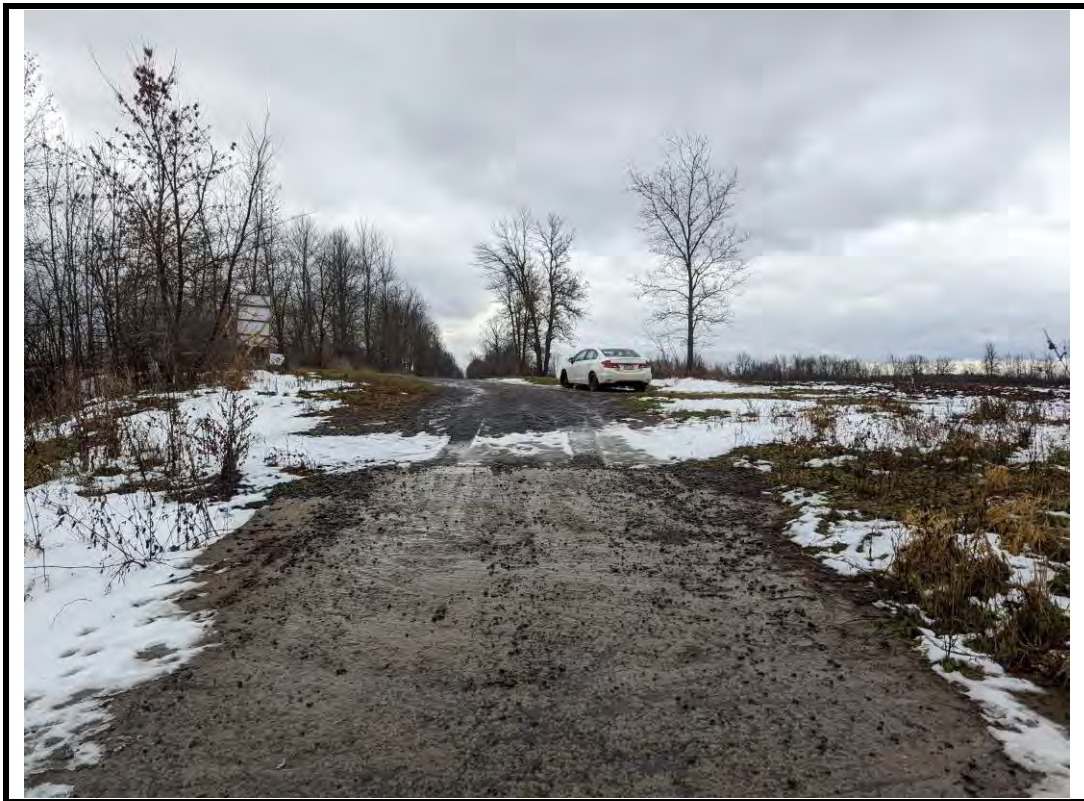
Photo 4 South approach from centre of structure

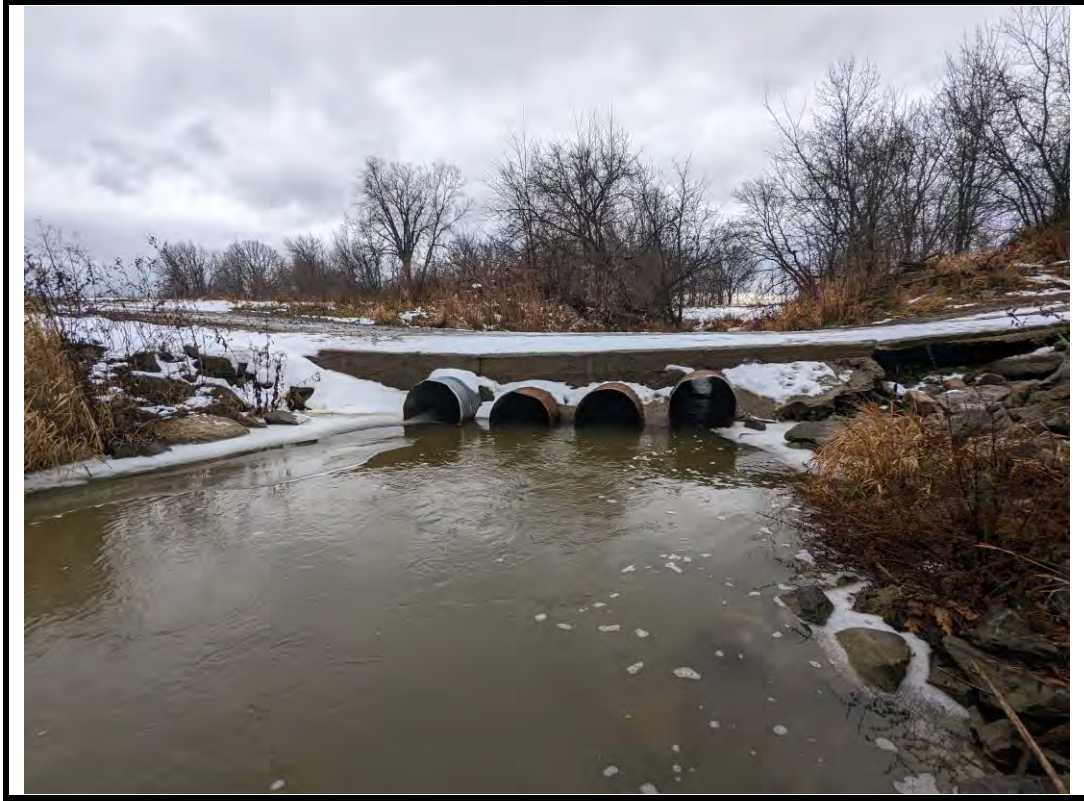
Photo 5 East elevation

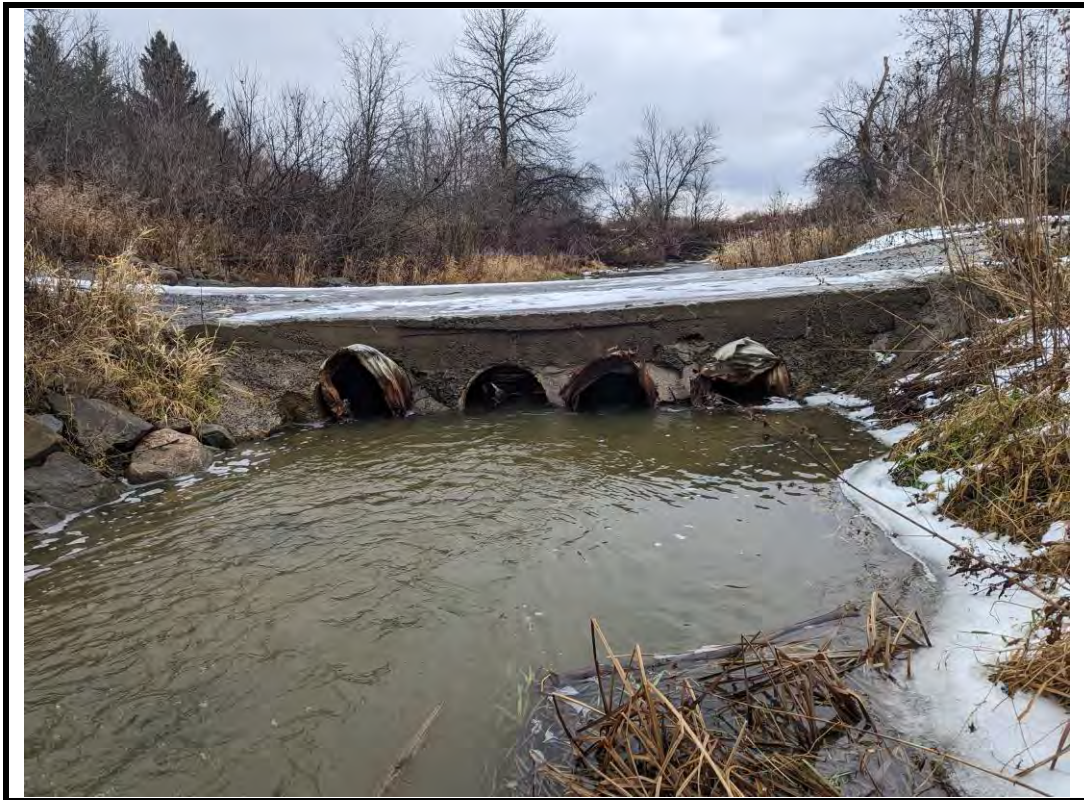
Photo 6 West elevation

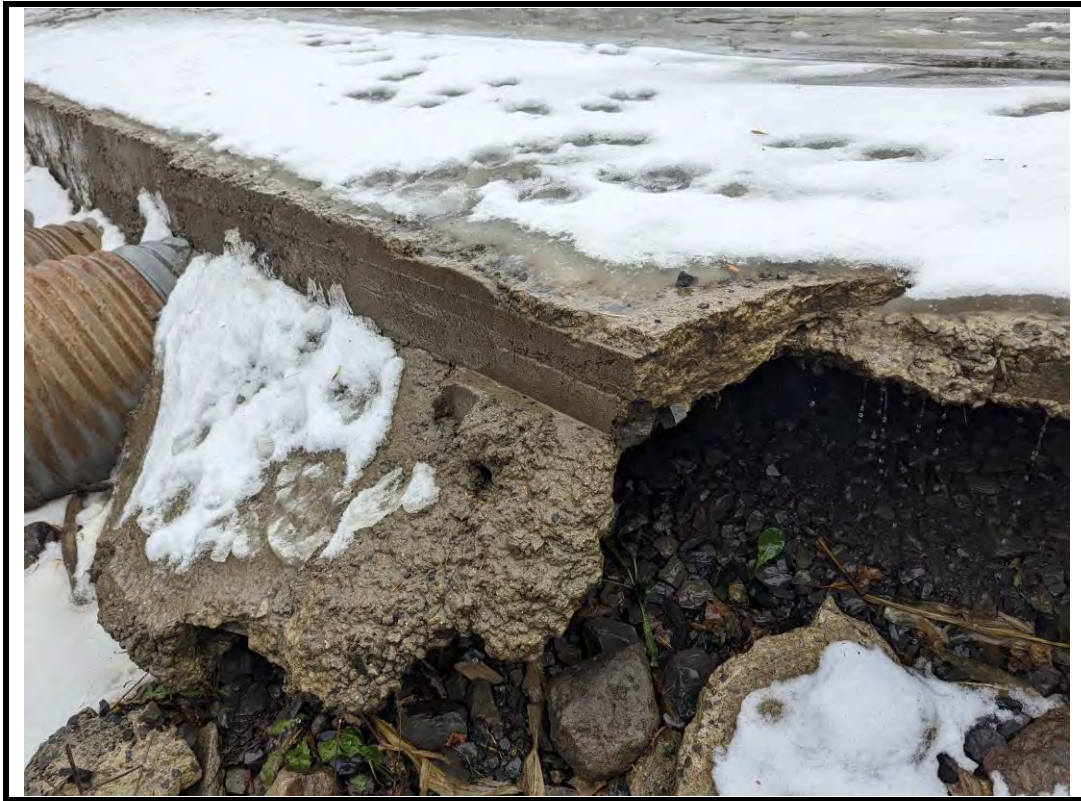
Photo 7 Severe undermining and loss of fill at North approach slab (1)

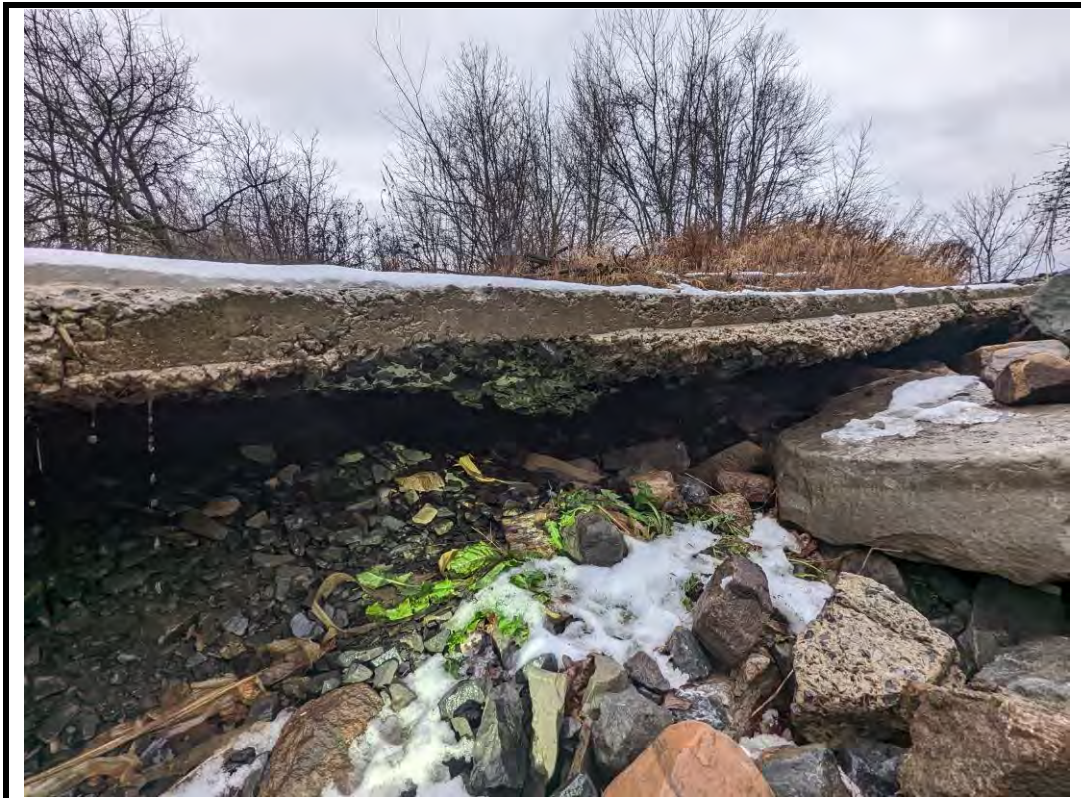
Photo 8 Severe undermining and loss of fill at North approach slab (2)

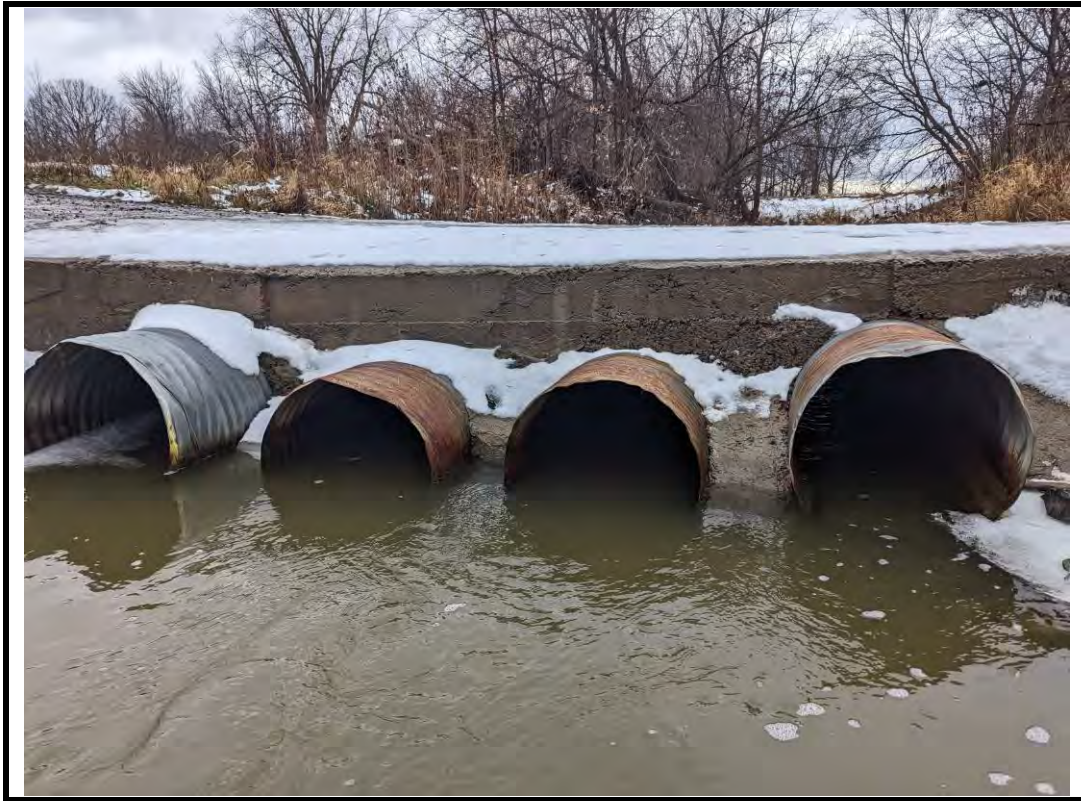
Photo 9 View of East barrel ends

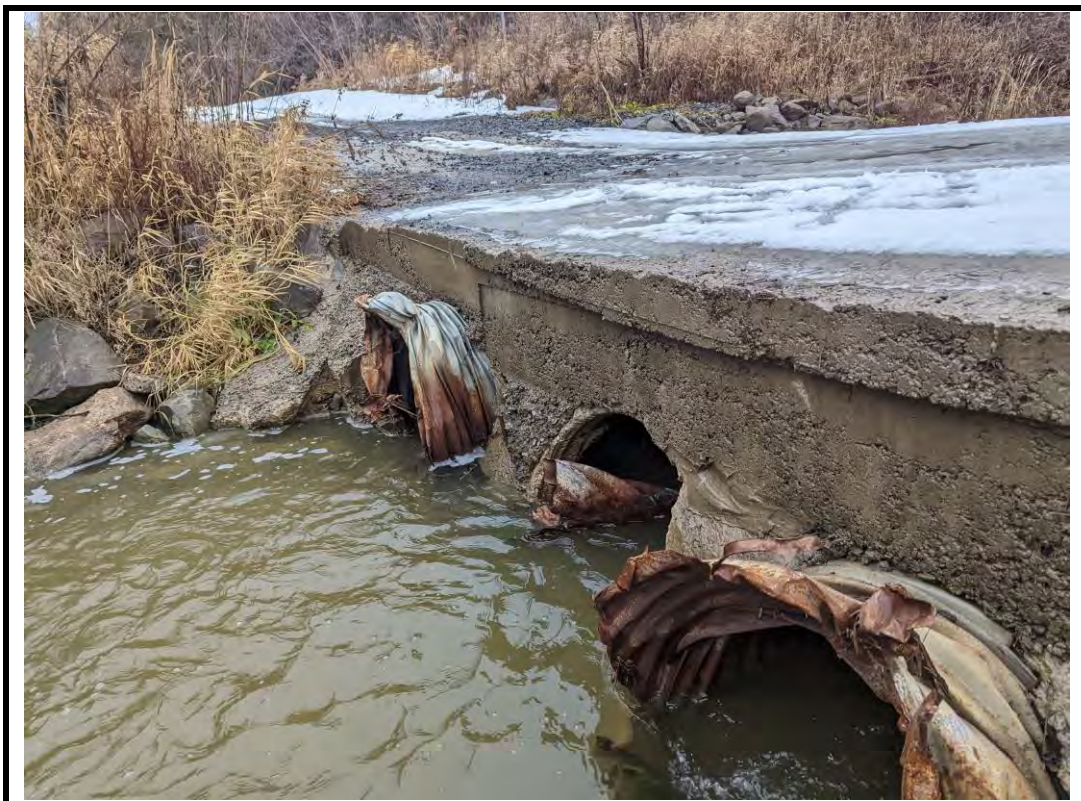
Photo 10 Severe deformations on west ends of barrels, and scaling on concrete deck

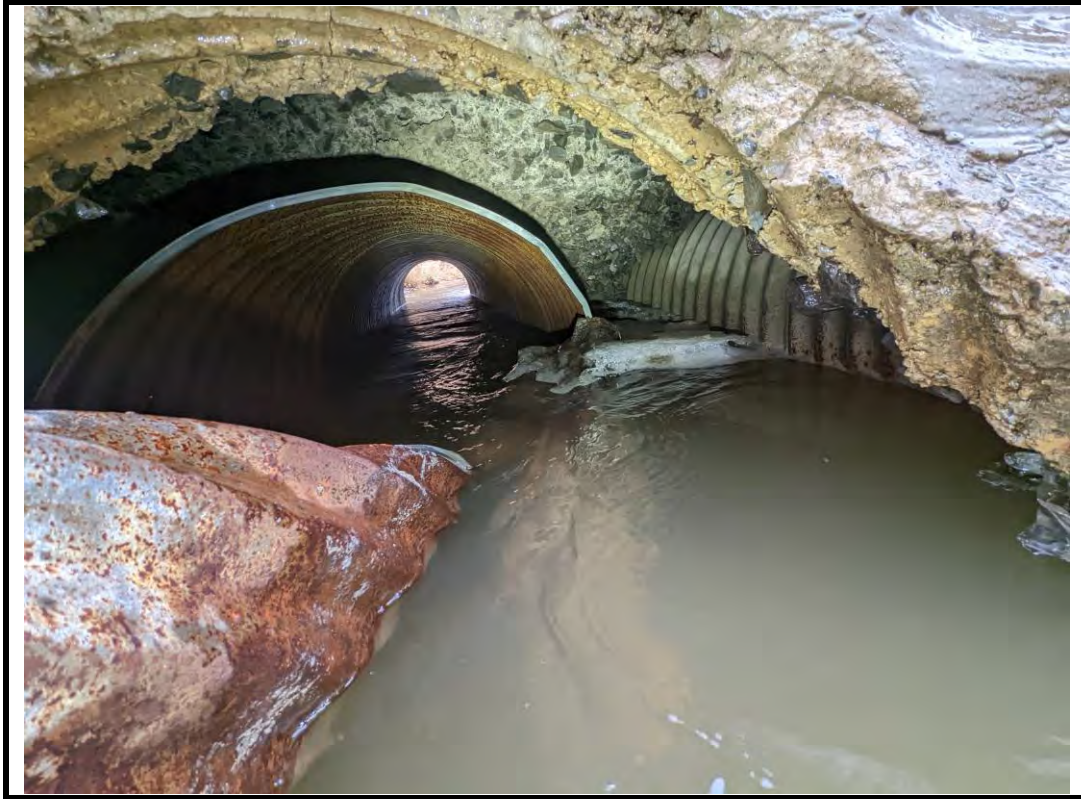
Photo 11 Separation of barrels and voids in slab around barrels on west side

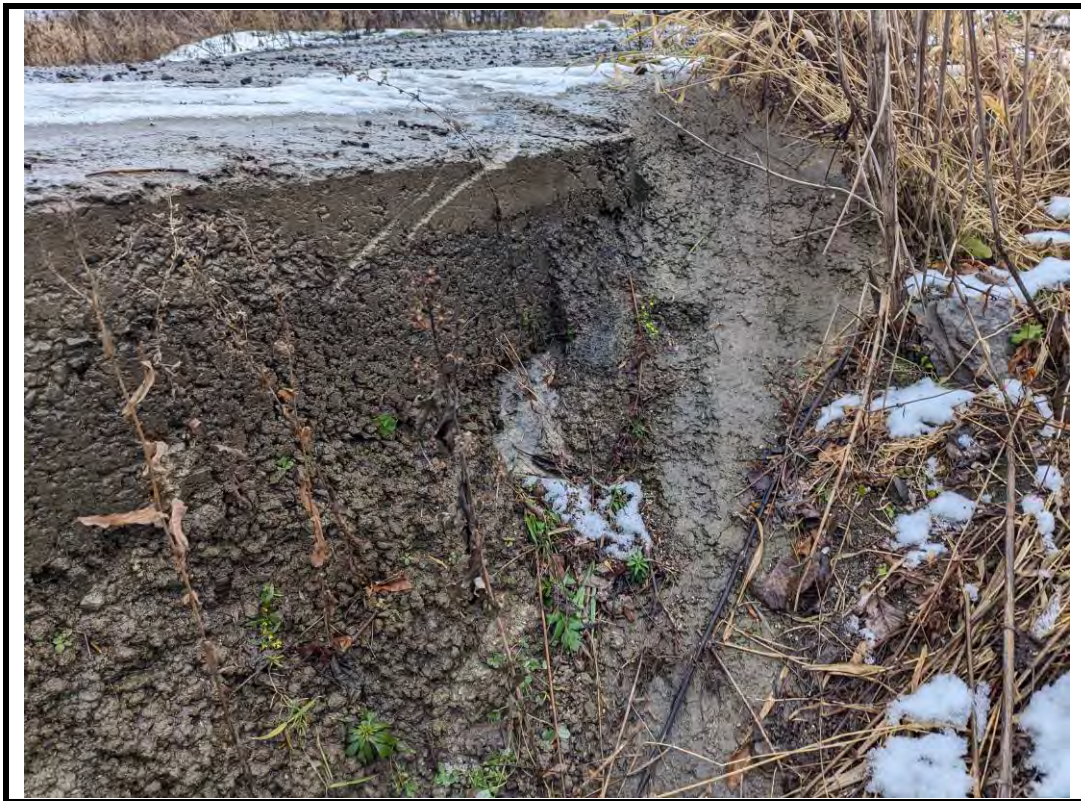
Photo 12 Severe scaling of concrete wingwalls and slab (typical)

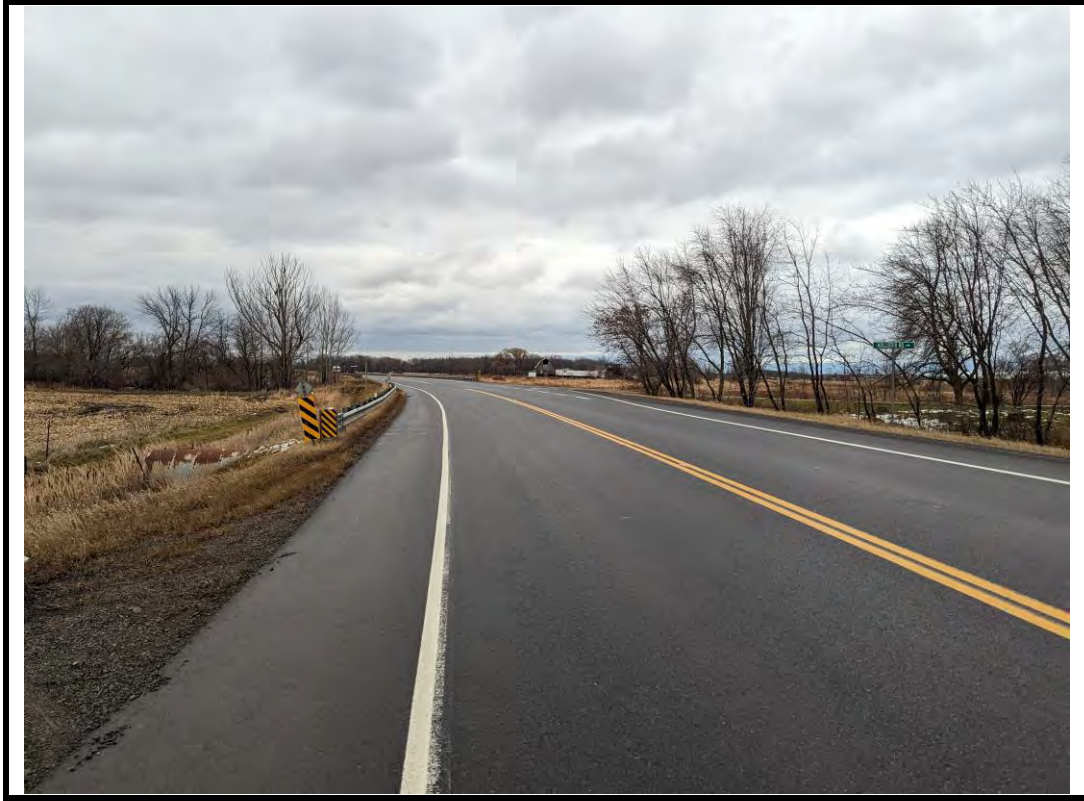
Photo 1 Structure from north approach

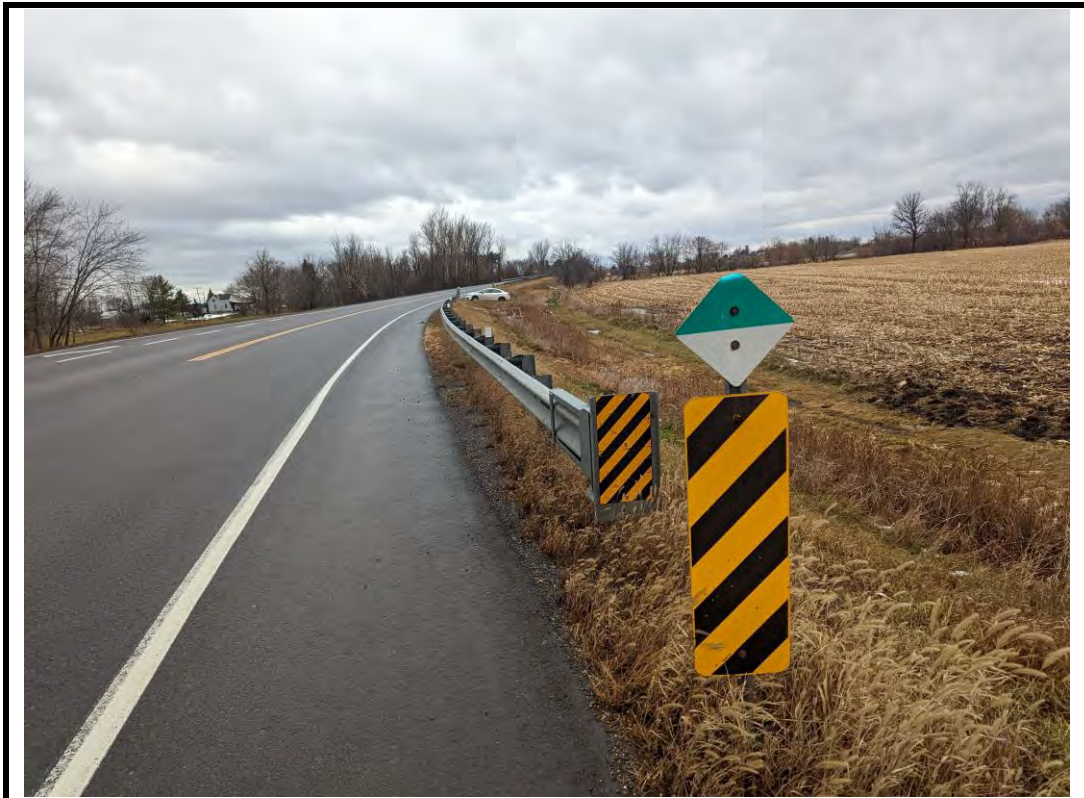
Photo 2 Structure from south approach

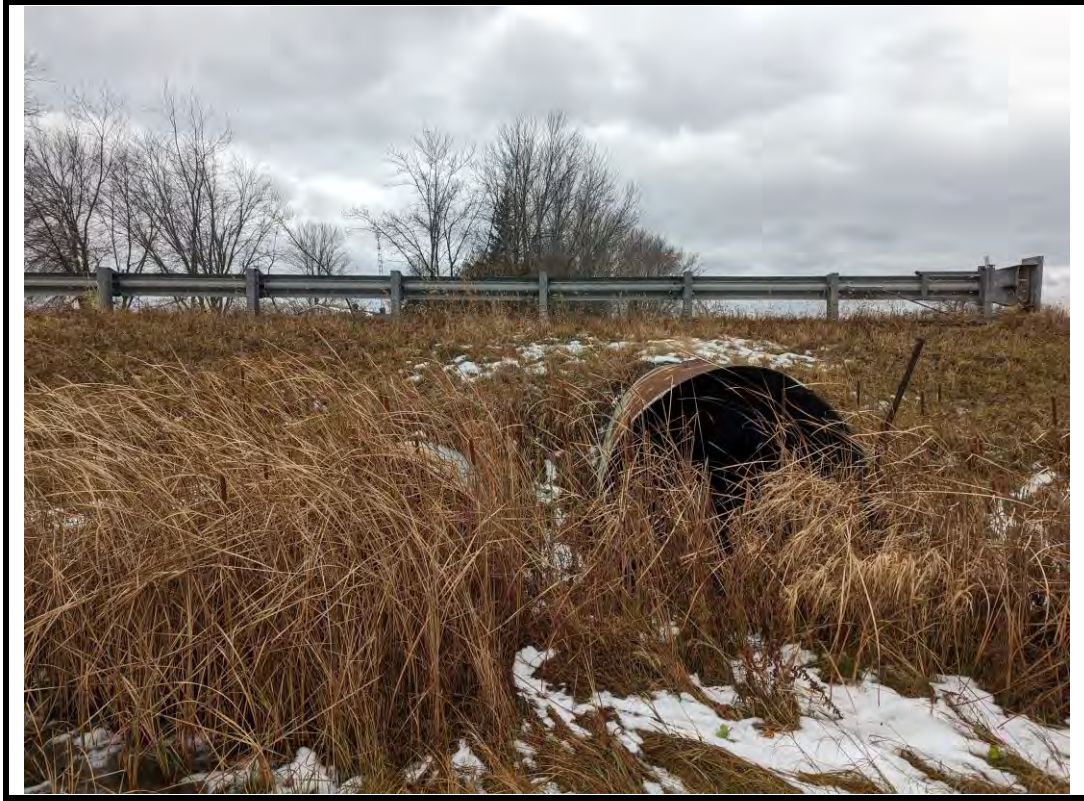
Photo 3 East elevation

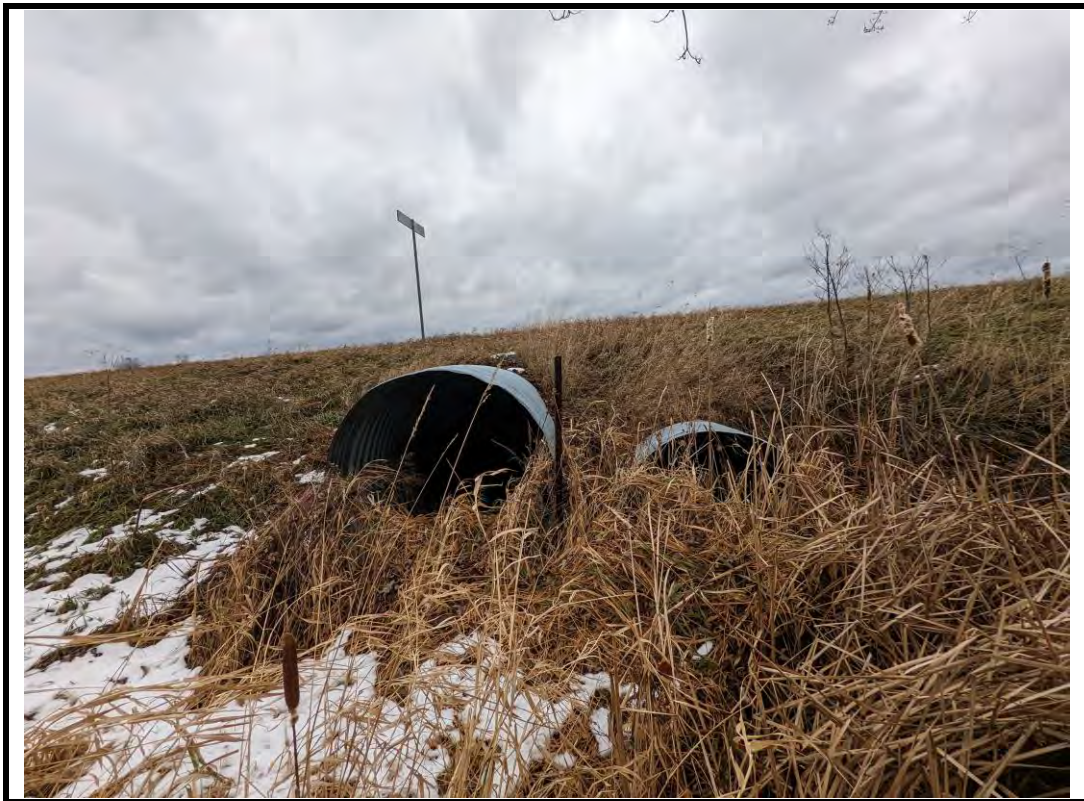
Photo 4 West elevation

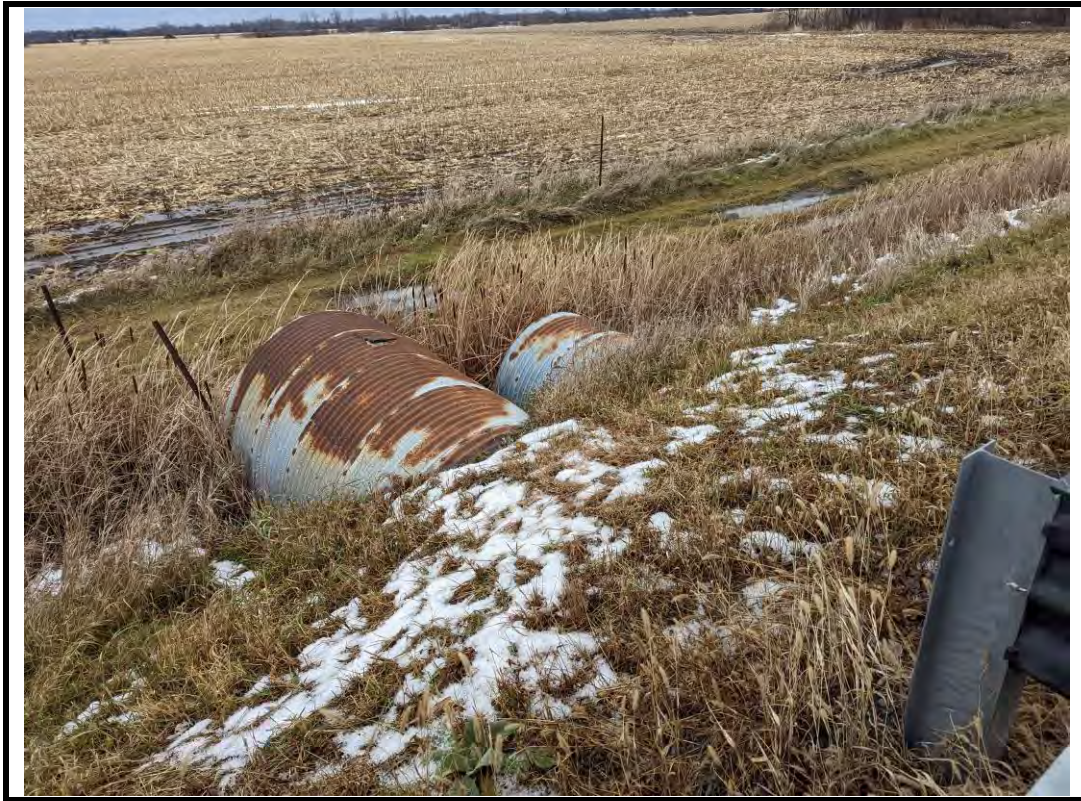
Photo 5 View of east end of barrels from roadway

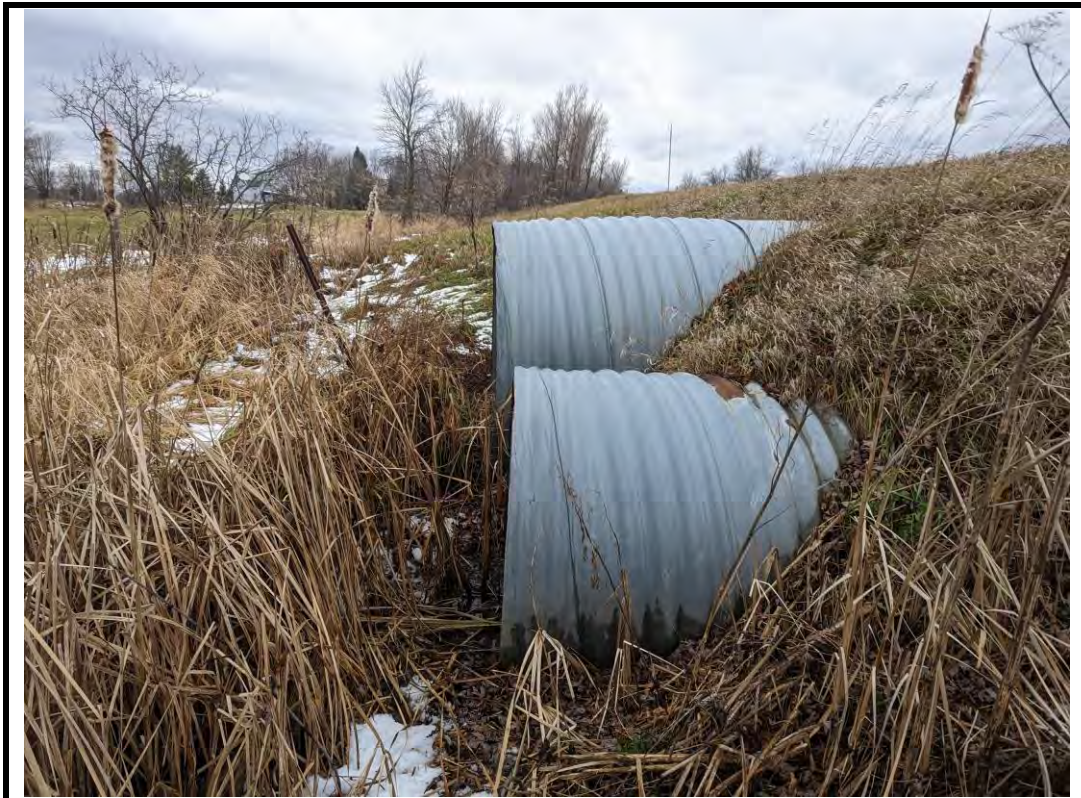
Photo 6 View of west end of barrels from the Southwest embankment

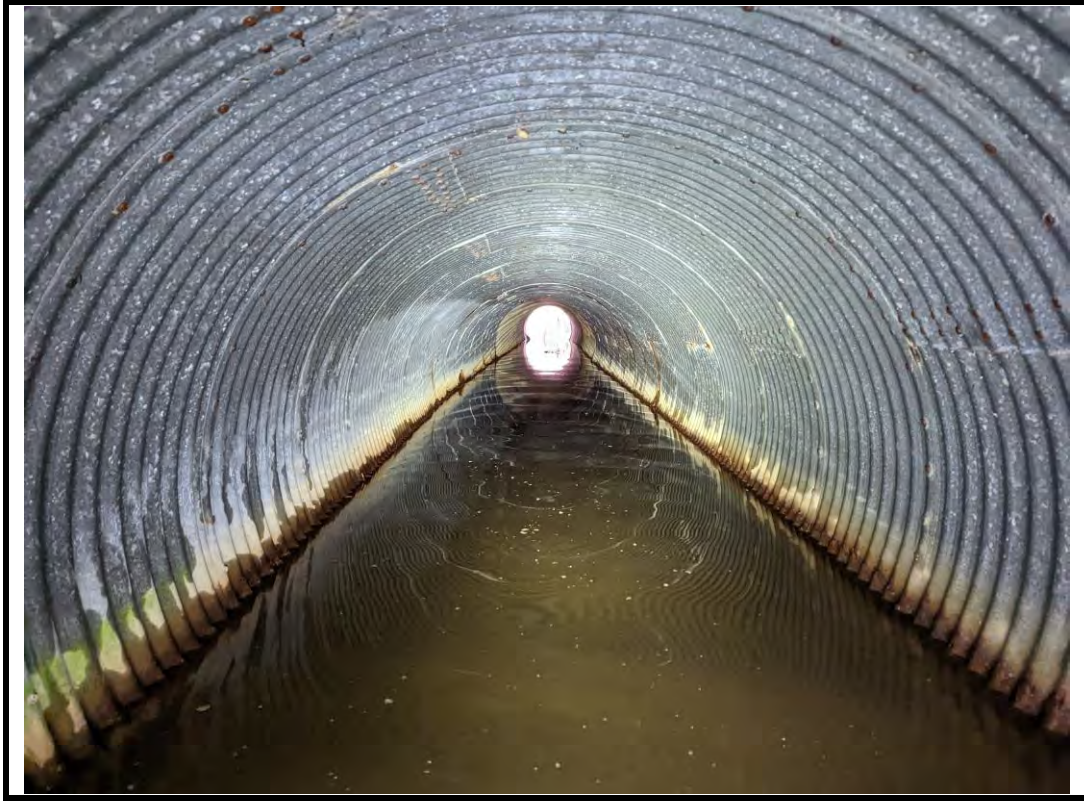
Photo 7 View through south barrel, looking west

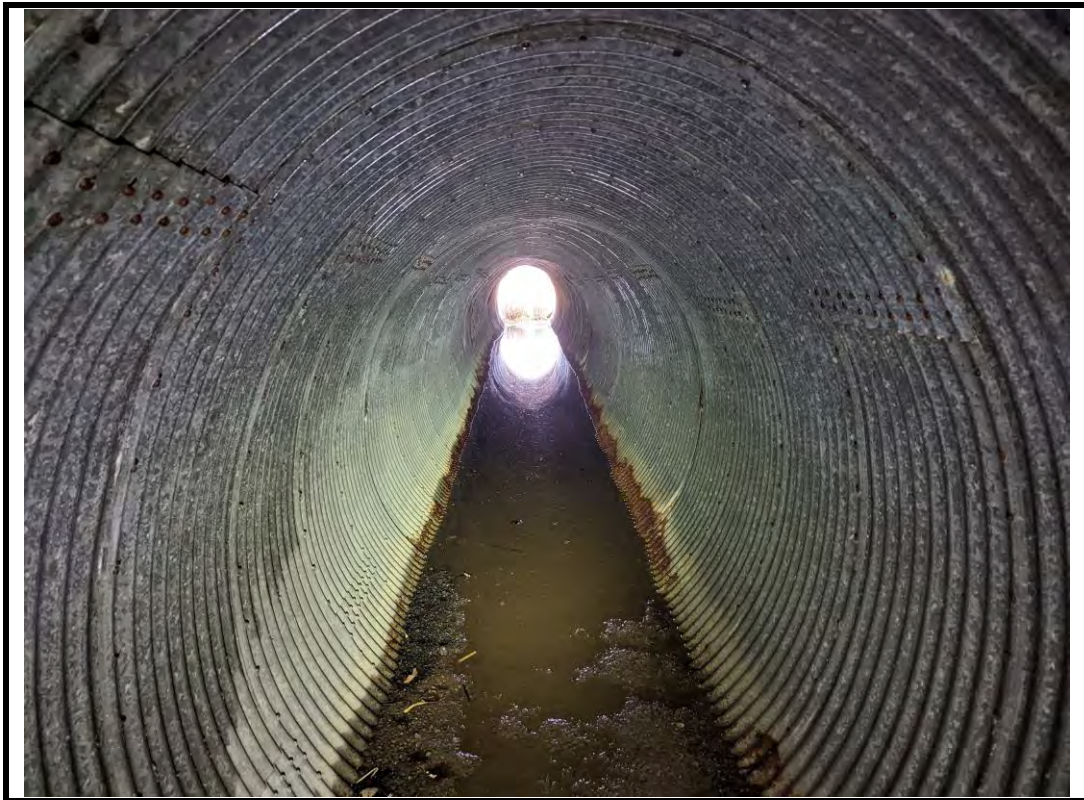
Photo 8 View through north barrel, looking east

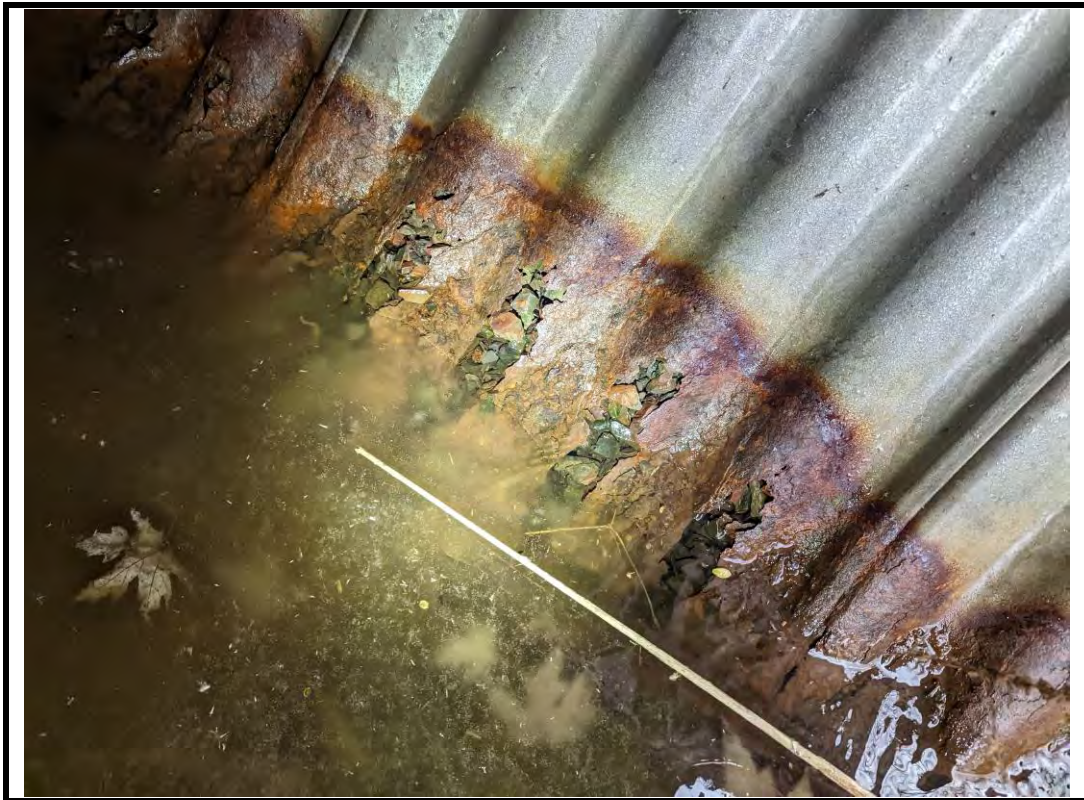
Photo 10 Perforations and corrosion at waterline in North barrel
