THE TOWNSHIP OF NORTH DUNDAS

DRAFT BRIDGE MANAGEMENT STUDY REPORT 18 BRIDGES / 31 CULVERTS

March 2023

HP Engineering Inc.

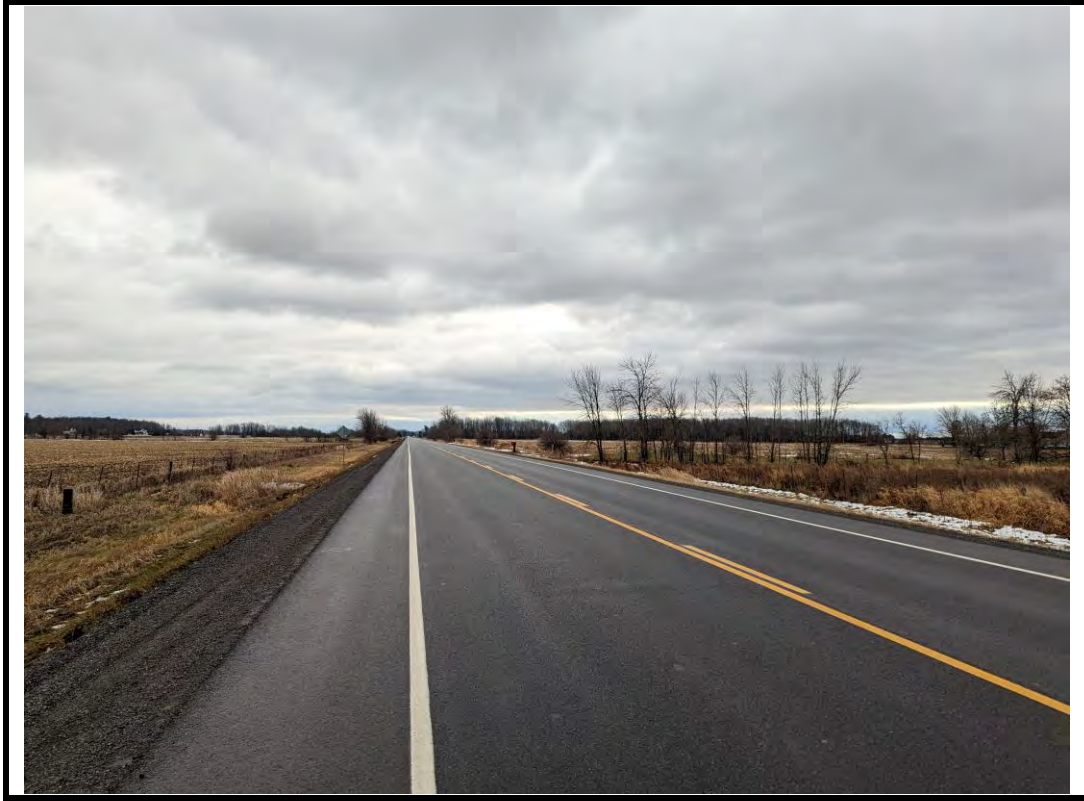
Photo 1 Structure from north approach

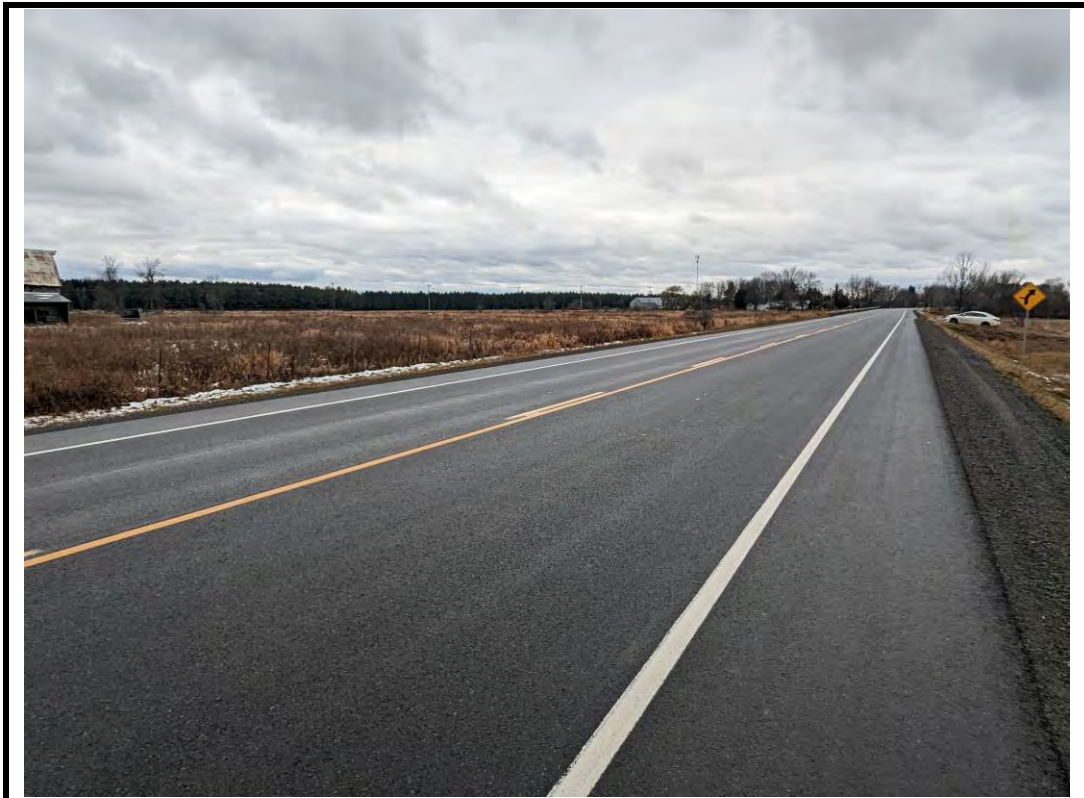
Photo 2 Structure from south approach

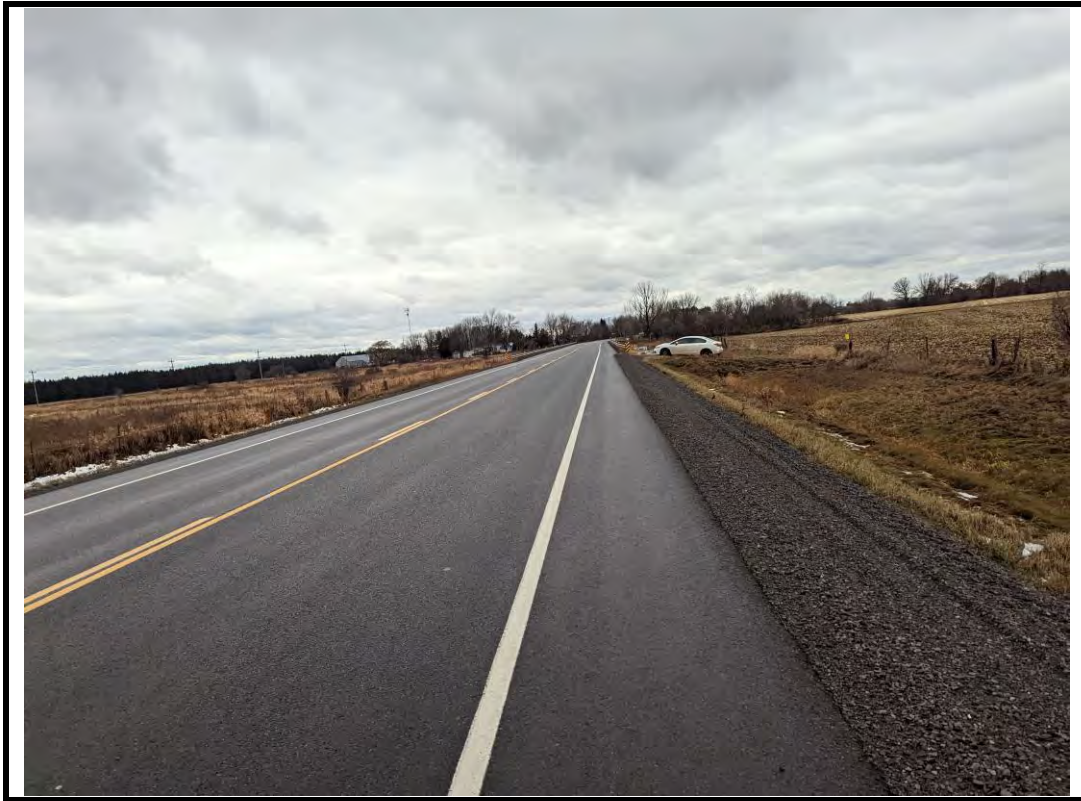
Photo 3 North approach from centre of structure

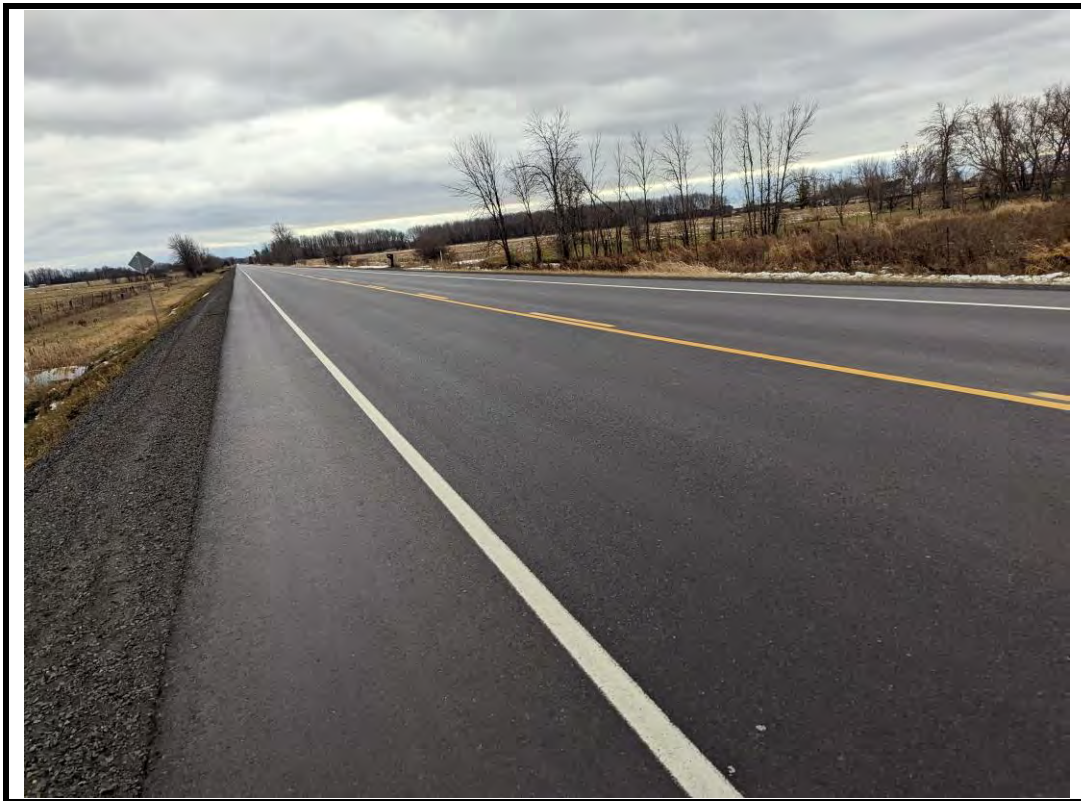
Photo 4 South approach from centre of structure

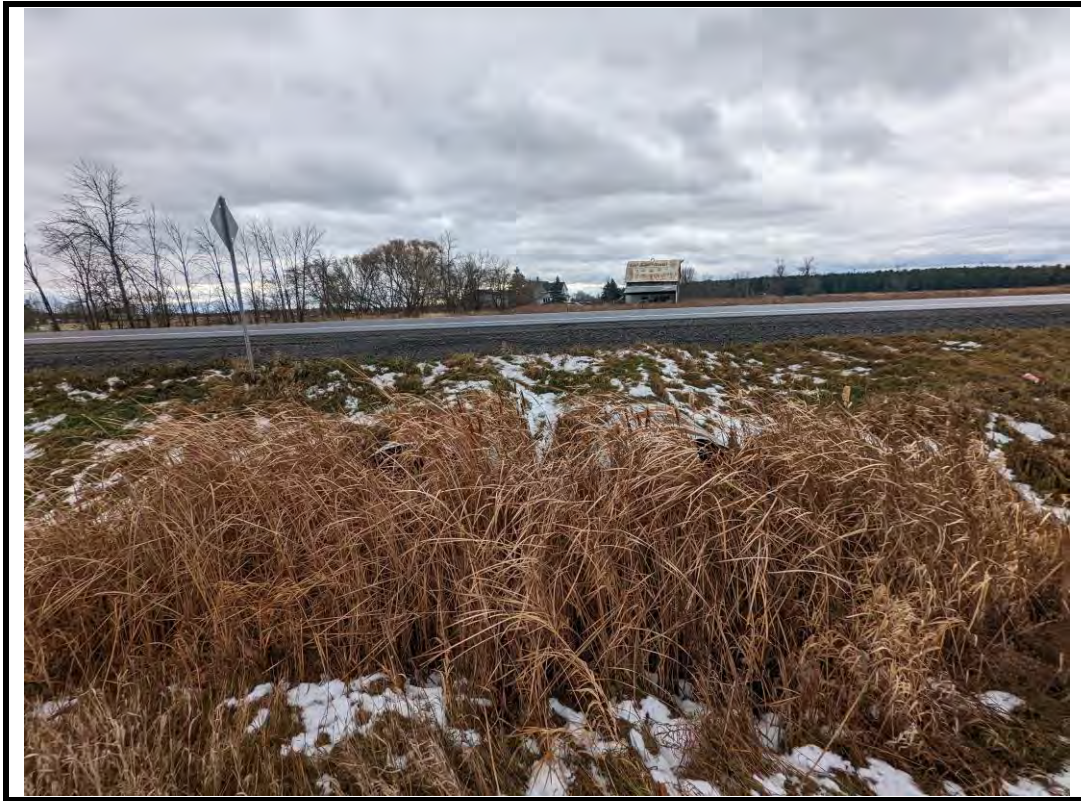
Photo 5 East elevation

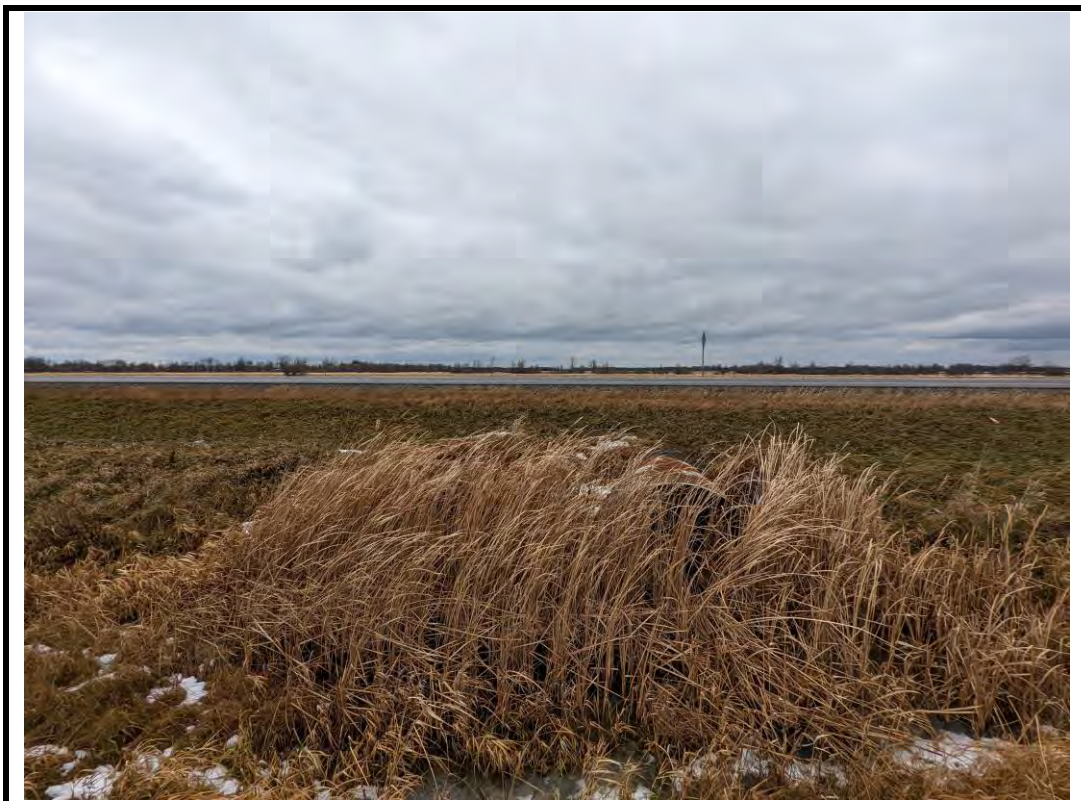
Photo 6 West elevation

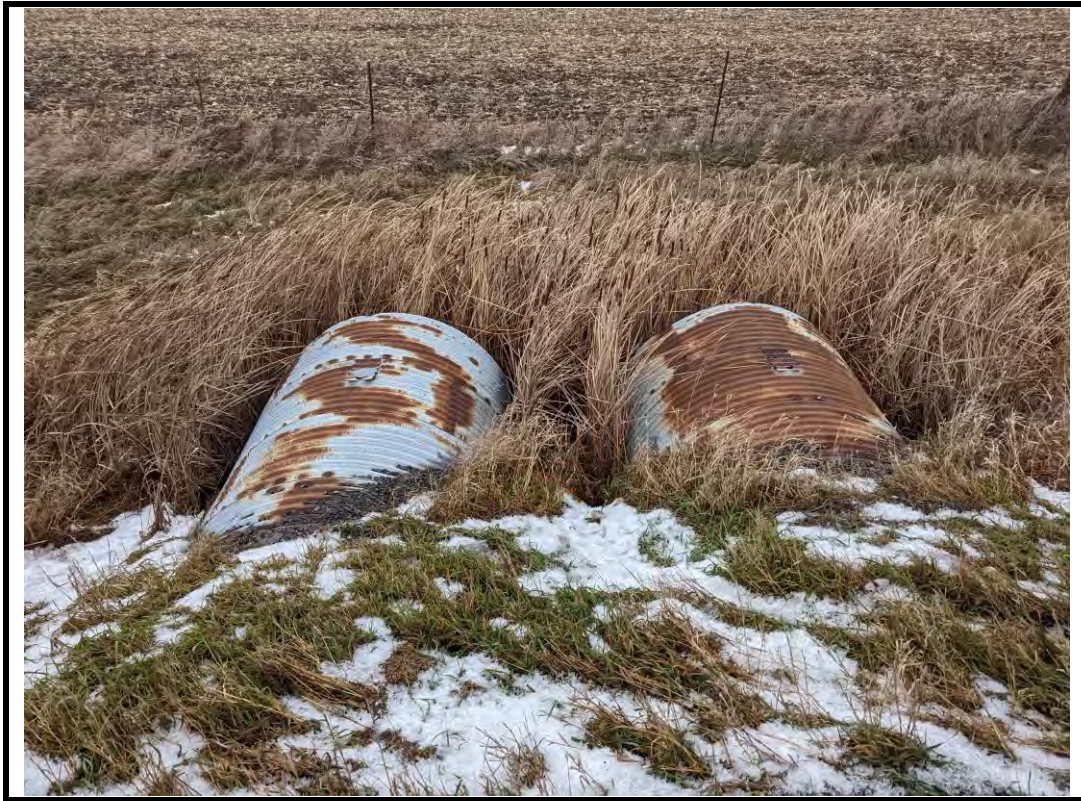
Photo 7 View over culverts towards the East

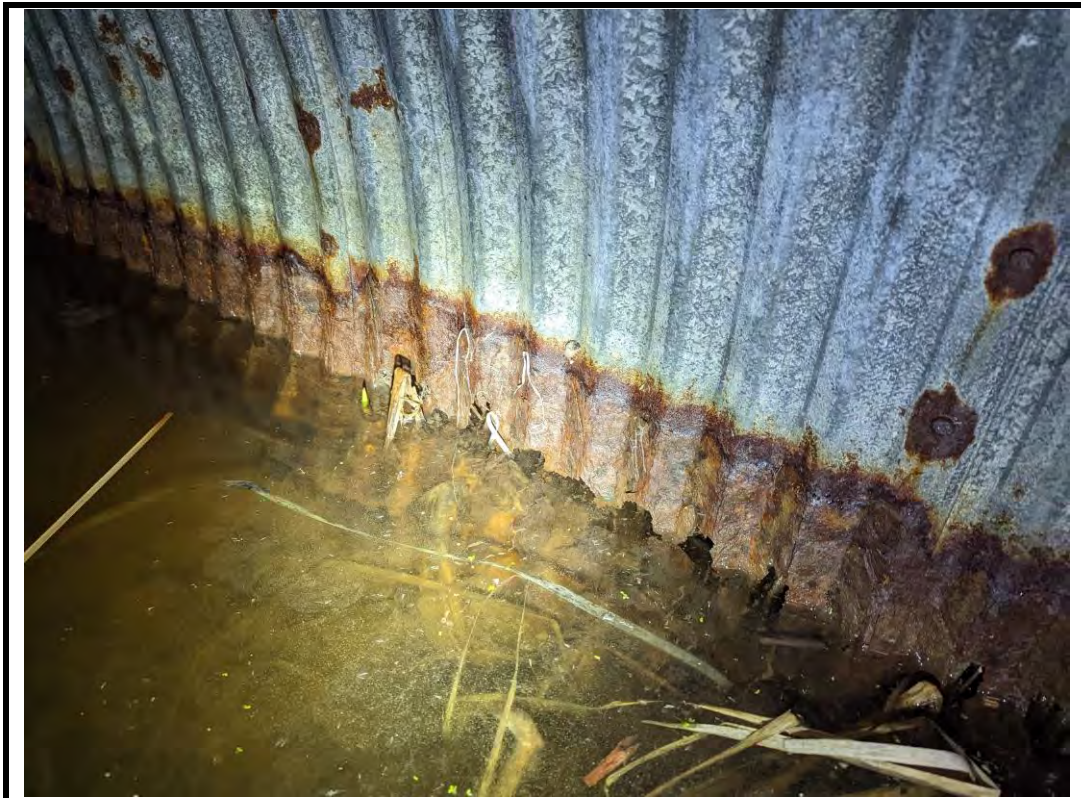
Photo 8 Severe corrosion and perforation at waterline within South barrel (typ.)

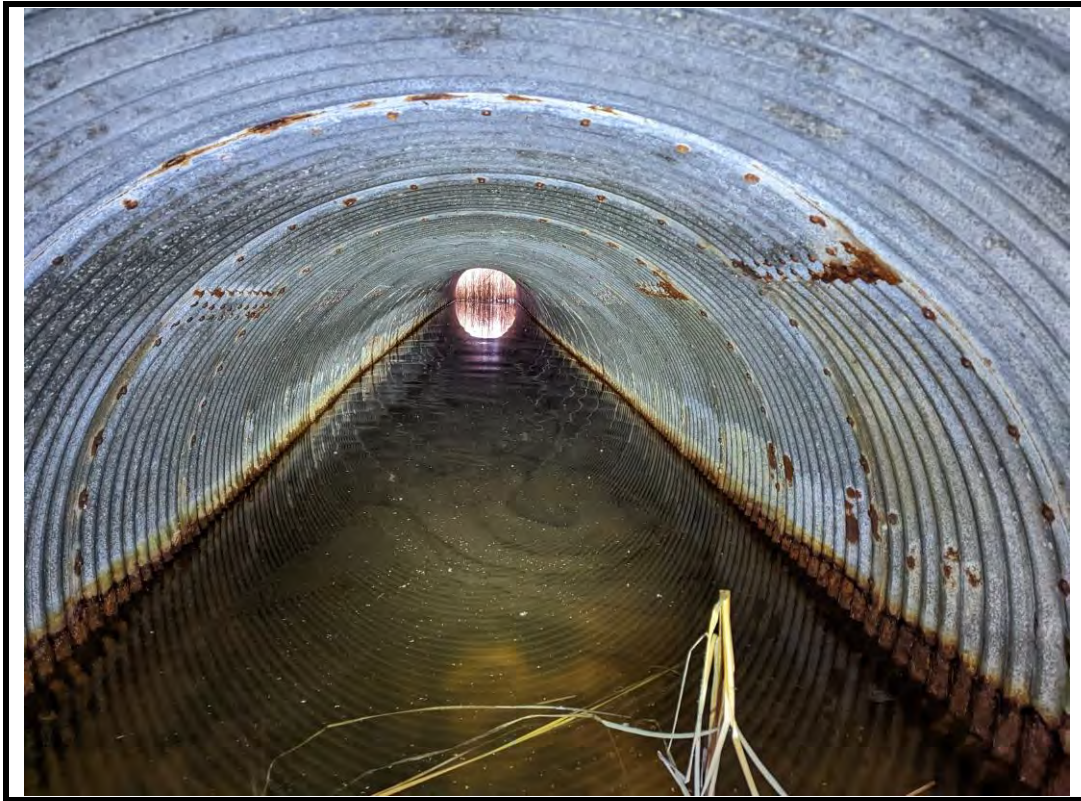
Photo 9 View through south culvert barrel, looking West

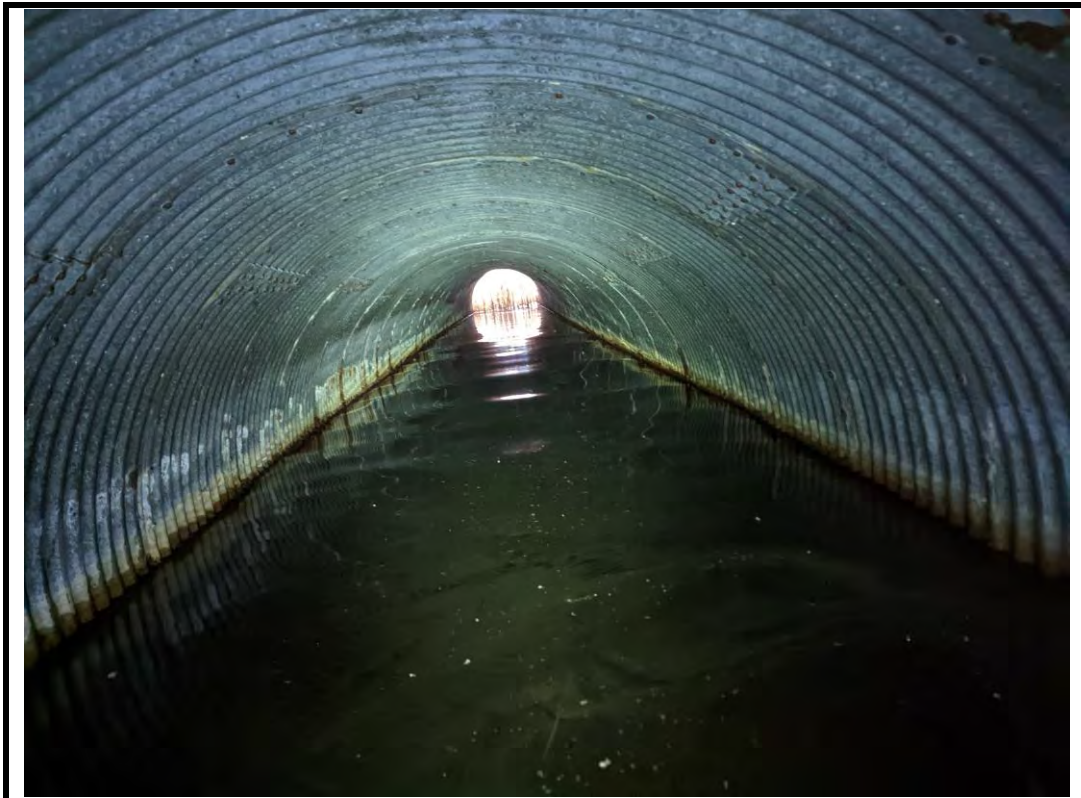
Photo 10 View through north culvert barrel, looking East

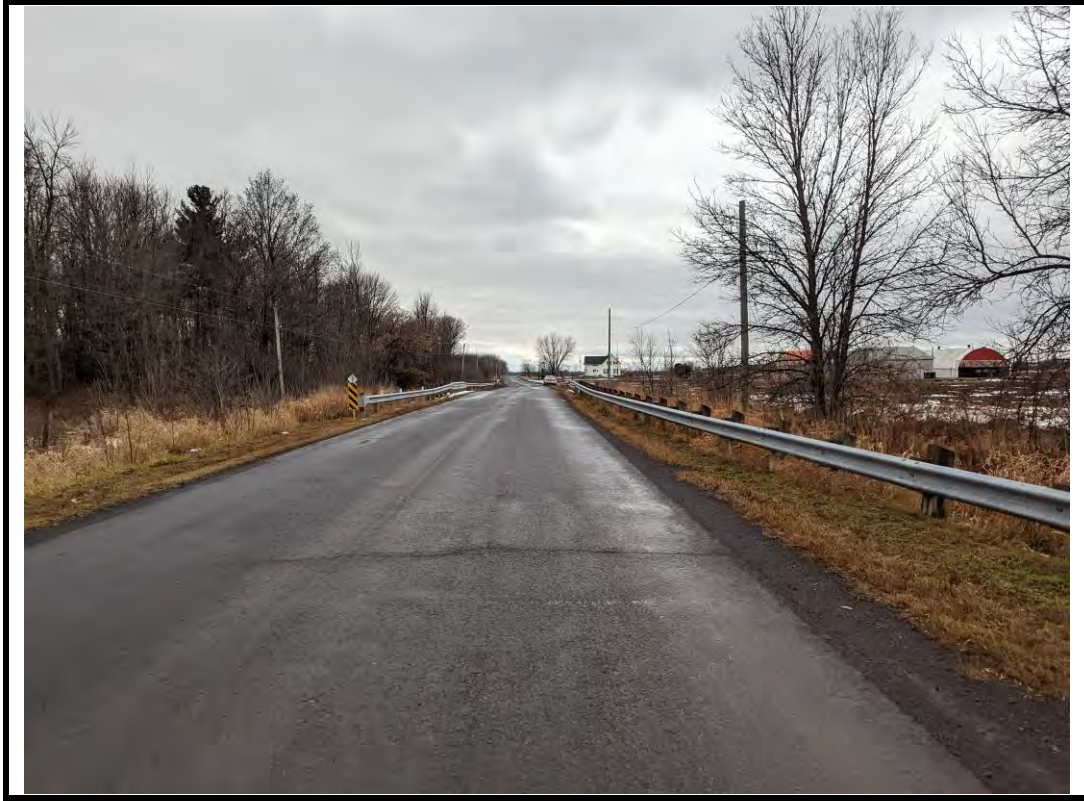
Photo 1 Structure from east approach

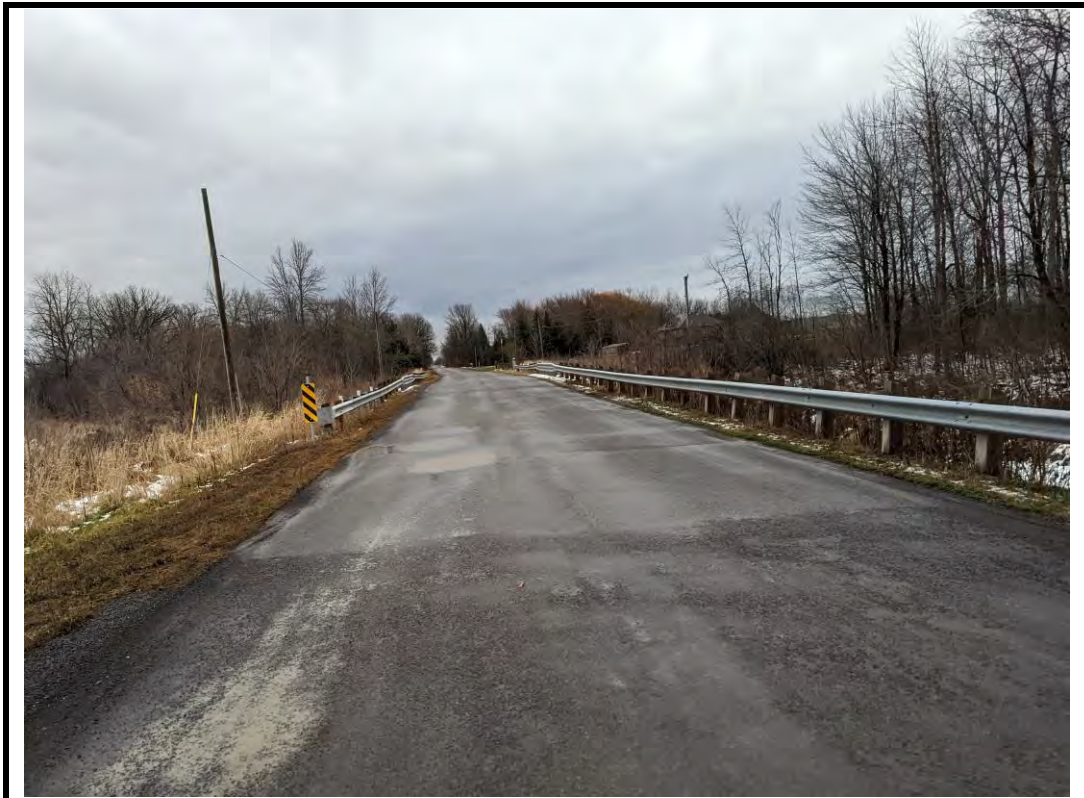
Photo 2 Structure from west approach

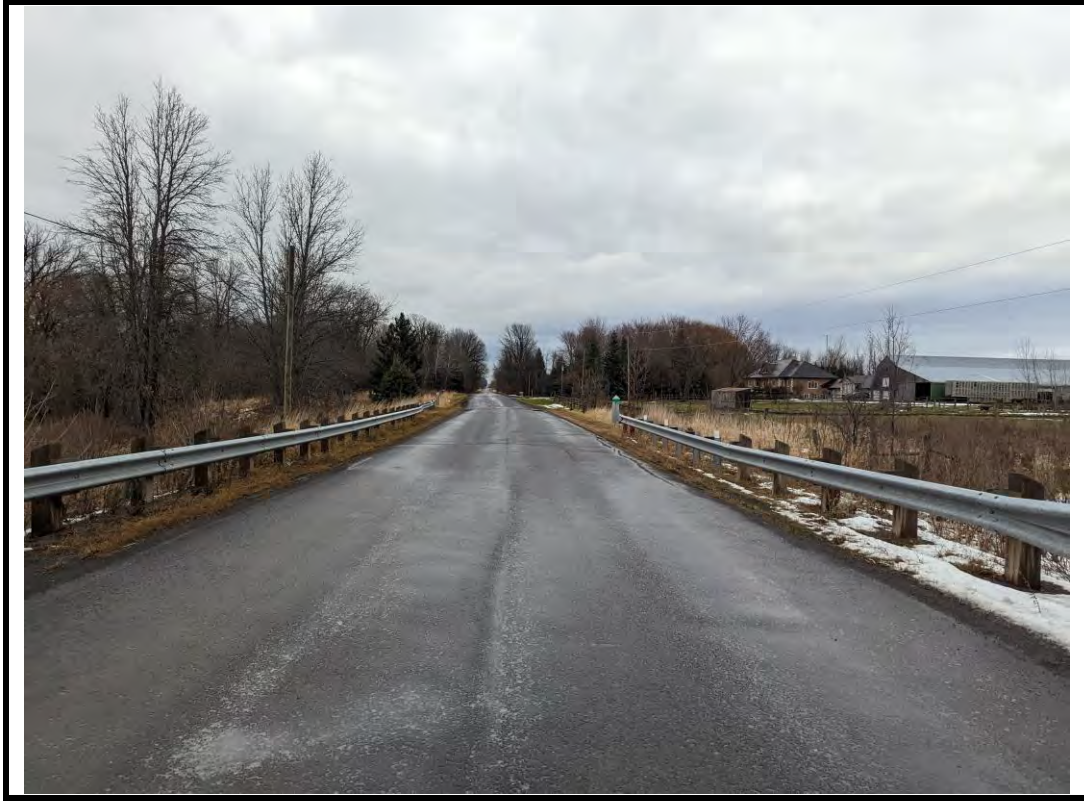
Photo 3 East approach from centre of structure

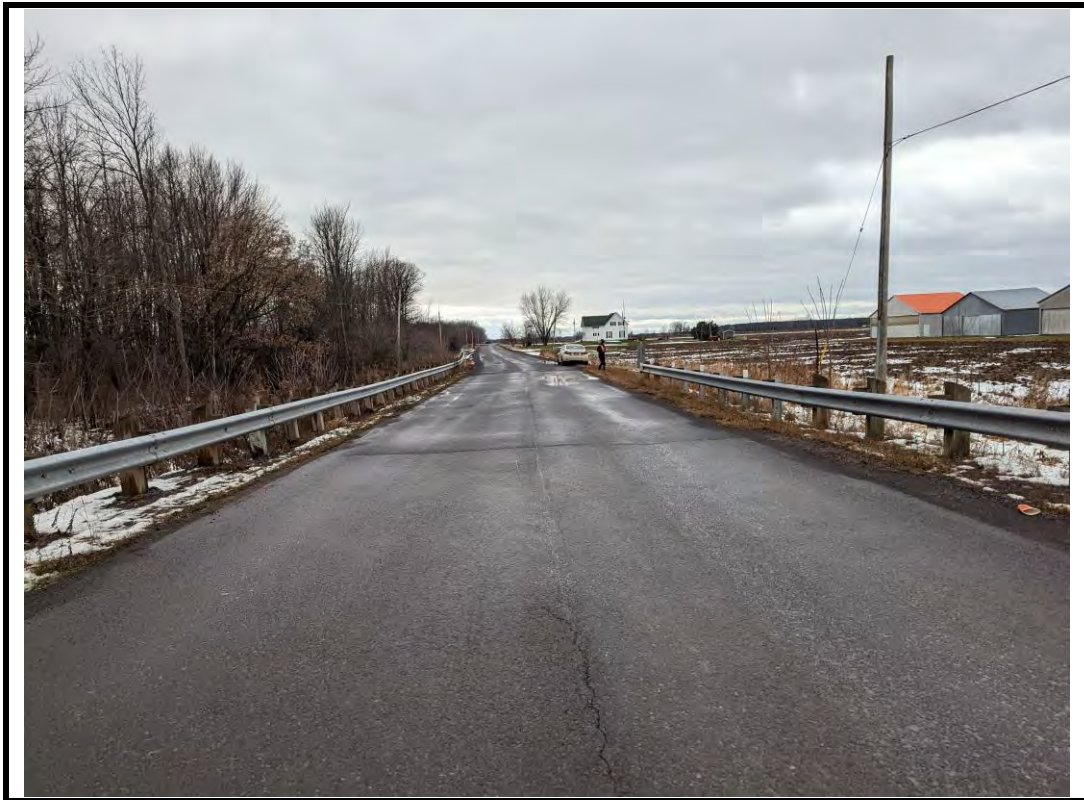
Photo 4 West approach from centre of structure

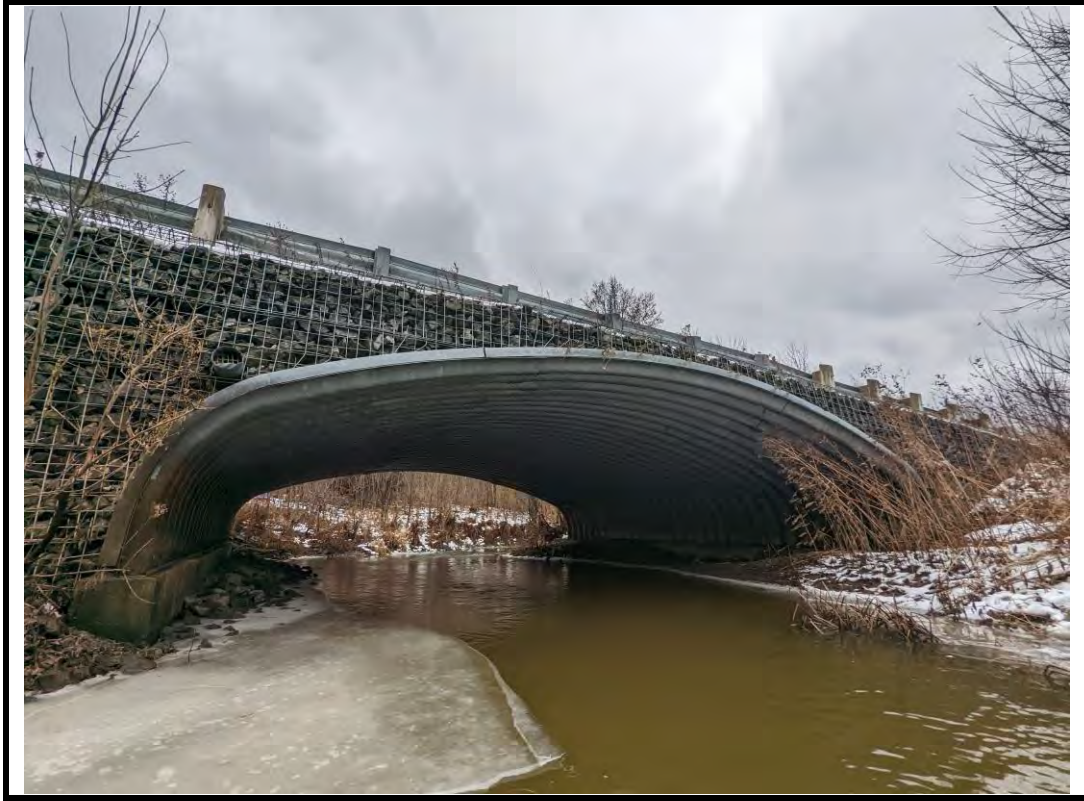
Photo 5 North elevation

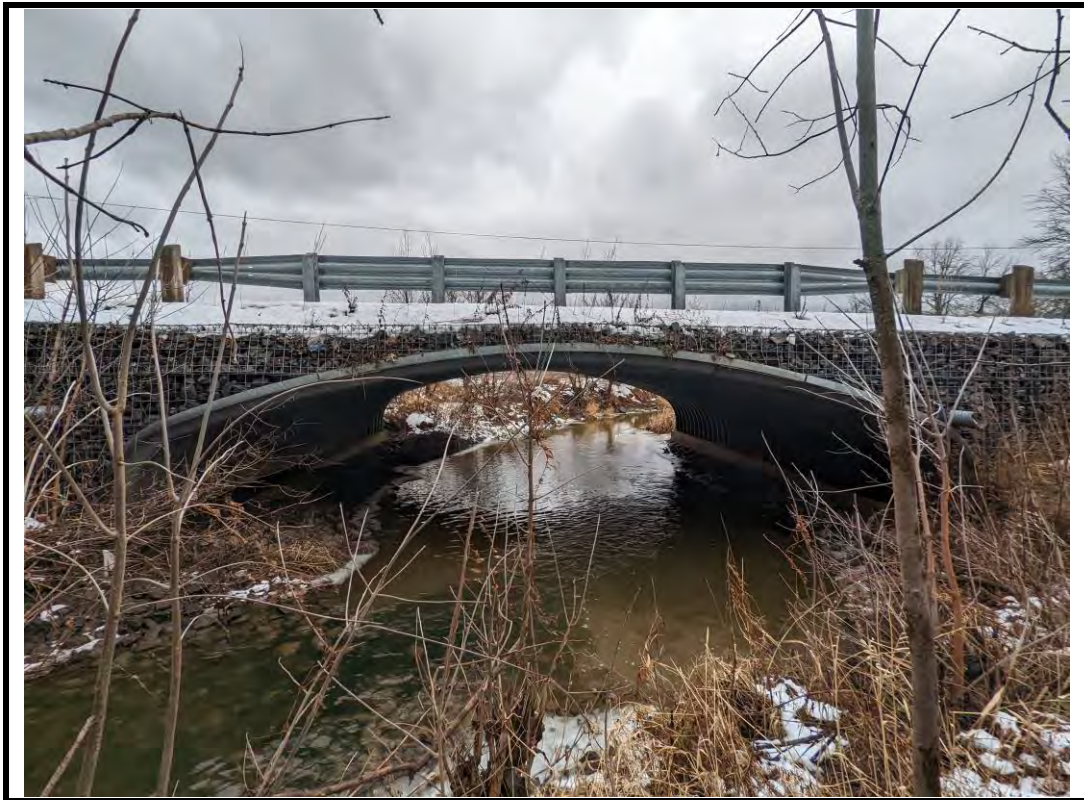
Photo 6 South elevation

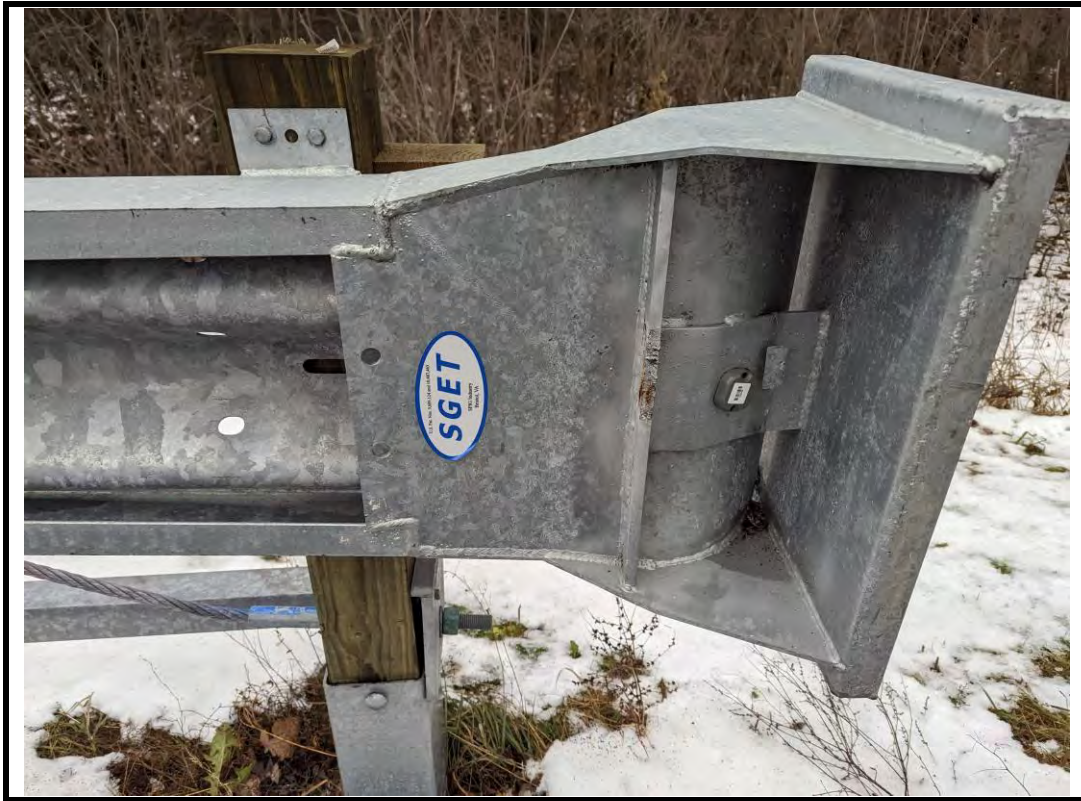
Photo 7 New approach guide rail and end treatments above structure (typ.)

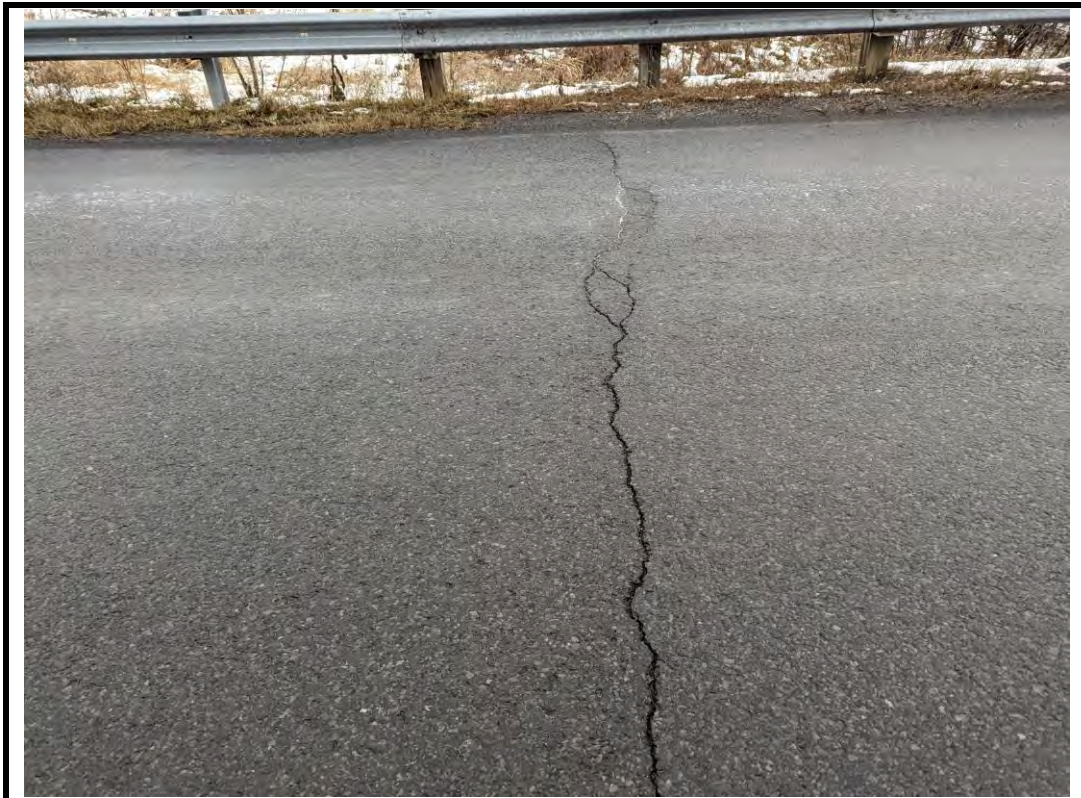
Photo 8 Wide transverse crack in asphalt wearing surface above structure

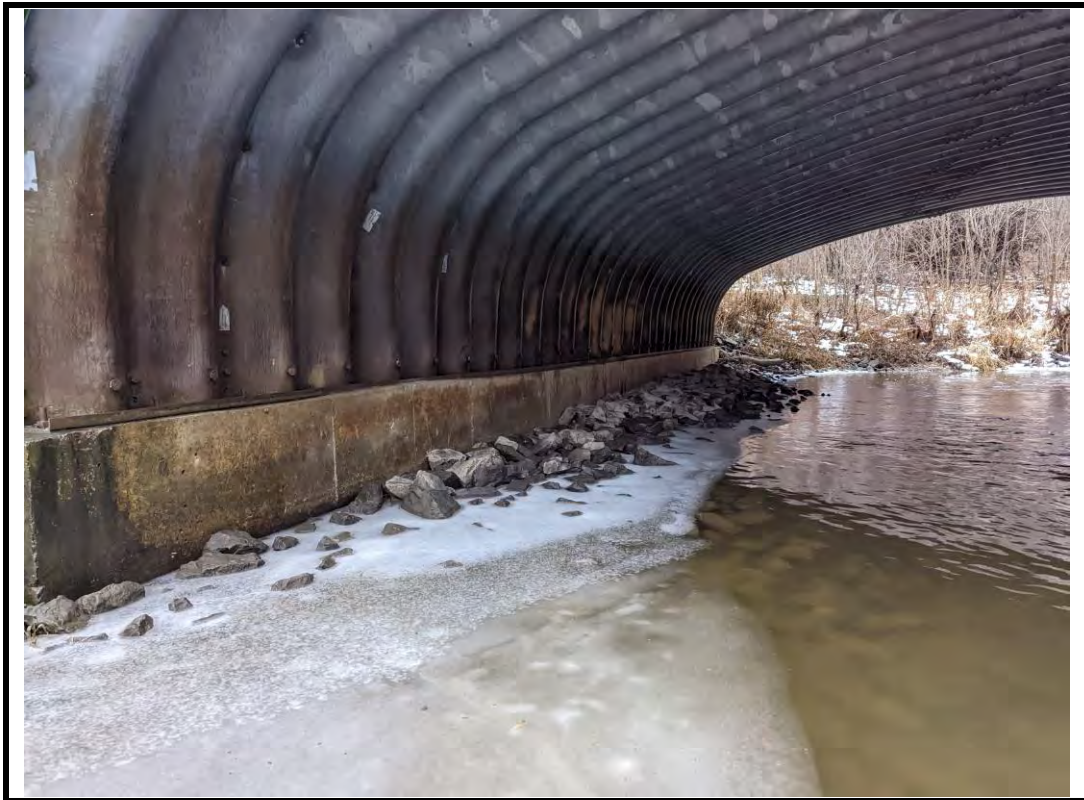
Photo 10 Coating failure within culvert along east strip footing

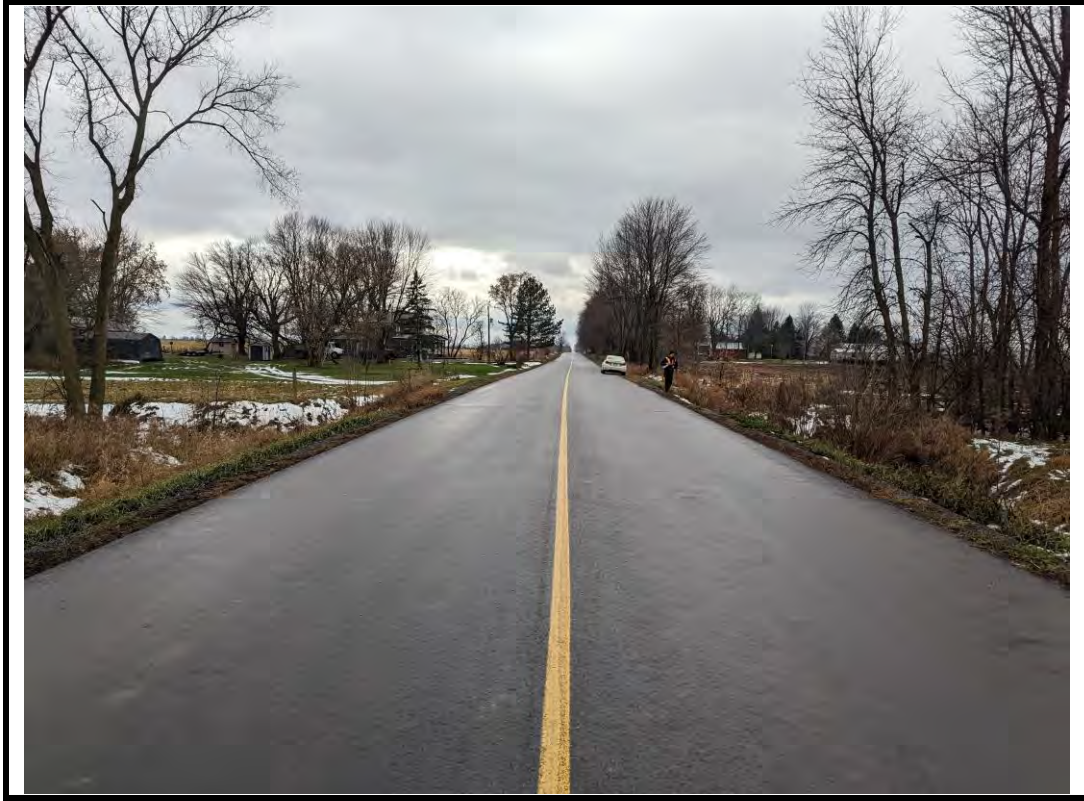
Photo 1 Structure from east approach

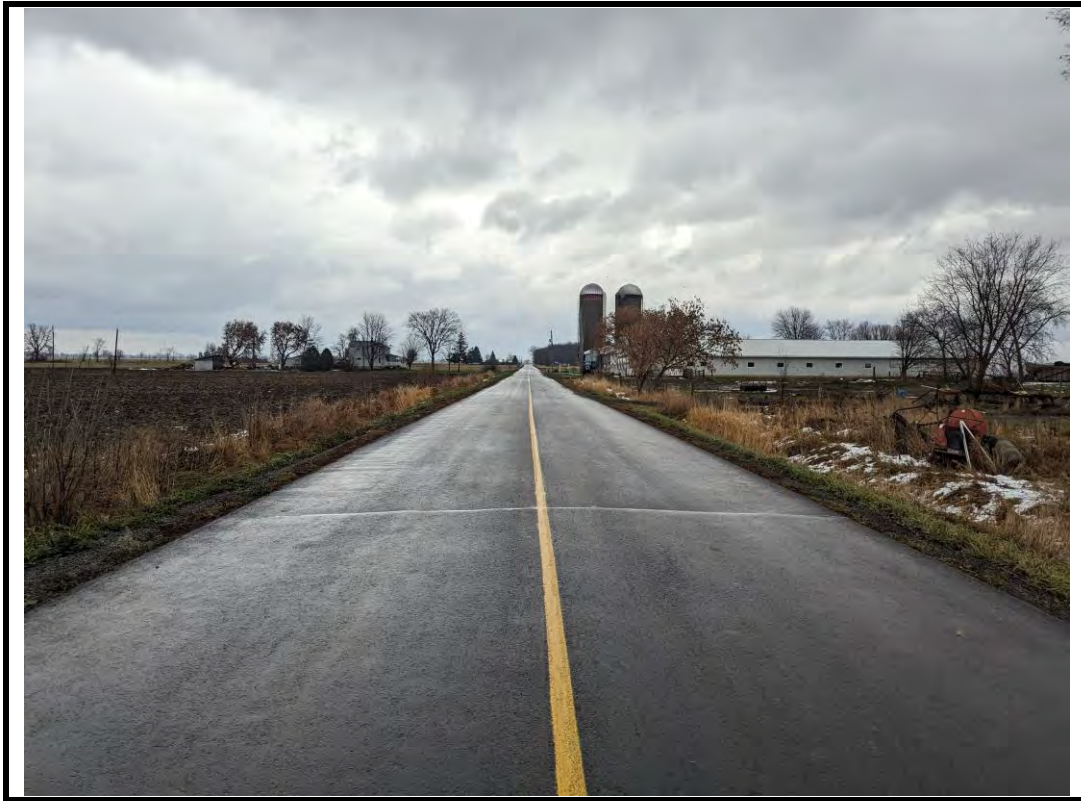
Photo 3 East approach from centre of structure

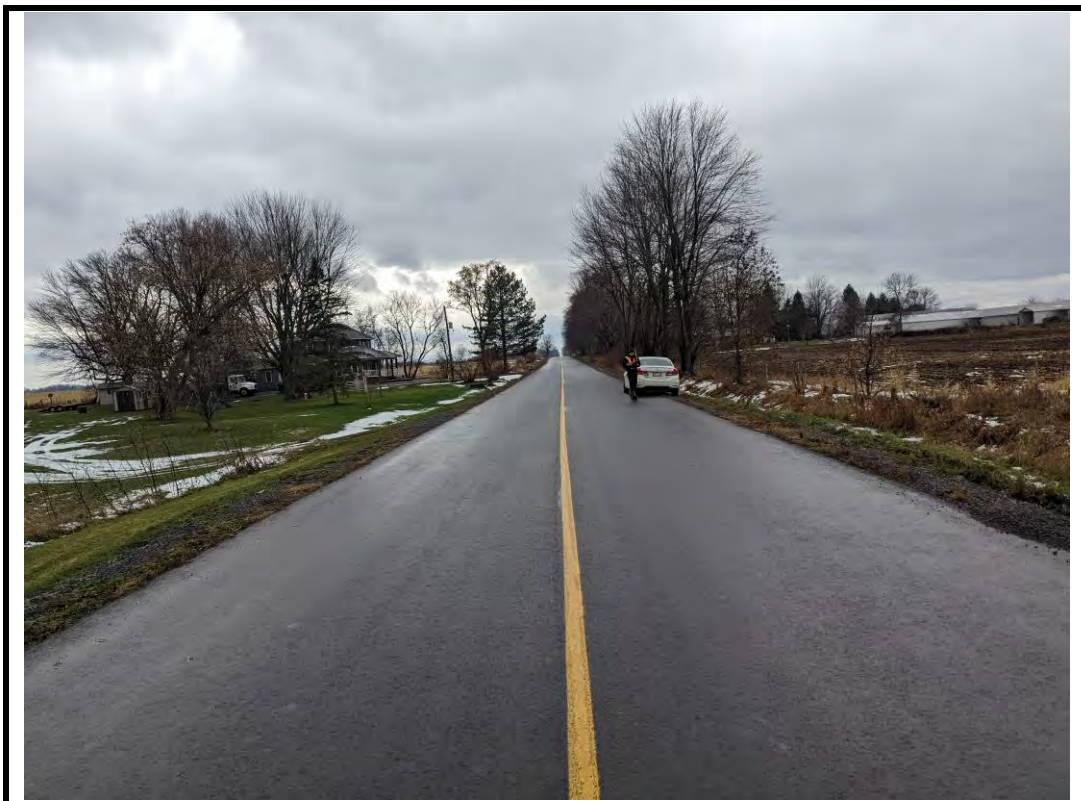
Photo 4 West approach from centre of structure

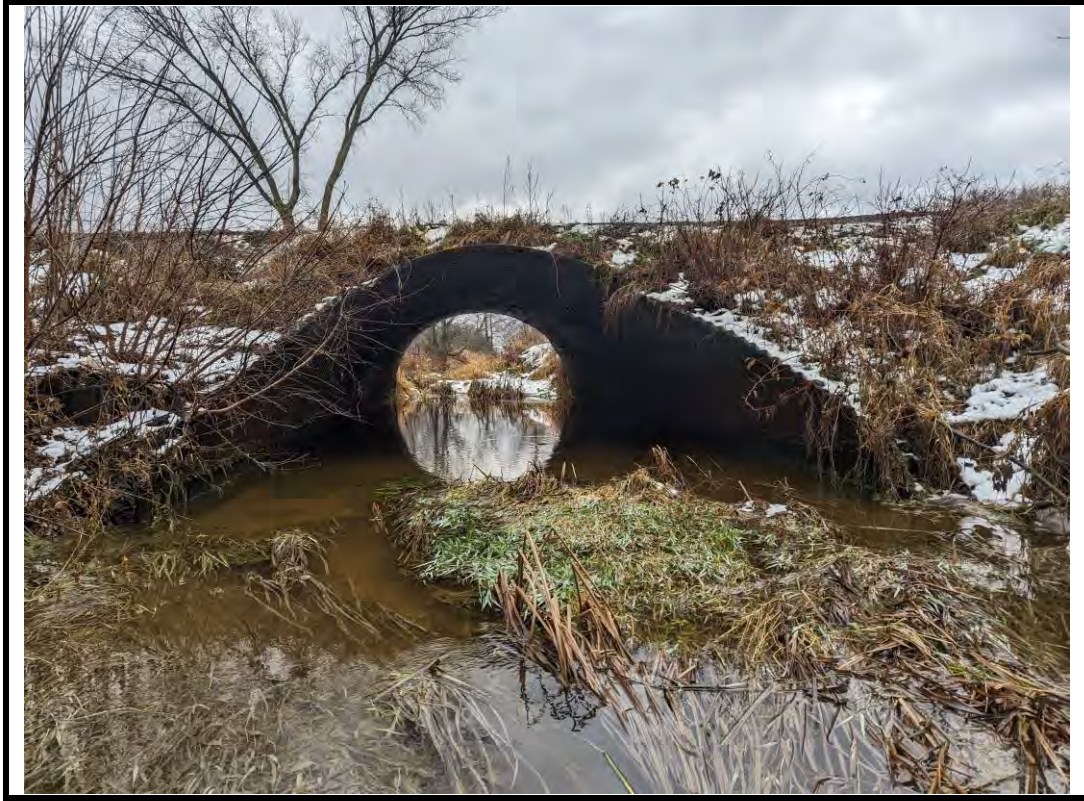
Photo 5 North elevation

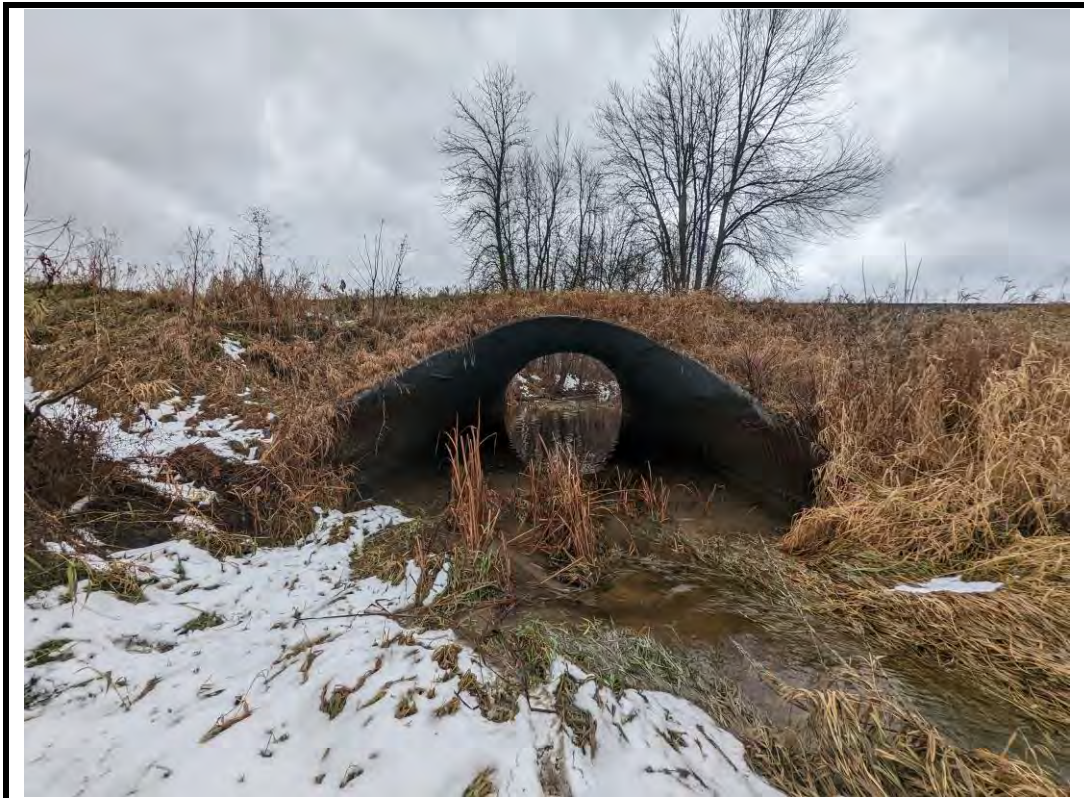
Photo 6 South elevation

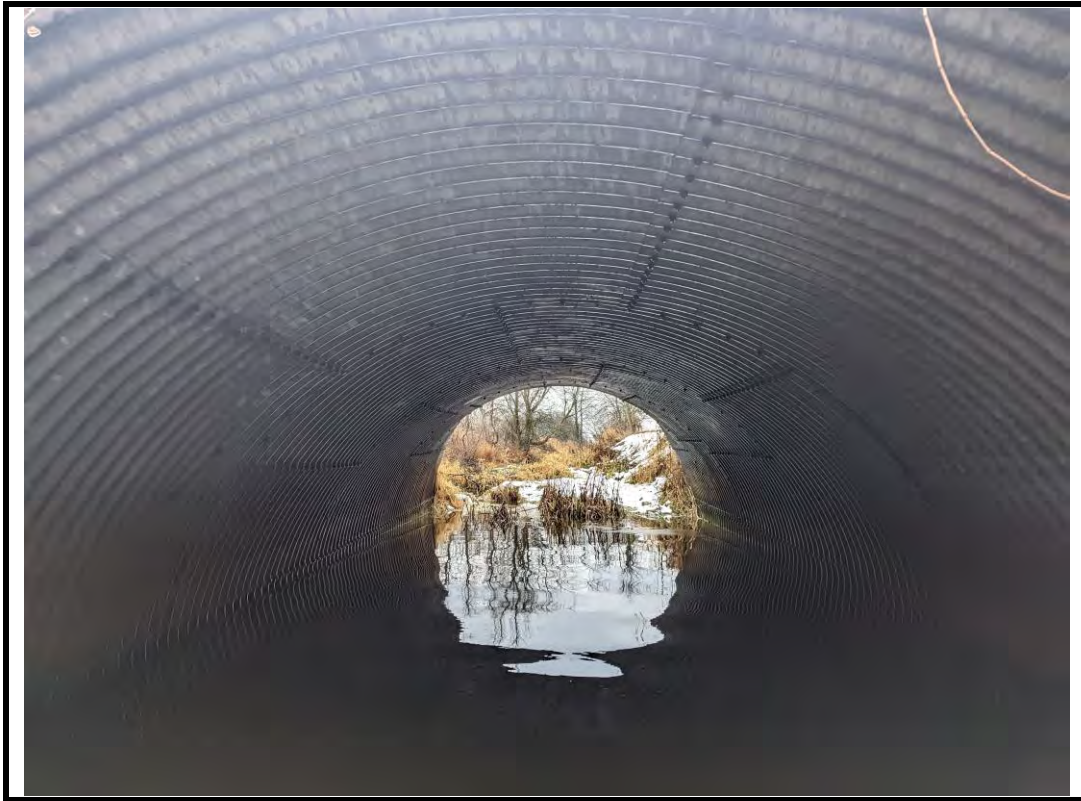
Photo 7 View of culvert sag from the North side

Repair and Rehabilitation Required:		Priority			Estimated Cost
Element	Repair and Rehabilitation Required	6-10 Years	1-5 Years	< 1 Year	
Pipe Arch	Replace		X		\$ 462,000.00
					\$ -
					\$ -
					\$ -
					\$ -
					\$ -
					\$ -
					\$ -
					\$ -
Total Cost:					\$ 462,000.00

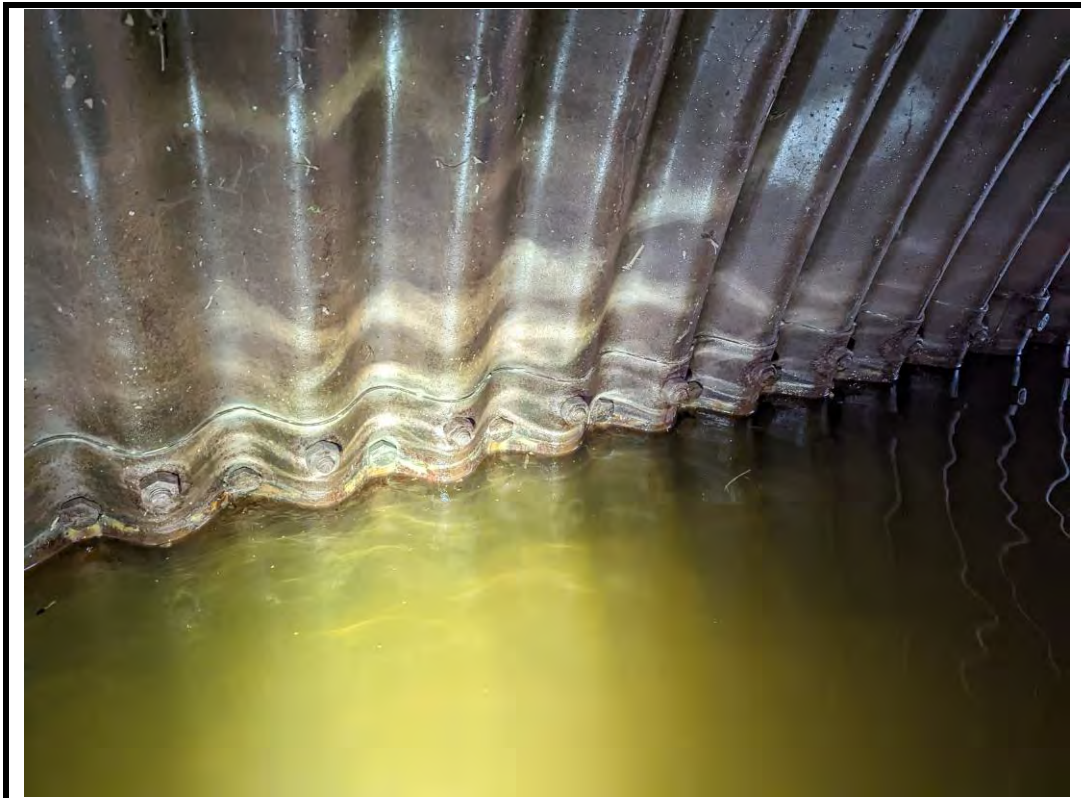
Photo 8 Section crack/splitting along boltline at East barrel wall, with coating loss
